RIO GRANDE DIVERSION INFRASTRUCTURE INVENTORY

Structure Name: FARMERS UNION CANAL

Date: April 9, 2019

PHOTO LOG

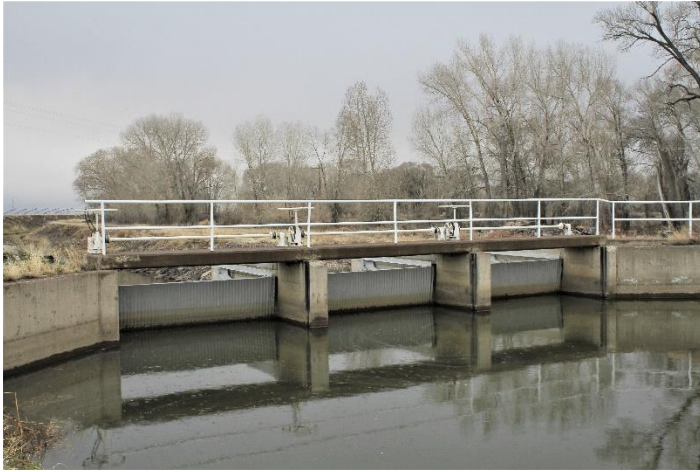
Headgate looking downstream

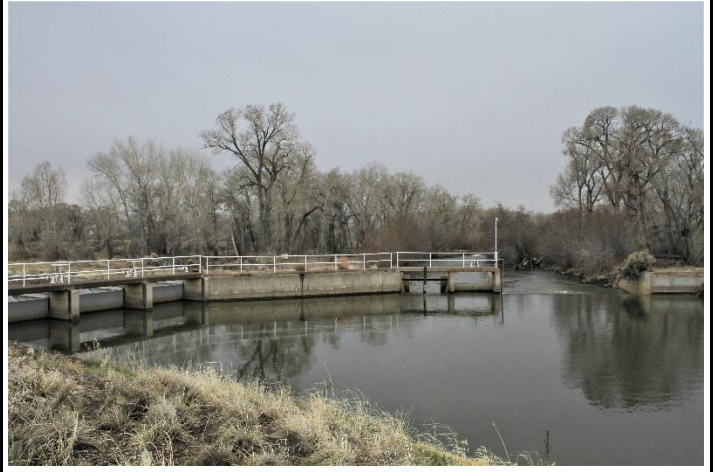
Headgate and diversion dam

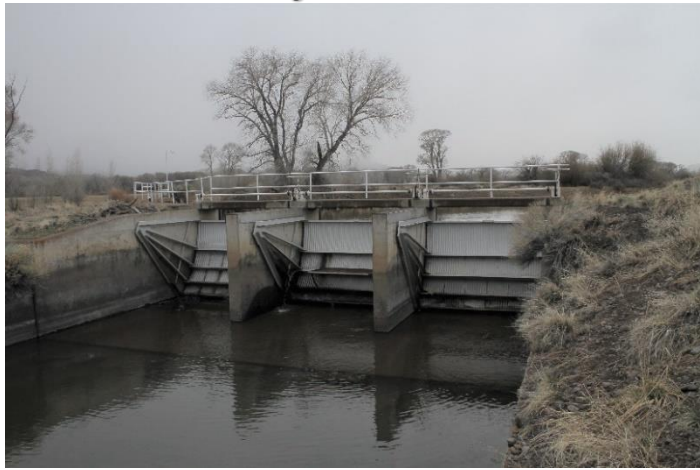
Headgate outlet

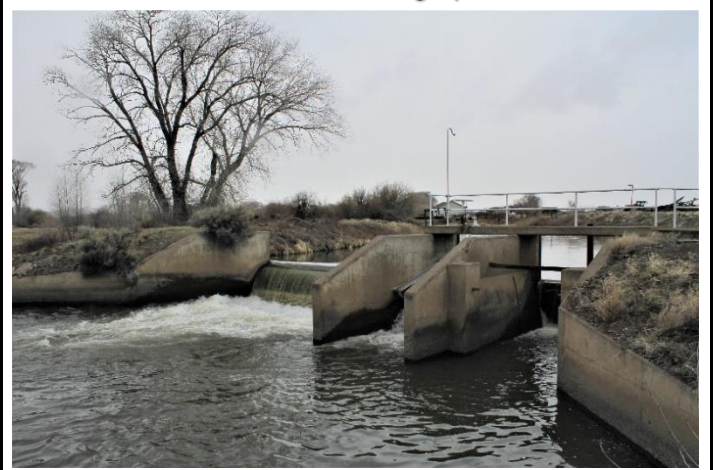
Diversion dam looing upstream

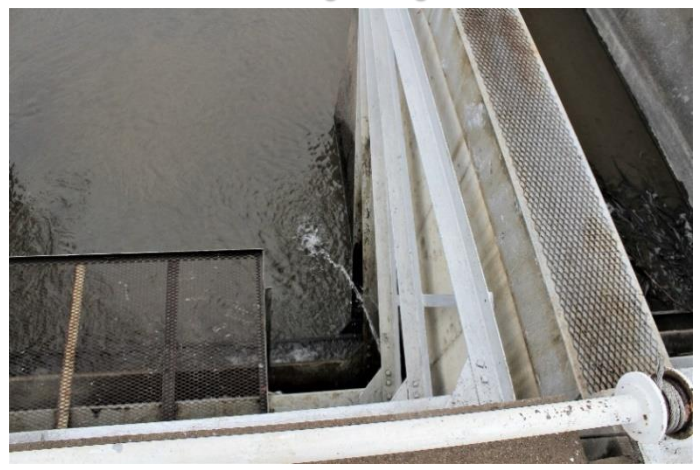
Leaking headgate

Repair(s) or Improvement(s) Currently Needed: The headgates leak and need to be repaired, but they function moderately well. Fish passage and riparian restoration should be considered as part of any future repairs or improvements.

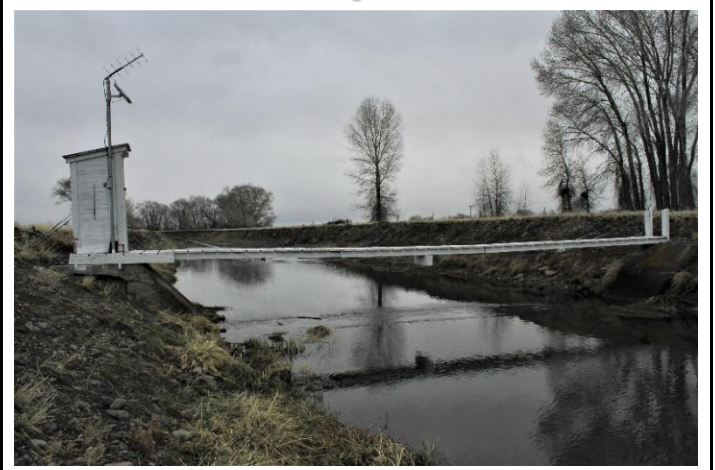
Flume looking downstream
