# SAGUACHE CREEK DIVERSION INFRASTRUCTURE INVENTORY

**Structure Name:** WARD HIGHLINE D

**Date:** April 12, 2019

Saguache Creek Stream Management Plan

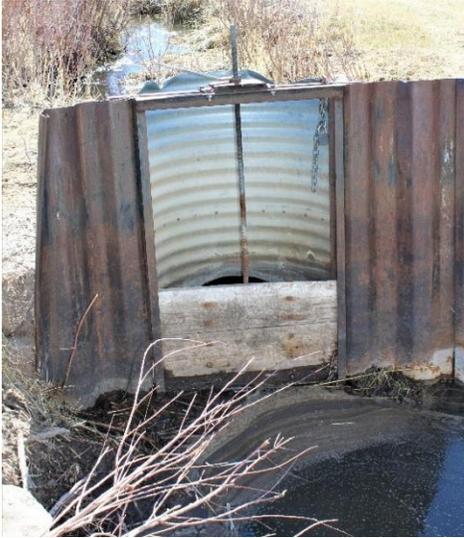
Headgate looking downstream

**Repair(s) or Improvement(s) Currently Needed:** The headgate could be improved and the diversion dam should be replaced with a less dangerous structure that allows for fish passage. Some woody vegetation should be cleared to improve access to structure. Riparian restoration should be considered as part of any future repairs or improvements.

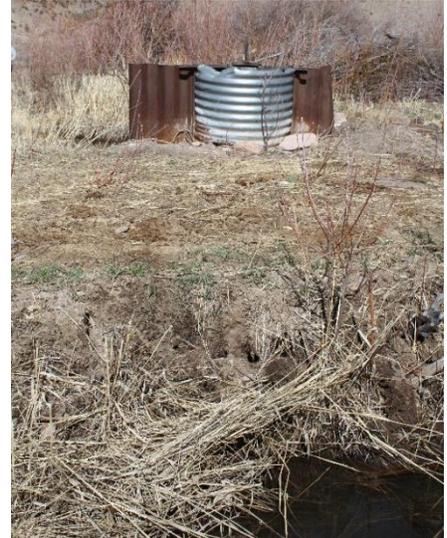
Headgate outlet

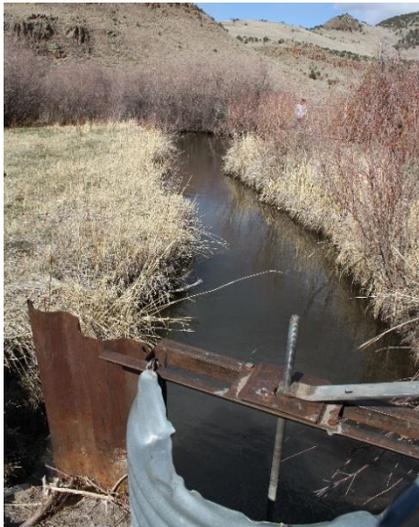
**Structure Description:** This ditch is located in the transition zone between two meanders. The diversion dam is made up of boulders, t-posts, and a large telephone pole spanning the river. The telephone poll provides bracing for the t-posts as well as an access bridge across the stream. The diversion causes a significant drop in the stream's elevation, which creates a barrier to fish passage. At some flows, the drop by can be as high as 6 feet. It also limits sediment transport and causes water to back up and the form a pool upstream of the diversion dam. Although this diversion functions moderately well for the water users, it is dangerous to cross the telephone pole. The diversion dam directs water to a short, ~50 foot feeder ditch and to the headgate. The headgate functions but could be improved.

Diversion dam and feeder ditch

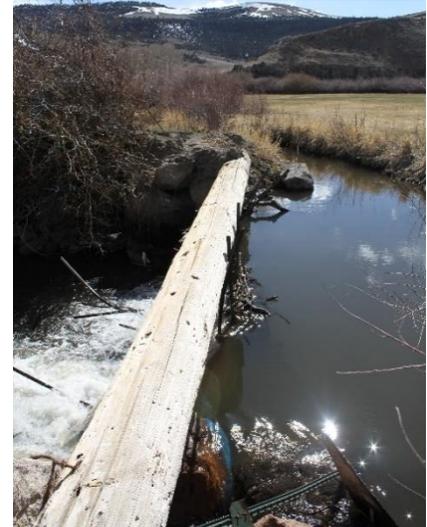
Diversion dam

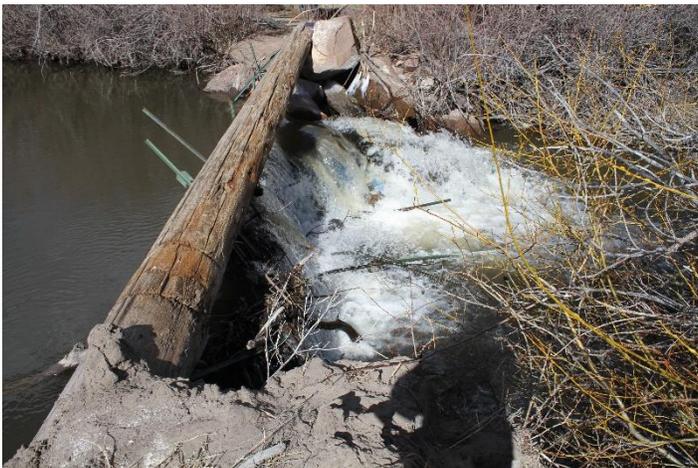
Diversion dam

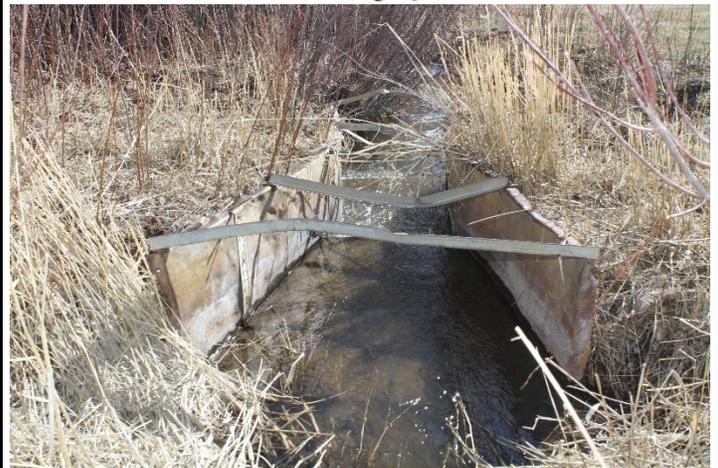
Flume looking upstream
