SAGUACHE CREEK DIVERSION INFRASTRUCTURE INVENTORY

Structure Name: STUBBS GALLEGOS D

Date: April 11, 2019

Saguache Creek Stream Management Plan

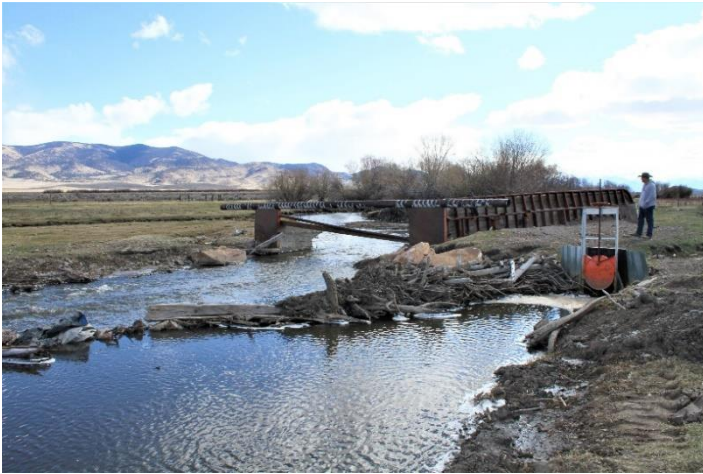
Headgate Condition:	A <input type="checkbox"/>	Diversion and Other Condition:	A <input type="checkbox"/>	Stream Miles From Saguache Creek Terminus (Point Of Diversion):	Structure Submerged: Yes <input type="checkbox"/>
	B <input checked="" type="checkbox"/>		B <input type="checkbox"/>	33.45 mi	No <input checked="" type="checkbox"/>
	C <input type="checkbox"/>		C <input checked="" type="checkbox"/>		
	D <input type="checkbox"/>		D <input type="checkbox"/>		
	F <input type="checkbox"/>		F <input type="checkbox"/>

Headgate looking downstream

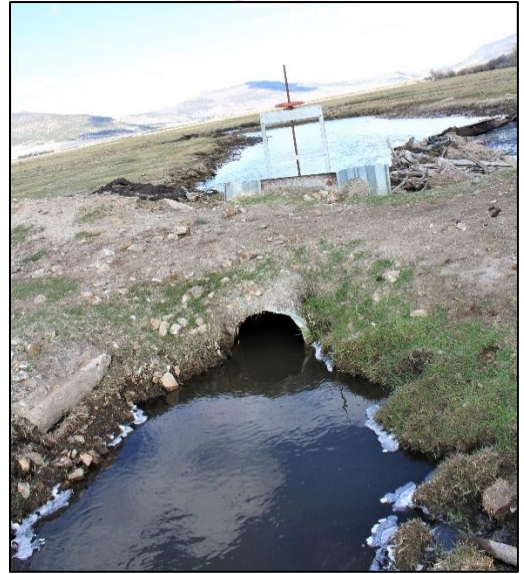
Headgate outlet

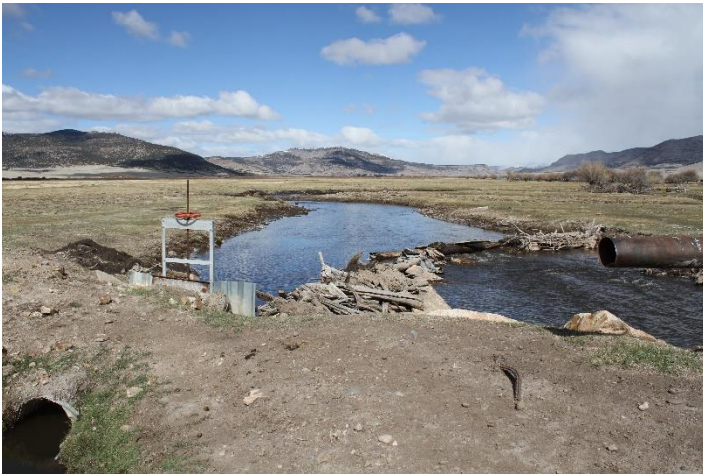
Structure Description: This ditch is located just downstream of the Reservoir Enlargement Ditch. The diversion dam is made up of boulders, debris, and a tree trunk and directs water to the headgate on the south bank of the stream. The old diversion dam is just downstream of the current dam. Debris accumulation at the headgate is a moderate issue. The flume is sunken and partially collapsed. It does not measure accurately.

Diversion dam looking upstream

Repair(s) or Improvement(s) Currently Needed: The old diversion dam is not serving a purpose and could be removed. The existing diversion dam could be improved to reduce maintenance at this structure. No other repair needs were noted. The headgate functions effectively. Fish passage and riparian restoration should be considered as part of any future repairs or improvements.

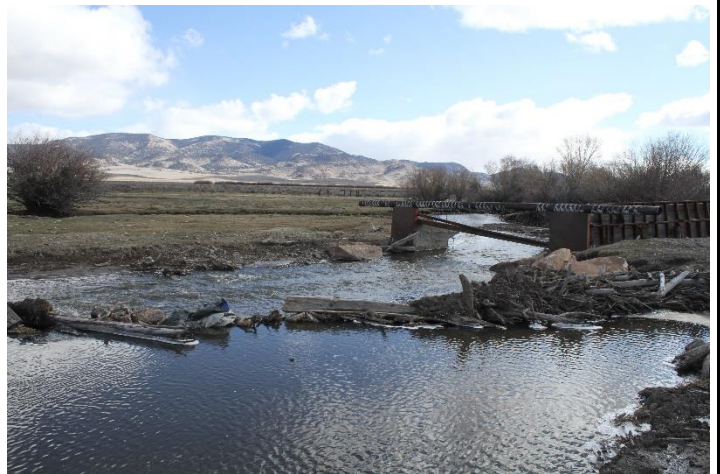
Diversion dam looking downstream

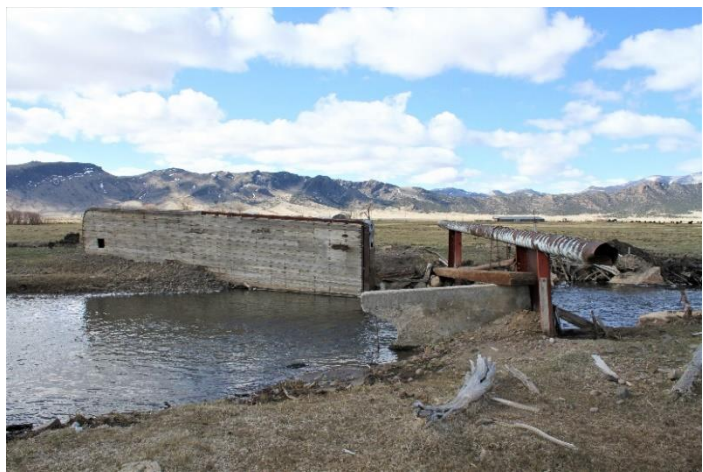
Old diversion dam

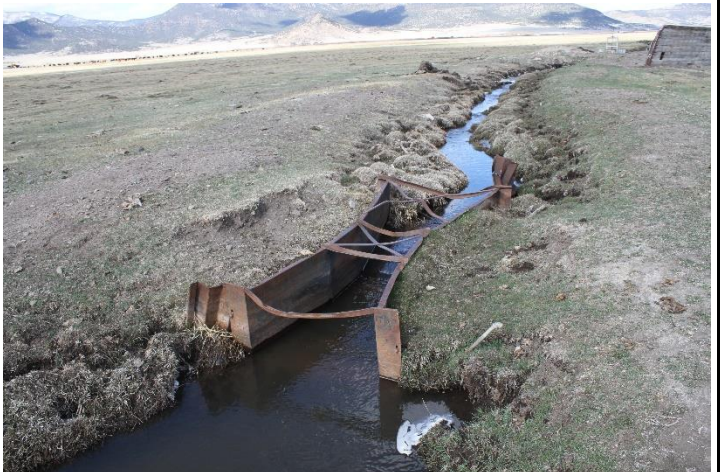
Flume looking upstream
