MUSTANG BEACH UNIT II BULKHEAD INVESTIGATION

Port Aransas, Texas

June, 2011
Revised January 2012
Job No. 42390.00.00

Mustang Beach Unit II **Bulkhead Investigation**

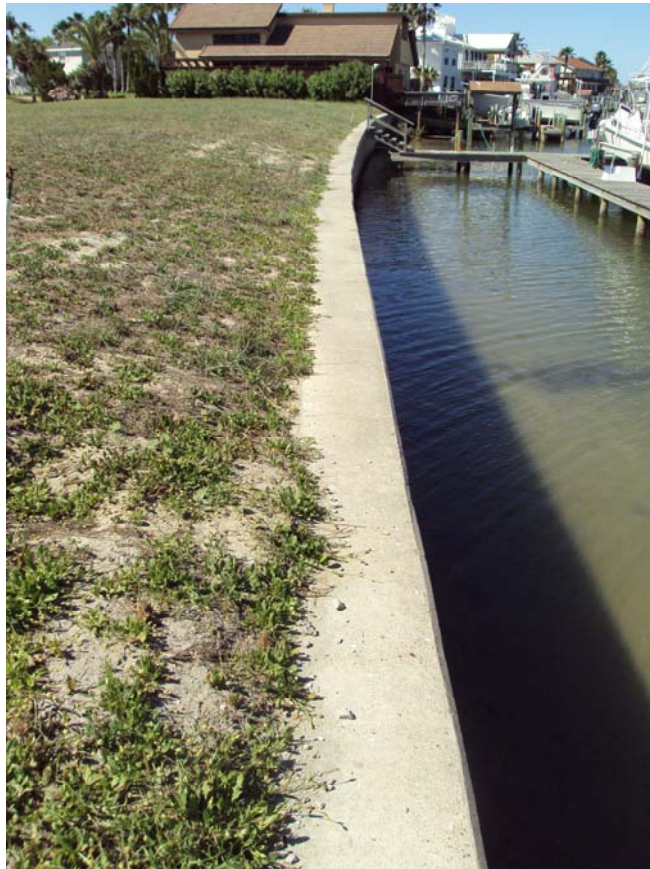
1. Lot 20, Block 3 – Rust Stains (1 - Good)

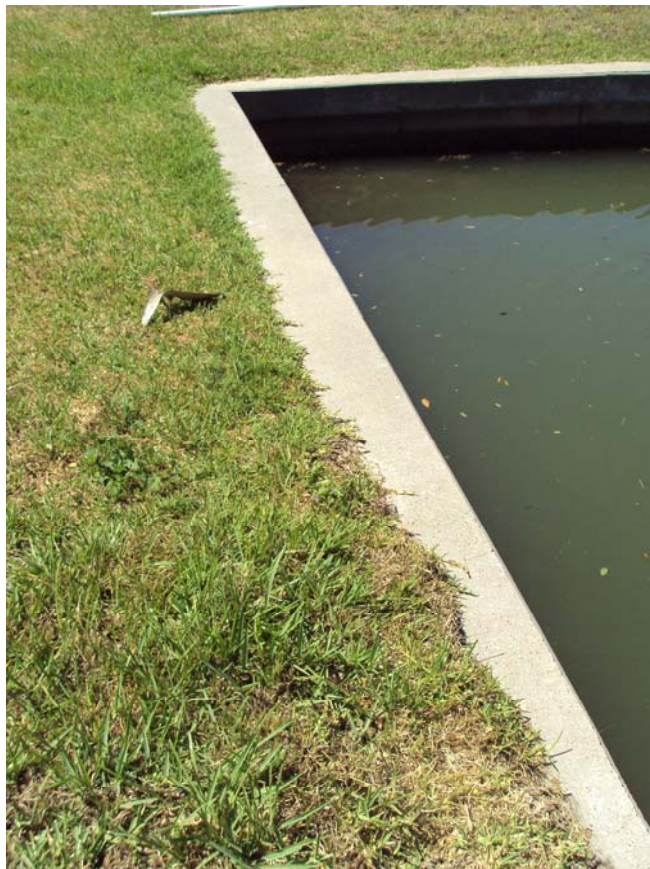
2. Lot 42, Block 3 – Minor/Shrinkage Cracks (1 - Good)

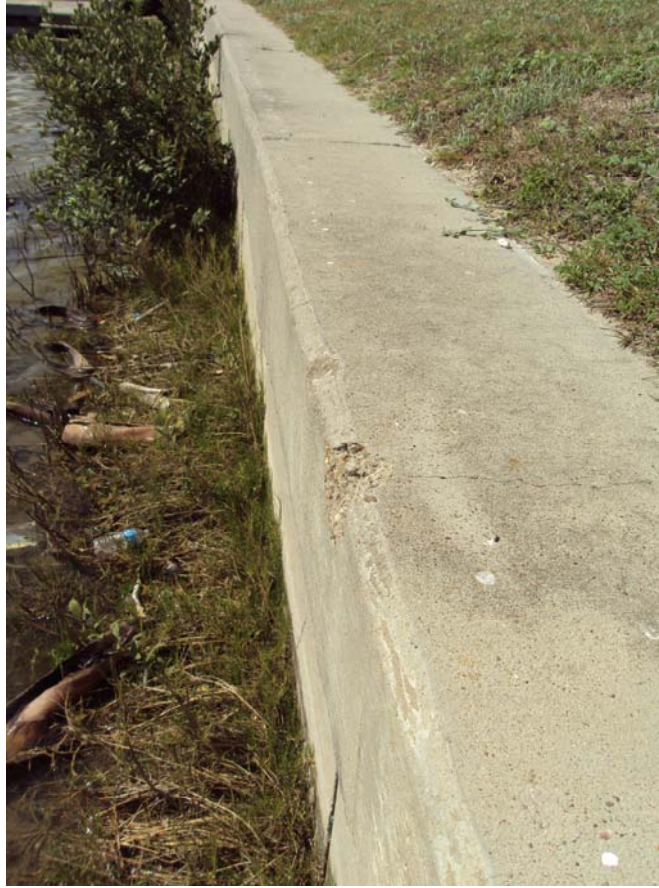
3. Lot 16, Block 3 – Minor Cap Damage (2 - Satisfactory)

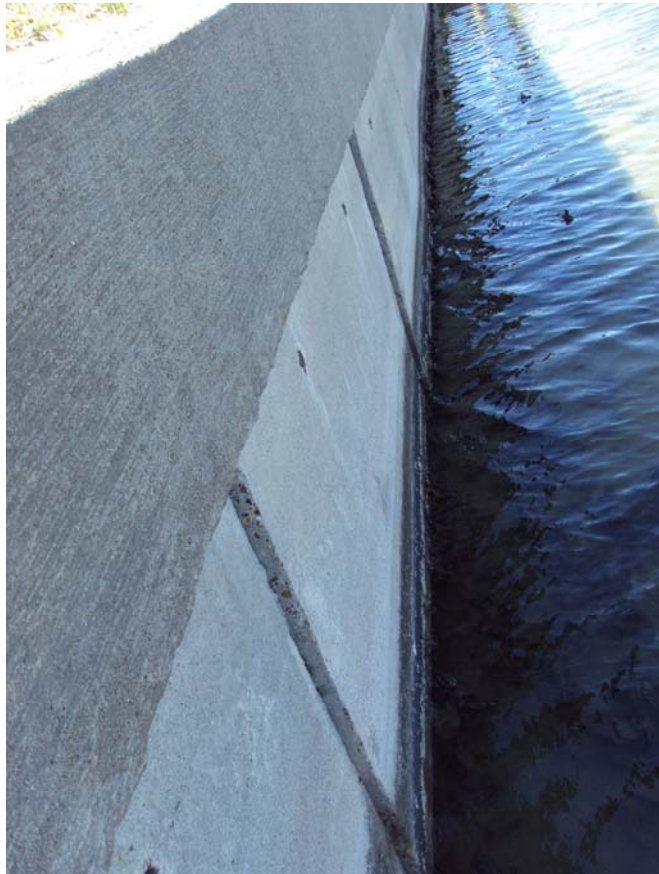
4. Lot 27, Block 3 – Panel Shift (2 - Fair)

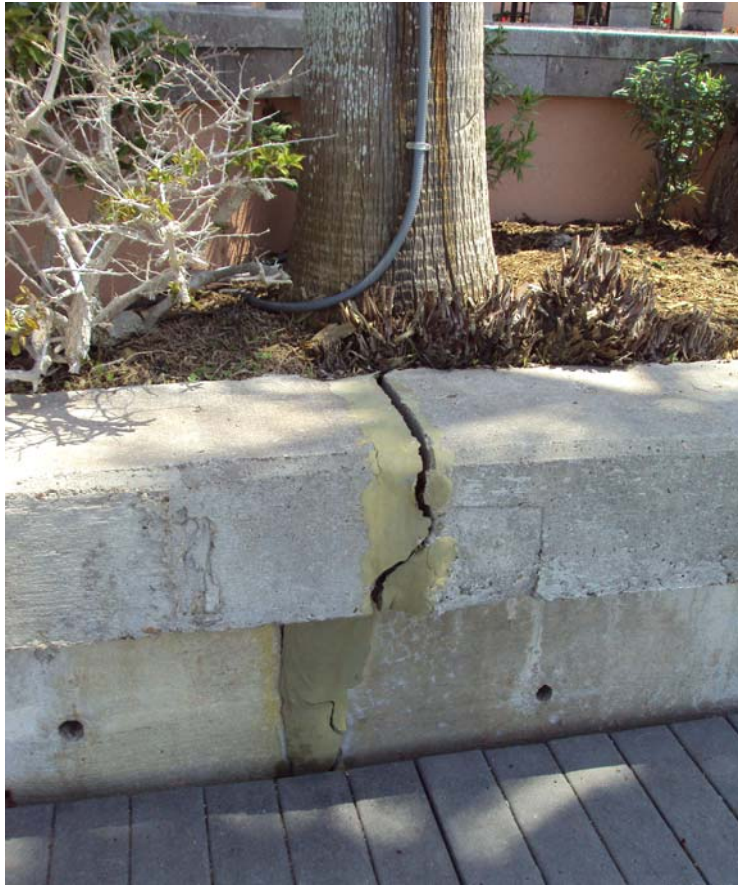
5. Lot 6, Block 2 – Joint and Panel Damage (3 - poor)

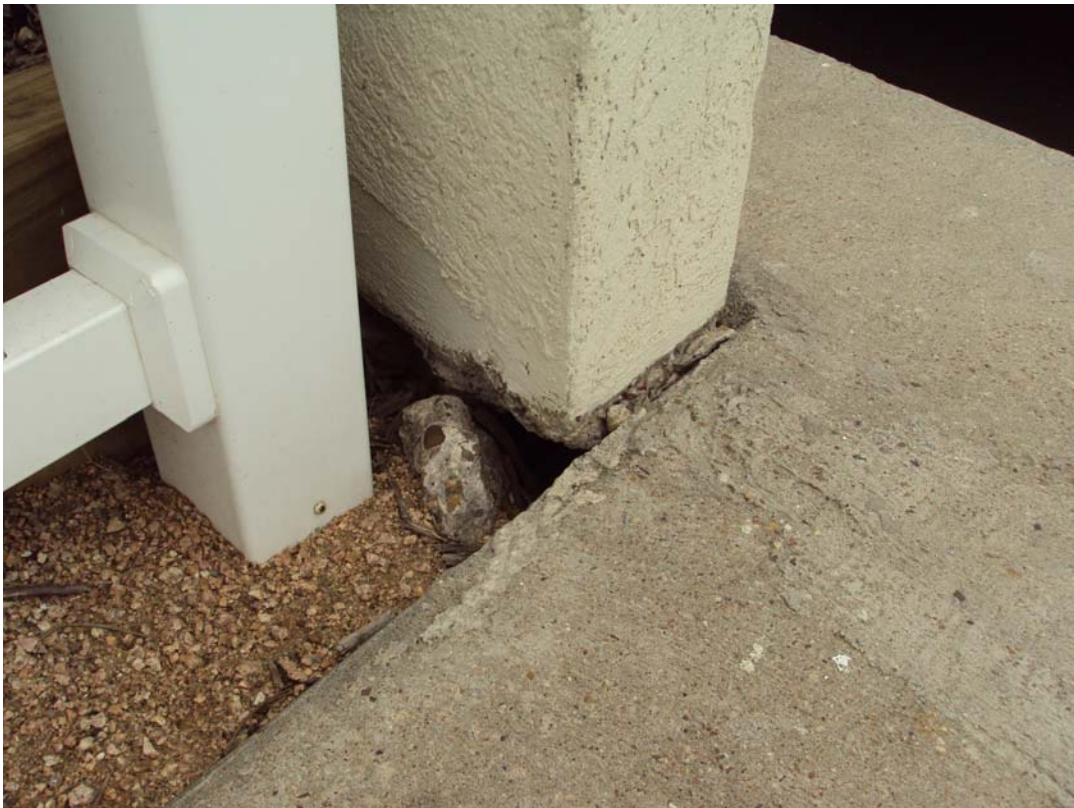
6. Lot 2, Block 1 – Small Sinkhole at Corner (3 - Fair)

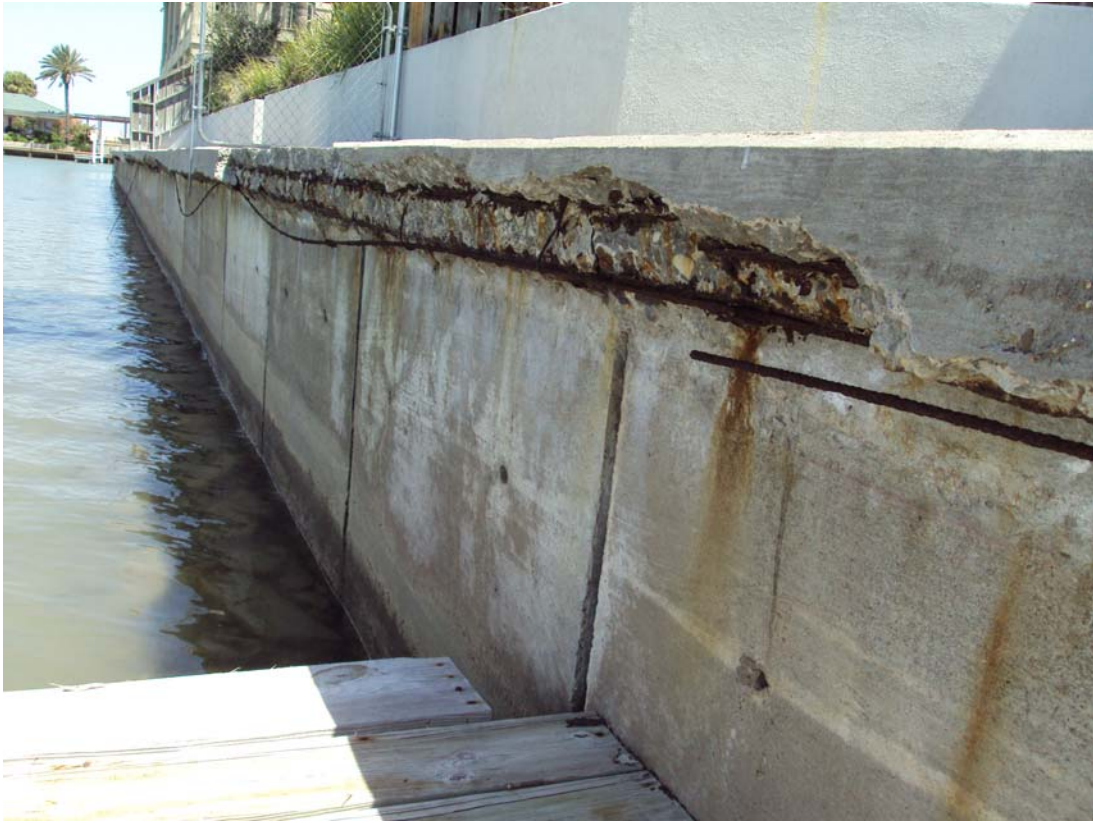
7. Lot 4, Block 3 – Major Cap Damage (4 - Poor)

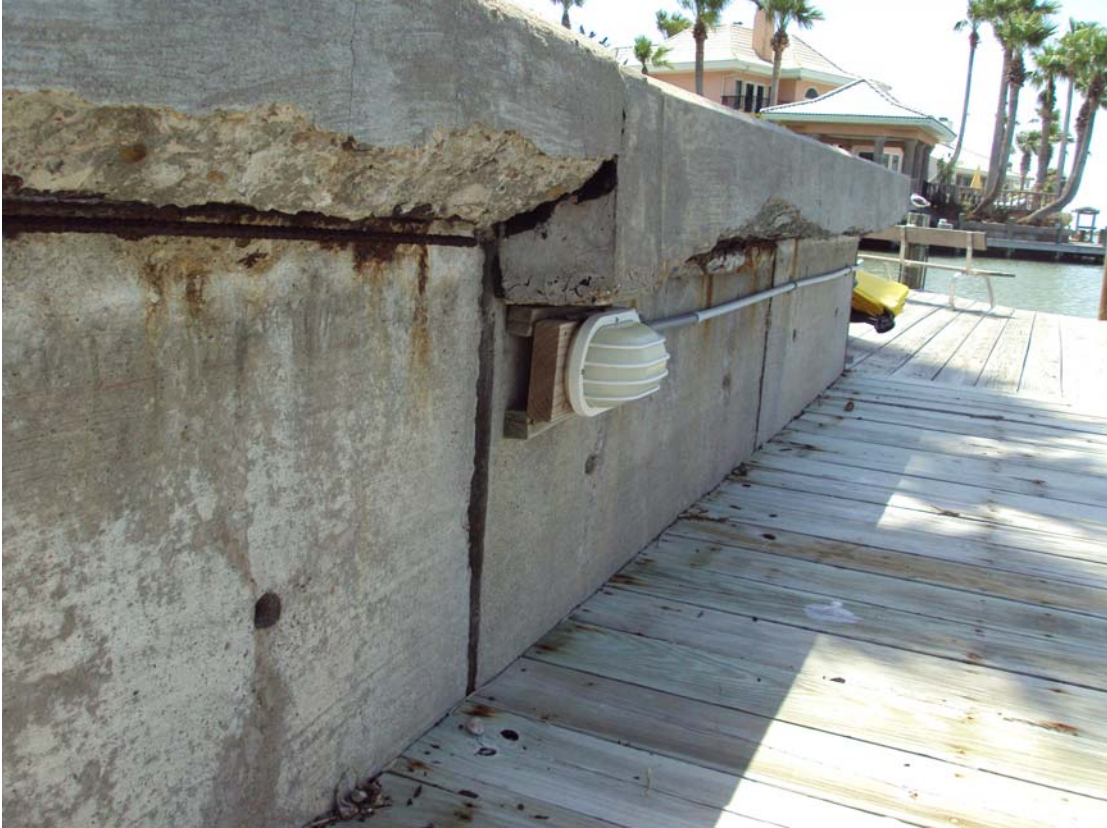
8. Lot 3, Block 3 – Major Cap Damage (4 - Poor)

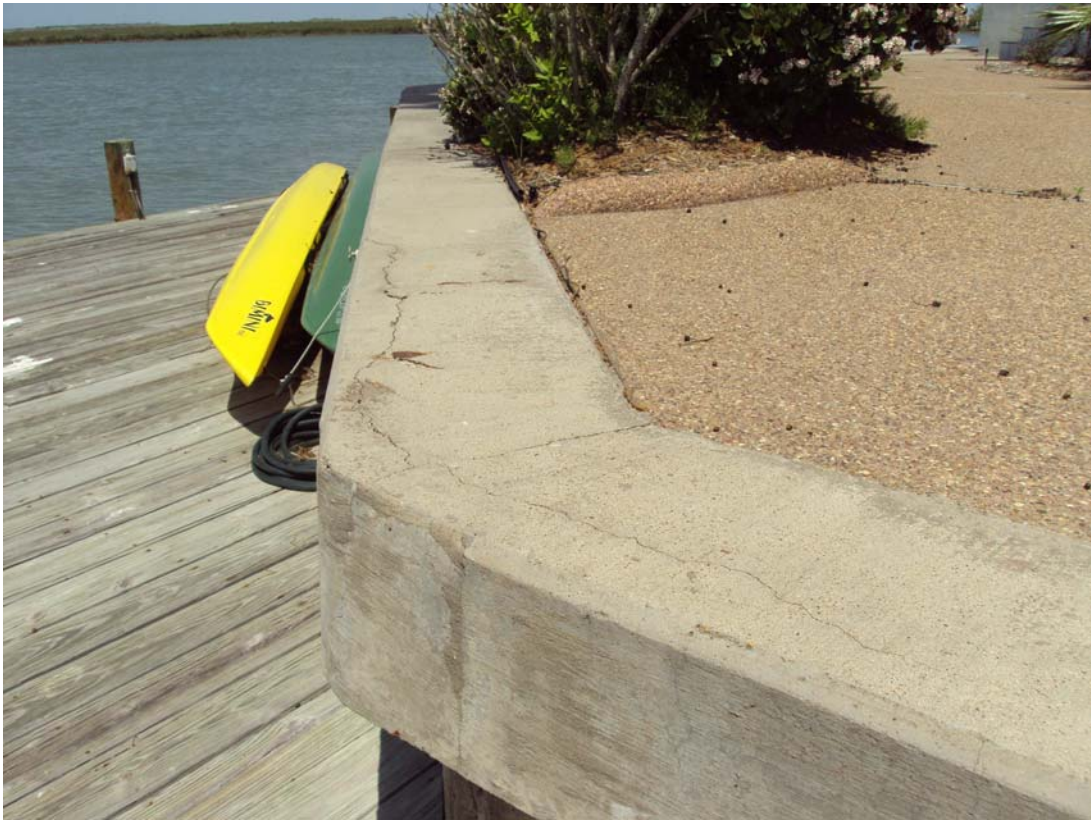
9. Lot 3, Block 3 – Settlement and Void below Concrete (4 - Poor)

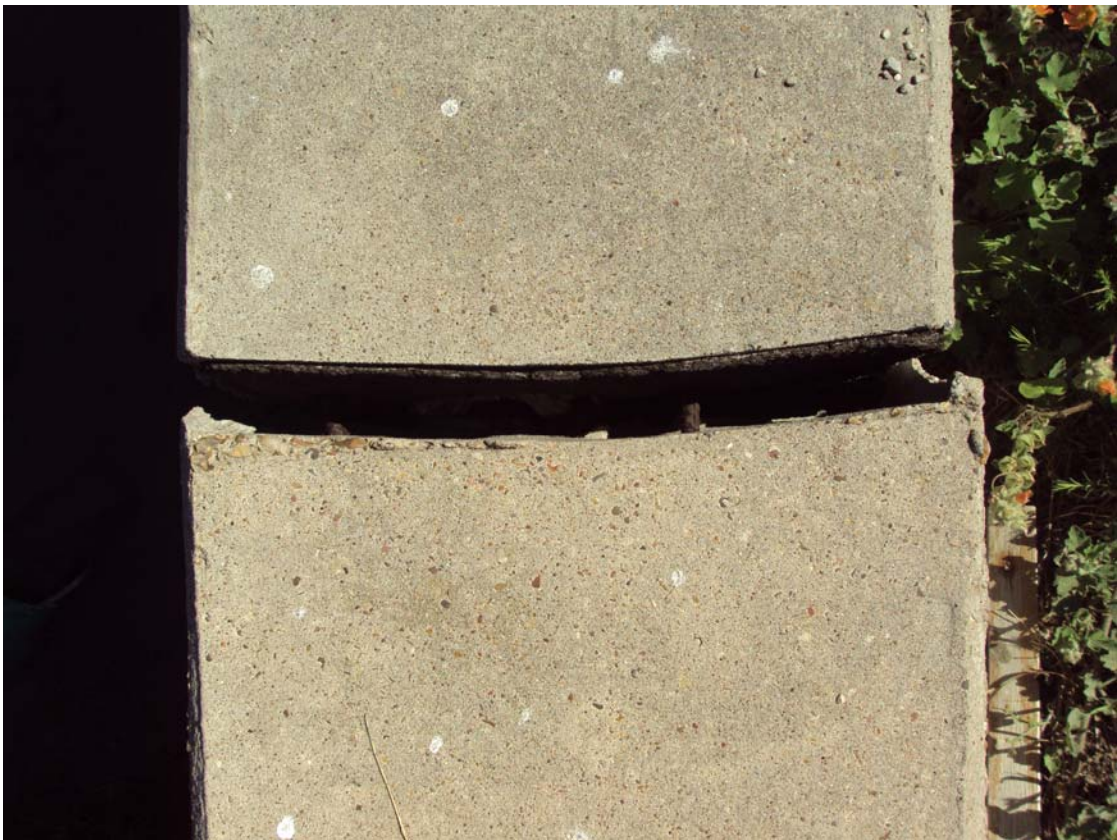
10. Lot 22, Block 3 – Cap Joint Material missing and Large Sinkhole behind Bulkhead (4 - Poor)

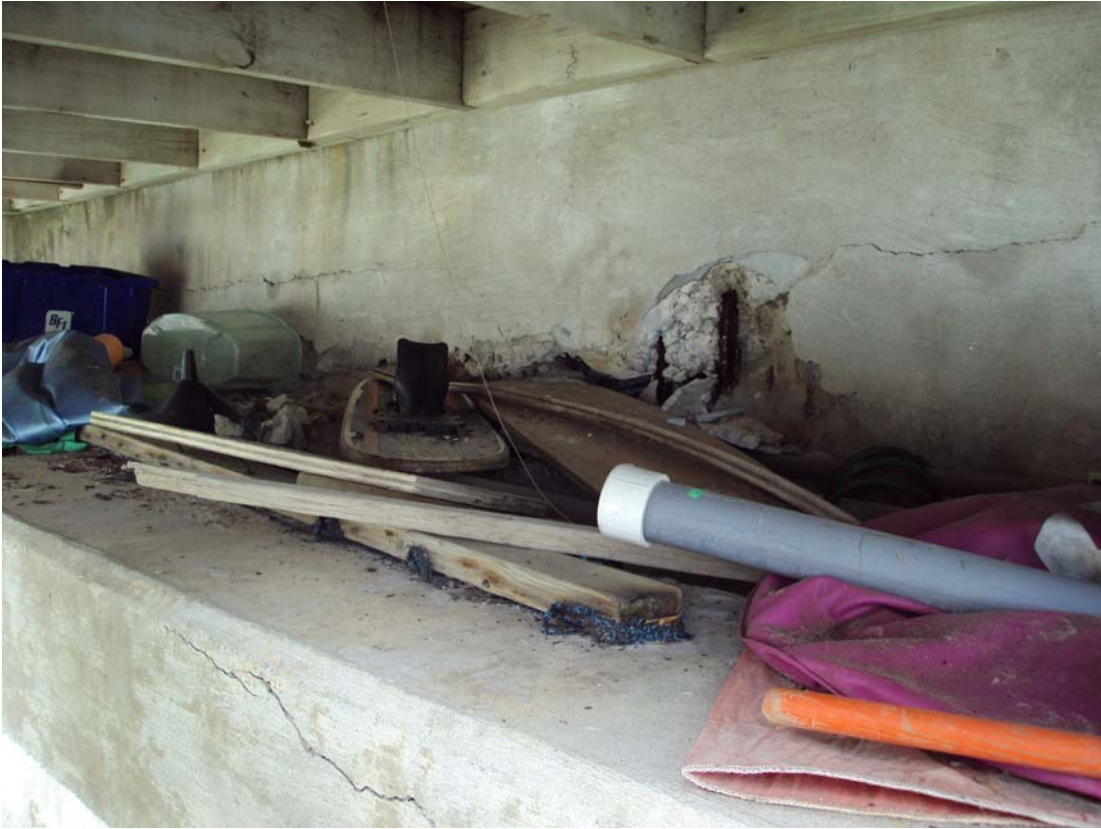
11. Lot 14, Block 3 – Foundation Failure and Moderate Cap Damage (5 - Critical)

14	3	Y	5 - Critical	6929 - 6948	60.00			Mod Cap cracks & damage due to boat lift loading, Maj Structural damage on Conc walls and foundation
15	3	Y	2 - Fair		60.00			
16	3	N	2 - Satisfactory	6926 - 6928	60.00			Min cracks, veg within J mtrl
17	3	Y	2 - Satisfactory	6923 - 6925	60.00			Min cracks, Min Cap damage
18	3	N	1 - Good	6920 - 6922	60.00			Min cracks, Panel 1/2" shift, rust spots, Min Cap damage
19	3	N	1 - Good	6916 - 6919	60.00		63	Min cracks, No visible damage
20	3	N	1 - Good	6913 - 6915	60.00			Little evidence of Rust

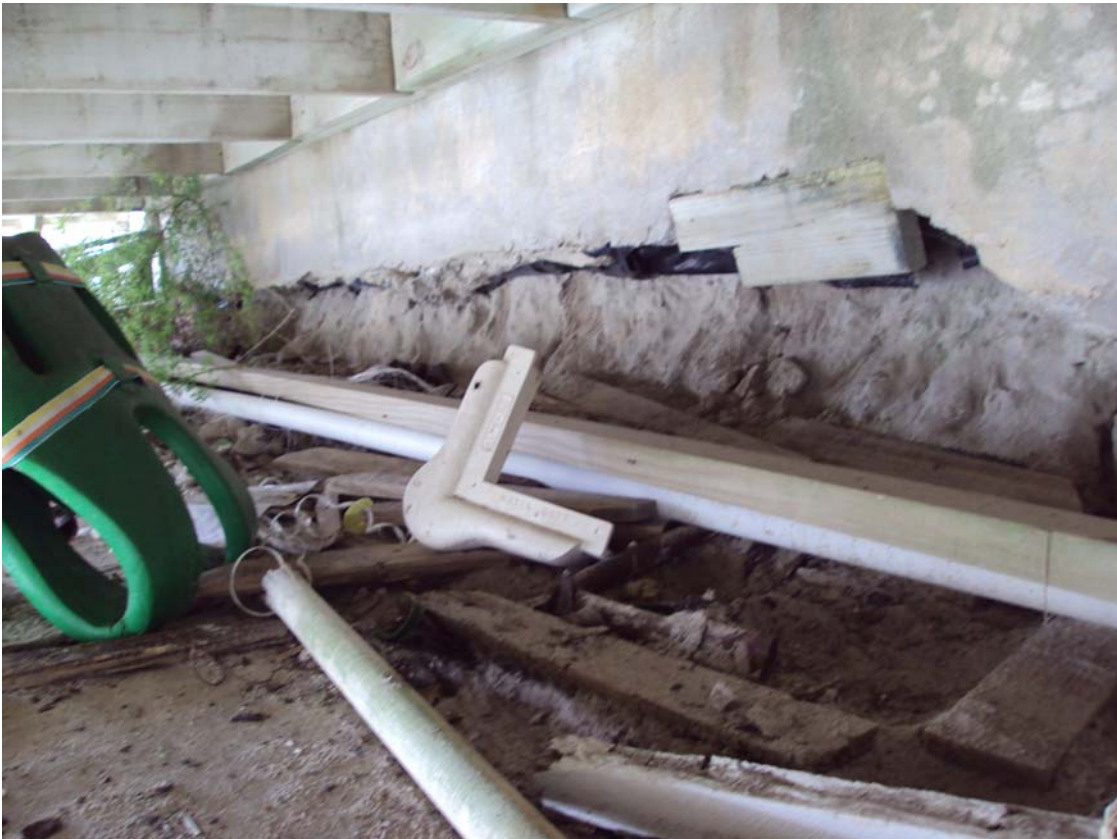
12. Lot 14, Block 3 – Foundation Failure (5 - Critical)

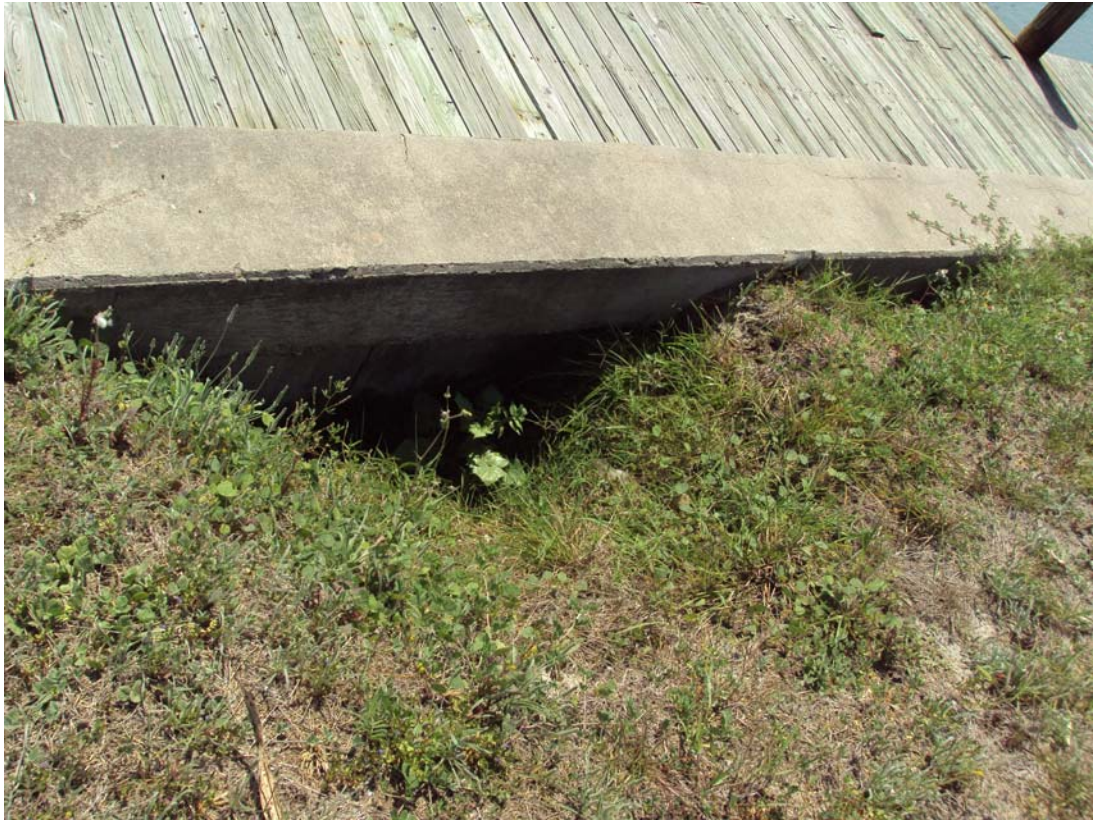
13. Lot 1, Block 2 – Large Sinkhole (4 - Poor)

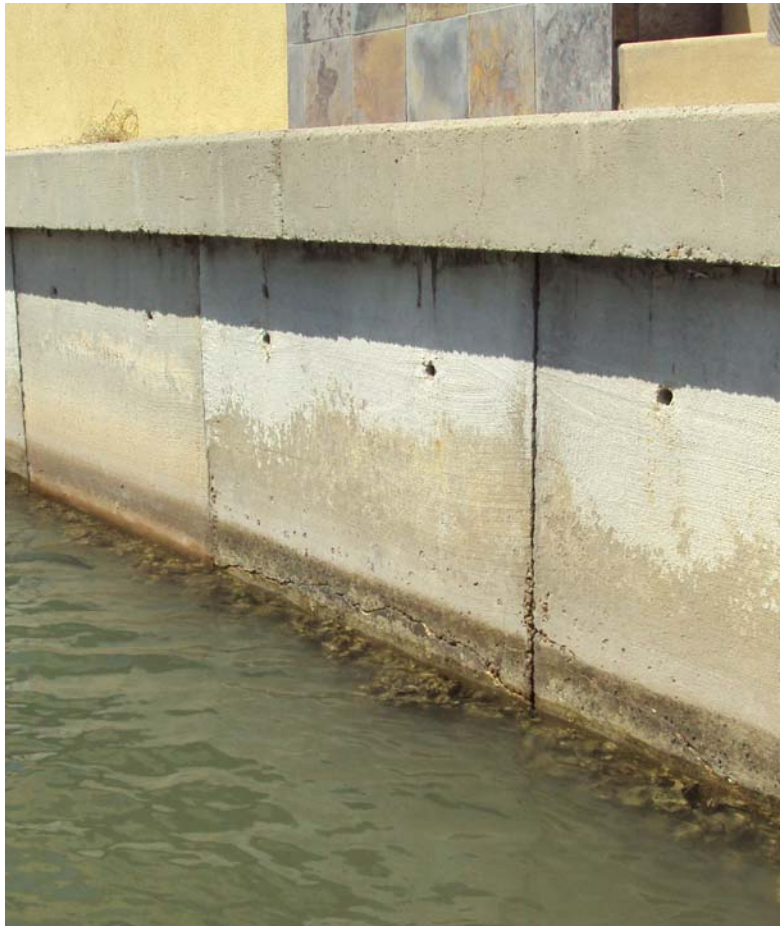
14. Lot 2, Block 2 – Cracked Bulkhead Panel (4 - Serious)
