Supplemental  
Report on the  
functional and  
physical adequacy  
of Baldwin's three  
existing fire station  
facilities

May 10, 2022

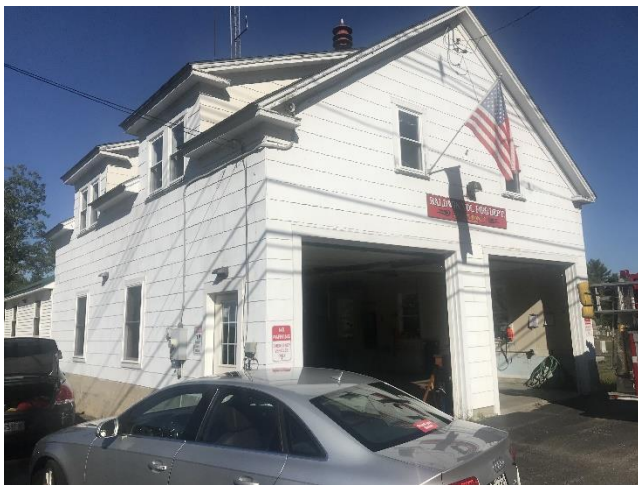
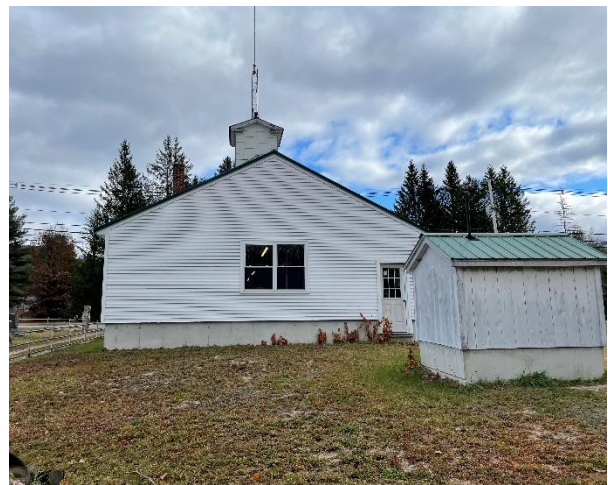
The Station at West Baldwin is a small two-story building with a 30' x 60' first floor apparatus bay and a 30' x 40' second floor meeting room over the apparatus bays. The original 2-story building in front appears to be around 80 years old. It is a slab-on-grade wood framed building and is in general disrepair. It is roofed with deteriorated asphalt shingles and sided with suspected asbestos siding. The 9'-6" h x 11'-0" w apparatus doors are too small for most modern equipment. The one-story rear section is newer and in better condition. It is vinyl sided with a metal roof. Insulation is poor to non-existent, especially at the exposed 2'-0" high concrete knee wall.

*West Baldwin Fire Station front and rear views, West Baldwin, Maine*

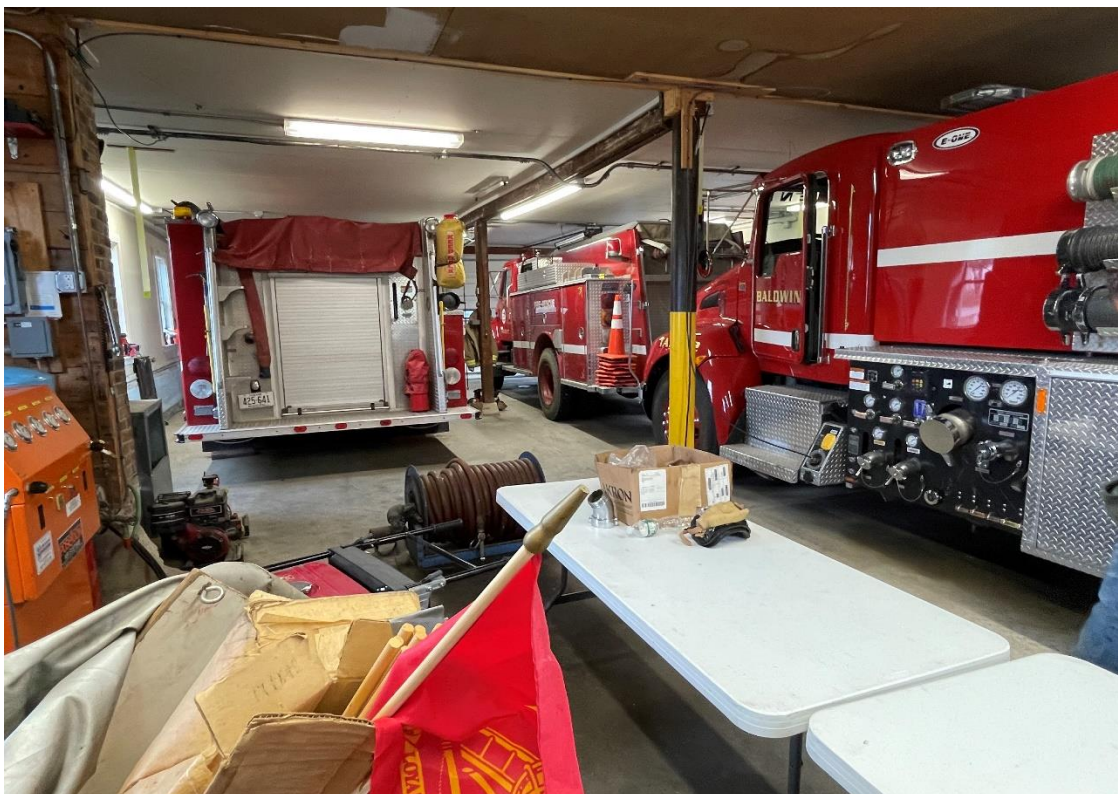
The apparatus bay is approximately 30' wide by 60' deep. It currently houses 1 tanker truck and 2 pumpers squeezed in bumper to bumper. The bay doors are 9'-6" high and the bay ceiling is just over 10' clear, providing minimal clearance for the existing apparatus and inadequate height to house a majority of modern equipment.

*West Baldwin Fire Station apparatus bays*

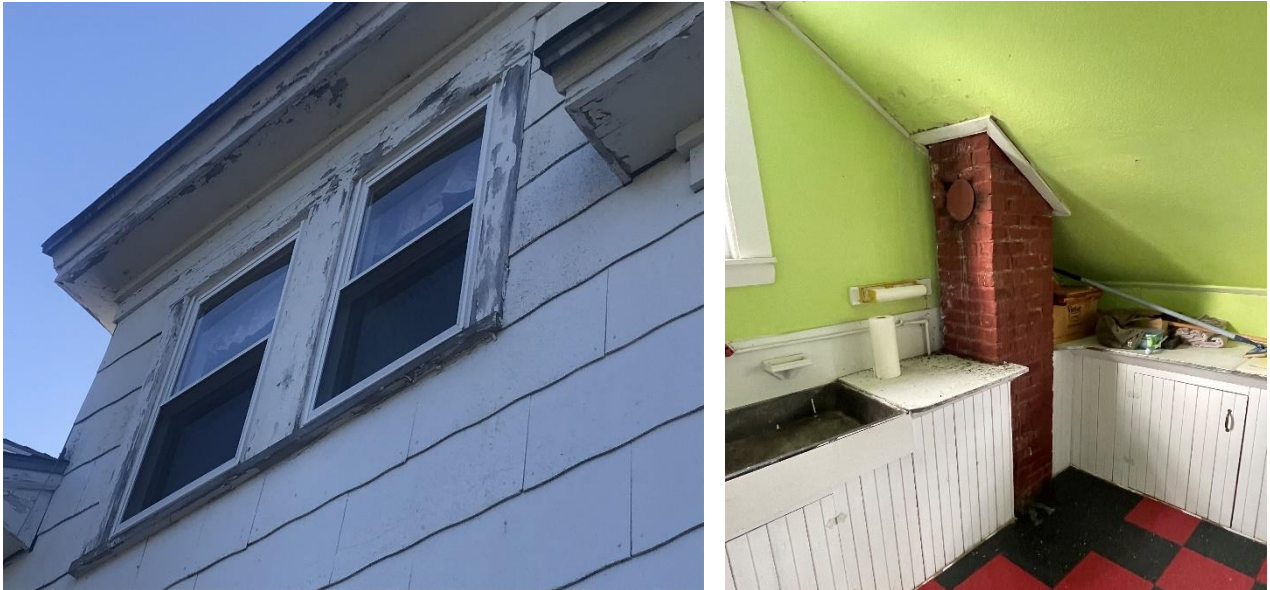
The West Baldwin station is a wood framed building with a slab-on-grade floor with no floor drains. As stated previously the siding and roofing of the original building need replacement. All interior finishes need refurbishment or replacement. The brick chimney is very deteriorated. Most significantly if the town were to retain the facility for a renovation, a structural analysis would need to be performed to ascertain whether the building meets the “essential facility structural standards of the building code.

*West Baldwin Fire Station generally deteriorated condition*

The facility at West Baldwin is grossly inadequate to service the fire protection needs of Baldwin into the future. Because the site is so small, any renovation, expansion, or new construction on the site is impossible without the addition of adjacent land. We would recommend that the town dispose of the facility when a better facility is available.

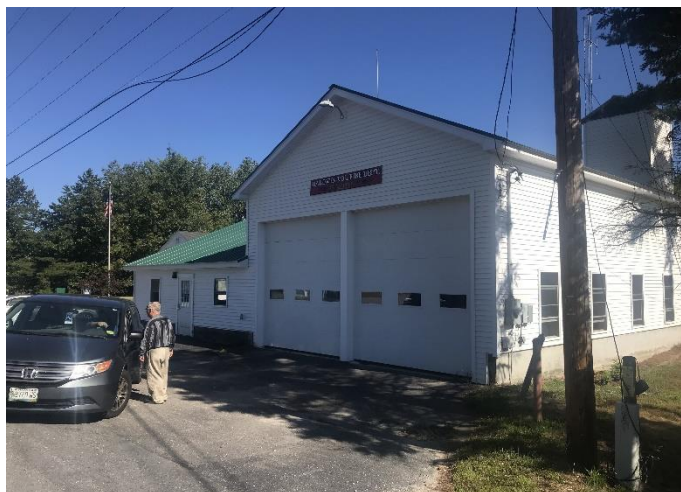
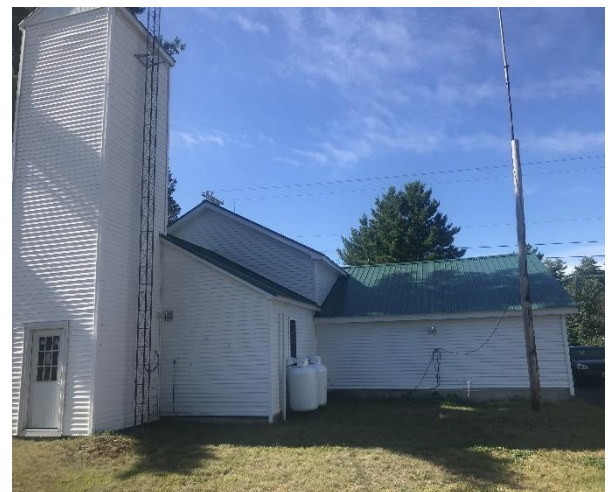
The Station at East Baldwin is a small one-story building of approximately 2,300sf. It contains a two door 25' x 38' apparatus bay with a 14' x 25' low ceiling apparatus extension on the rear, and a 25' x 38' meeting room beside the apparatus bays. The building appears to be around 50 years old. It is a slab-on-grade wood framed building and is in relatively good condition with a metal roof and vinyl siding. The 11'-0" w x 12'-0" h apparatus doors are on the smaller than today's standards but should still accommodate most equipment. Insulation is poor to fair. The app bay exposed CMU knee walls are uninsulated and appear to be ungrouted.

*East Baldwin Fire Station, East Baldwin, Maine*

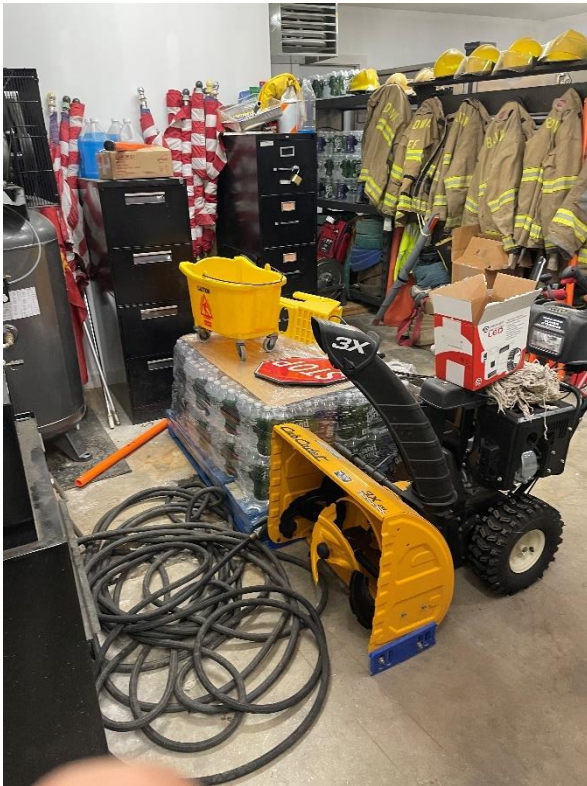
The building is missing many essential functions even if it were able to continue to operate as a 100% volunteer station which is unlikely as volunteer departments continue to decline. There is no decontamination area, no workroom, no storage, no turnout gear locker area, no offices, no showers, no generator, and no sleeping rooms to house paid staff if needed. Similar to West Baldwin, the station is essentially just a garage for apparatus.

*East Baldwin Fire Station, missing functional areas crammed into app bay*

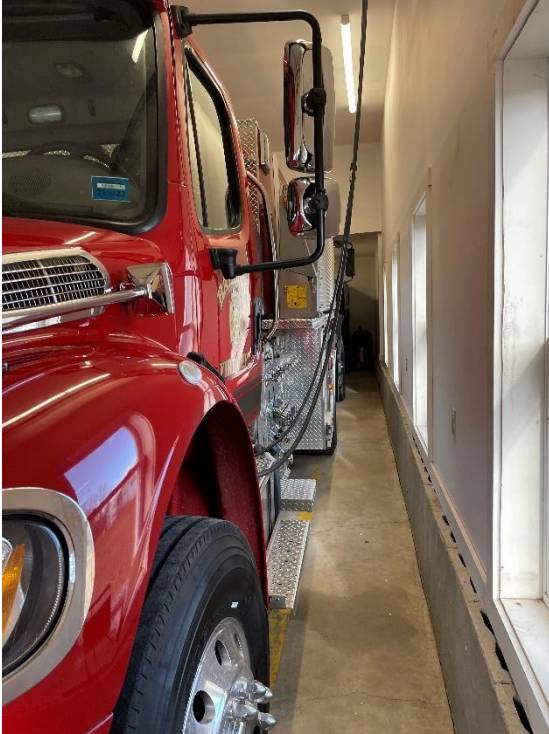
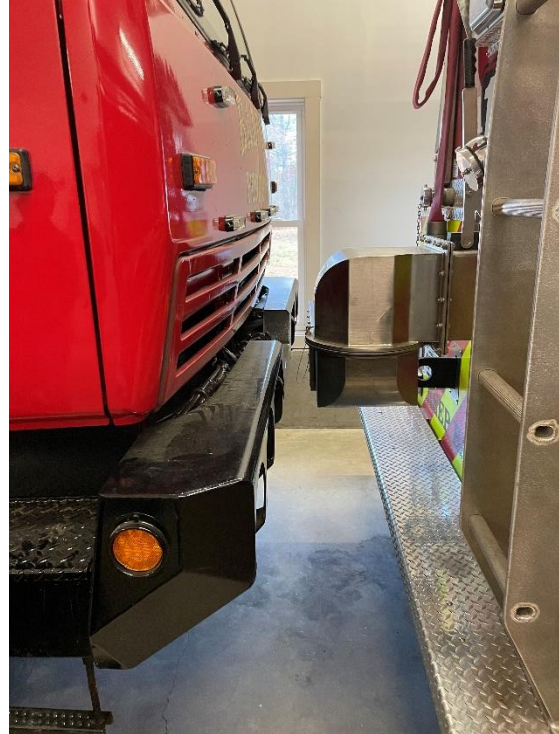
The apparatus bay is approximately 28' wide by 52' deep including the low ceiling area in the rear. It currently houses 1 tanker truck, 1 pumper truck, and 1 forestry truck squeezed in bumper to bumper. There is very little room to walk around the equipment. The 11' x 12' bay doors are marginally adequate, as is the front bay ceiling height. The width and depth, however, are inadequate for even the existing equipment.

*East Baldwin Fire Station apparatus bays*

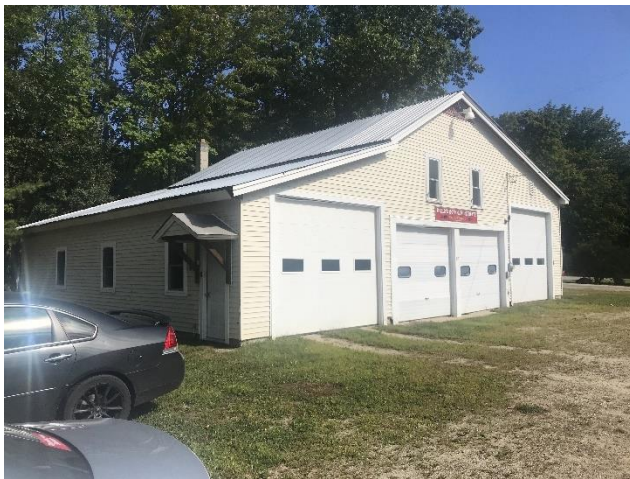
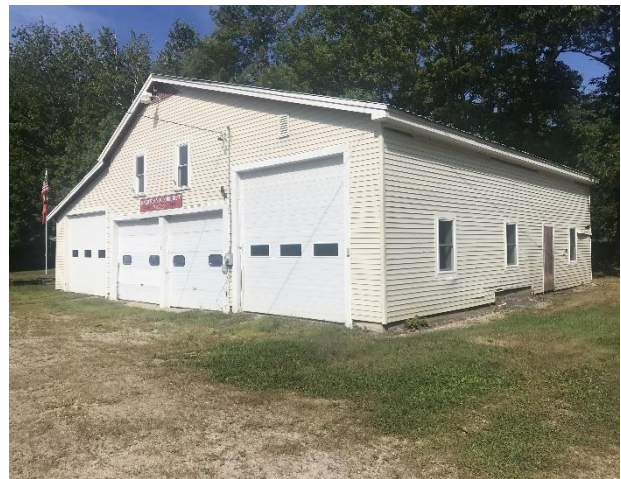
The Station at North Baldwin is a small two-story building of approximately 3,500sf. The first floor consists of two 18' x 46' apparatus bays on each end with a 20' x 34' low ceiling apparatus bay in the middle and a 20' x 12' workroom behind. The 20' x 46' second floor is located above the low ceiling bays in the middle and contains a meeting room with a bunkroom and toilet behind. The building appears to be around 60 years old. It is a slab-on-grade wood framed building and is in very poor condition with a metal roof and peeling vinyl siding. It also has a cold storage shed behind the building.

*North Baldwin Fire Station, East Baldwin, Maine*

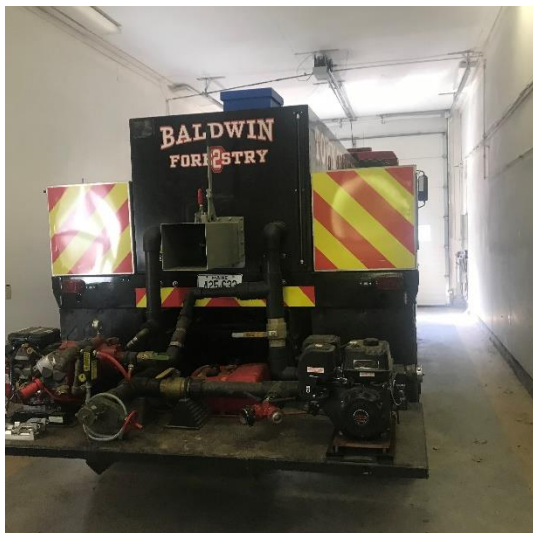
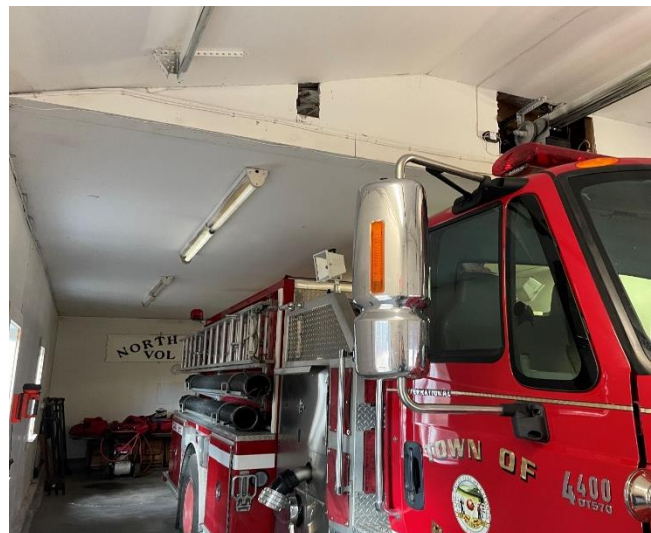
The two end apparatus bay are approximately 18' wide by 46' deep each. They currently house 1 engine and 1 forestry truck. The bay doors are 12' x 12' and the bay ceiling is just over 13' clear, providing reasonable clearance for the existing apparatus and potential future apparatus. The low ceiling center bays contain a foam trailer and other stored items. The 8'-8" h x 10' w doors could accommodate a pickup or trailer but would probably be better if remodeled into working space with a stair to the outside from the second floor.

*North Baldwin Fire Station apparatus bays*

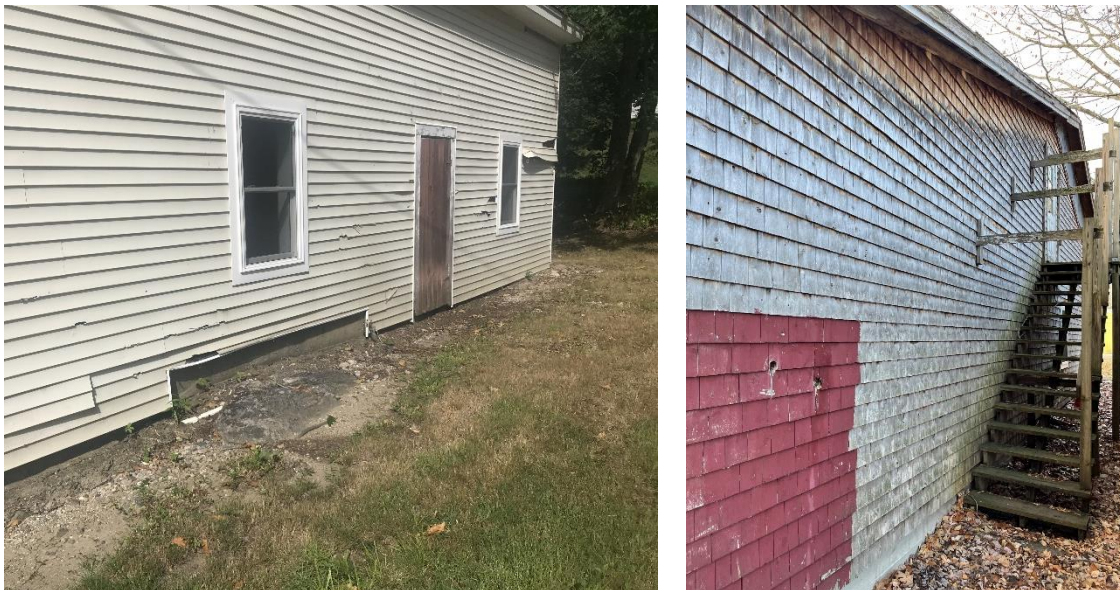
The North Baldwin station is a wood framed building with a slab-on-grade floor with no floor drains. As stated previously the building is in poor condition. The vinyl siding is peeling in many places and needs replacement. Most interior finishes need refurbishment or replacement. There is a noticeable sag to the center beams over the small center overhead doors, and the second floor looks to be sagging as well. It is partially suspended by two metal rods from the ridge beam, and the whole second floor is structurally suspect. If the town were to retain the facility for a renovation, a structural analysis would need to be performed to ascertain whether the building meets the “essential facility structural standards of the building code.

*North Baldwin Fire Station generally deteriorated condition*

The facility at North Baldwin could possibly service the fire protection needs of Baldwin in a very limited fashion. Because the site is so small, any expansion or new construction on the site is impossible without the addition of adjacent land. We would recommend a study before the town provided any renovations in order to establish a cost/benefit report.
