CONEJOS RIVER

DIVERSION INFRASTRUCTURE INVENTORY

Structure Name: GARCIA D

Date: April 3, 2019

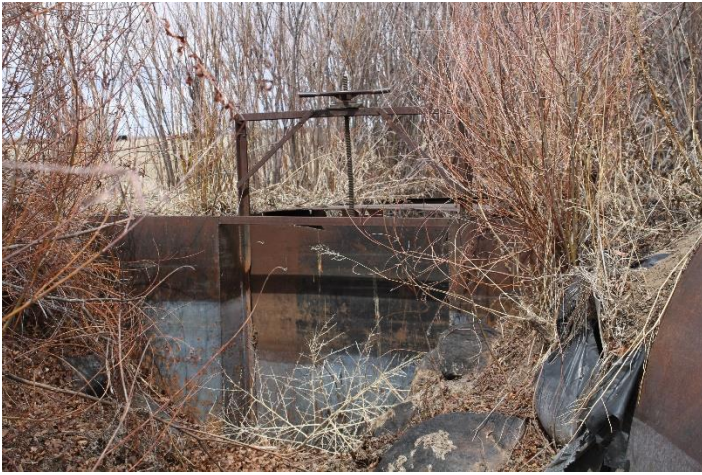
Headgate looking downstream

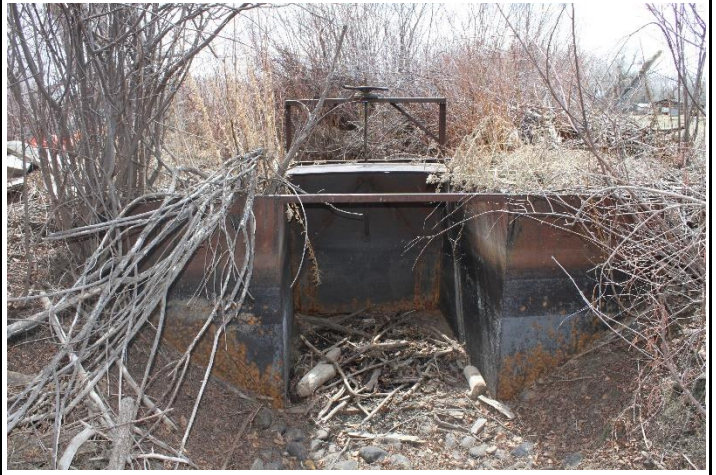
Headgate outlet

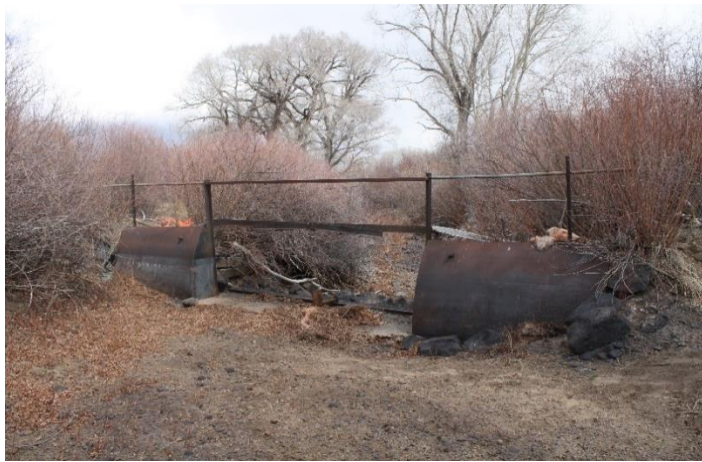
Repair(s) or Improvement(s) Currently Needed: Localized erosion is occurring downstream of the diversion dam that should be addressed. An improved diversion dam for these ditches would be a significant improvement. Erosion mitigation should include riparian vegetation and aquatic habitat enhancement. Any improvements to the diversion dam should also consider fish passage.

Diversion dam looking downstream

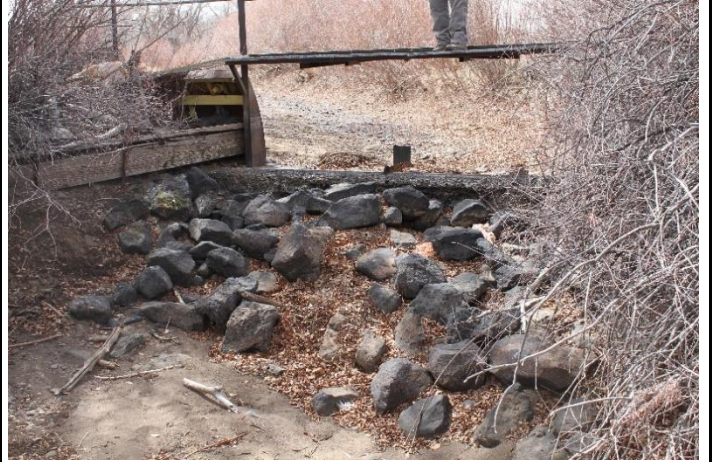
Diversion dam looking upstream

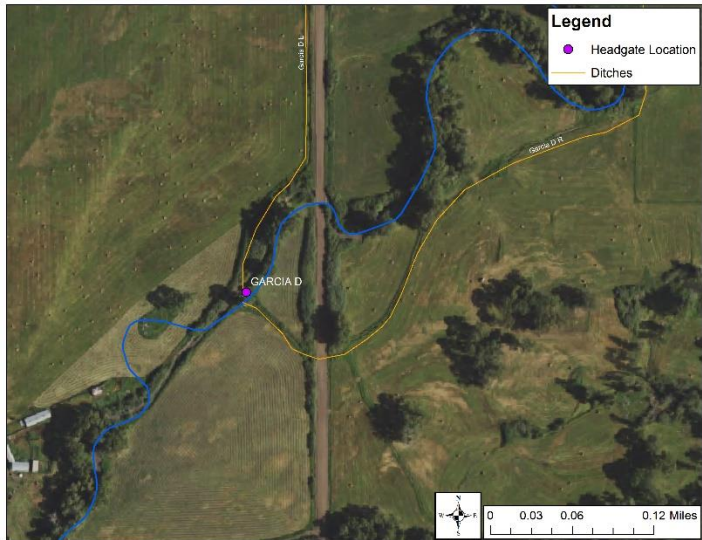
Aerial image of structure

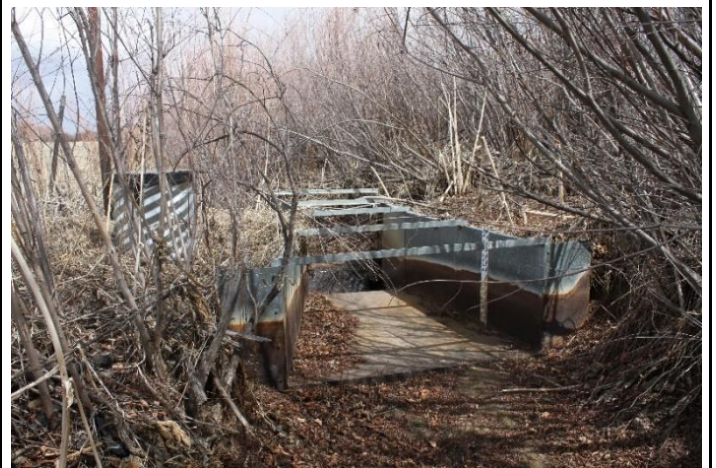
Flume looking downstream
