SAGUACHE CREEK DIVERSION INFRASTRUCTURE INVENTORY

Structure Name: SEITZ MCCLURE ASHLEY D

Date: April 3, 2019

Saguache Creek Stream Management Plan

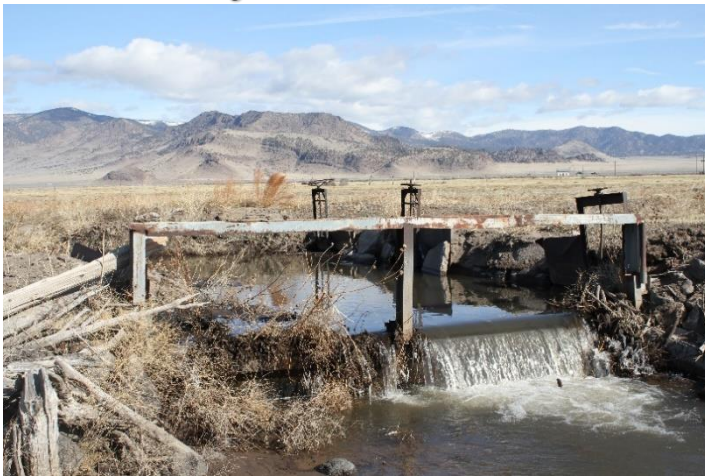
Headgate and diversion dam

Structure Description: This ditch is located at the apex of a meander. The diversion dam is a welded steel checkboard structure that also services the Taylor A Ashley Ditch. A catwalk was installed on the diversion dam for ease of maintenance and access. The headgate is adjacent to the Taylor A Ashley Ditch headgate. Sediment accumulation is a serious issue for this ditch.

Repair(s) or Improvement(s) Currently Needed: A sluice gate could be installed on the north bank of the stream to improve sediment transport and reduce ditch maintenance. Fish passage and riparian restoration should be considered as part of any future repairs or improvements.
