SAGUACHE CREEK DIVERSION INFRASTRUCTURE INVENTORY

Structure Name: LAWRENCE D 3

Date: April 11, 2019

Saguache Creek Stream
Management Plan

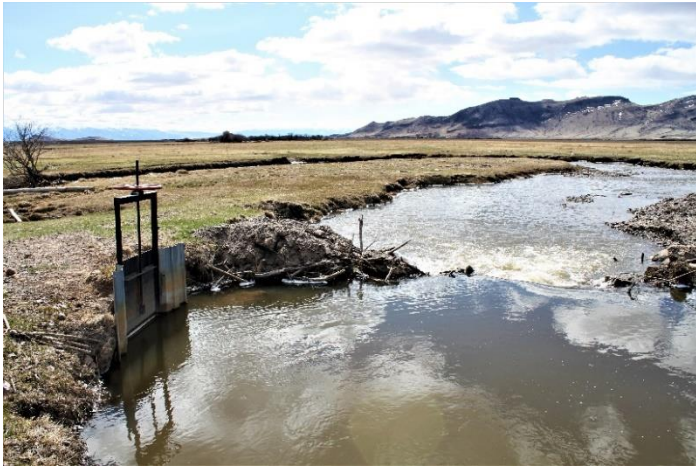
Headgate and diversion dam

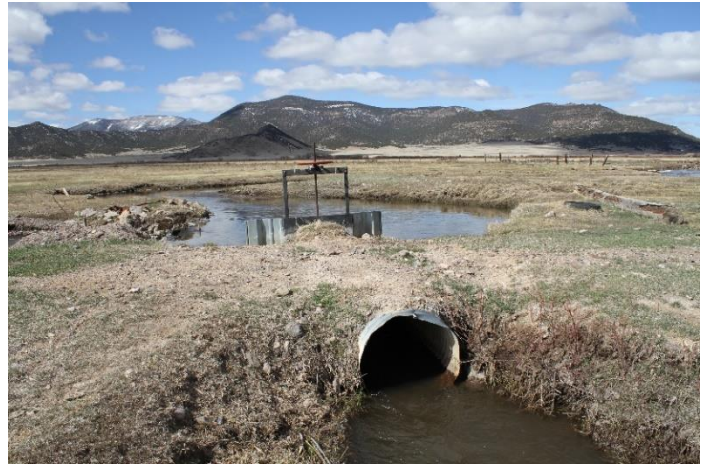
Headgate outlet

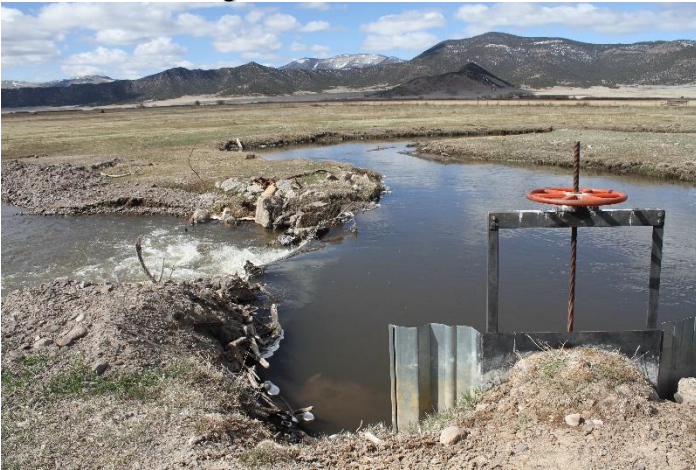
Headgate and diversion dam

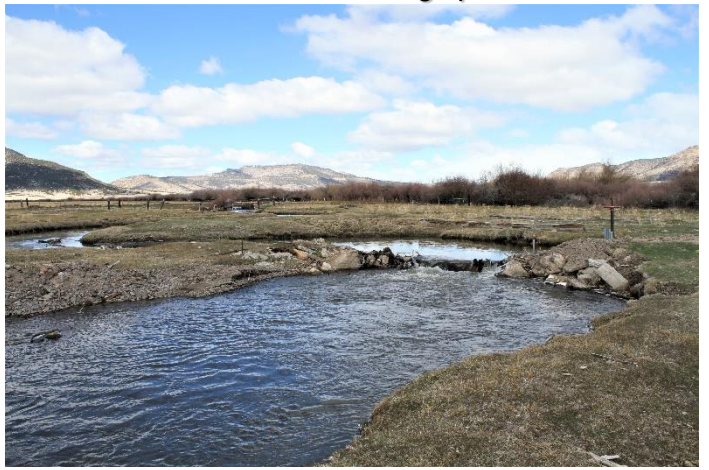
Diversion dam looking upstream

Repair(s) or Improvement(s) Currently Needed: Bank stabilization is recommended upstream and downstream of diversion dam to prevent the ditch from flooding out into the stream and to prevent the meander from being cut off. No other repair needs were identified. The headgate functions effectively and the flume measures accurately. Fish passage and riparian restoration should be considered as part of any future repairs or improvements.

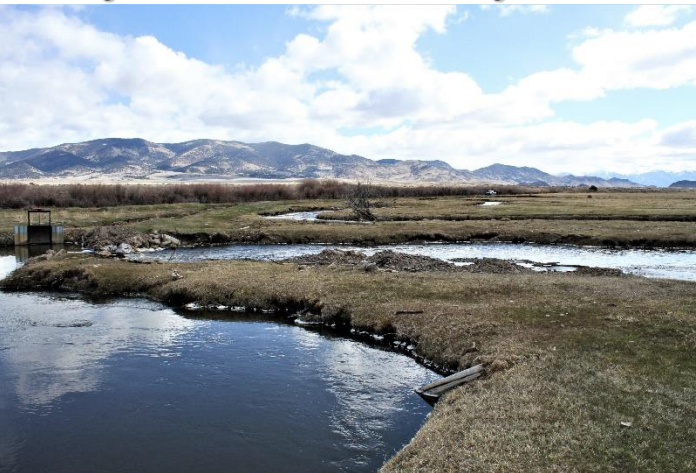
Headgate and diversion dam looking downstream

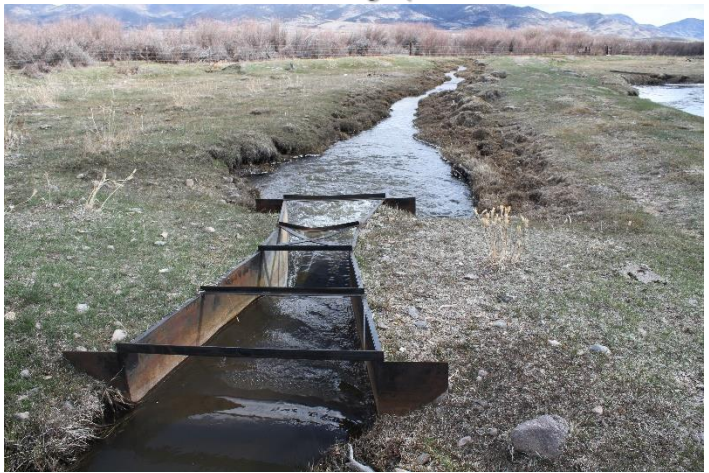
Flume looking upstream
