# PROPERTY INSPECTION REPORT

Concerning: 2112 Westlake Dr, Plano, TX 75075

By: Mason Johnson, Lic. #20598

04/18/2020

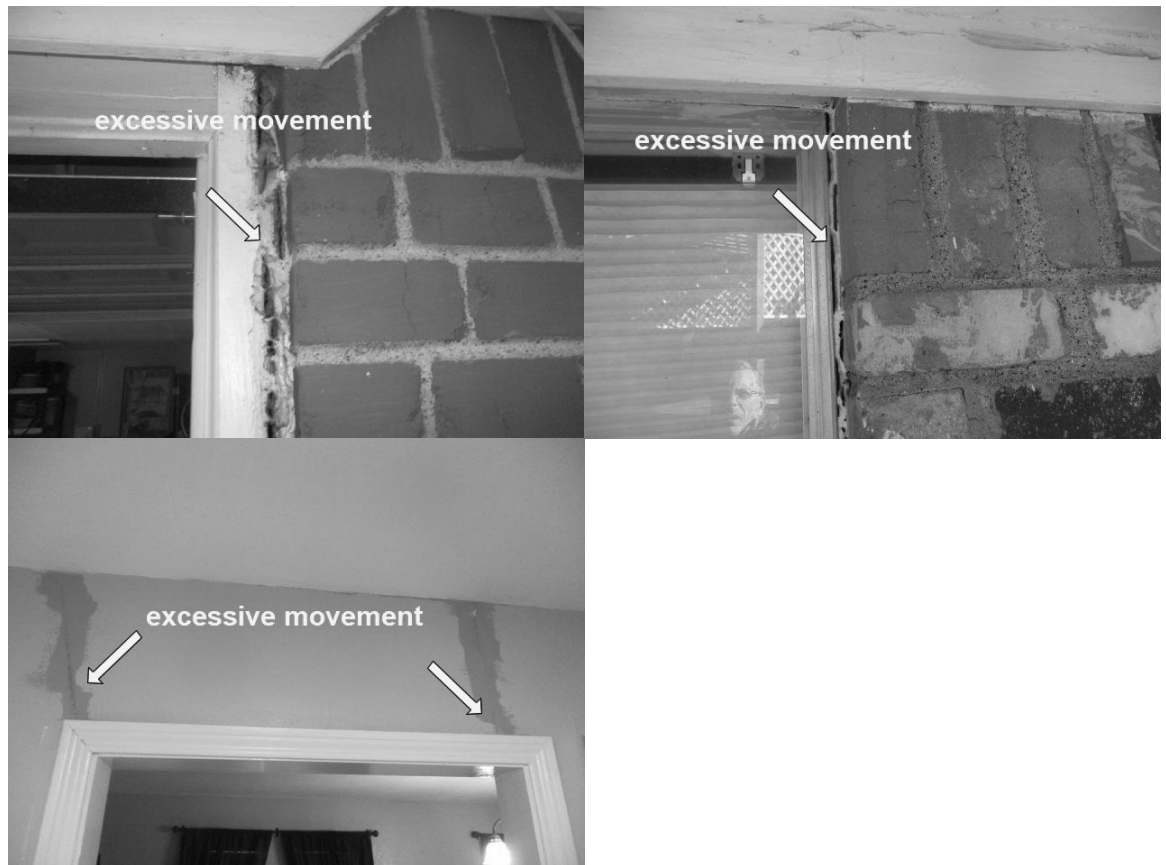
**In our opinion, the home has experienced movement (including differential cracking, sloping/unlevel floors, wall separation at window/door frames, Etc.) which is greater than normal for its age and location. We recommend a qualified structural engineer or foundation specialist determine the extent of any needed repairs prior to closing.**

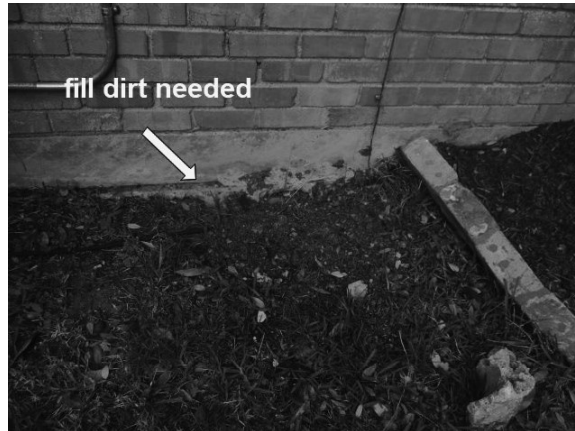
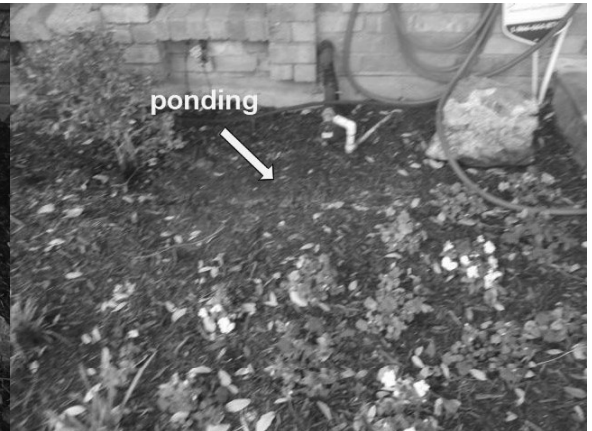
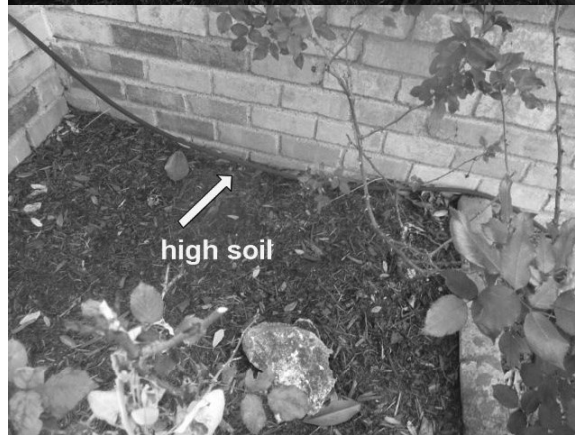
Areas of ponding were noted near the foundation on North, East, West side(s) of the house. We recommend repairs to these areas to allow water to drain away from the structure.

The dirt level in the planter box against the house is over the brick line. High soil levels in planter boxes can allow water to penetrate into the structure; we suggest that the dirt be removed from the planter box to help prevent damage.

We recommend that at least two inches of concrete show between the brick or siding and the dirt line. A high soil line was noted at the West side(s). Inadequate clearance can allow water to penetrate into the structure causing moisture damage.

A low lying area noted at the foundation at the East side(s). We recommend adding dirt backfill to any low lying areas located around the foundation.

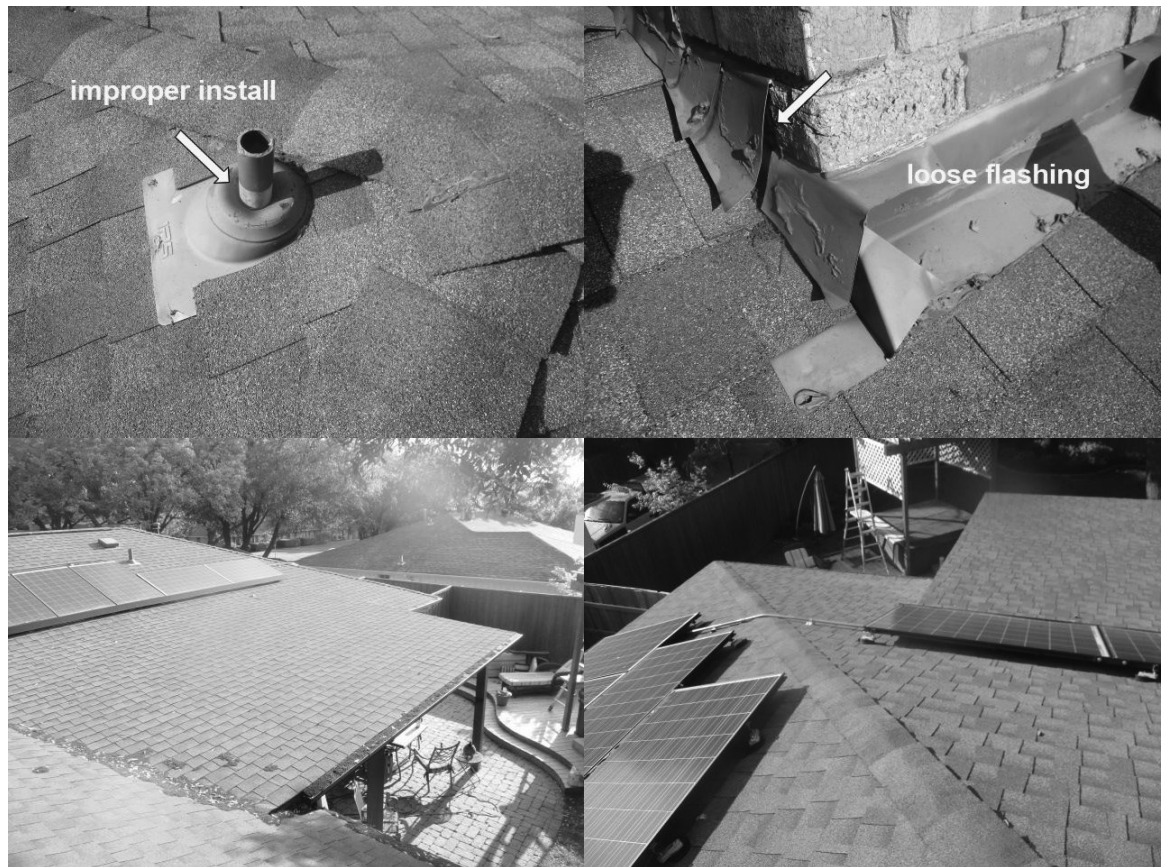
Some surface nailing observed. It is recommended that nail heads be sealed to prevent dripping leaks. As with any roof sealant, periodic inspection is advised to ensure a proper seal as the material ages.

**Deficiencies were noted on the roof: improperly installed pipe flashing; recommend evaluation of the roof system and repair as necessary.**

**Loose/lifted flashing was noted at the chimney . Recommend evaluation and repair as necessary to help ensure serviceability.**

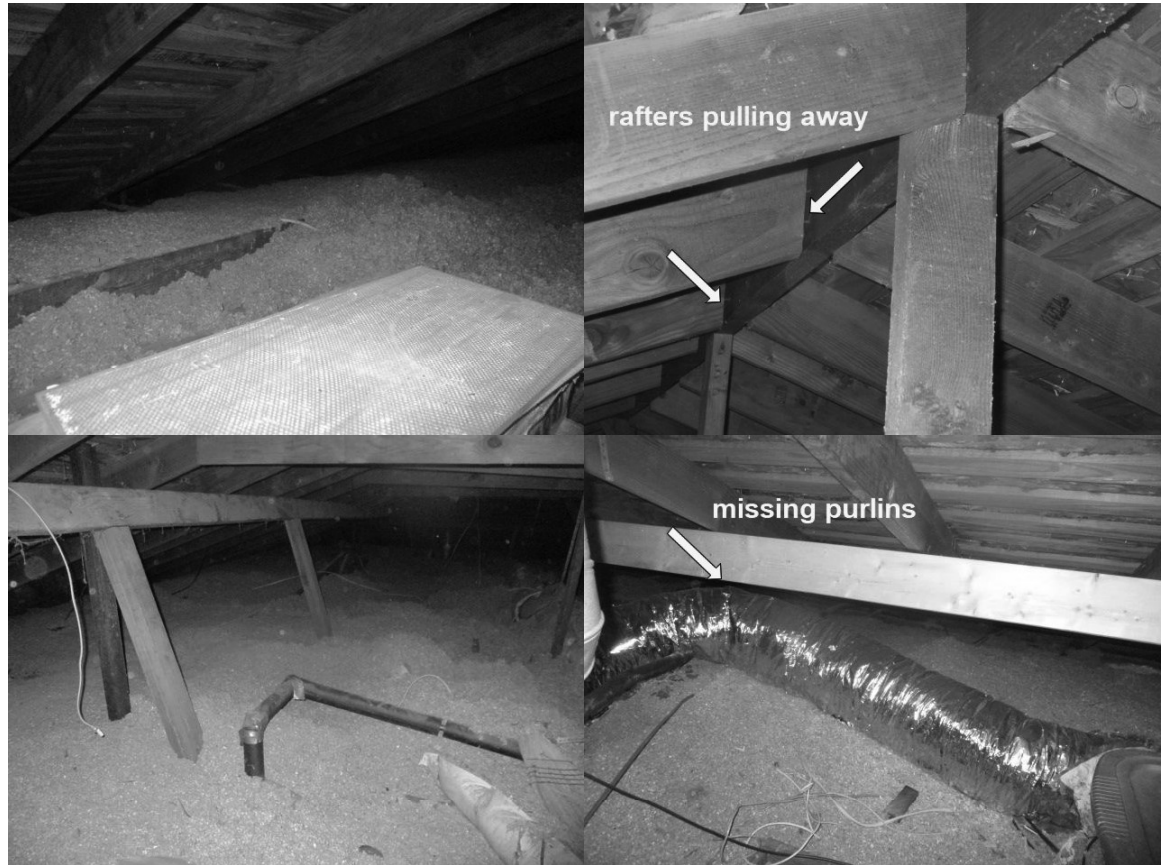
Loose hardware was noted at the attic ladder(s). We recommend repairs/adjustments as necessary to help assure safety.

**Rafters were observed pulling away from the ridge beam. We recommend any repairs necessary to help assure long term serviceability be performed by a qualified contractor.**

**Areas of roof bracing are Missing; recommend repair as necessary (East attic area).**

Some Splitting (also called checking) noted in the rafters. As wood ages it becomes more prone to cracking. This typically will not affect the serviceability, unless the cracks become severe of completely spilt a rafter.

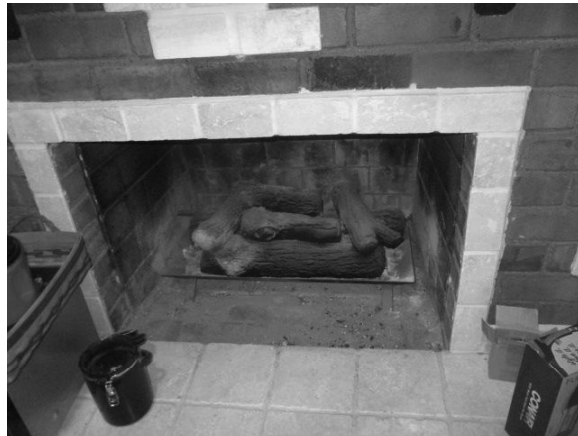
Cracking and some deterioration noted in the fireplace. We recommend sealing all cracks.

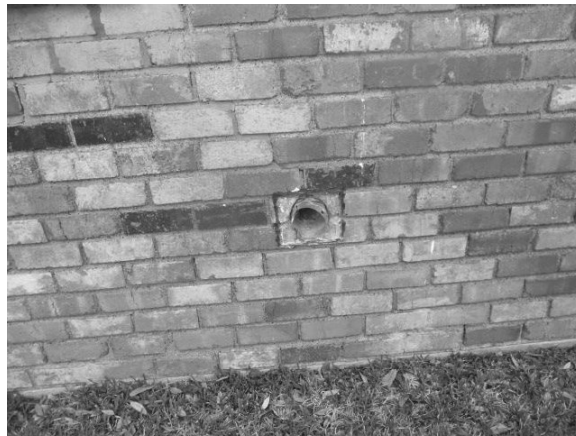
**The exterior vent flap was missing (West side). We recommend replacement to help prevent unwanted animal entry.**

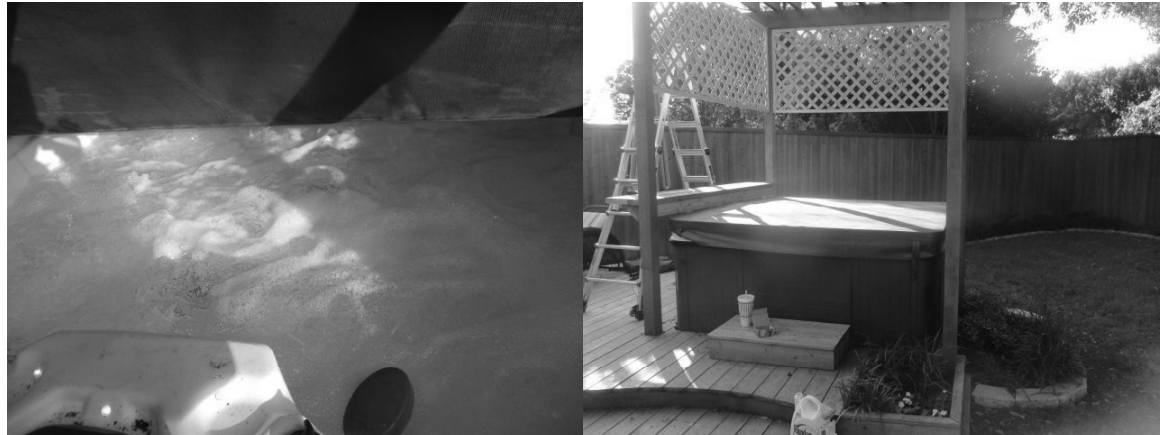
**Proper GFCI protection for the underwater lighting could not be located. We recommend that a licensed electrician locate or install proper GFCI protection to help assure safety before the pool and/or spa is entered.**
