Confidential Inspection Report

August 14, 2023

Inspection Table of Contents

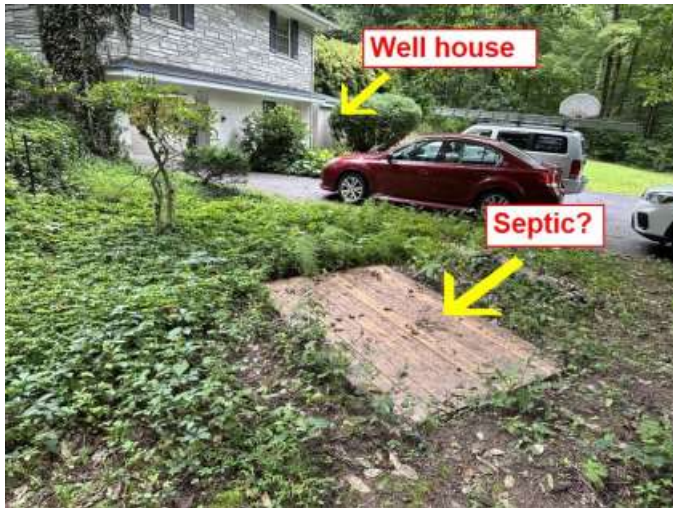
Private. A septic company needs to verify that the tanks and absorption fields are far enough away from the well at the property.

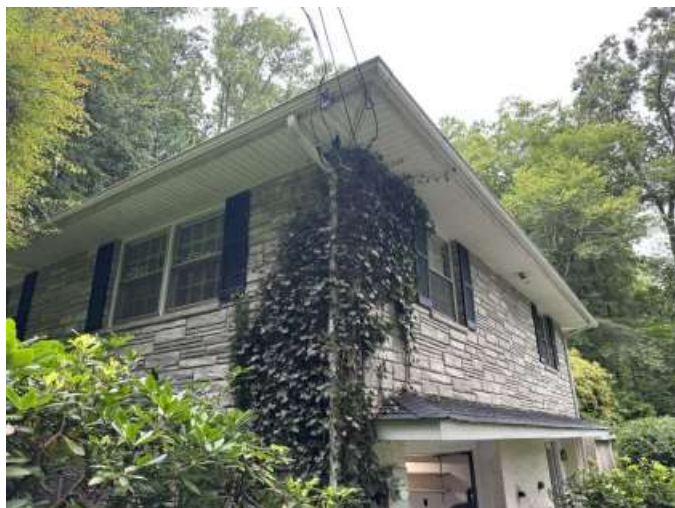
<i>Grounds:</i>	⚠	Vines noted growing on structure. Proper regular maintenance is required to control growth and limit damage to the structure. If removal is desired, pull down ivy while alive. Cleaning the ivy feet off the siding is not easy.
-----------------	---	---

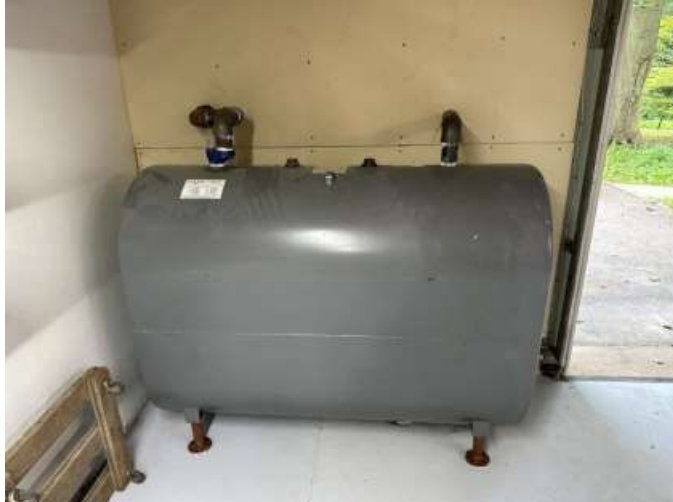
<i>Oil Tank:</i>	ⓘ	Oil tank located in garage. Some municipalities require protective caging or barriers be built around the tank to avoid this hazard. Consult with local authorities for determination of requirements.
------------------	---	--

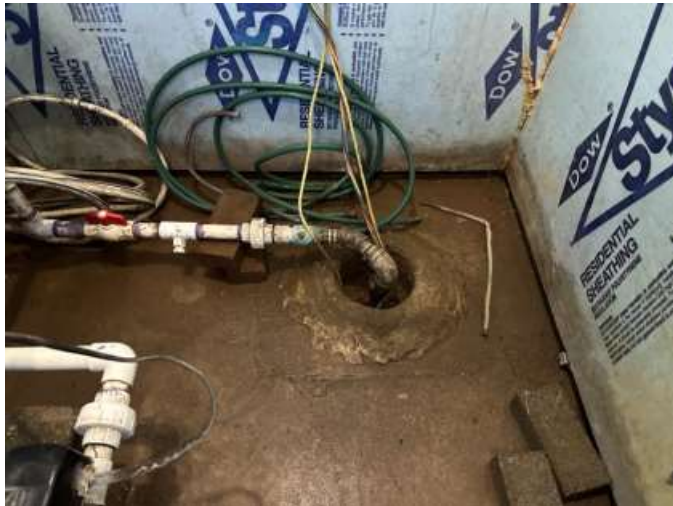
Well:

Well head is low to ground surface and could allow surface water entry and contamination. Typical residential well head height is 8" or more. Recommend repair as needed by qualified well plumber.

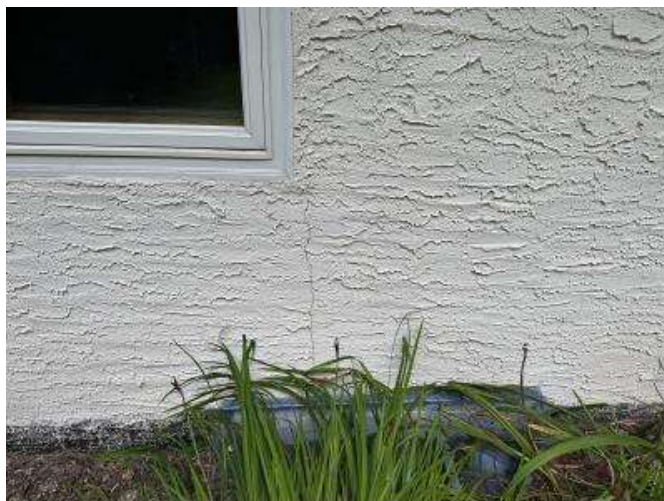
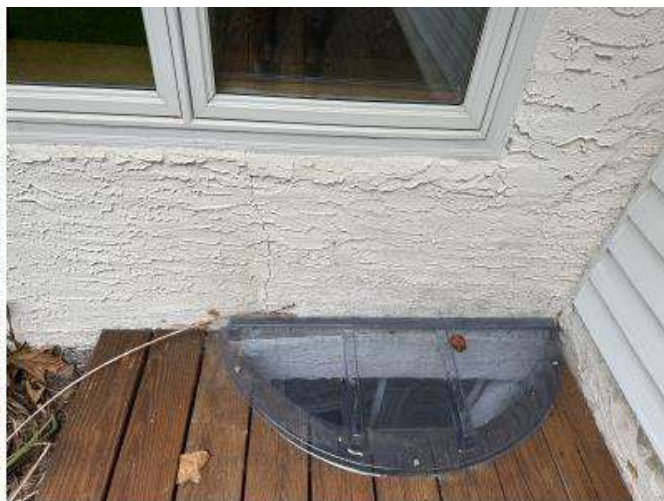
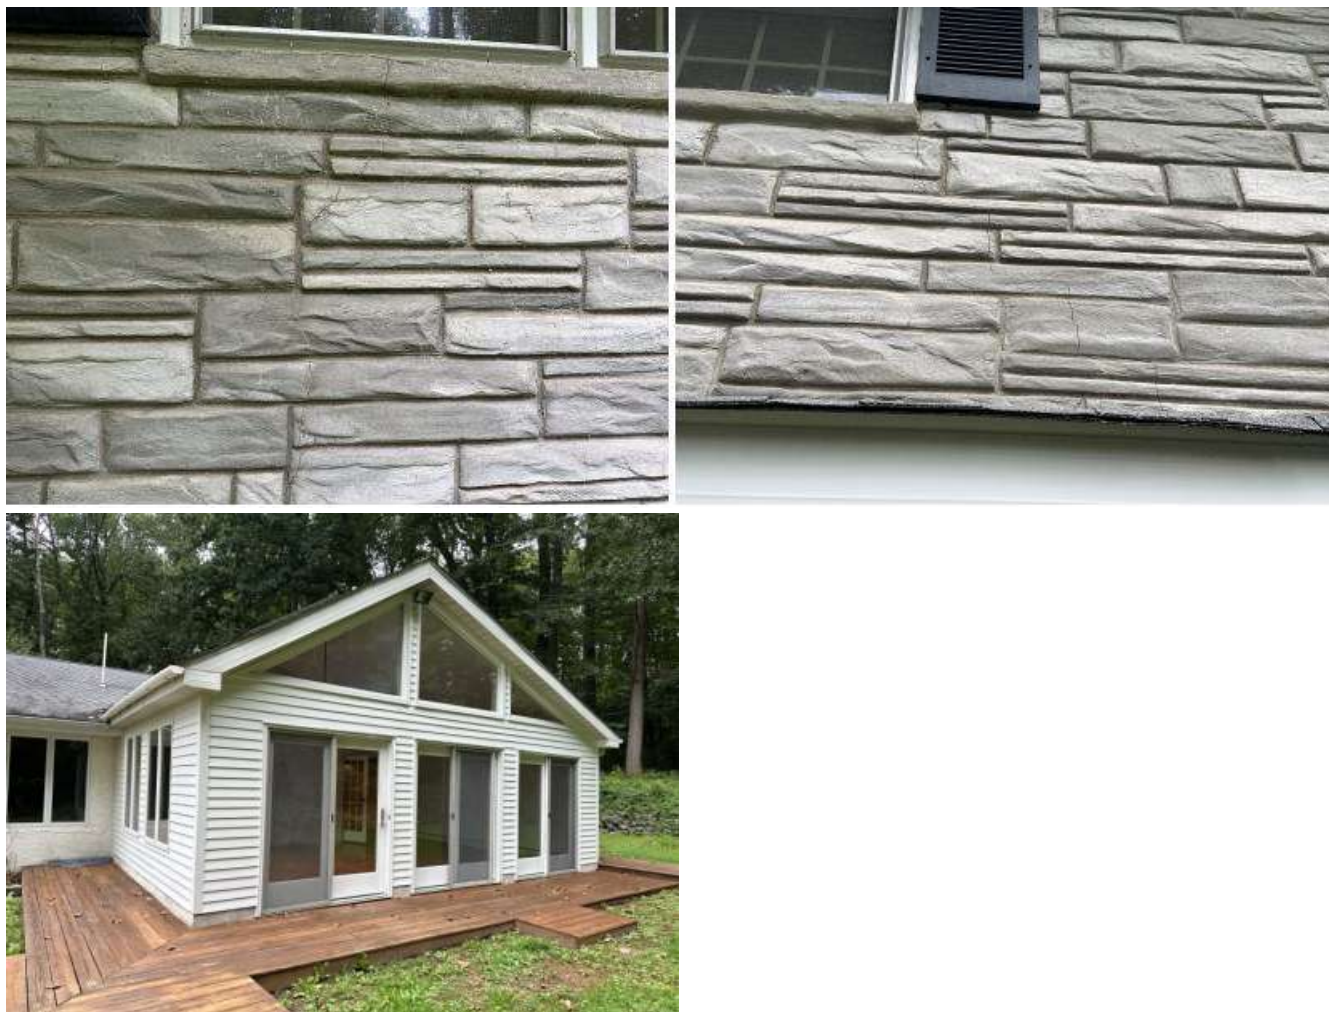
Stucco over masonry. Stucco requires normal maintenance to remain functional for preventing water entry into the structure. Caulk areas where stucco meets another material, such as trim and cladding. Monitor for cracks and repair as needed.

Veneer stone siding noted at front; A stucco-like material. This material is known for durability, but is not impervious to moisture penetration. Monitor for signs of moisture entry in the future. It is not possible to see inside walls during this inspection, and hidden damage can exist. A thorough and invasive evaluation is available and recommended in some cases. Consult the inspector or your agent for more information. Some cracks are noted throughout the property but are hairline and appear to be older. Recommend sealing to prevent moisture entry.

Wood siding. Exterior wood requires maintenance. Re-stain or paint as needed in course of maintenance.

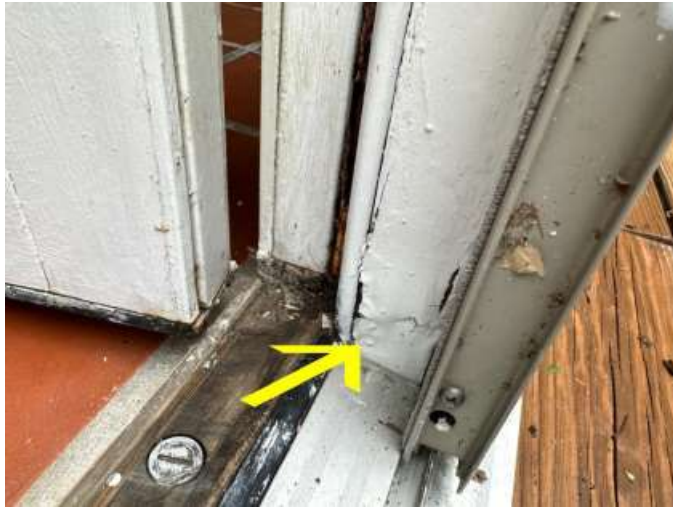
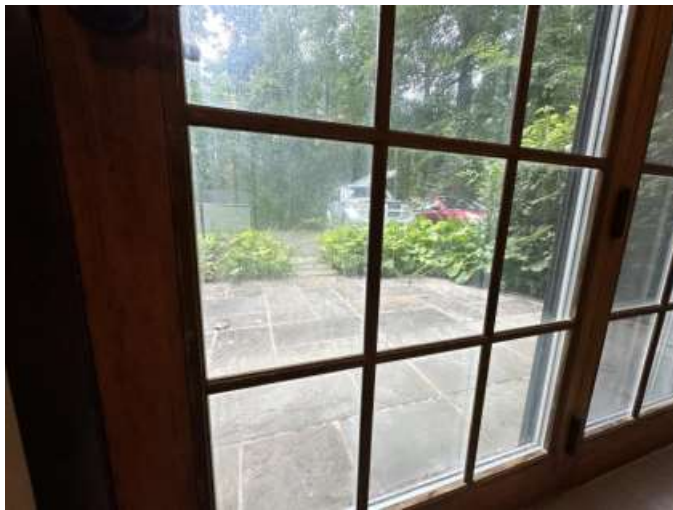
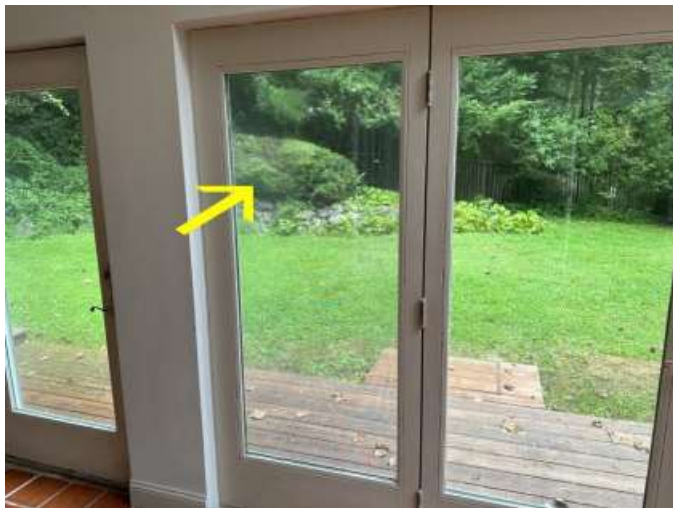
- ⚠ Wood, Hinged. Some trim rot noted at the rear sunroom doors. Recommend repair to prevent worsening conditions.
- ❗ Blown seal, fogged glass noted at side door to basement from driveway. This has allowed the weather protective gas to escape the door. This slightly reduces the temperature protection of the door and provides an undesirable haze or moisture to form inside the glass panes. Repair as needed. (Cost estimate is for glass replacement only)
- ❗ Blown seal, fogged glass noted at middle rear sunroom door. This has allowed the weather protective gas to escape the door. This slightly reduces the temperature protection of the door and provides an undesirable haze or moisture to form inside the glass panes. Repair as needed. (Cost estimate is for glass replacement only)

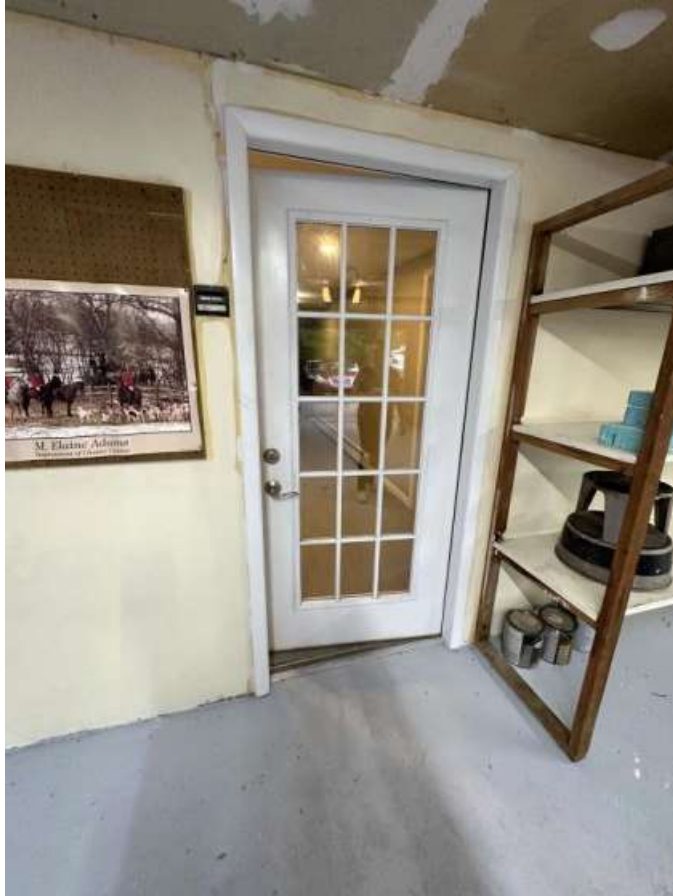
The door has a glass window that is too large for the door to be considered a fire rated installation. Over 100" of glass is too large. Recommend replacement with fire rated door.

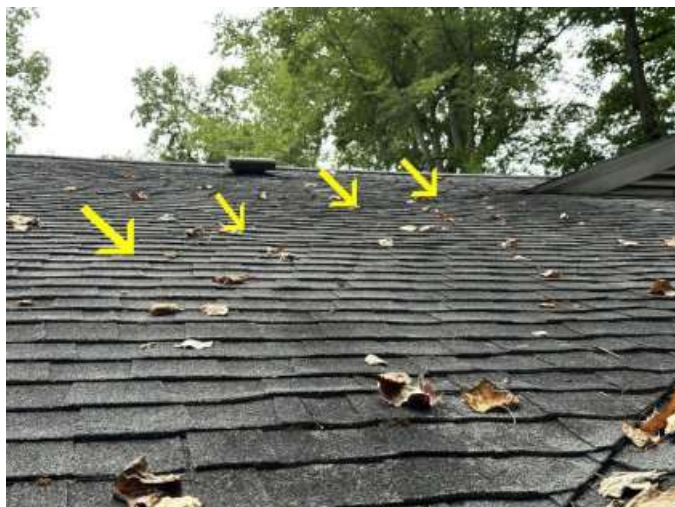
Roofing material appears to be in good condition for its age and nature. Monitor for future wear and leakage. Slight raised area on the north side hip roof that appears to coincide with staining and sheathing damage noted in the attic. See comments in Attic section below.

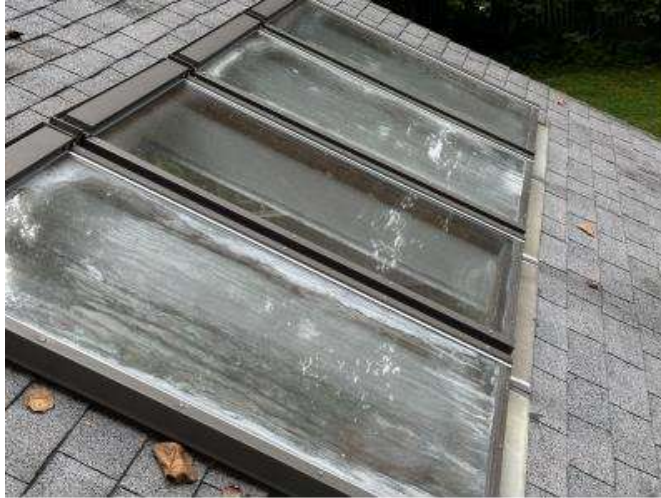
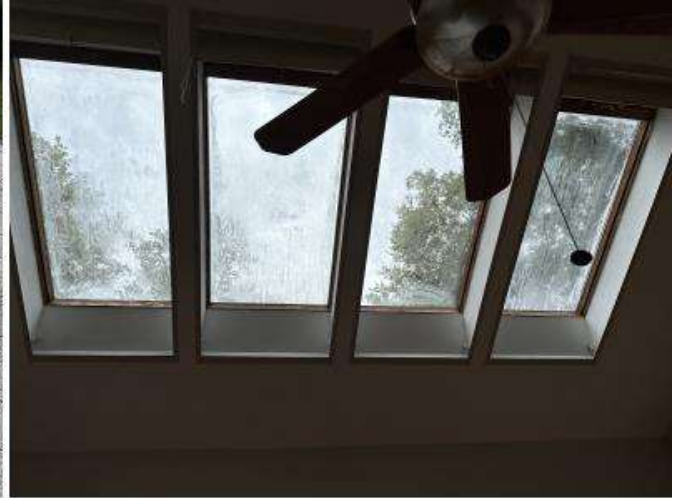
Raised curb type skylight noted. Monitor for future leakage. Fogged window, blown thermal seal noted at all four sun room skylights. Seal at double pane insulated window has failed, allowing moisture between the panes. Not all blown seals are visible in all seasons and visibility can vary with other factors such as temperature. This inspection can only mention those that are clearly visible at time of inspection. Repair typically is the replacement of the glass unit. Recommend evaluation for repair as needed by qualified window contractor. (Attached cost estimate assumes replaced glass only)

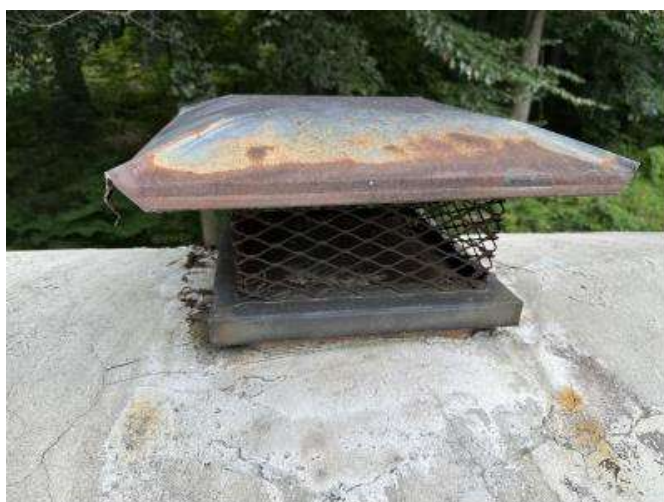
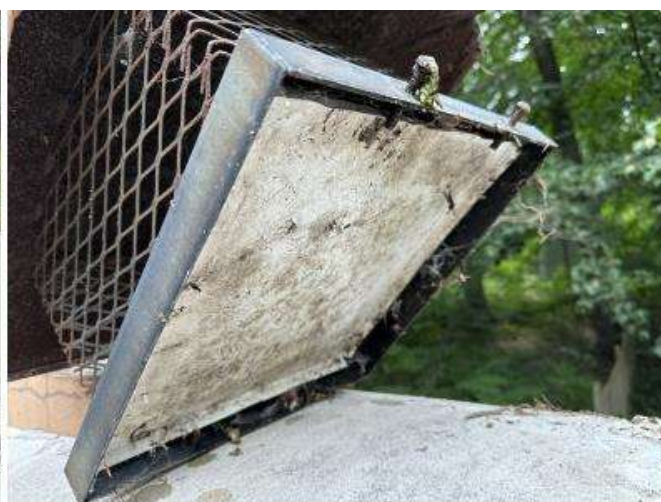
Flue #2:

Fireplace flue. Terra Cotta clay. A rain cap was installed to prevent rain and birds from entering the flue. An additional metal plate was added to the rain cap which must be removed if the fireplace is to be used as a wood burning or gas fireplace. Currently an electric fireplace is in place that does not required a flue.

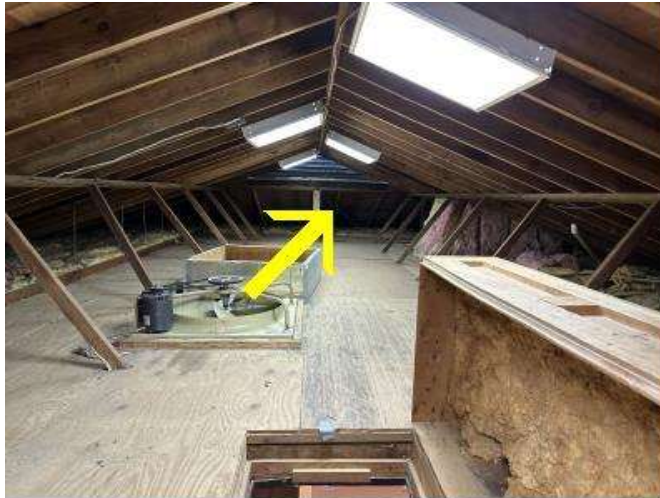
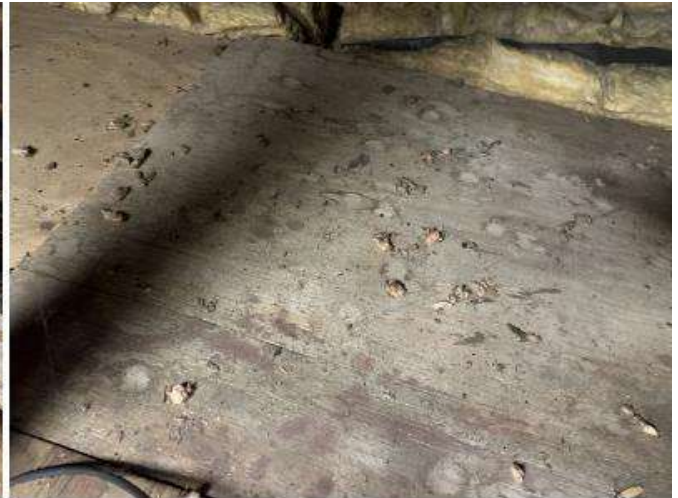
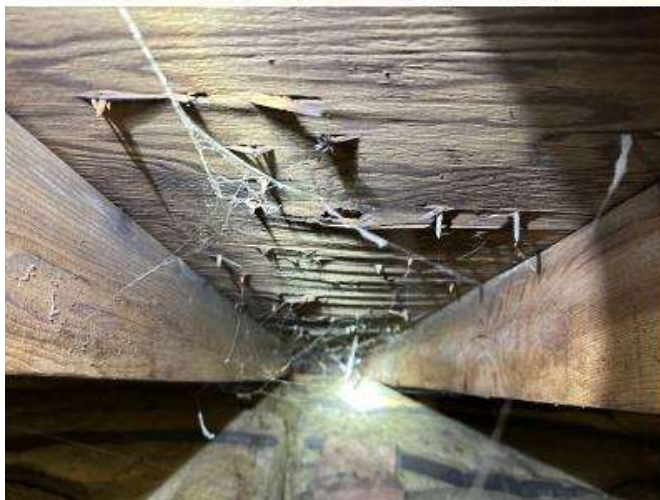
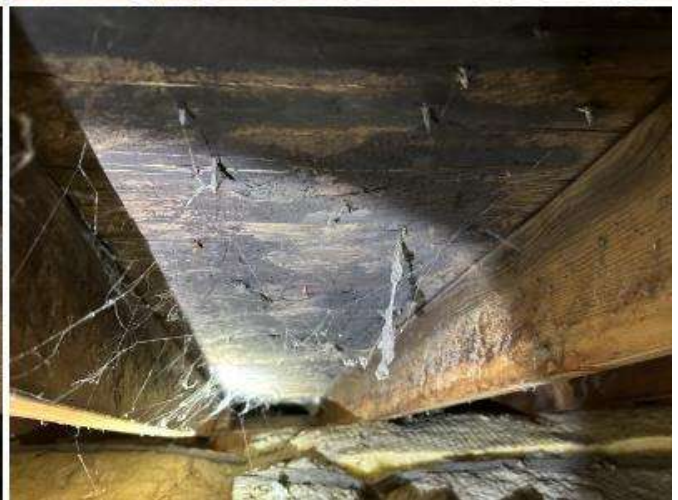
Plywood sheathing. Localized water damaged an potential mold noted on the north side hip roof. Area approximately 10 feet in diameter showed drip stains on the flooring, rusted nails, and delaminated wood sheathing. Recent rains suggest that this was a possibly a previous roof leak as the sheathing was dry at the time of inspection. Recommend evaluation by a qualified roofer to determine if repairs are necessary prior to the next roof installation.

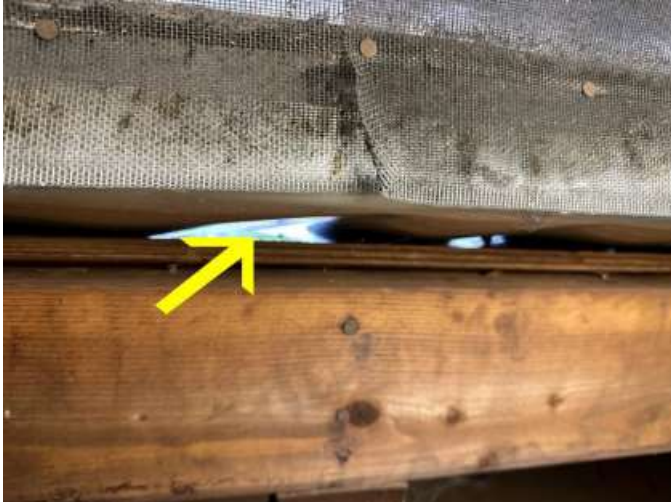
There are ridge vents installed. There are soffit vents installed. Gable vents installed. Gaps under the gable vents were noted. Recommend screening or sealing by a qualified roofer or handyman to prevent animal and insect entry.

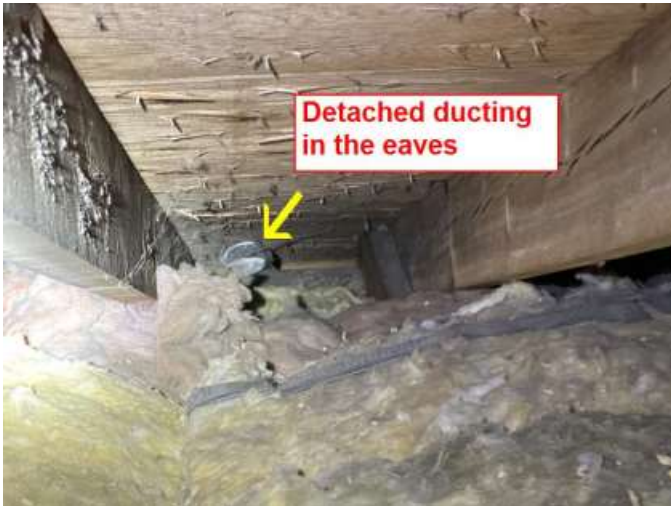
Bathroom vents terminate in the attic. Recommend extending to vent to the exterior to prevent moisture issues.

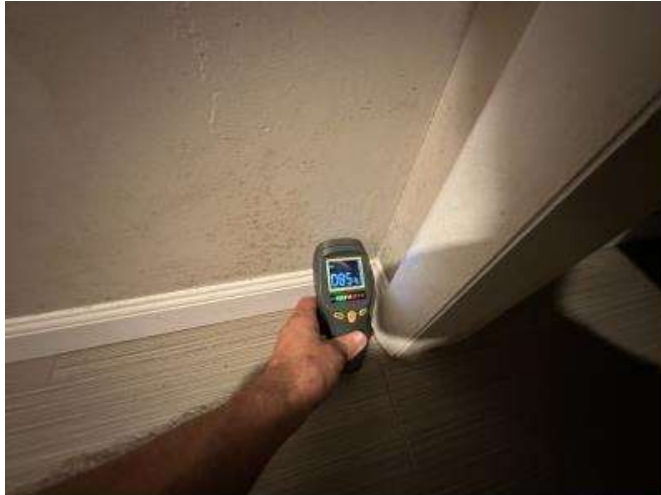
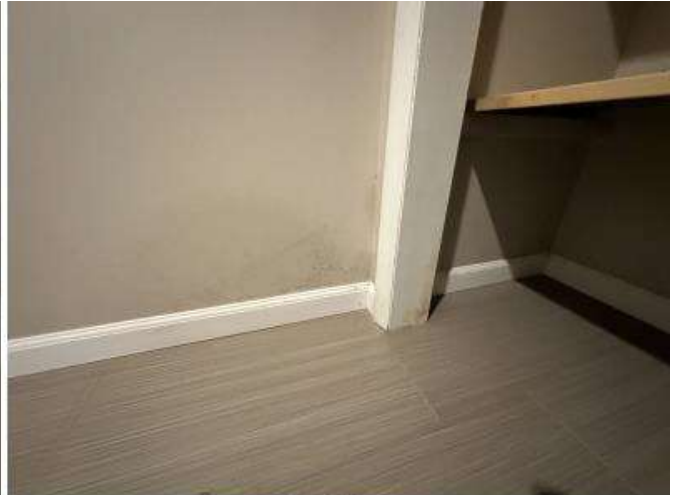
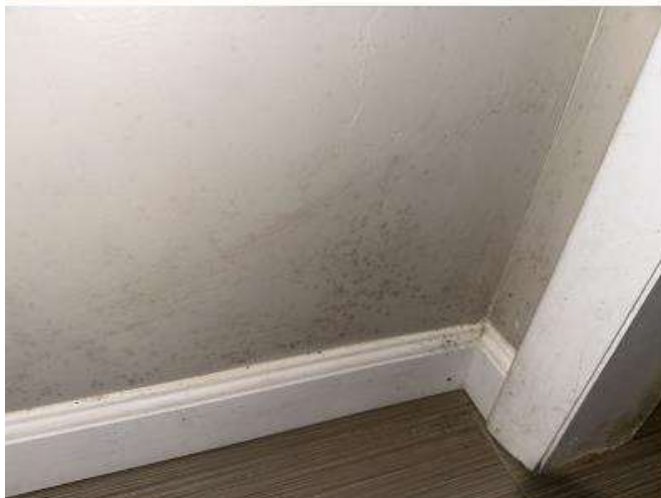
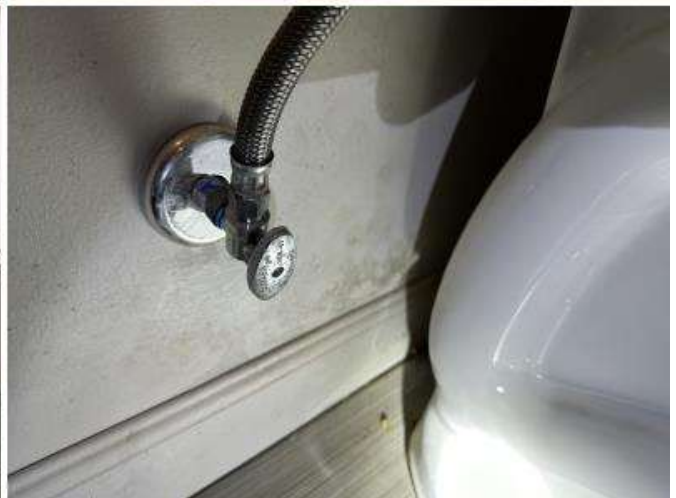
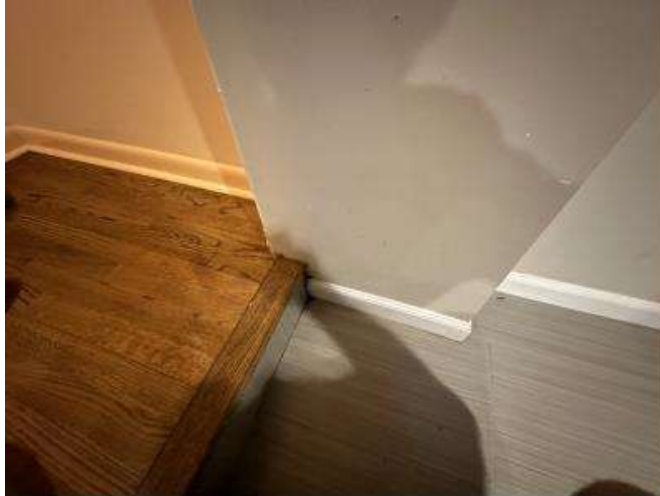
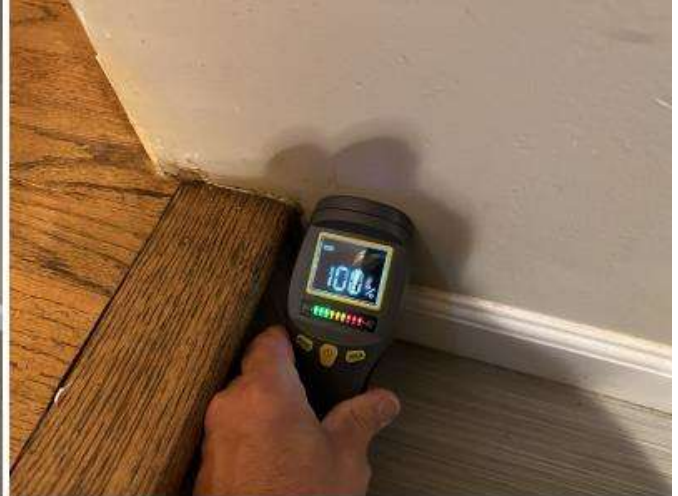
Drywall. Stains, physical growth, suspected mold noted at basement finished walls, visible at on the lower portions of the wall in the basement bathroom behind the toilet, and on the same wall in the room to the right of the bathroom. Stains, deterioration and moisture are all signs of active and/or ongoing water entry at these locations and at the rear basement wall at the entrance to the basement steps. Address exterior downspouts and drainage. Consider consulting with a water proofing contractor for adding or improving a sump system.. Recommend testing and remediation by qualified contractors for health safety. Address water entry and moisture issues.

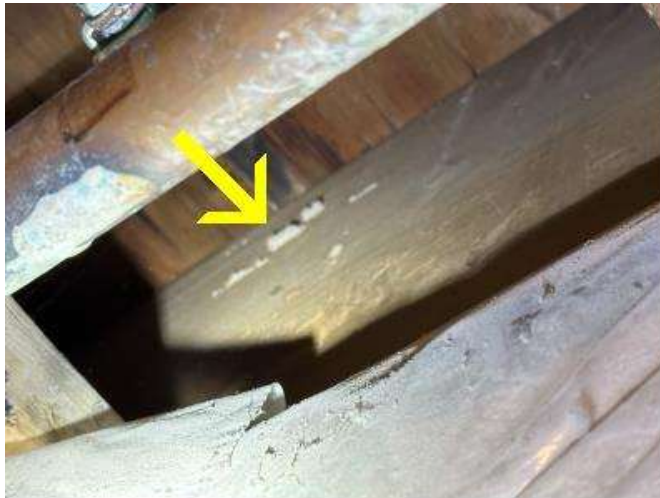
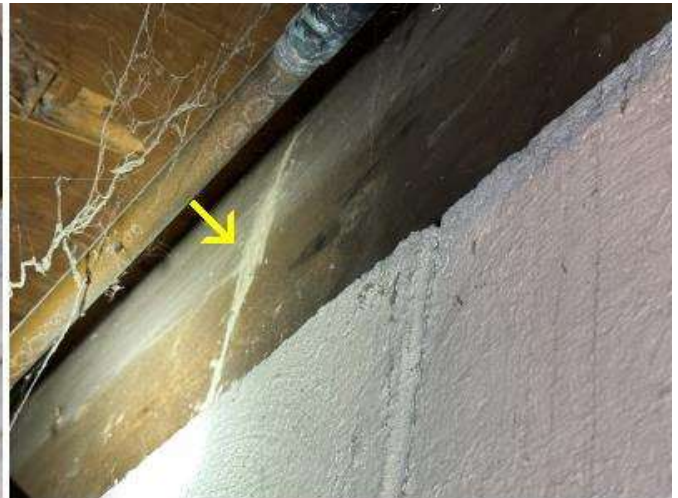
Most not visible due to finished surfaces. Limited view in boiler room. Termite shelter tubes noted. See termite inspection report ordered with this report.

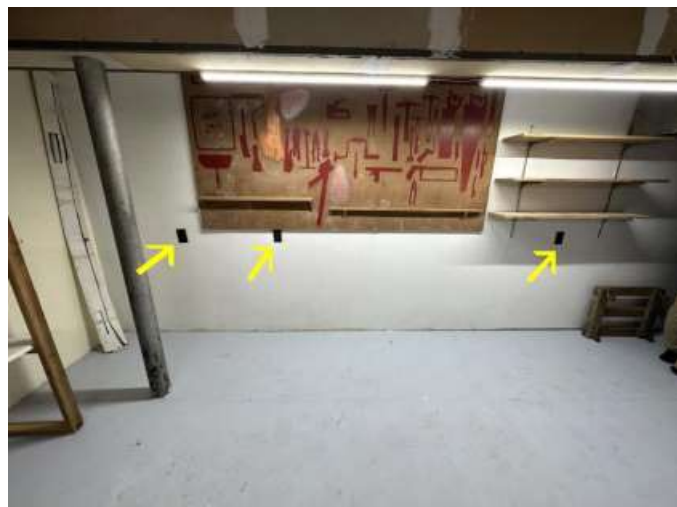
Garage Interior: ⚠ Ground Fault Circuit Interrupter (GFCI) protection is required at all garage outlets. Recommend evaluation for installation or repair as needed by qualified electrician for safety. Outlet(s) at the right side wall require upgrade. Damaged or missing outlet cover noted at left of electrical panel. Recommend installation for safety.

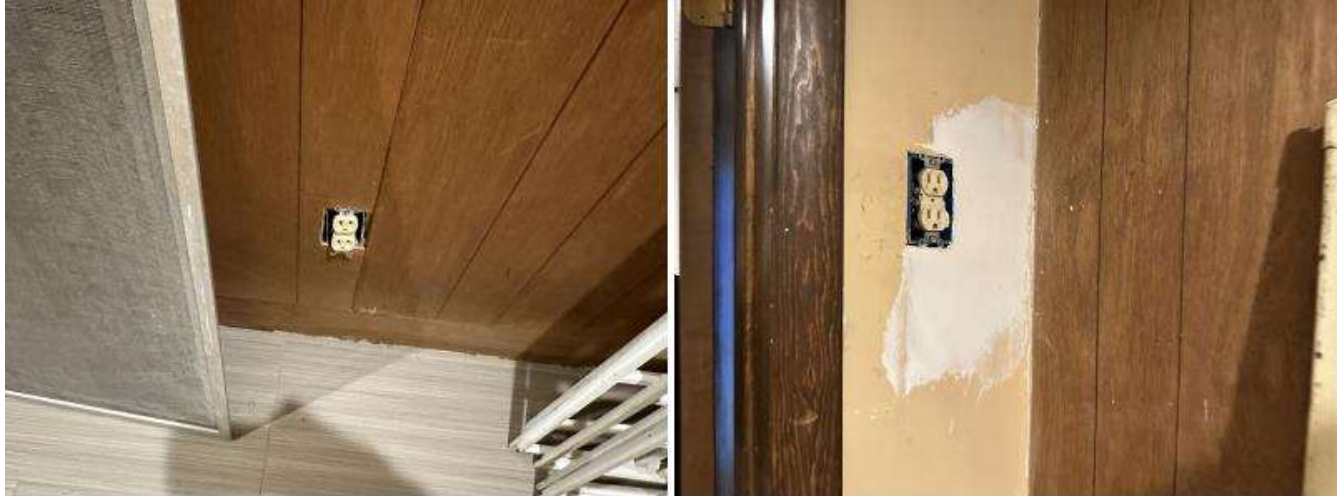
Basement: ⚠ Damaged or missing outlet cover noted at interior closet . Recommend installation for safety.

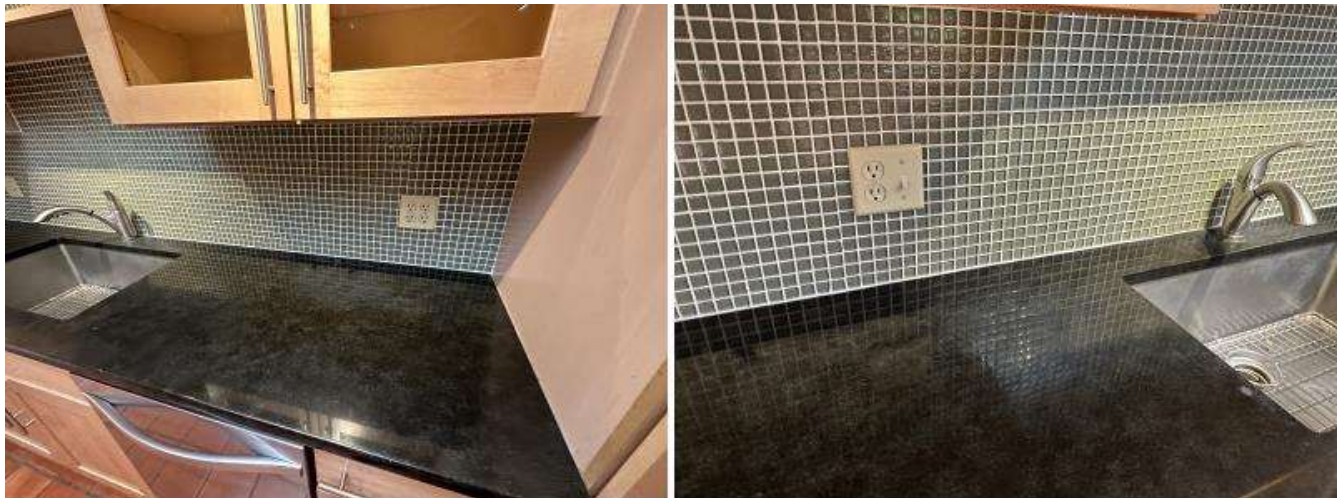
Missing GFCI protection noted at kitchen at all countertop outlets.. Ground Fault Circuit Interrupter (GFCI) protection is required at all outlets above kitchen counters and outlets for use related to kitchen counters. Recommend evaluation for installation or repair as needed by qualified electrician for safety.

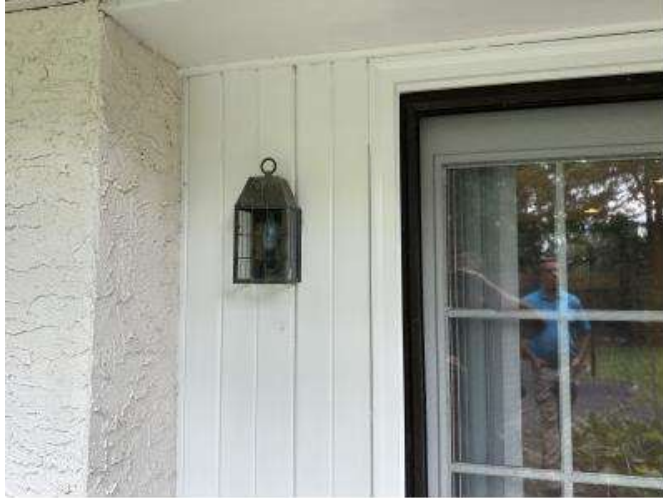
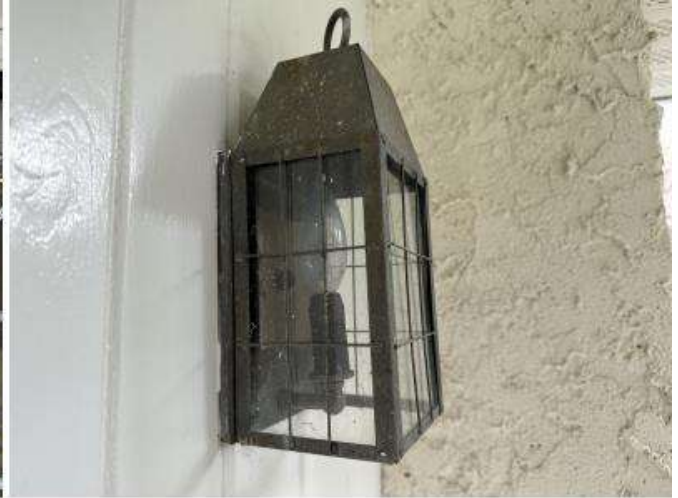
Exterior lights on either side of the side door next to the well room did not function. Recommend replacing light bulb prior to hiring an electrician.

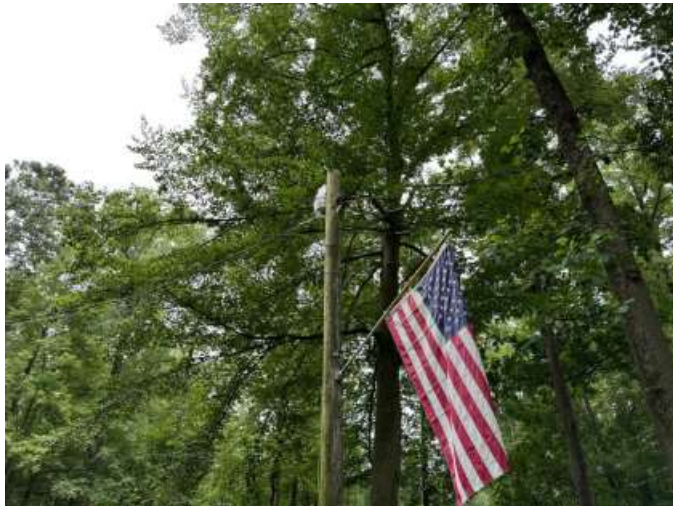
Aluminum, 110/220 Volt, Circuit breakers. Overhead, Overhead wires are contacting tree limbs. Recommend reporting this to the local power company for trimming in future.

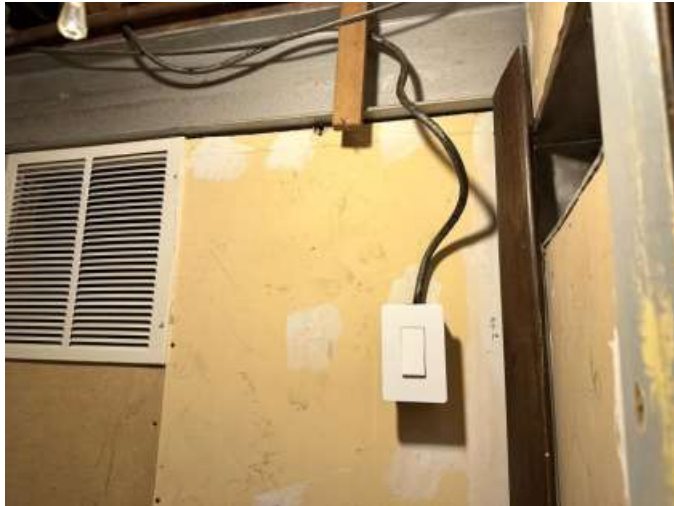
! Power kill switch for the boiler on the wall was not marked and could easily be mistaken for a light switch. Recommend replacing with a proper red switch and cover plate.

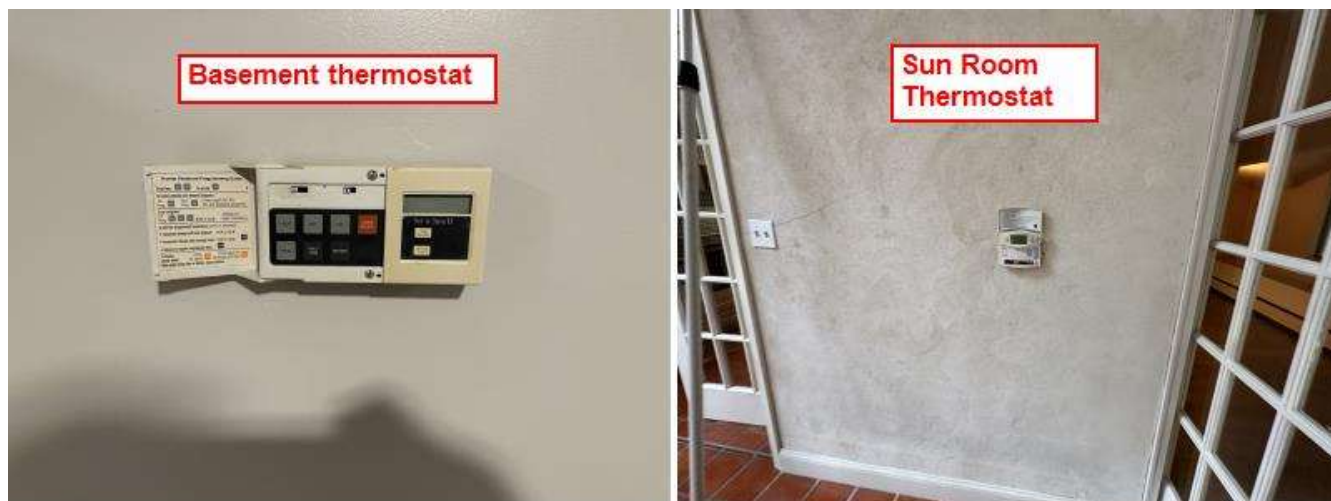
⚠️ There are multiple thermostats. The structure is divided into zones. The basement thermostat was malfunctioning and difficult to operate however it was possible to at least manage to activate the system to test for heat in the basement radiators which was operative. The thermostat located in the rear sunroom was inoperative and the radiators could not be tested in that room. Recommend replacing the thermostats with modern style thermostats and re-testing the heat systems by a qualified hvac technician.

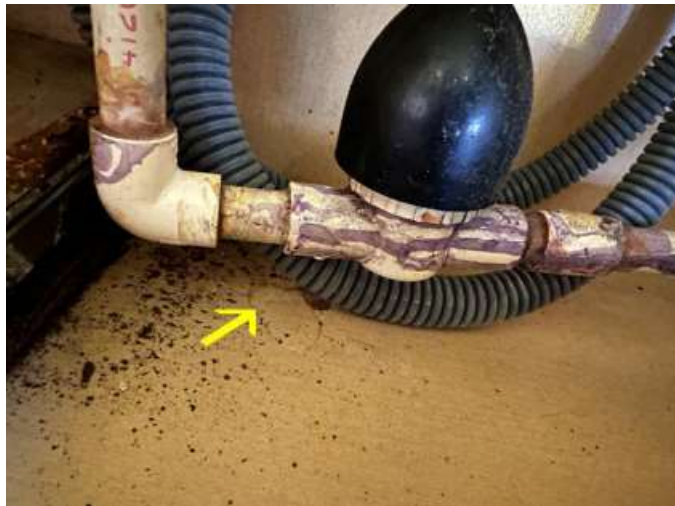
Plastic, CPVC. Small leak noted in cold water supply line under the kitchen sink. Recommend repair by a qualified plumber.

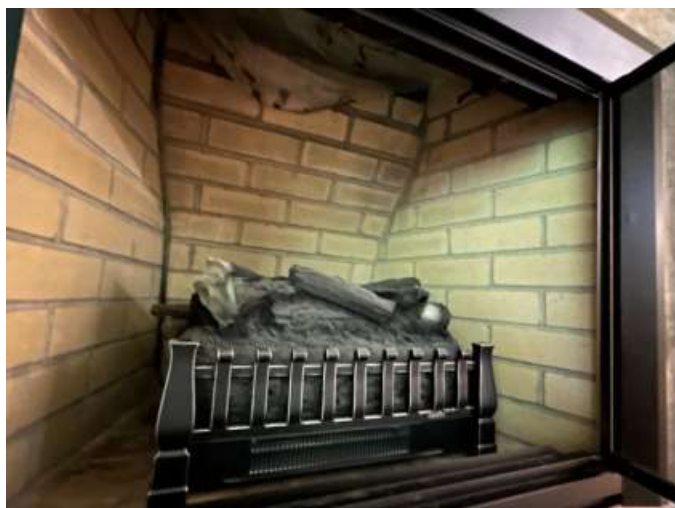
Brick. An electric fireplace was inserted with hardwiring into the masonry chimney. This produces minimal heat and is for aesthetics only. A plastic sheet was installed over the damper. If the fireplace is to be used for wood burning or a gas insert in the future, the electrical wiring and any hole produced from it would need to be removed and sealed, the plastic removed from the damper, the metal plate inserted into the chimney rain cap removed, and the damper, smoke chamber, and flue should be properly inspected by a qualified chimney specialist.

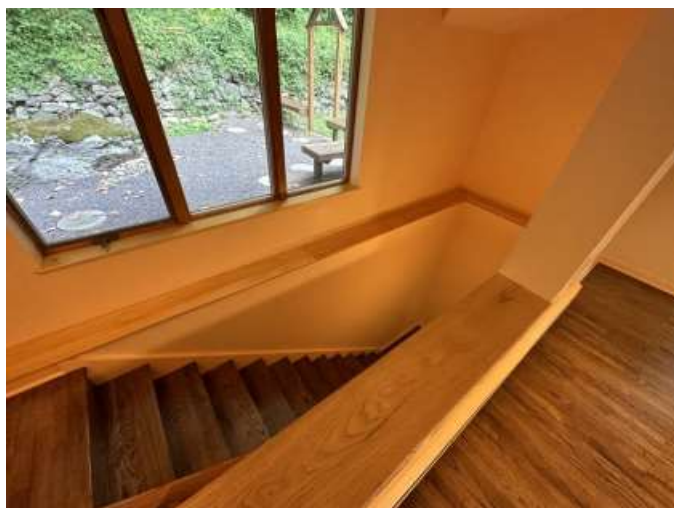
Opening from the kitchen to the basement stairs is low to the ground and a potential fall risk for children or impaired occupants. Use caution or add a rail for safety.

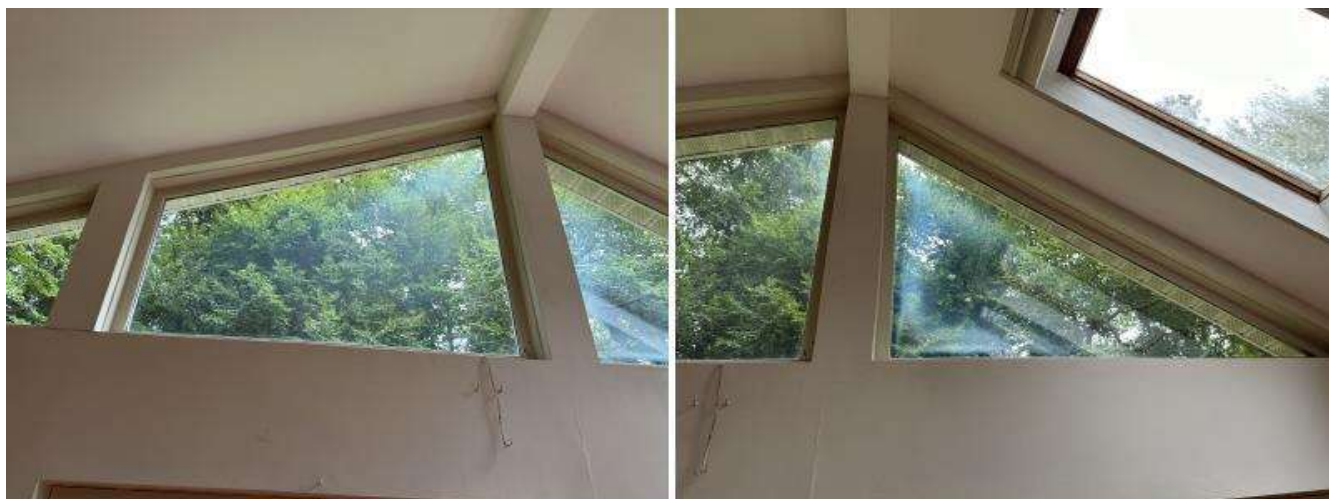
Fogged windows, blown thermal seals noted at two large upper panels in the sunroom. Seal at double pane insulated windows has failed, allowing moisture between the panes. Not all blown seals are visible in all seasons and visibility can vary with other factors such as temperature. This inspection can only mention those that are clearly visible at time of inspection. Repair typically is the replacement of the glass unit. Recommend evaluation for repair as needed by qualified window contractor.

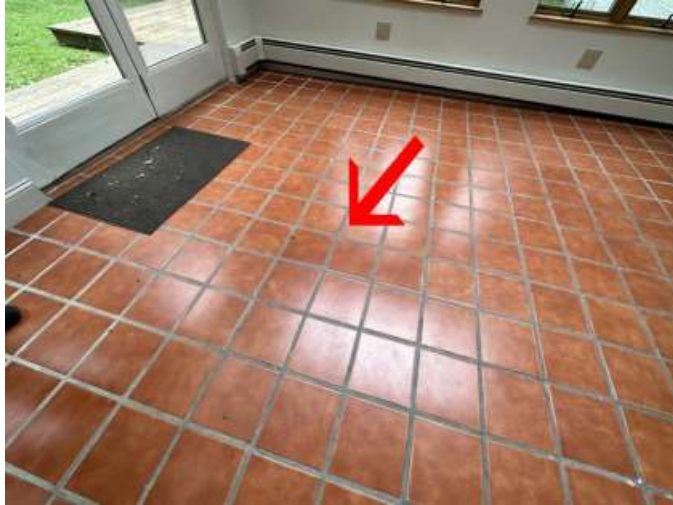
A depression is noted in the rear sunroom in front of the right rear door (facing outward). It appears that this formed after the floor was installed as there is a consistent line crack through the tiling at one side. The room is sloped towards the back and towards the southeast corner of the addition. No other defects in the room were noted except for superficial wall cracks on the interior wall. It appears the floor in this room was not level when the addition was added as the walls, radiators, and ceiling were level and plumb. Consult seller for more information or have a foundation contractor review the flooring as desired.

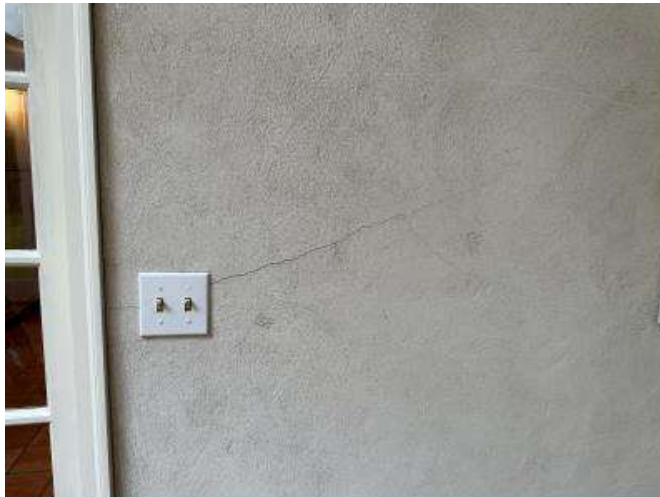
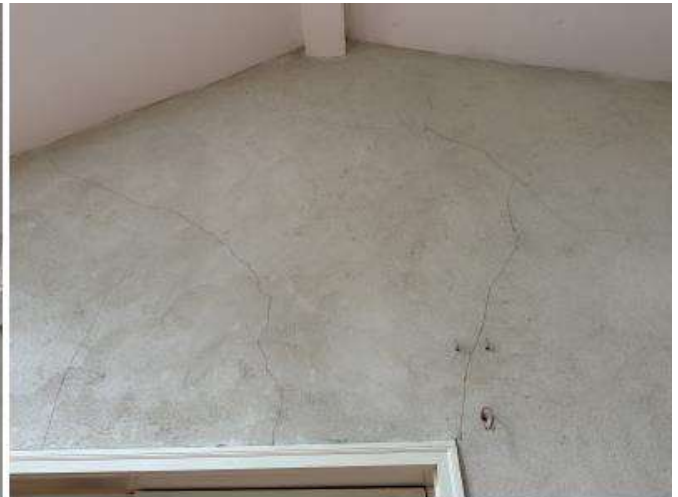
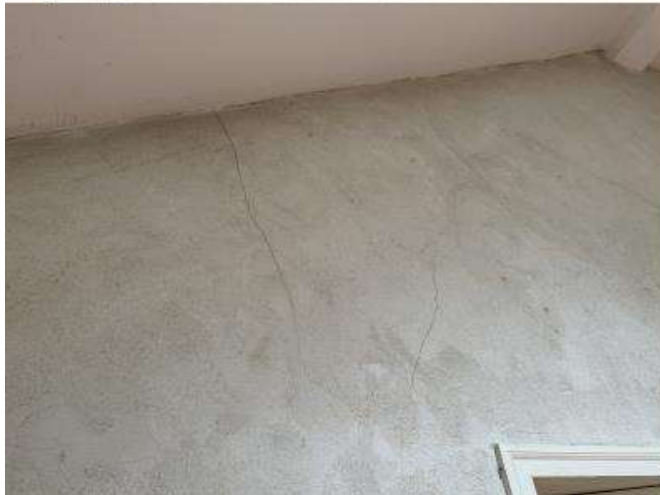
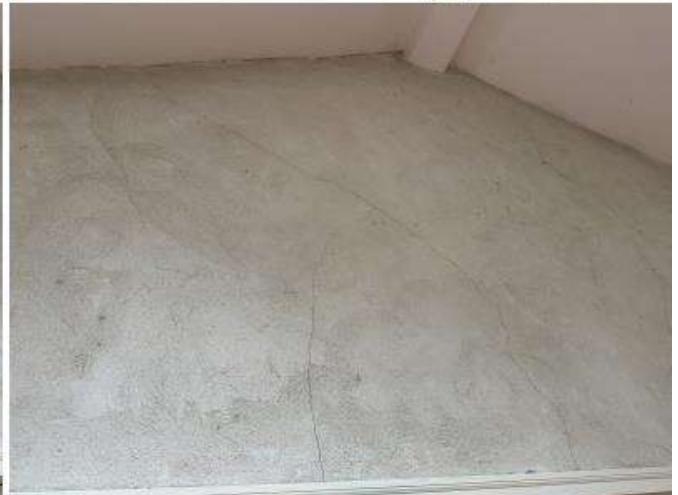
Plaster. Cracks noted in the sunroom interior wall appear to be settling cracks only. No moisture was noted at this location from the attic or interior side. Patch and paint as needed.
