SAGUACHE CREEK DIVERSION INFRASTRUCTURE INVENTORY

Structure Name: FORD D

Date: April 11, 2019

Saguache Creek Stream
Management Plan

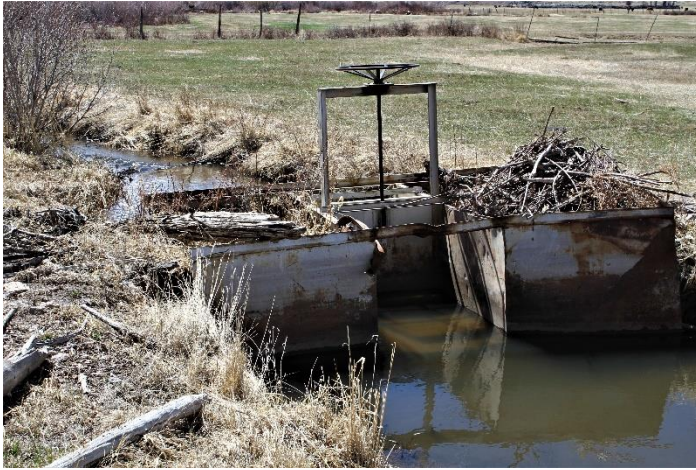
Headgate looking downstream

Structure Description: This ditch is located on the outside of a meander. A boulder diversion dam with an island in the middle directs water to a short feeder ditch located on the north bank of the river. The headgate functions well but experiences debris accumulation due to its location. The downstream bank of the feeder ditch is eroding and could fail at high flows.

Repair(s) or Improvement(s) Currently Needed: A trash rack should be installed to reduce debris accumulation at the headgate. Bank stabilization upstream of the diversion is recommended. The point of diversion could also be relocated to mitigate erosion and debris accumulation issues. Fish passage and riparian restoration should be considered as part of any future repairs or improvements.
