Northern Neck Master Gardeners

Subject: Requested Shoreline Evaluation

To: Deb Beutel, Corrotoman by the Bay Association (HOA)
PO Box 99, Mollusk, VA 22517, Lancaster County

Evaluation of Lot 7

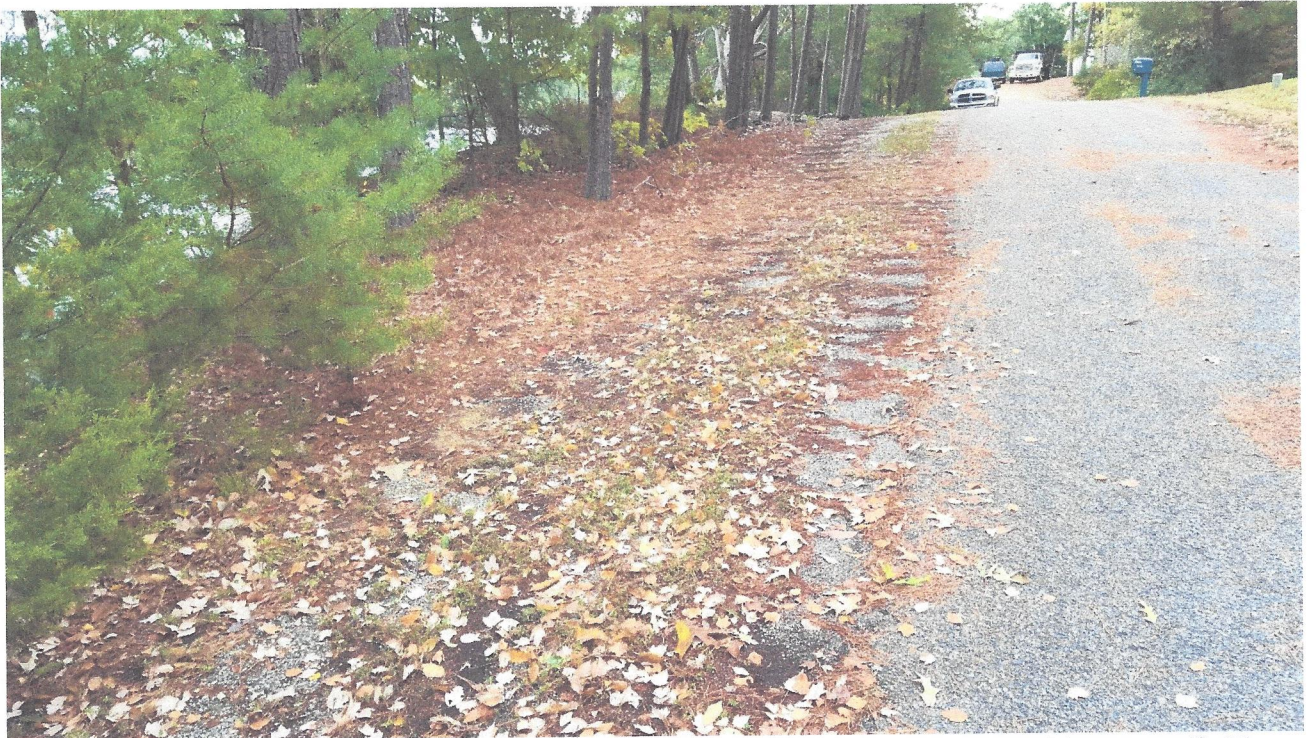
Photo 1. Development Road and Top of Evaluated Properties Shoreline Bank. Note runoff rills.

8. In light of recent increases in rainfall amounts in storms, upland erosion from storm water runoff is a concern. Existing vegetation should be maintained except for leaning trees. It is recommended that all storm water runoff from the road should be diverted away from the shoreline bank.

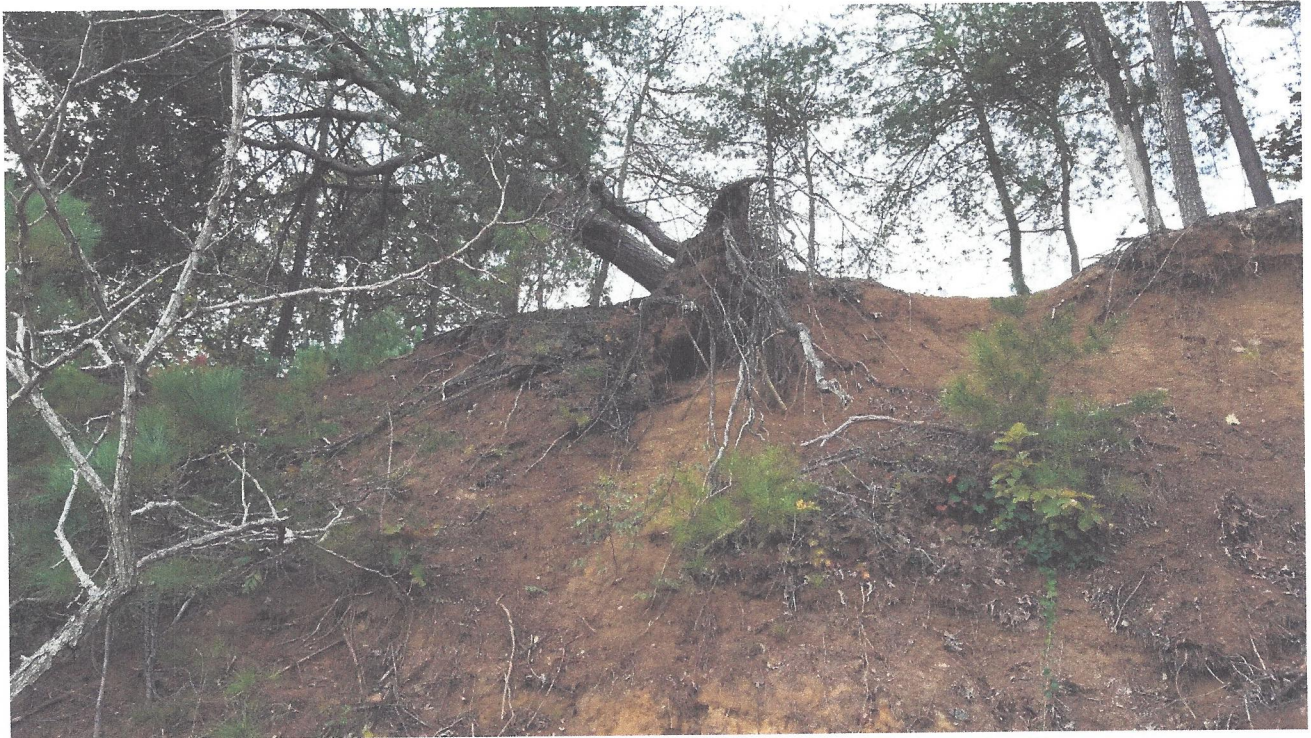
Photo 2. Lot 3a & 4a Upper Slope erosion and loss of Protective Veneer and Vegetation.

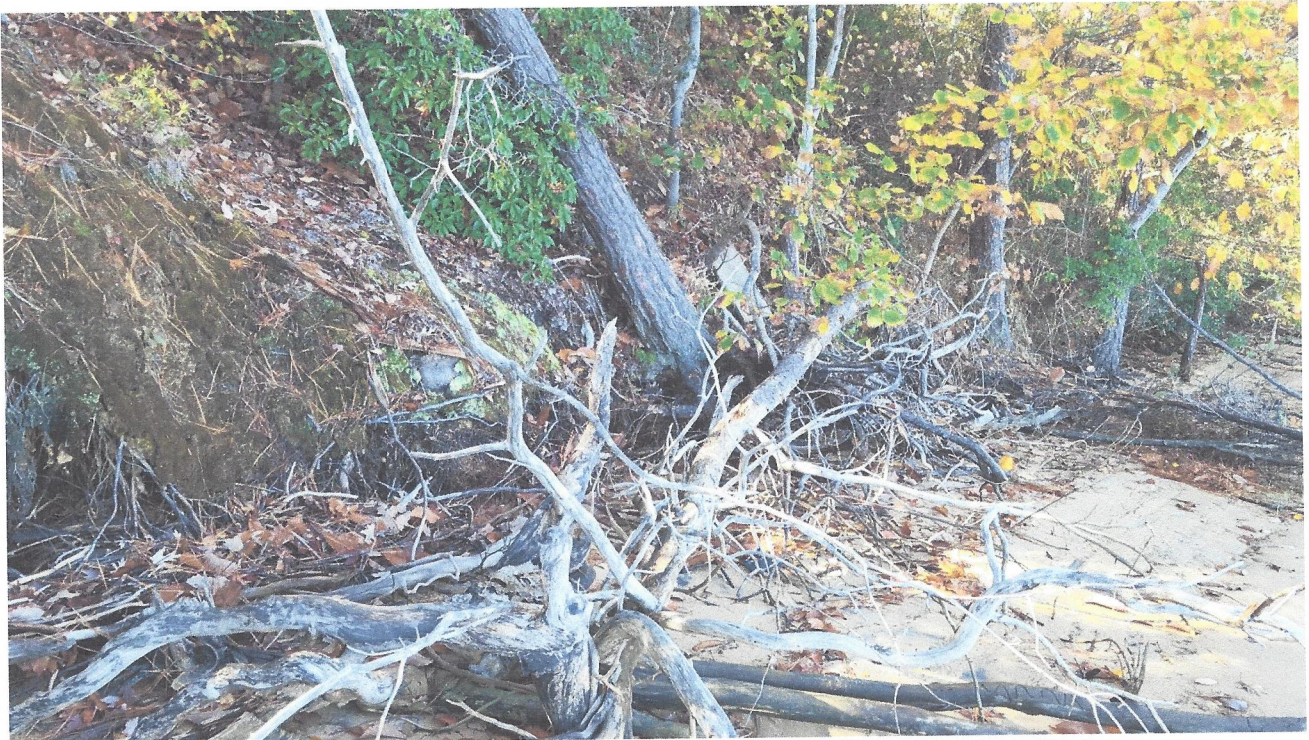
At high tide the river water rises up against the bank. There is tidal erosion undercutting along the bank (Photo 3). At low tide there is a sand beach approximately 10 to 15 ft wide depending upon the tide and the location on the shoreline. Because the shoreline is north facing and there are overhanging trees blocking sunlight, there is little intertidal vegetation except for a few patches of shoreline grasses where the upland vegetation is thin. The shoreline is also filled with accumulated debris of dead branches, roots and fallen trees (Photo 3).

This small property has several upland features. From east to west, it starts with a steep bank close to the shoreline similar to the other two neighboring properties (Photo 3). The bank then recedes away from the road and the shoreline with a high forested area giving way to a low and level area along the shore. The eastern portion of which is wet although not marshy and the western portion slightly higher is dry (Photo 4). All areas are forested and the western portion may be retained as natural habitat.

The actual shoreline is a sandy beach 10 to 15 feet wide at low tide terminating at the foot of the bank at the eastern end (Photo 3). At the more open western end, there are shoreline grasses (*Spartina alterniflora*) and shrubs (saltbush) above the beach primarily due to sunlight access (Photo 6). Above the shoreline vegetation is a mixed hardwood forest.

Photo 3: HOA Lot 7, Shoreline and Steep Bank with undercutting at Eastern End

1. For the eastern shoreline with steep bank, the VIMS CCRM decision tree (Attach 3) recommendation for forested shorelines with eroded shoreline and banks up to 30 feet is to manage the forest to prevent tree falls and address the shoreline erosion. For a moderate fetch, the

recommended shoreline erosion protection is a marsh with sill. See discussion above regarding living shoreline installation.

Given the potential approval hurdles because of the offshore SAV designation and if neighboring properties elect to install a revetment, it may be appropriate to install a revetment at the eastern end of lot 7 to facilitate approval and integration.

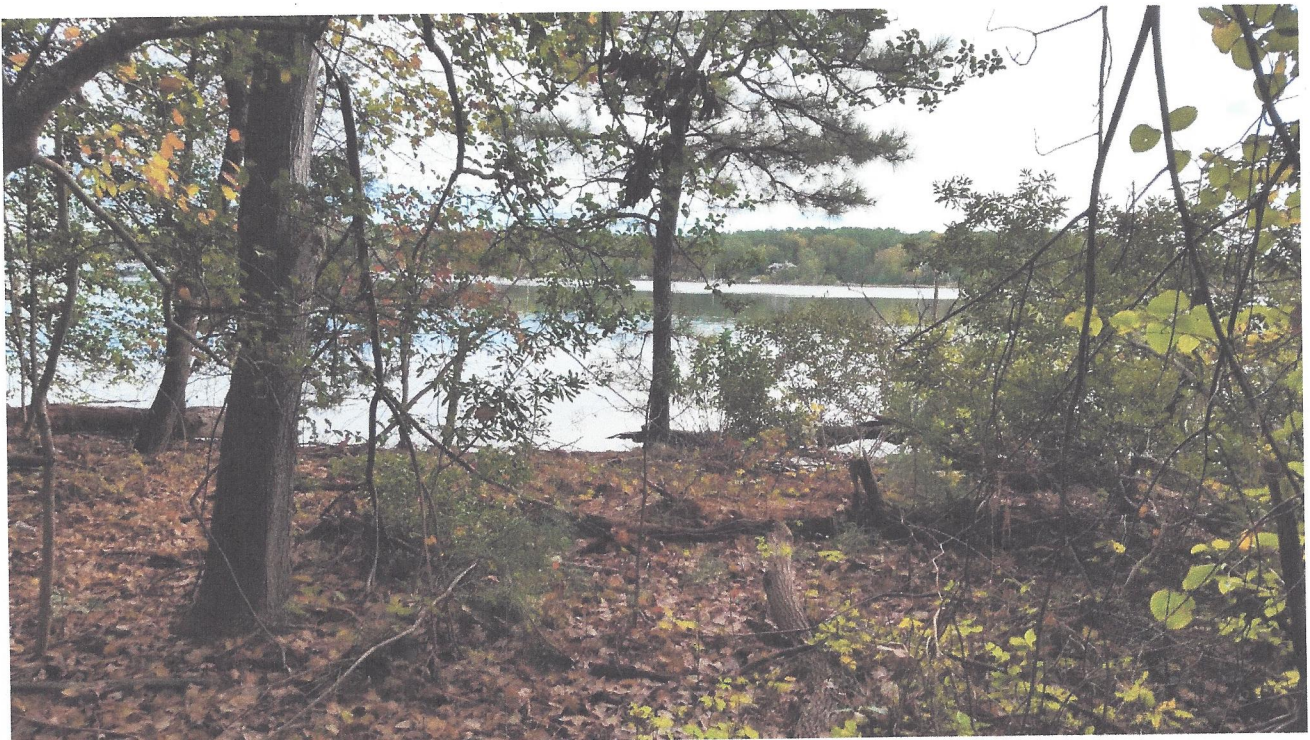
Photo 4. Level portion of HOA lot 7

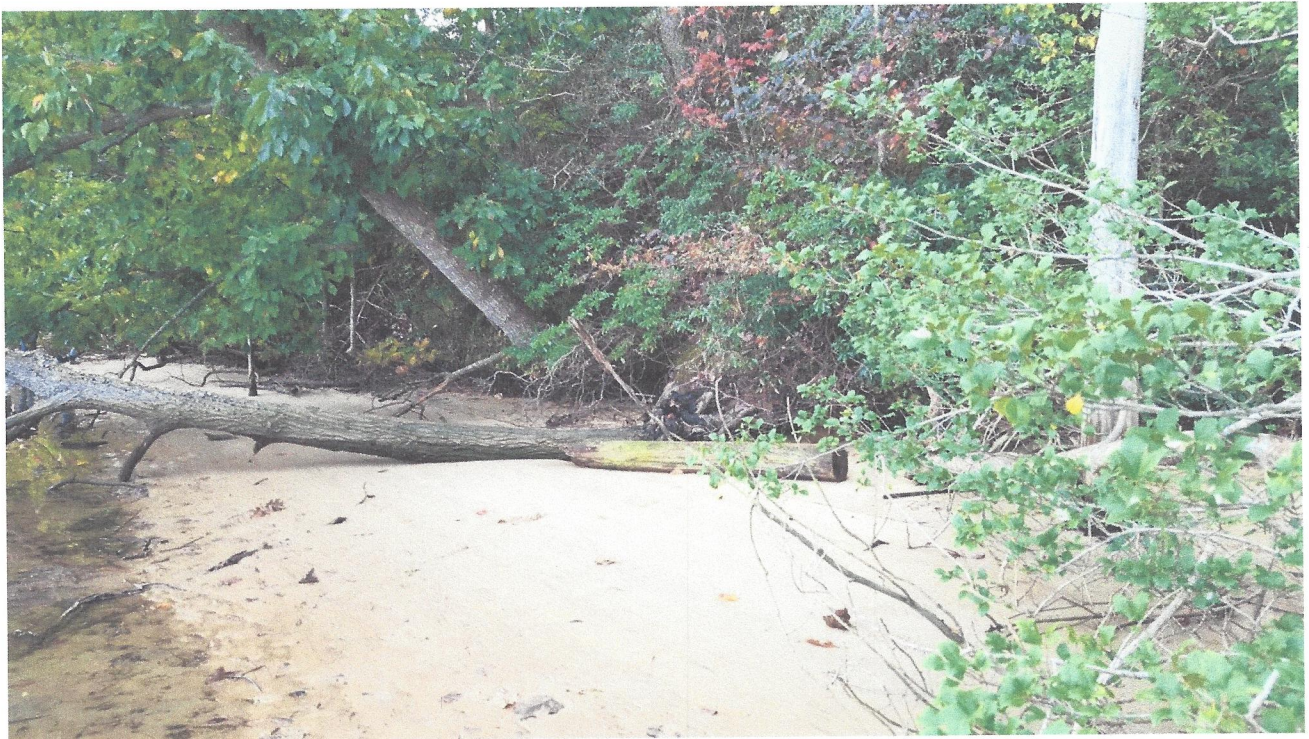
Photo 5. Beach and Tree Fall on HOA Lot 7

4. If a living shoreline is selected or sections of the bank are not subject to revetment installation, manage the forested bank to prevent tree fall. Selectively remove dead, dying and severely leaning trees. Prune branches with weight bearing load over the water. Also, prune to increase the sunlight on the shoreline to promote growth of shoreline grasses. Note, tree removal will require a permit from the county.

5. Replace any removed trees with mid-story trees, native shrubs and deep-rooted grasses utilizing species that are already growing on the bank. Native grasses such as switchgrass, shrubs such as wax myrtle, mountain laurel and lowbush blueberry are preferred options to stabilize a slope. In particular because they have extensive root systems. Control establishment of invasive species. Reference the SEP Homeowners' Guide appendices (Attach 1) for suggestions in each category, and listings of native plant suppliers

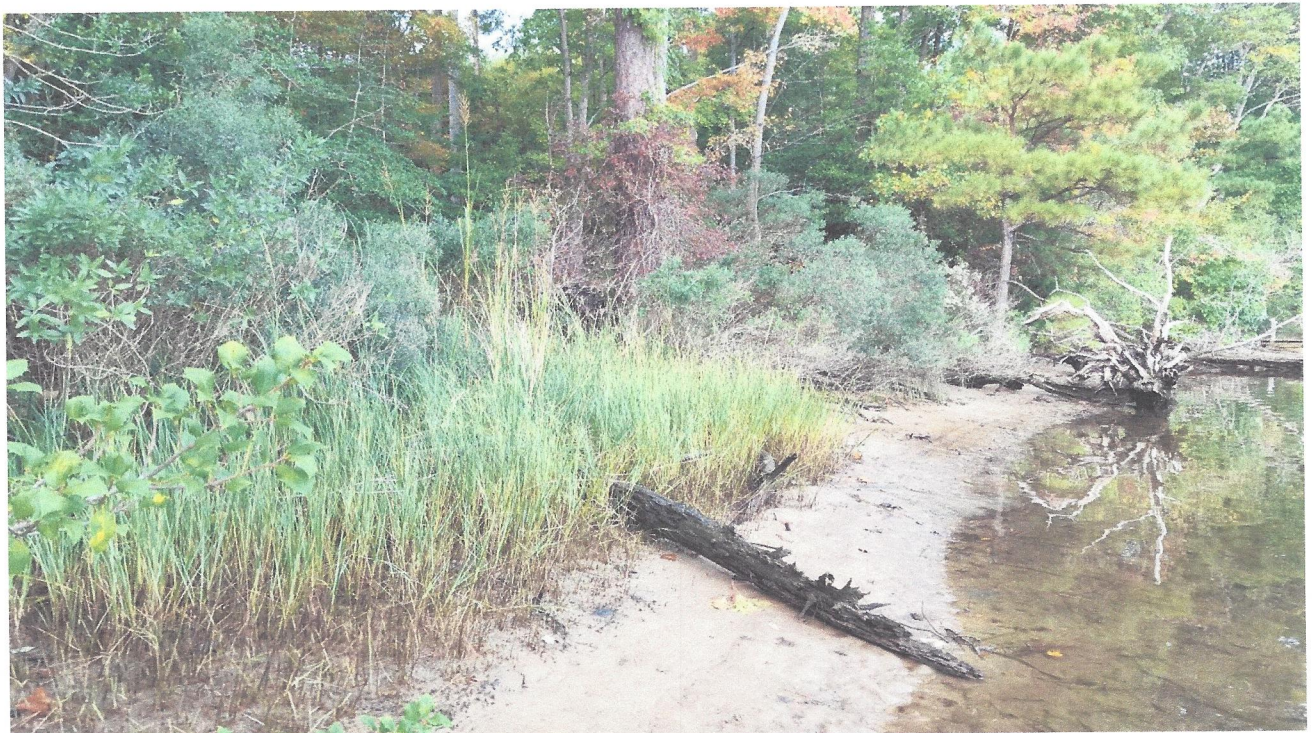
Photo 6. Western end Shoreline, HOA Lot 7

2. For the western beach with marsh and low erosion, the VIMS CCRM Decision Tree (Attach 3) recommendation is to manage the marsh and upland riparian buffer.

6. On the western shoreline, prune overhanging trees to improve sunlight on the shore and allow establishment of new and spread of existing grasses.
7. Clean up the existing marsh and upland by removing deadfall and rubbish. Deadfall in a marsh can kill grasses and result in erosion caused by eddy currents around obstacles during regular tidal flow.
