INSPECTION REPORT

For the Property at:
1234 MAIN ST
AMERICA, MD 11111

Prepared for: JANE SMITH
Inspection Date: Saturday, April 30, 2016
Prepared by: Dan Zook

RE: Report No. 1085, v.3
1234 Main St
America, MD
11111

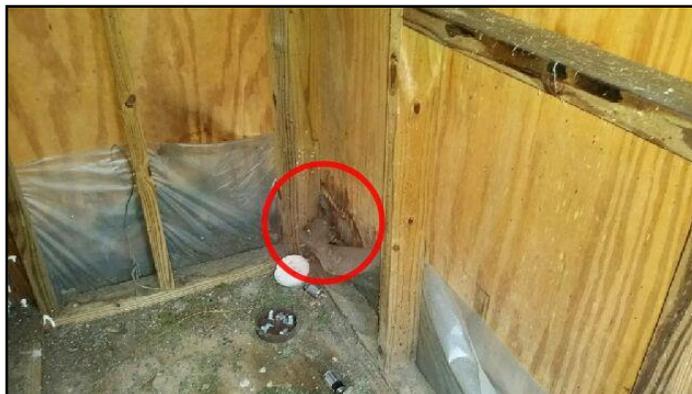
Location: Rear

Task: Improve

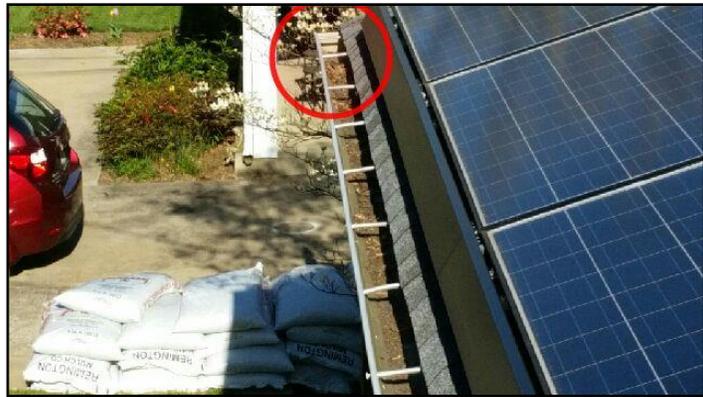
2. **Condition:** • [Clogged](#)

Implication(s): Chance of water damage to contents, finishes and/or structure

Clogged

Task: clean

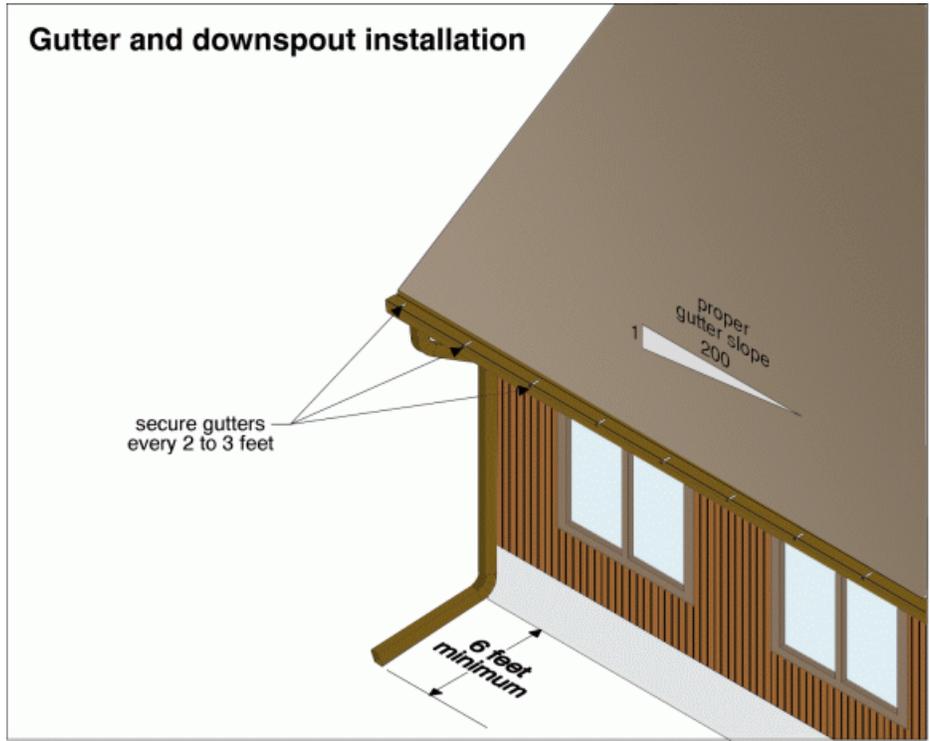
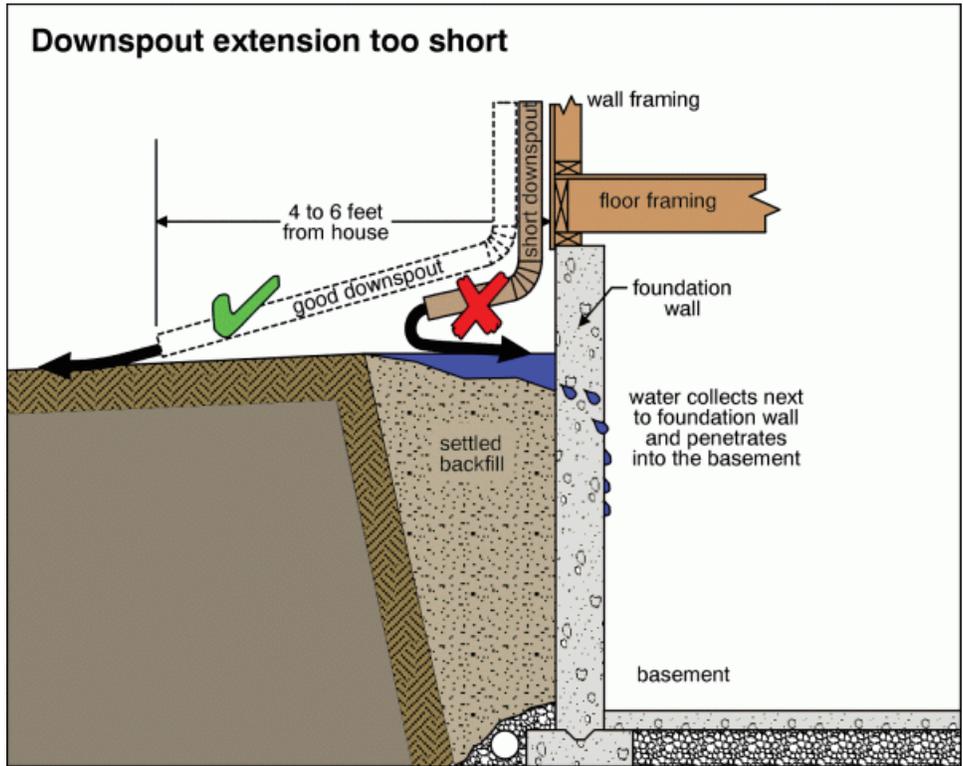
5. Condition: • [Downspouts end too close to building](#)

Implication(s): Chance of water damage to contents, finishes and/or structure

Task: Improve

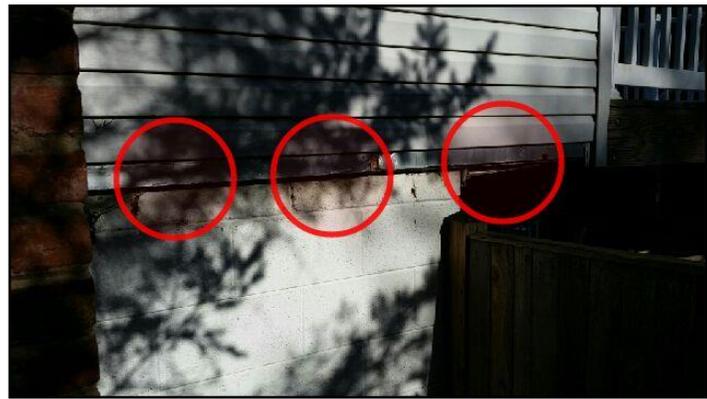
6. Condition: • [Loose or missing pieces](#)

Implication(s): Cosmetic defects | Chance of water damage to contents, finishes and/or structure

Loose or missing pieces

Task: Repair or replace

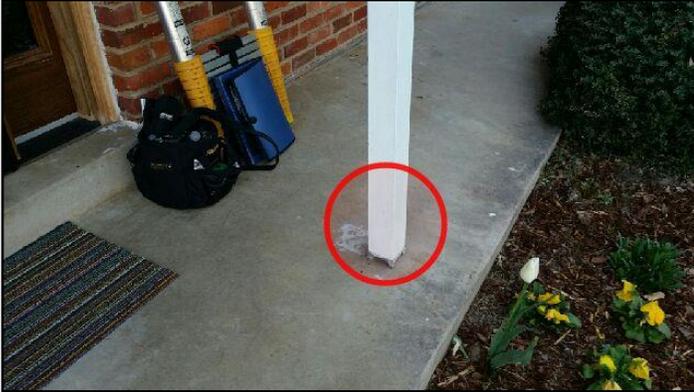
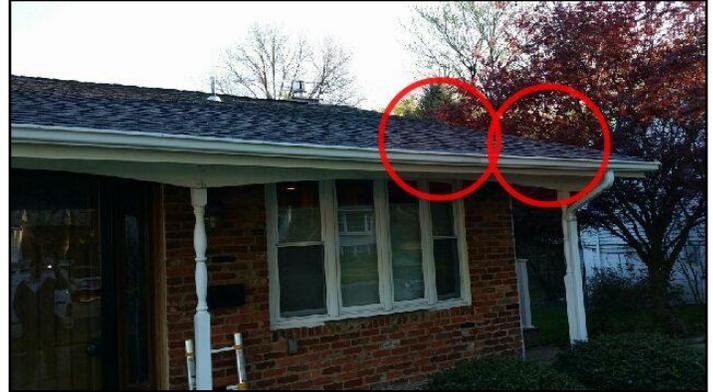
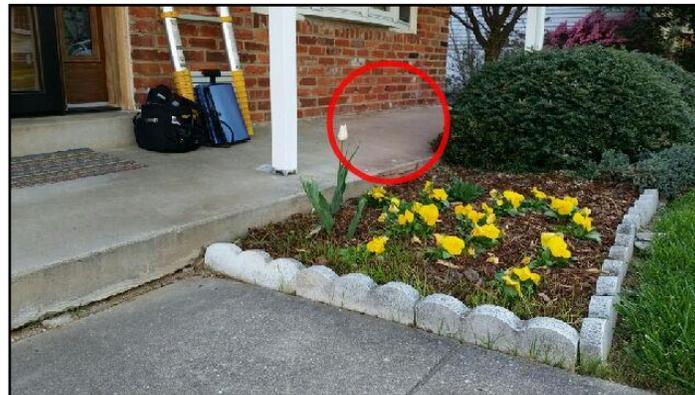
7. Condition: • [Settled](#)

The Front Porch posts are no longer secured to the concrete floor. The slope of the roof sags towards the right corner because of this condition. It appears the primary cause for these conditions is the concrete porch floor is now slipping away from the home. I recommend a licensed contractor determine the best way to repair the concrete floor either by

Settled

Movement

Task: Repair or replace

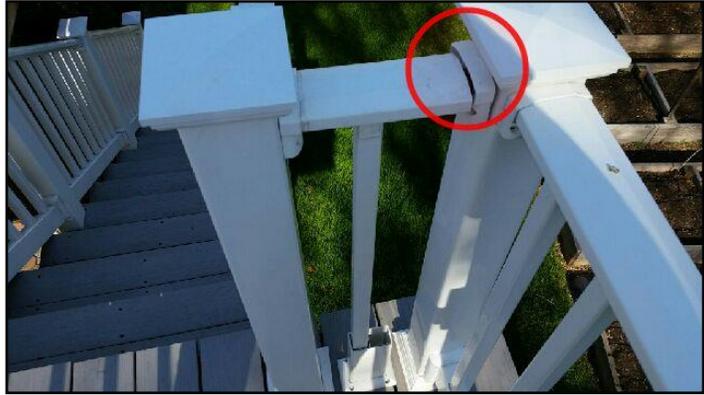
9. Condition: • [Loose](#)

loose railing

Implication(s): Fall hazard

Loose

Task: Repair or replace

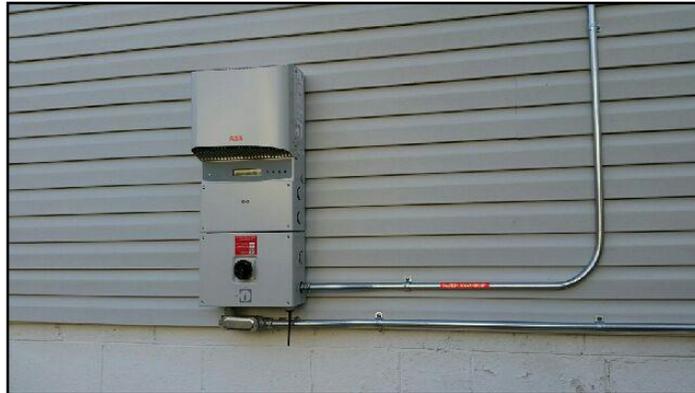
10. • solar panels are not inspected as part of a home inspection. It is recommended the installation company be contacted to show proper usage of this specific system. This would include emergency handling situations such as turning off the solar system as well as maintenance requirements

Task: Further evaluation

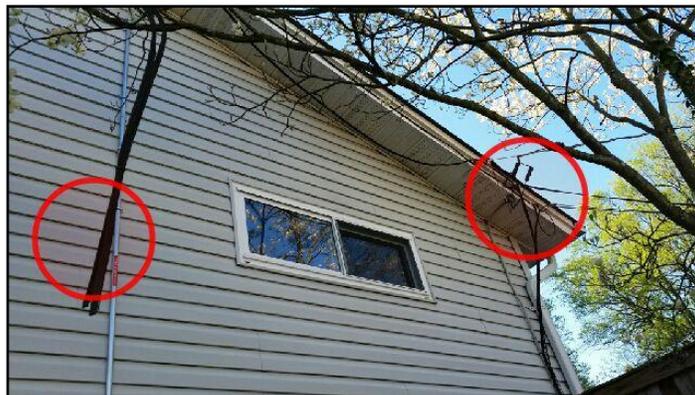
11. • remove the cable coax wires. it appears they may have the potential to come in contact with the Service drop wire coming from the utility pole in the front yard

Task: Remove/ safety improvement

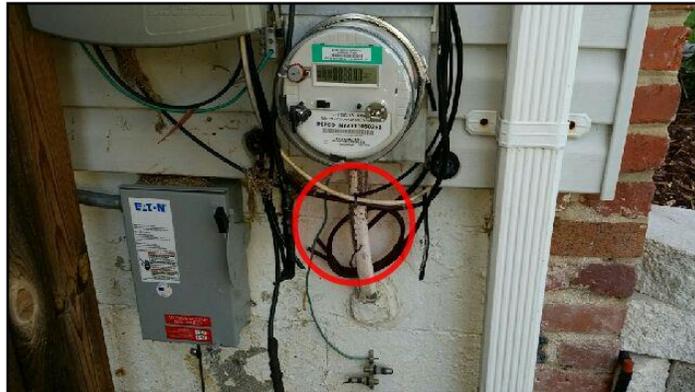
12. **Condition:** • [Insulation missing or damaged](#)

Implication(s): Fire hazard

Insulation missing or damaged

Task: Repair or replace

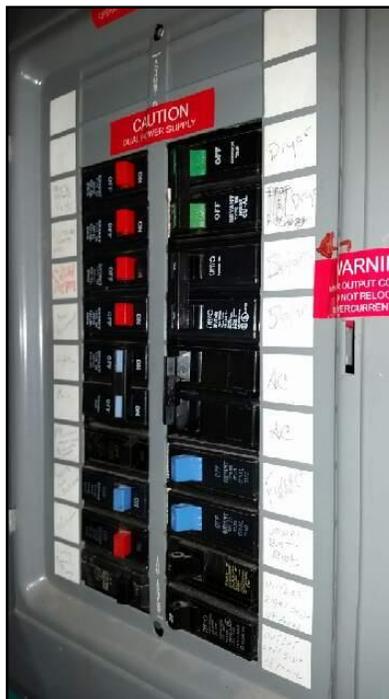
14. Condition: • [No single main disconnect](#)

It is recommended to determine which Breakers must be thrown to shut off all of the Power. It's unknown which Breakers the main lighting breaker is connected to

No single main disconnect

Task: Safety Improvement

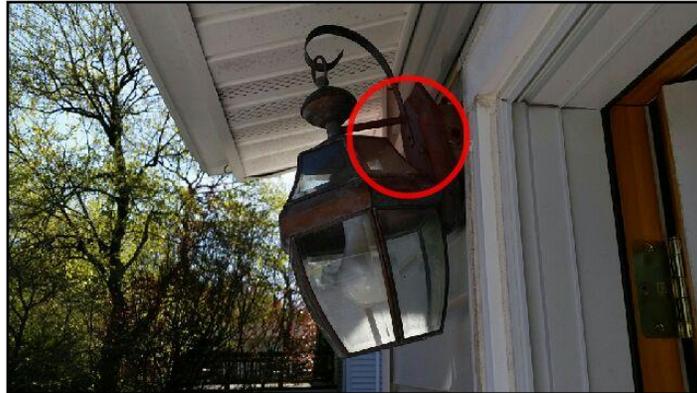
15. Condition: • [Loose](#)

Implication(s): Electric shock | Fire hazard

Loose

Task: Repair or replace

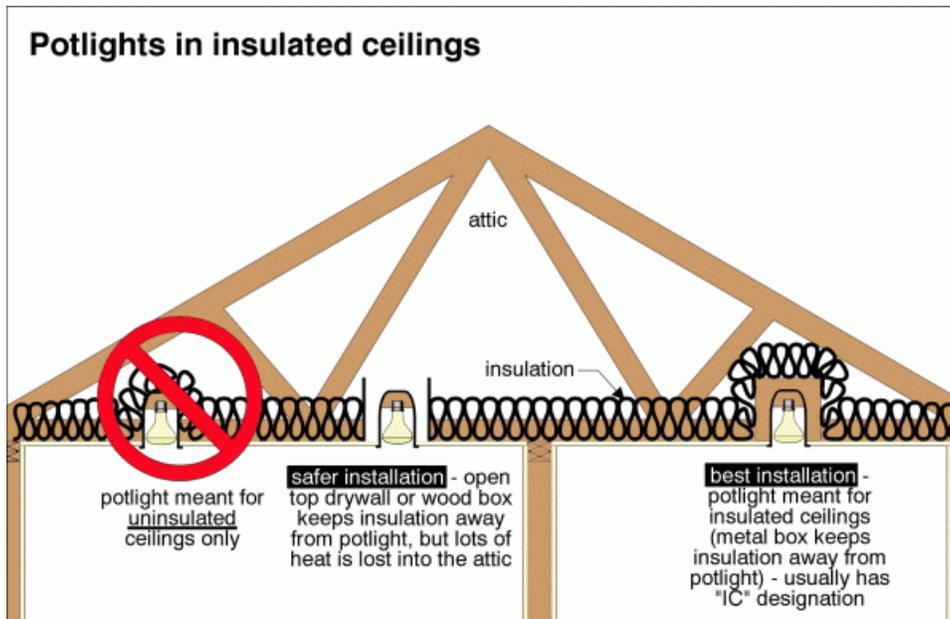
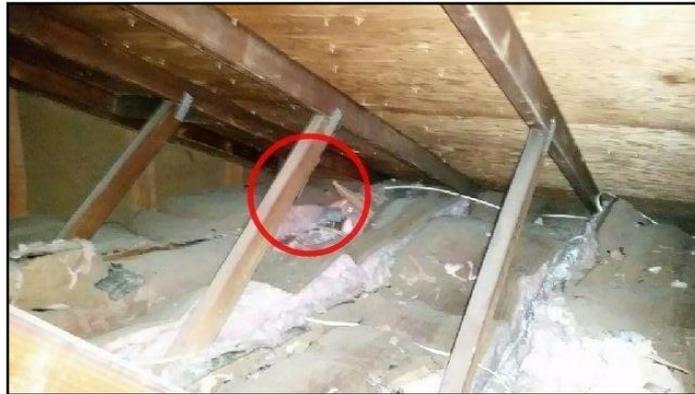
16. Condition: • [Improper potlights](#)

Implication(s): Fire hazard

Improper potlights

Task: Monitor or improve

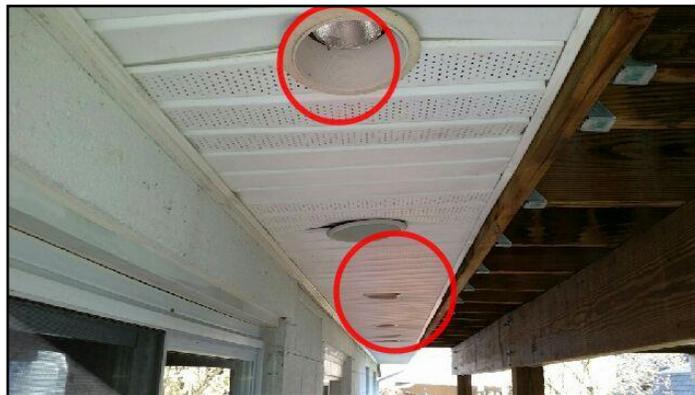
17. Condition: • [Conventional lights in wet areas](#)

Implication(s): Electric shock | Fire hazard

Conventional lights in wet areas

Task: Safety Improvement

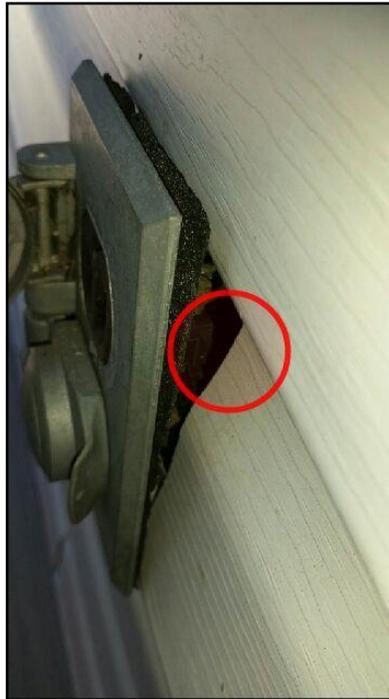
18. Condition: • [Loose](#)

Implication(s): Electric shock | Fire hazard

Loose

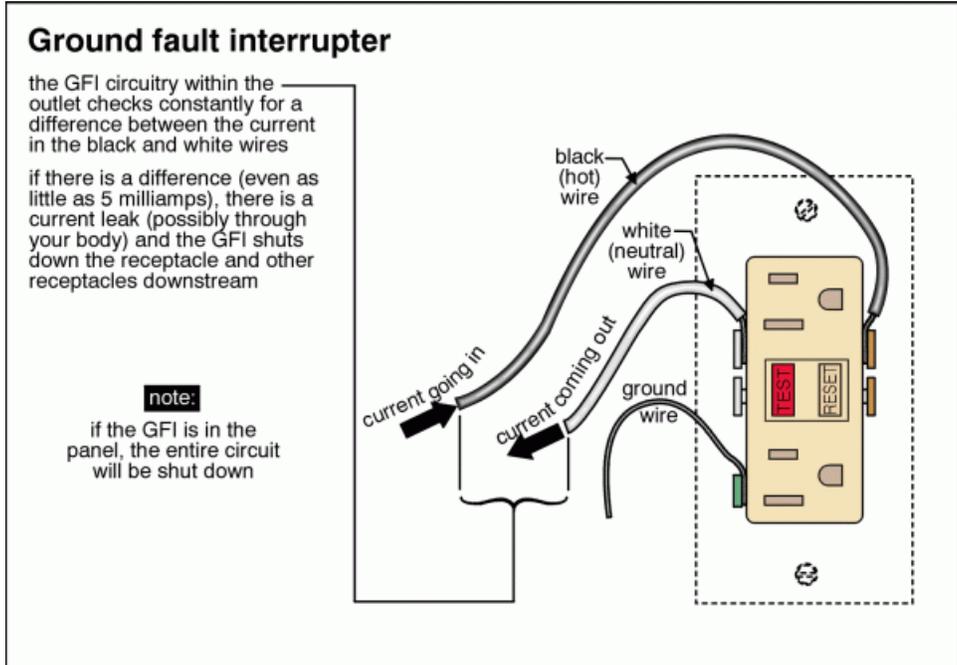
19. Condition: • [No GFCI \(Ground Fault Circuit Interrupter\)](#)

Task: Safety Improvement

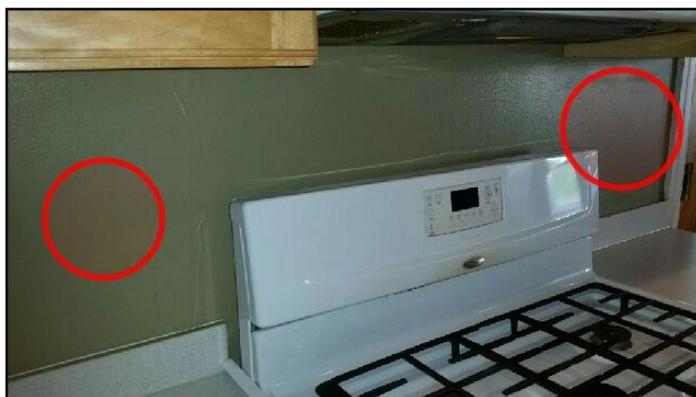
21. Condition: • [Too few outlets](#)

Too few outlets

Task: Improve

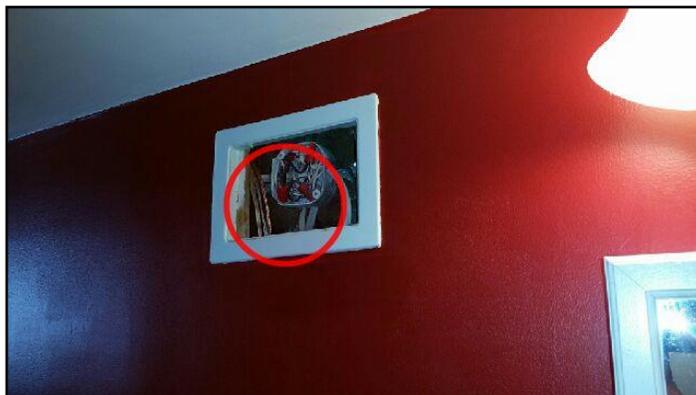
22. Condition: • [Missing](#)

Missing

Task: Repair or replace

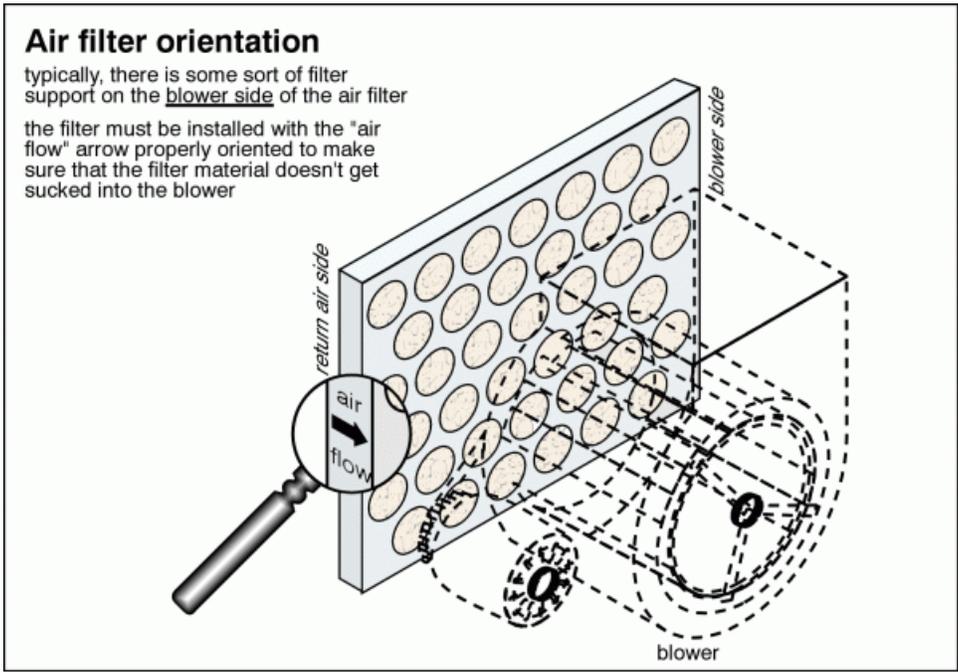
26. **Condition:** • [Installed backwards](#)

install a new filter. It is not recommended to turn the old filter around. This may dislodge dust.

Task: Repair or replace

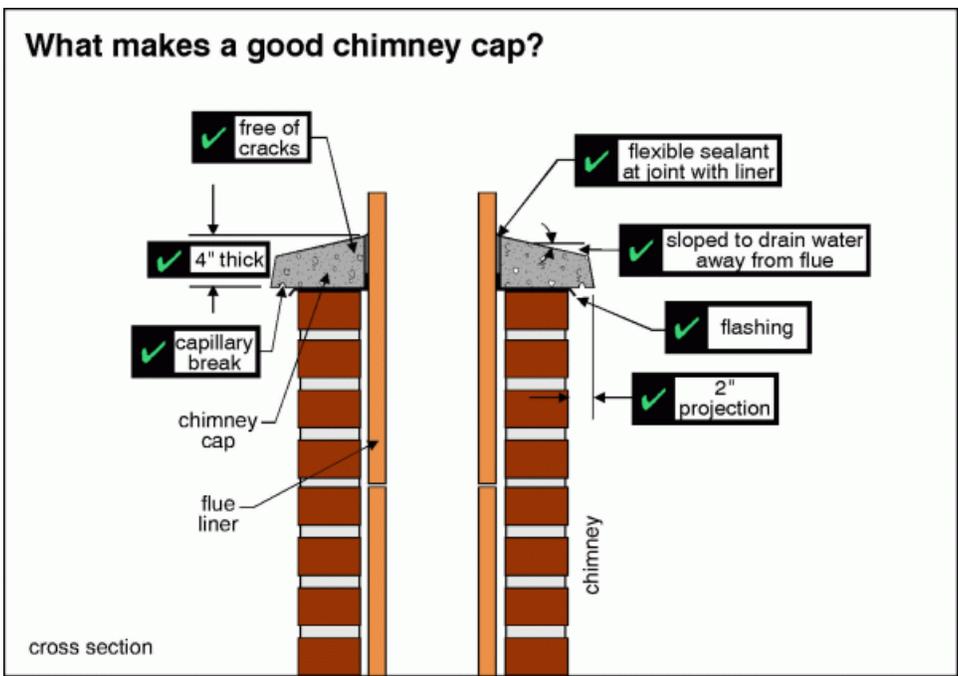
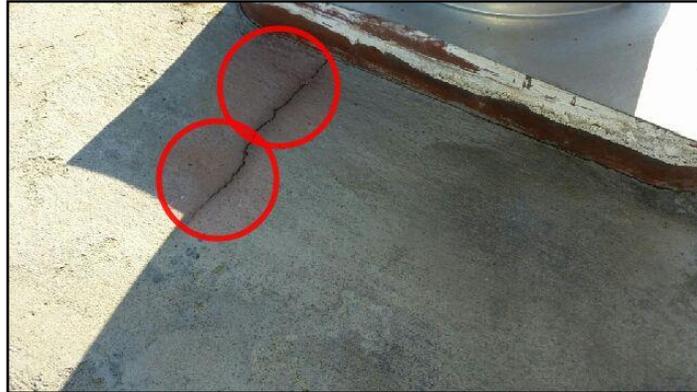
27. Condition: • [Cracked](#)

Minor crack on cap

Implication(s): Chance of water damage to contents, finishes and/or structure | Shortened life expectancy of material

Cracked

Task: Repair or replace

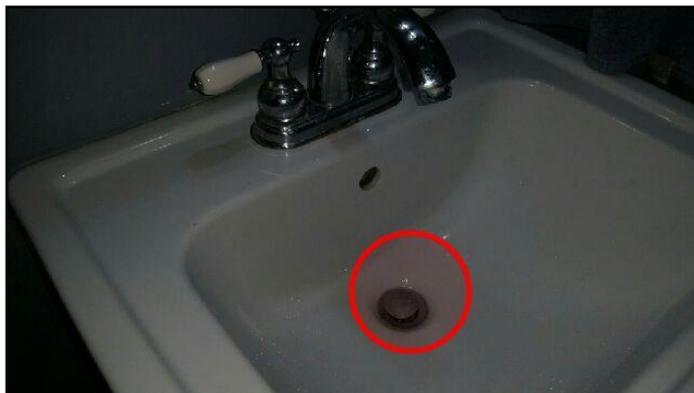
32. Condition: • Drain stop ineffective

Drain stop ineffective

Task: Repair or replace

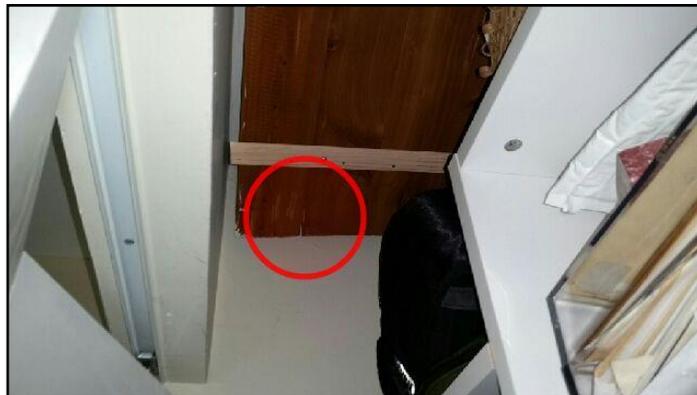
36. Condition: • Cedar ceiling is falling. cosmetic repair.

Task: Improve

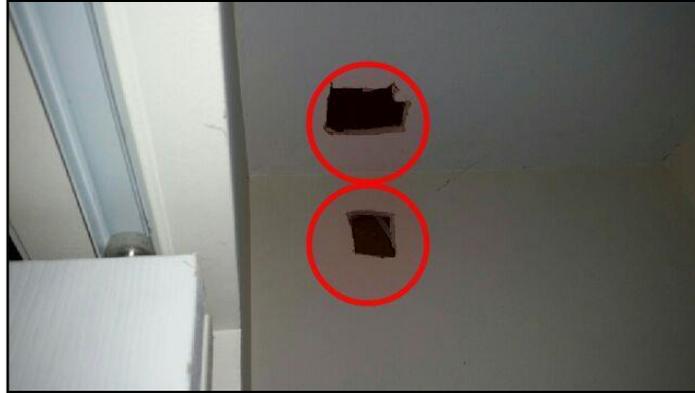
37. Condition: • Holes are visible in the ceiling and wall. Patch and repair as needed

Task: Repair or replace

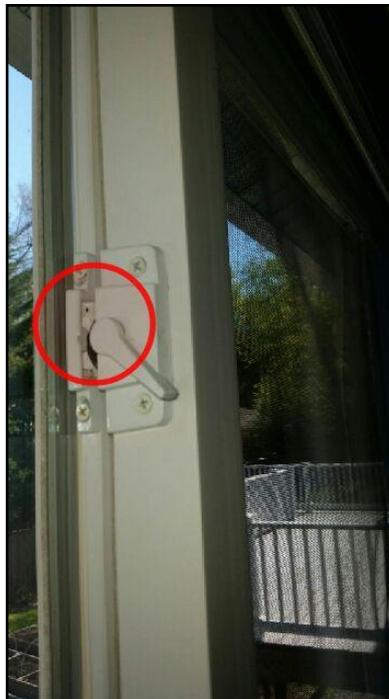
38. Condition: • [Inoperable](#)

Inoperable

Task: Repair or replace

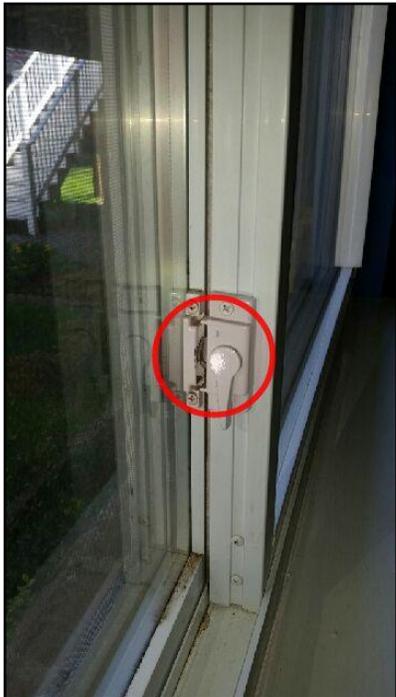
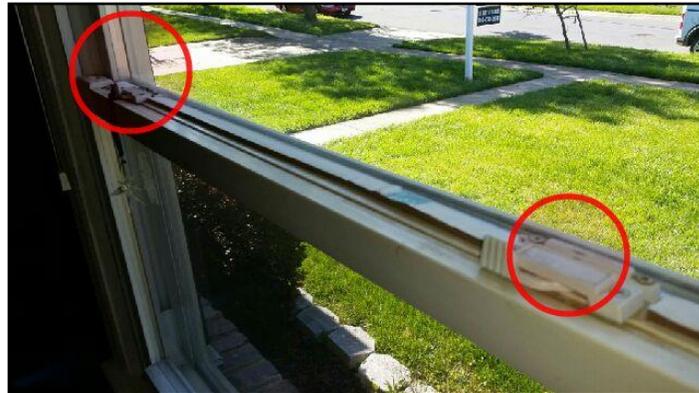
39. Condition: • [Inoperable](#)

Inoperable

Task: Repair or replace

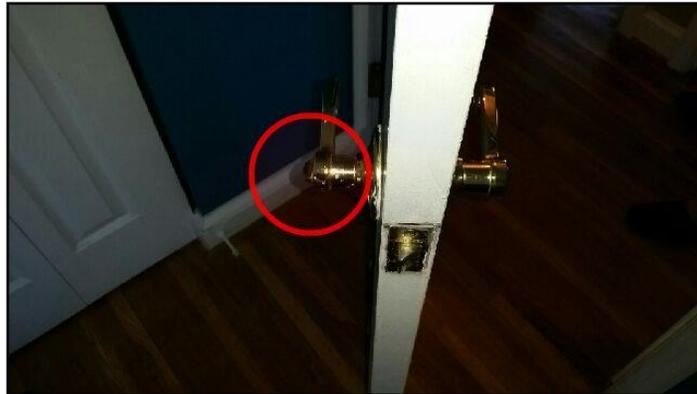
42. Condition: • [Inoperable](#)

Inoperable

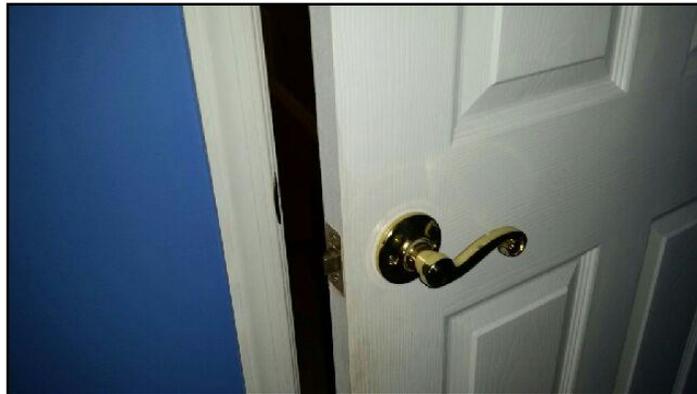
43. Condition: • [Inoperable](#)

Inoperable

Task: Repair or replace

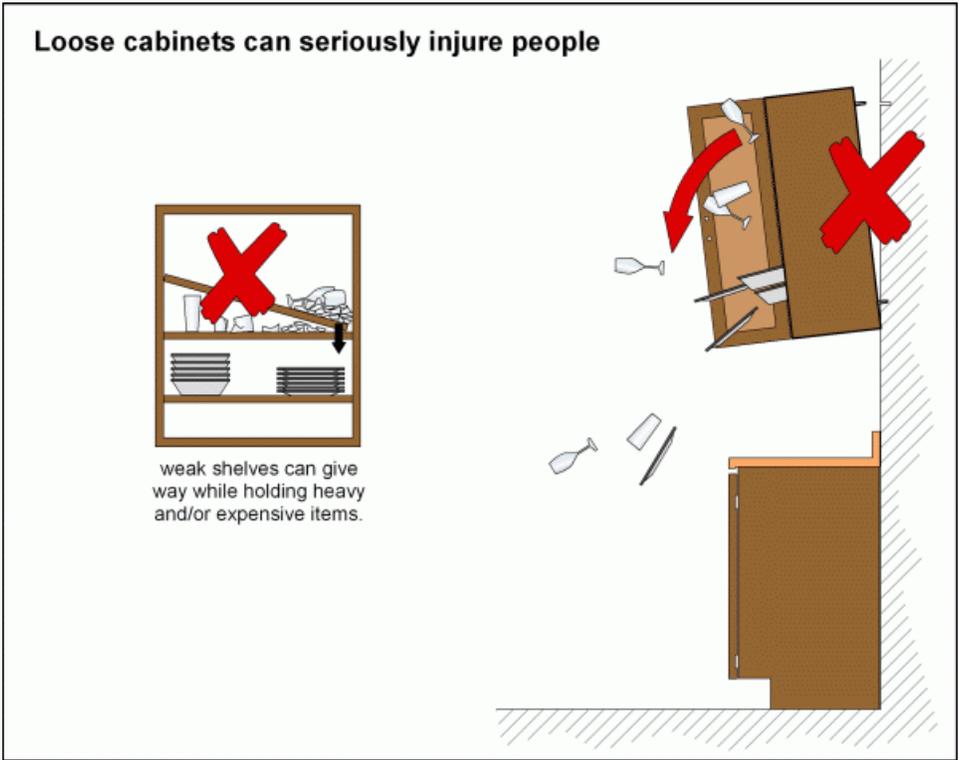
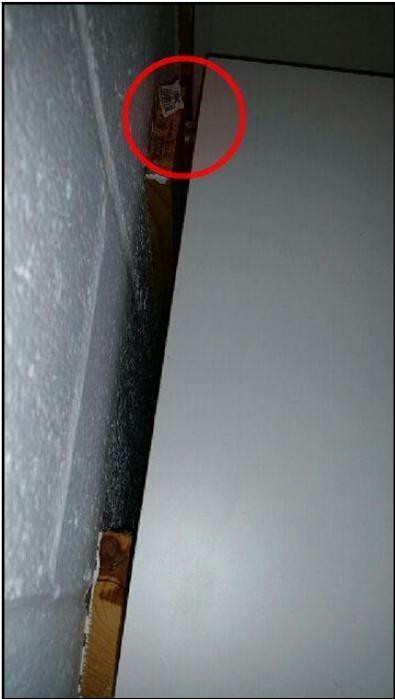
45. Condition: • [Not well secured to wall](#)

Implication(s): Damage to equipment | Damage or physical injury due to falling materials

Not well secured to wall

Task: Repair or replace

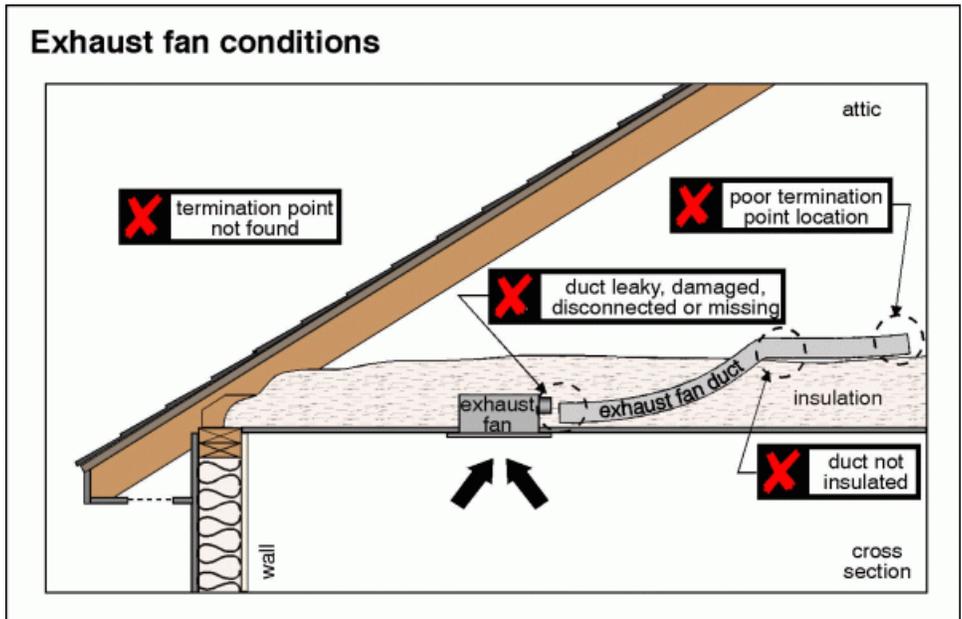
46. Condition: • [Not insulated in unconditioned space](#)

Implication(s): Chance of condensation damage to finishes and/or structure

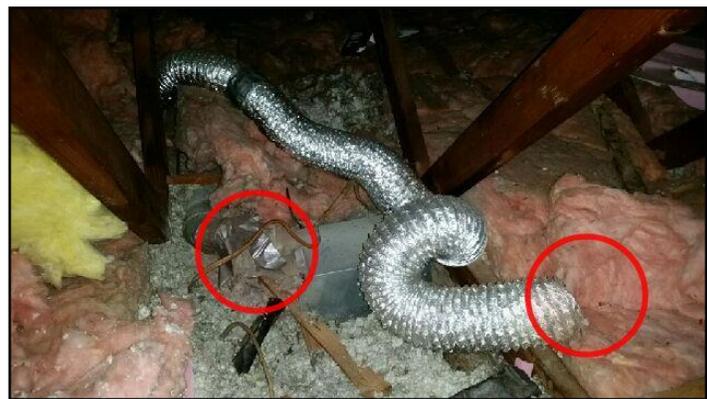
47. Condition: • [Not vented to exterior](#)

Implication(s): Chance of condensation damage to finishes and/or structure

Not vented to exterior

Task: Repair or replace

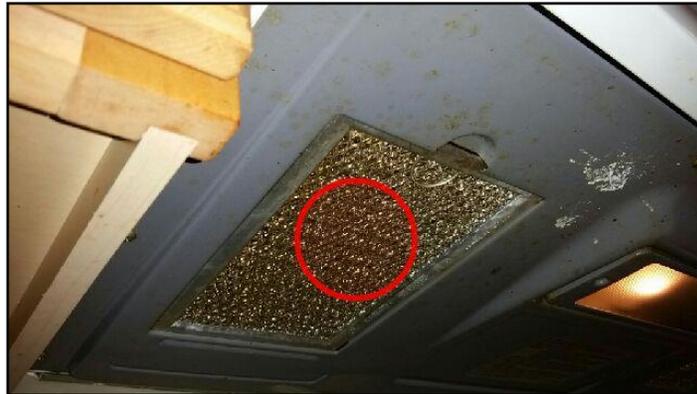
48. Condition: • Dirty filter

Dirty filter

Task: Clean

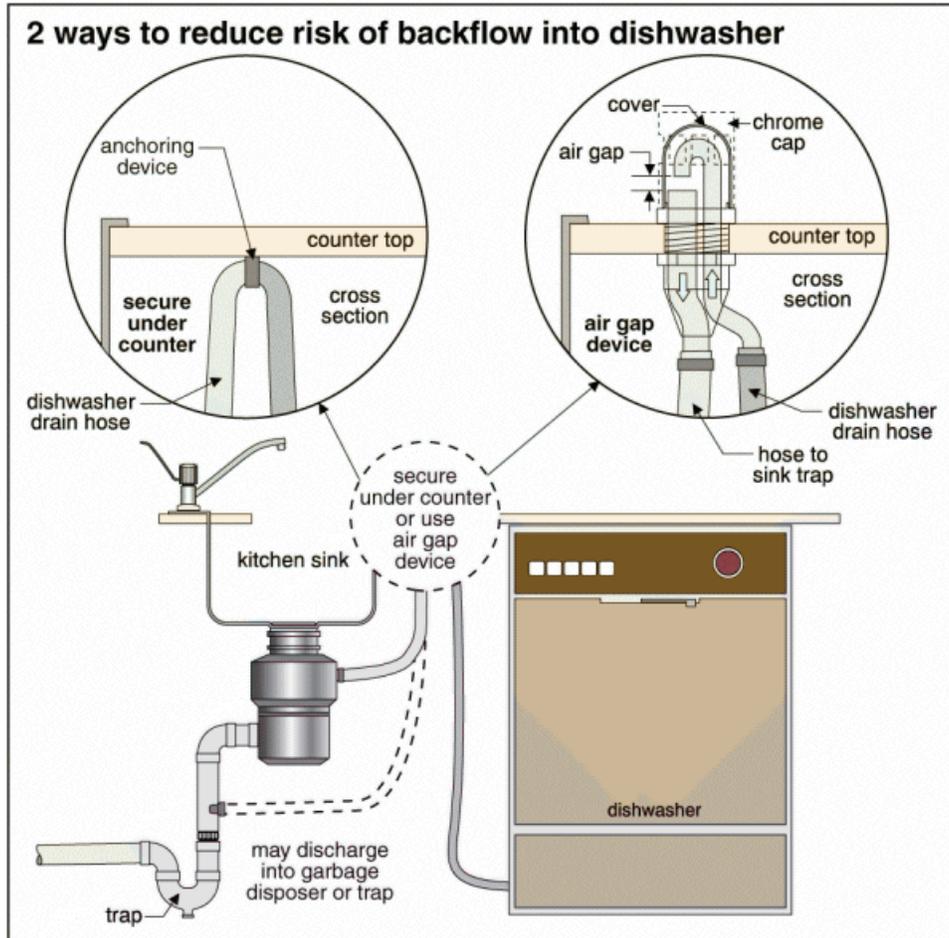
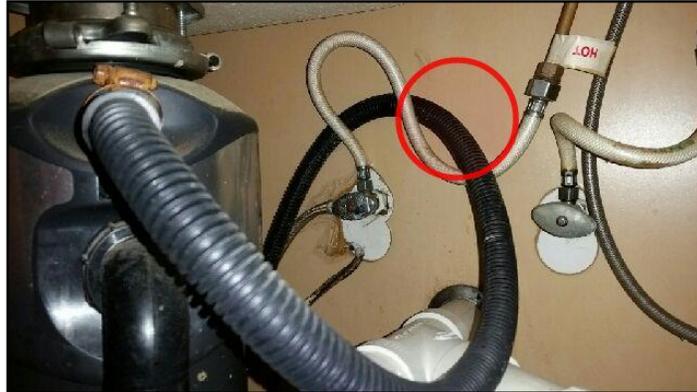
49. Condition: • Backflow prevention missing

Backflow prevention missing

Task: Repair or replace

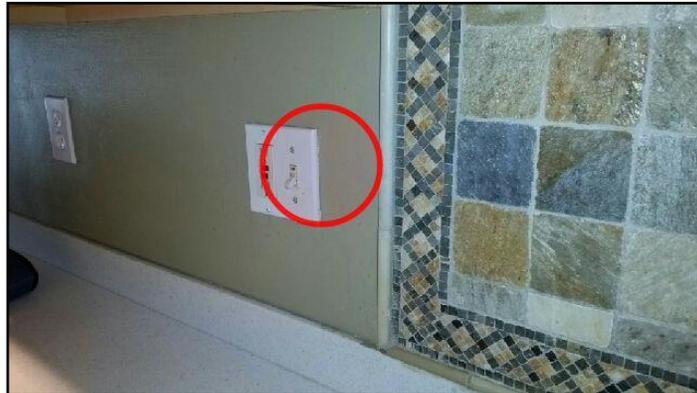
50. Condition: • switch is intermittent.

Task: Repair or replace
