Code Red Home Inspections

PROPERTY INSPECTION REPORT

Concerning: 1234 Street, Somewhere, TX 76000
(Address or Other Identification of Inspected Property)

By: John Denison TREC#21631 Oct 01, 2015
(Name and License Number of Inspector (Date)

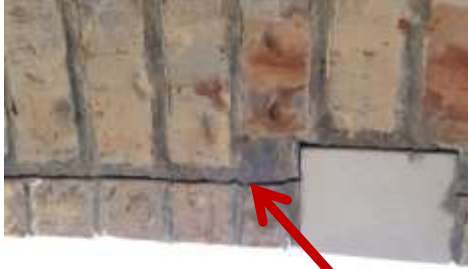
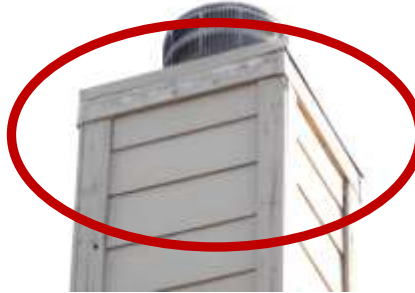
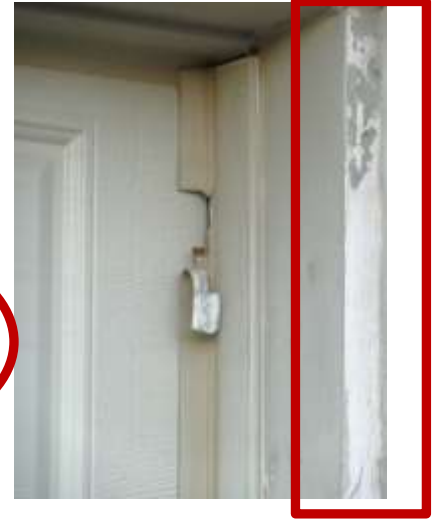
- Mortar joint separations on arch located at front porch entrance.
- Paint chipping and peeling around outside trim on fire place chimney and garage door trim.

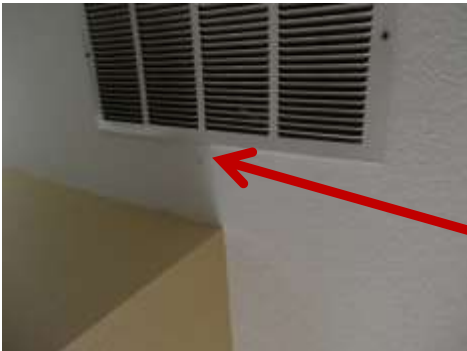
- Minor Sheetrock crack in ceiling along a tape joint near the kitchen sink.
- Missing texture next to return air vent in downstairs hallway.
- Evidence of painting to the ceilings interior finish was observed.
These conditions are mainly cosmetic in nature and should be patched.

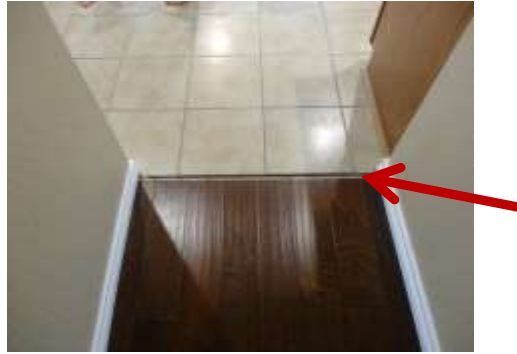
- Transition molding missing between engineered hardwood flooring and ceramic tile.

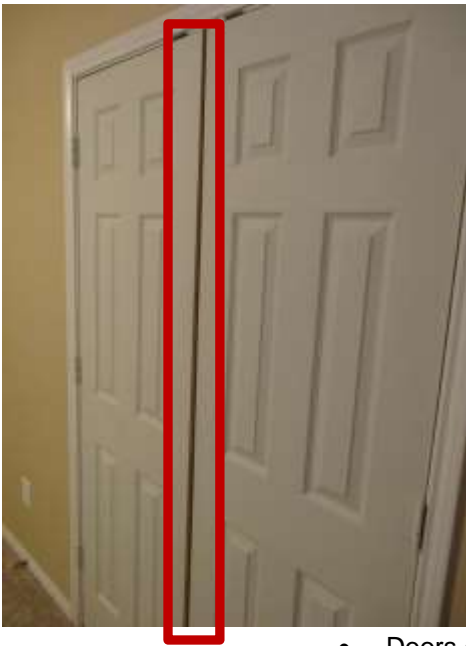
Upstairs bed room door and closet door to left of the stairway.

- Doors do not have equal margin when closed.

Interior: This condition is mainly cosmetic in nature and should be adjusted.

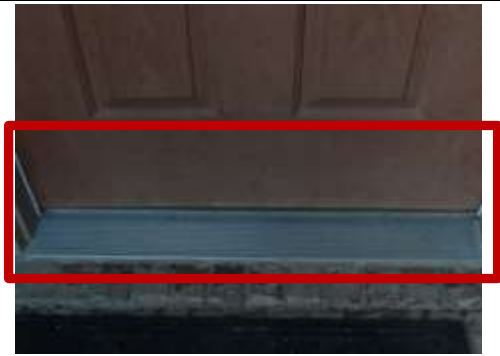
- The door is starting to bow in the middle.
- The bottom of the door is starting to delaminate and show signs of water penetration.

The door will need to be replaced in the near future.

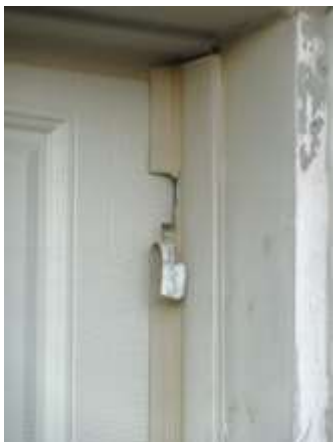
Additional Notes: Torn on right hand side of the garage door, needs be replaced.

- Garage door weather strip is torn on right hand side of the garage door is in of repair.
- Fireplace the fire brick assembly had been removed and is missing fire screen. This will need to be replaced and inspected by a fireplace service technician.

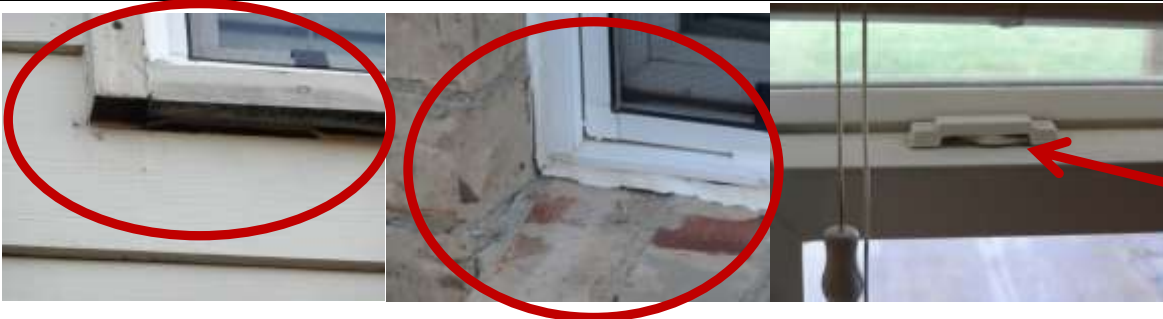
- On the outside of the window on the northwest corner is showing signs of water penetration, where the sealant had pulled away from window frame or trim.
- One or more window screens missing or has holes
- One or more windows had signs of water penetration on the outside.
- One or more window latches have been broke or missing, in need of repair.

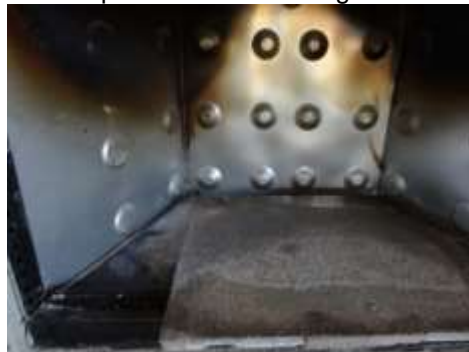
Comments: The fire place was dismantled on day of inspection. Full inspection on the fire place was not completed due to the condition.

- Fire brick assembly had been removed.
- Missing fire screen.

Recommend that a fireplace specialist further evaluate this unit.

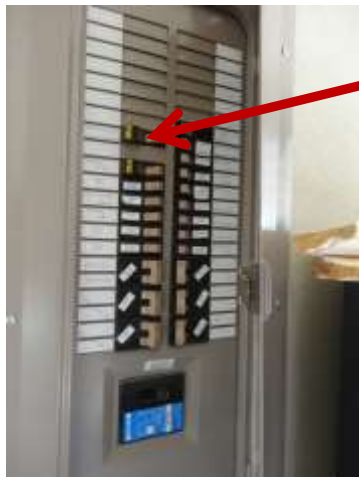
Arc-fault breaker will have a yellow test button on them.

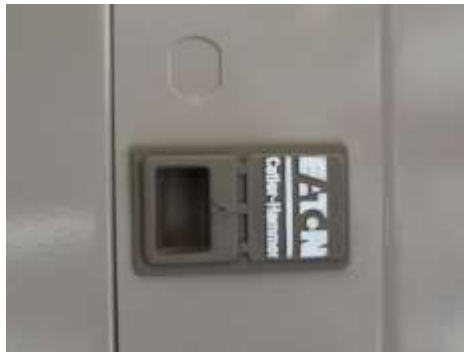
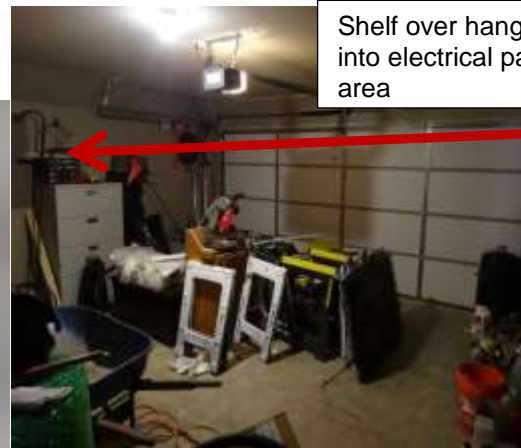
Shelf over hanging into electrical panel area

- Unable to remove front cover due to shelves too close to the panel, improper clearance as shown in above illustration.
- Electrical PVC conduit was observed to be broken on the east side of the house. This should be further investigated and repaired as necessary.
- Under current electrical standards arc-fault circuit interrupting devices are required at the following locations; family rooms, dining rooms, living rooms, parlors, libraries, dens, bedrooms, sunrooms, recreations rooms, closets, hallways, or similar rooms or areas. The lack of this protection is a recognized hazard. Homes not equipped with arc-fault circuit interrupting devices are not required to convert to them but doing so protects from electrical fires.
- This system is partly covered by arc-fault circuit interrupting breaker appear to be properly installed and functional at the time of this inspection.

Due to defects observed, recommend service and complete system check by licensed electrician

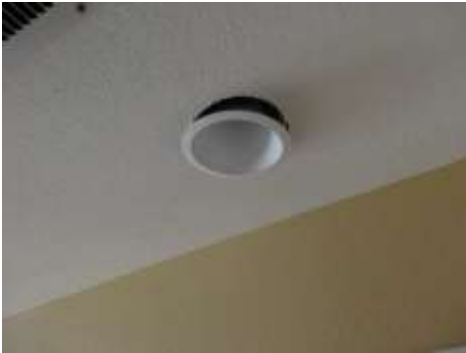
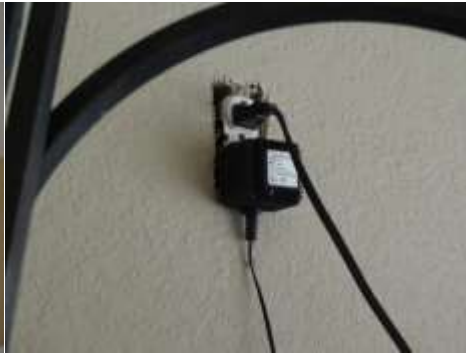
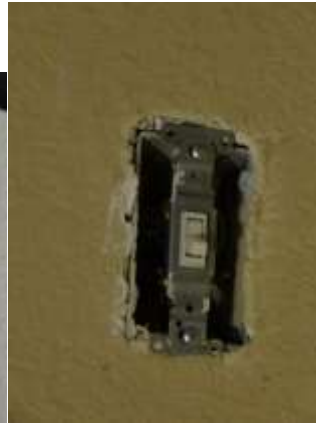
- Downstairs hallway light fixture needs to be mounted tight against the ceiling and light bulb installed.
- One or more garage receptacles missing cover plate. This is a safety hazard and a potential for electrical shock.
- Upstairs bed room right of the stairway is missing a switch plate cover. This is a safety hazard, a potential for electrical shock.

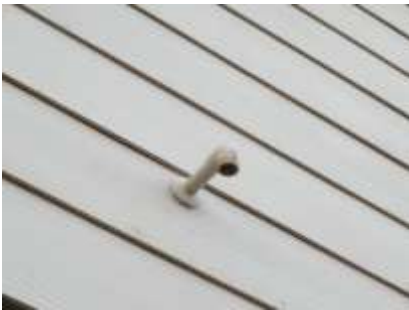
- The primary condensation drain line has been clogged in the past and the secondary drain has drained water due to the evidence of staining around the opening of the pipe on the outside of the house.

Due to defects observed, recommend service by qualified H.V.A.C Service Company
 Note: RECOMMEND MAINTENANCE AND SERVICE PRIOR TO USE.

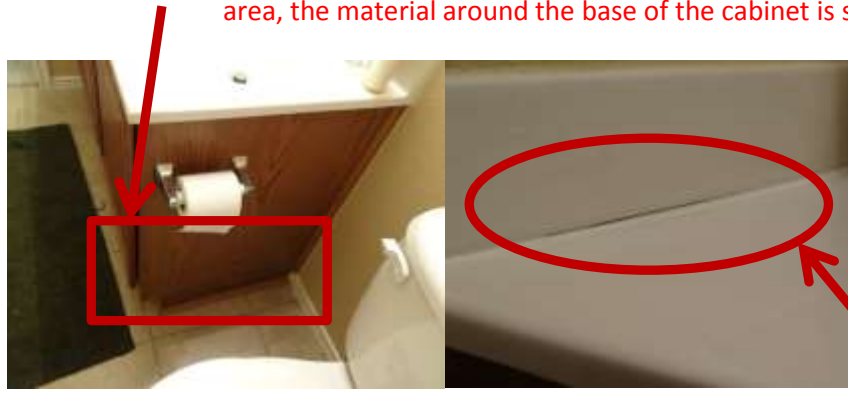
- Upstairs bathroom appears to have a water leak at one time around the sink area, the material around the base of the cabinet is swollen due to moisture.
