CONSERVATION AUTO TOUR

SITE 3: GRASSED WATERWAY

Conservation Cooperator PROJECT FACT SHEET

Jeff Gibbs/Grade Stabilization-Complete 7/28/19

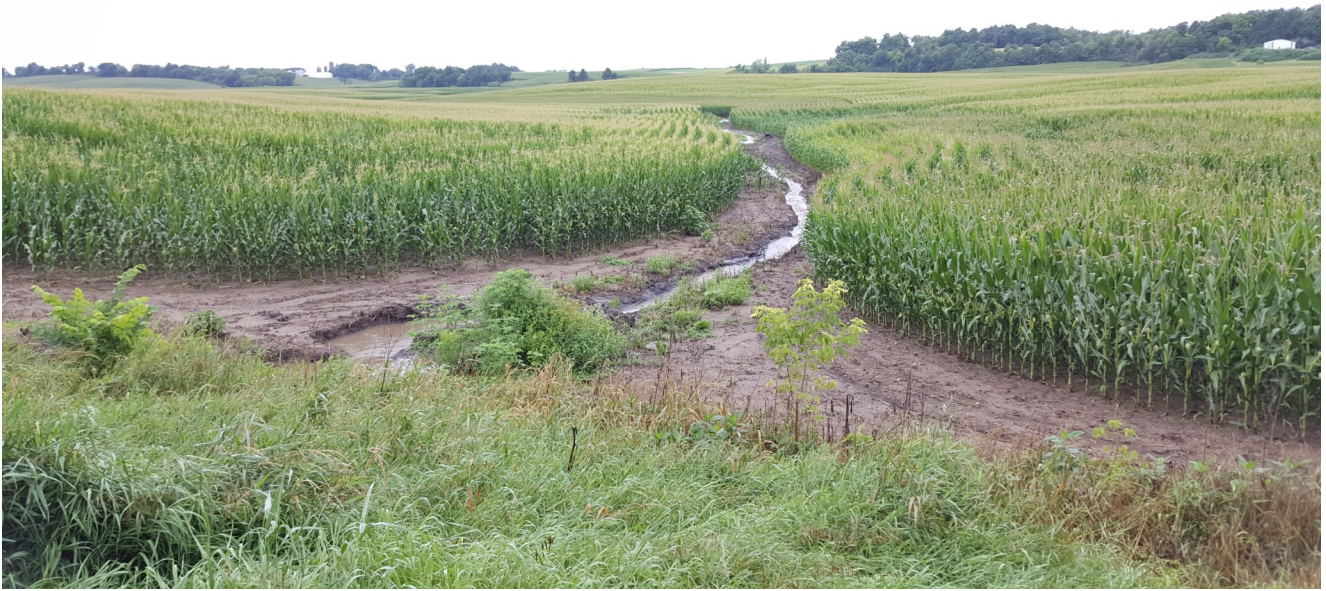
Install a grade stabilization structure along Le Sueur/Rice, the site has a large amount of water coming from Rice County that does not all go into tile. The site is washed out from the county road 450' west. A waterway will be installed downstream until the grade stabilizes.

Above: Picture of erosion before Construction Below: Approx. Site Location

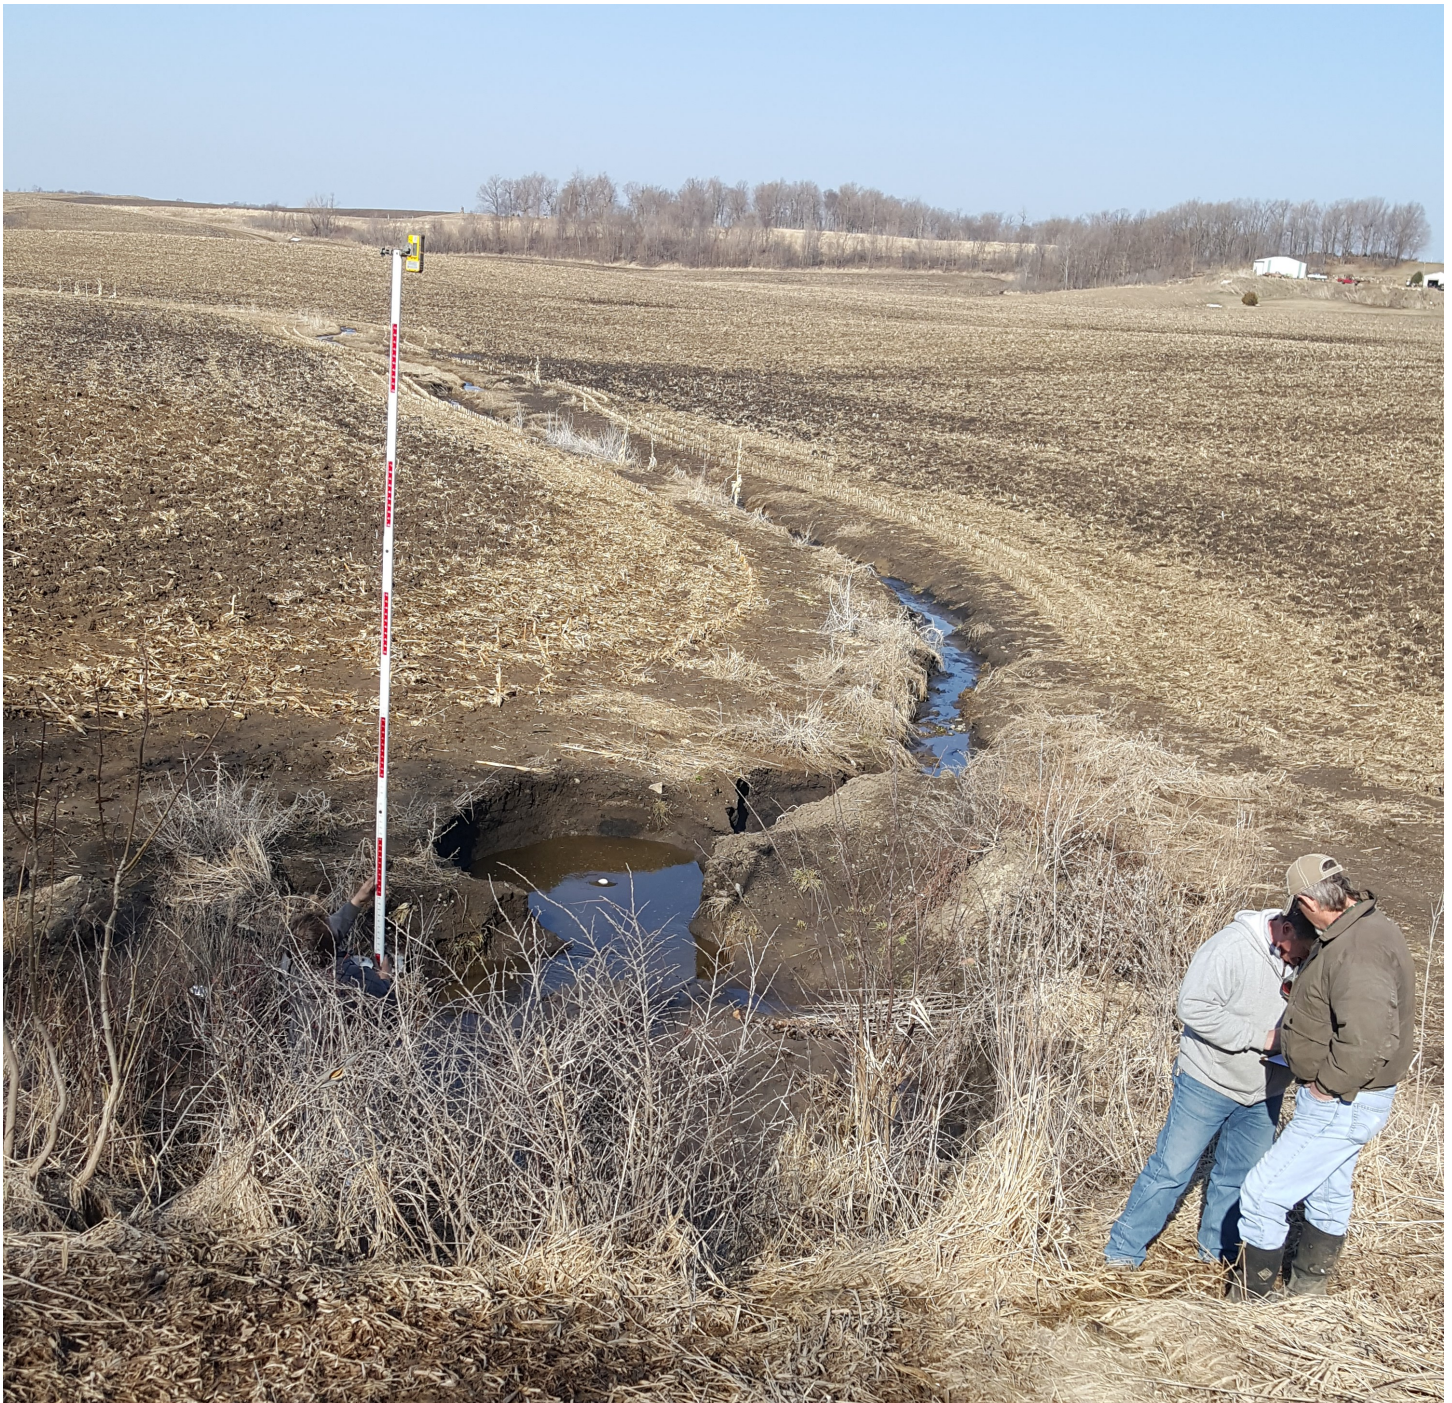
Before photo, taken while project was surveyed for design

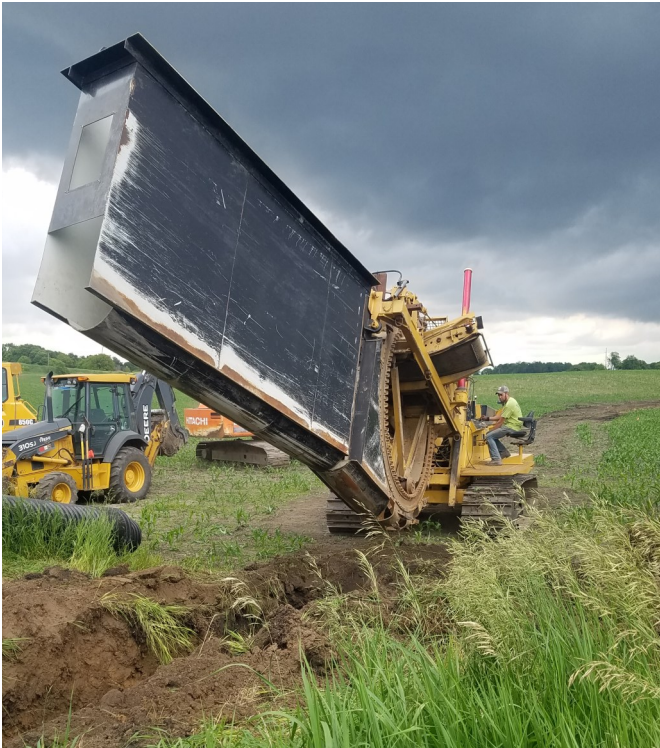
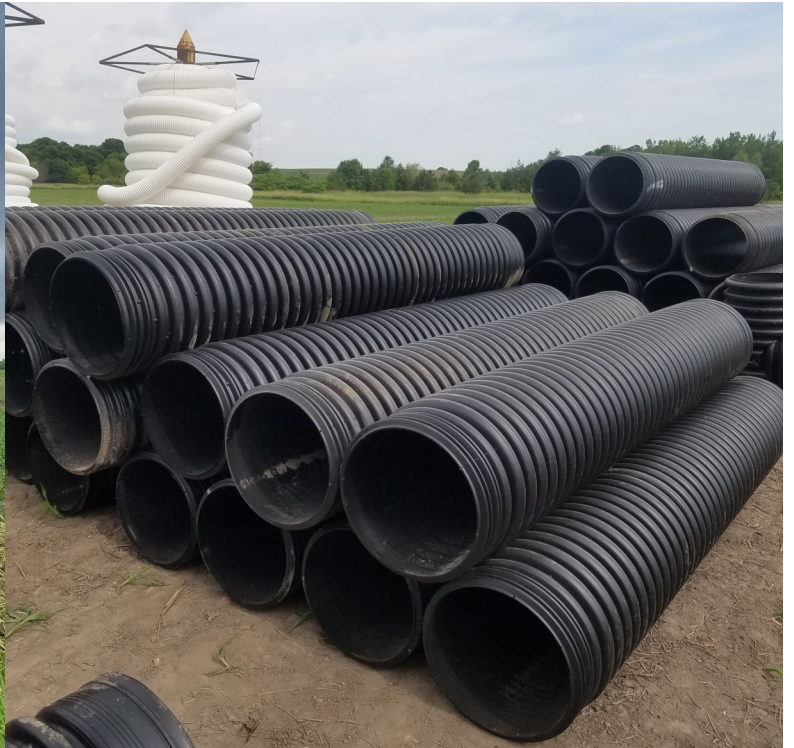
Above: Tile being installed to convey water from upstream tile outlets and a road culvert– Below: Water going into the newly installed tile intake shortly after construction
