ORO DRUM MOTOR/PULLEY ALIGNMENT

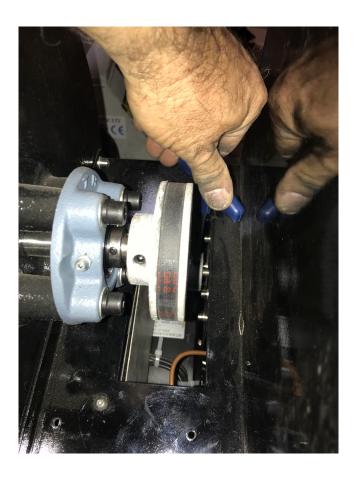
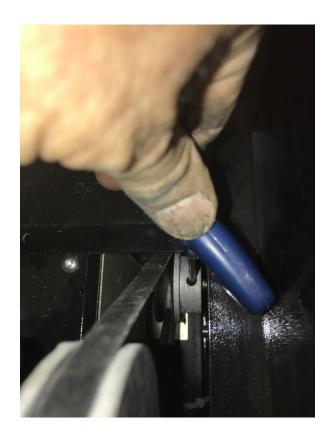
If your drum motor begins to vibrate or vibration increases when drum speed control is turned up or set to a different speed it is likely that the Pulley attached to the drum motor is or has become slightly out of alignment. This can happen during transit or over time as it would with a tire spinning on a vehicle gets out of alignment.

LOCATE HEX KEY PIN ON PULLEY AND LOOSE.

- 1. Turn off and unplug unit.
- 2. Remove protective cover over drum pulley so you can reach The drum motor pulley as seen in picture below:
- 3. NEXT USING THE CORRECT SIZE HEX KEY TO LOOSEN THE PULLEY ATTACHED TO DRUM MOTOR (YOU MAY ALSO BE ABLE TO DO THIS WITH JUST ADJUSTING THE PULLEY ON DRUM) PICTURE SHOWS PULLEY ADJUSTMENT ON MOTOR.
