CHAPTER TWO

Inventory and Analysis

Pike River Maintenance Plan

Mount Pleasant, Wisconsin

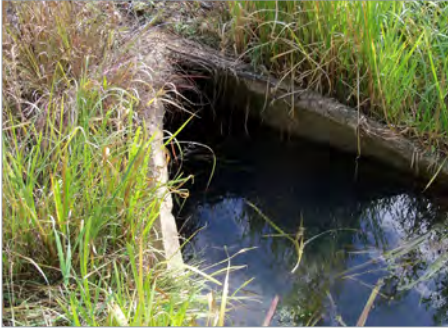
Photo 1: The end section edges of Structure 19 are spalling and are exposing the rebar reinforcement.

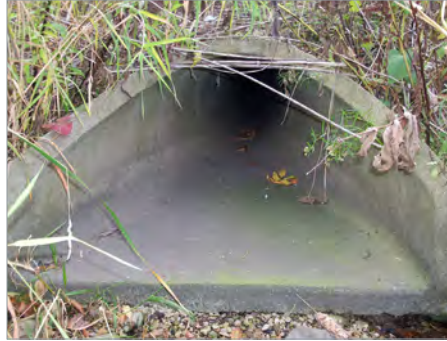
Photo 2: The as-built plan for Structure 41 shows that a trash rack was installed; however, no trash rack is present.

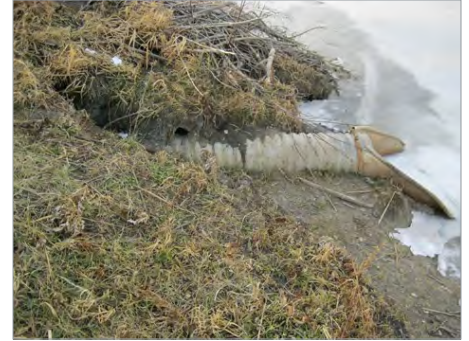
Photo 3: Gully erosion has formed around the west end of Structure 29 from the shoreline to approximately ten feet landward over the top of the pipe.

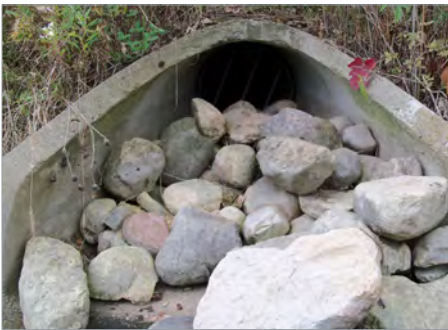
Photo 4: The channel end section of Structure 31 is approximately half-full of riprap.

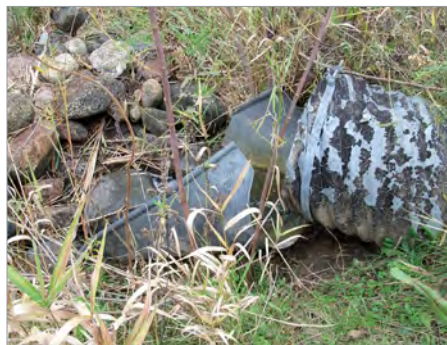
Photo 5: The channel end section of Structure 45 is detached from the pipe.

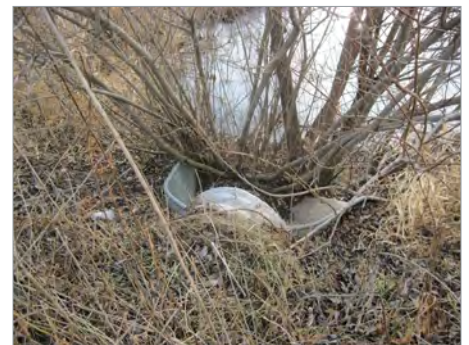
Photo 6: The end section of Structure 26 is obstructed by woody vegetation.

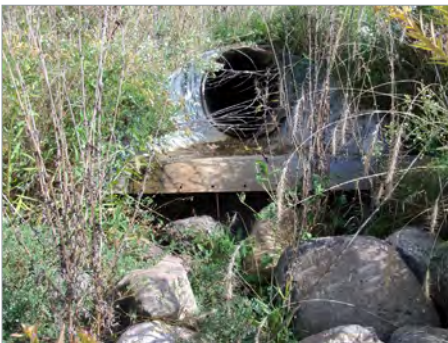
Photo 7: The end section of Structure 94 is undermined by approximately twelve inches.

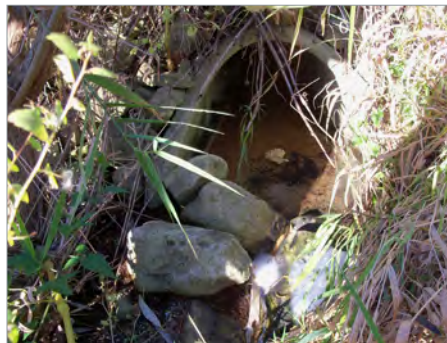
Photo 8: Suds were observed at the channel outfall of Structure 52 indicating a possible illicit discharge.

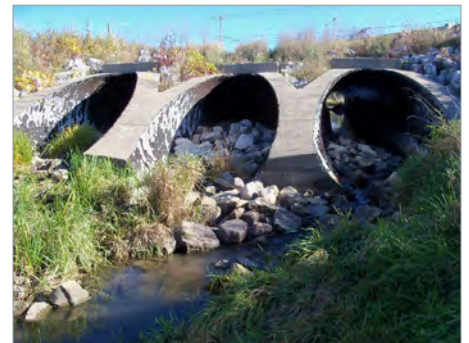
9. The Oakes Road culverts (Structure 61) are set too high and impede fish passage, which is discussed in more detail in Chapter 2.4. An example is shown in photo 9

Photo 9: The downstream inverts of Structure 61 (three parallel pipes) sit at least twelve inches above the water surface.
