**EXHIBIT E**  
**APPENDIX N**  
**WETLAND ASSESSMENT**

**Scott's Mill Hydropower Project**

**FERC Project No. 14867**

**RE: Scott's Mill Dam Hydropower Project  
Wetland Assessment  
H&P Project 20150824  
Bedford County / Amherst County / City of Lynchburg, Virginia**

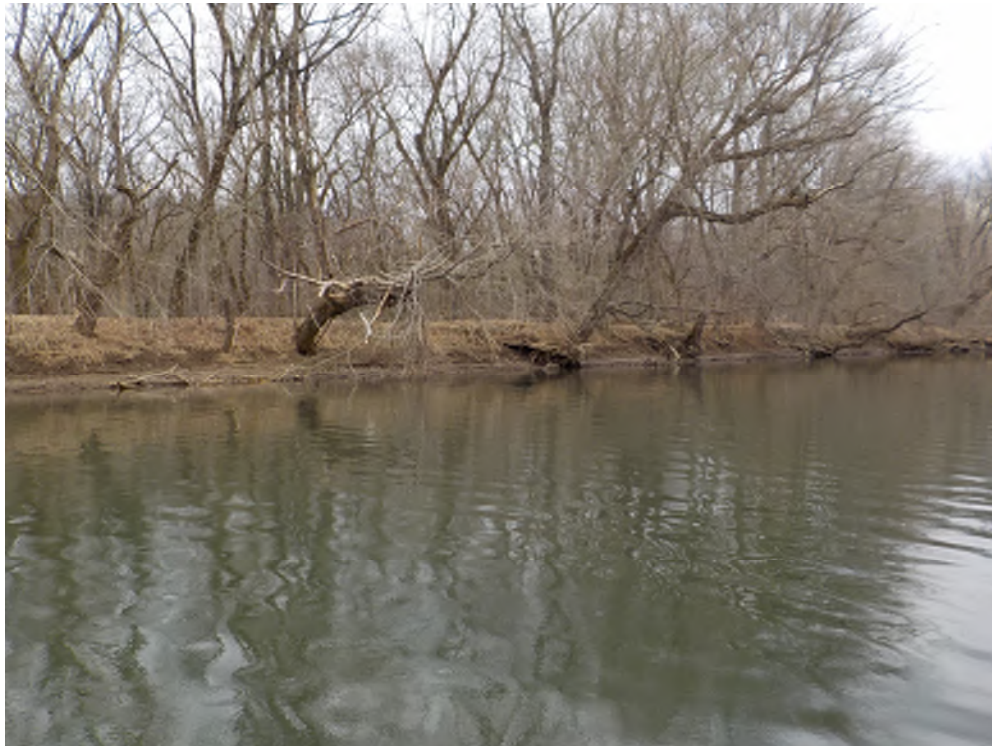
Photograph 1 – Typical island riverbank, with low-gradient depositional area

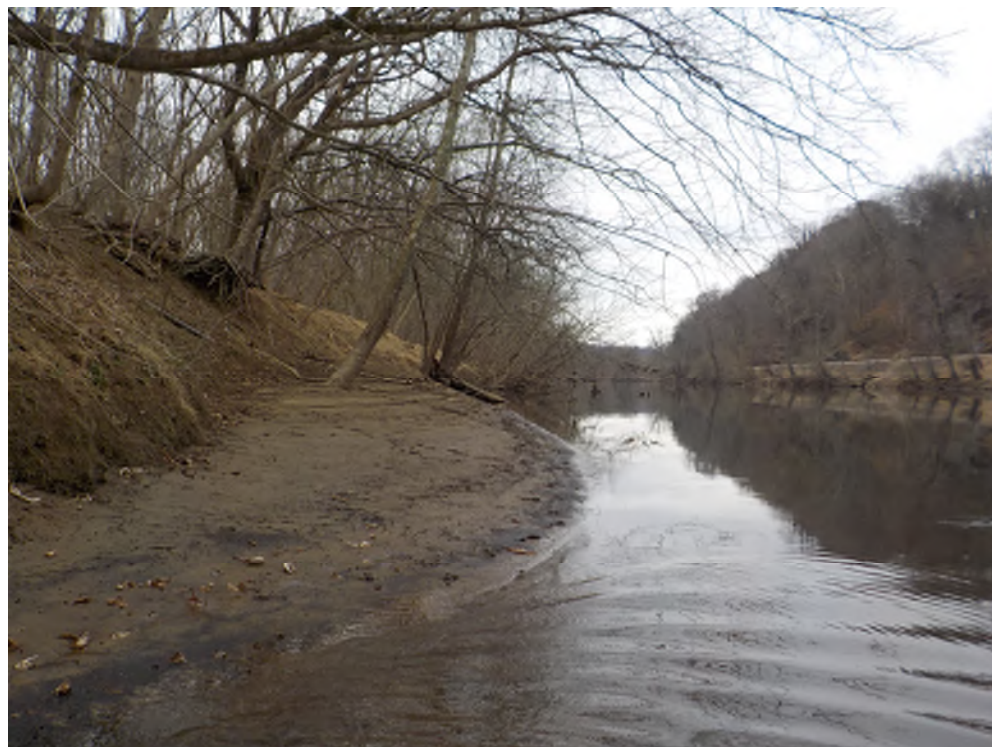
Photograph 2 – Typical island riverbank

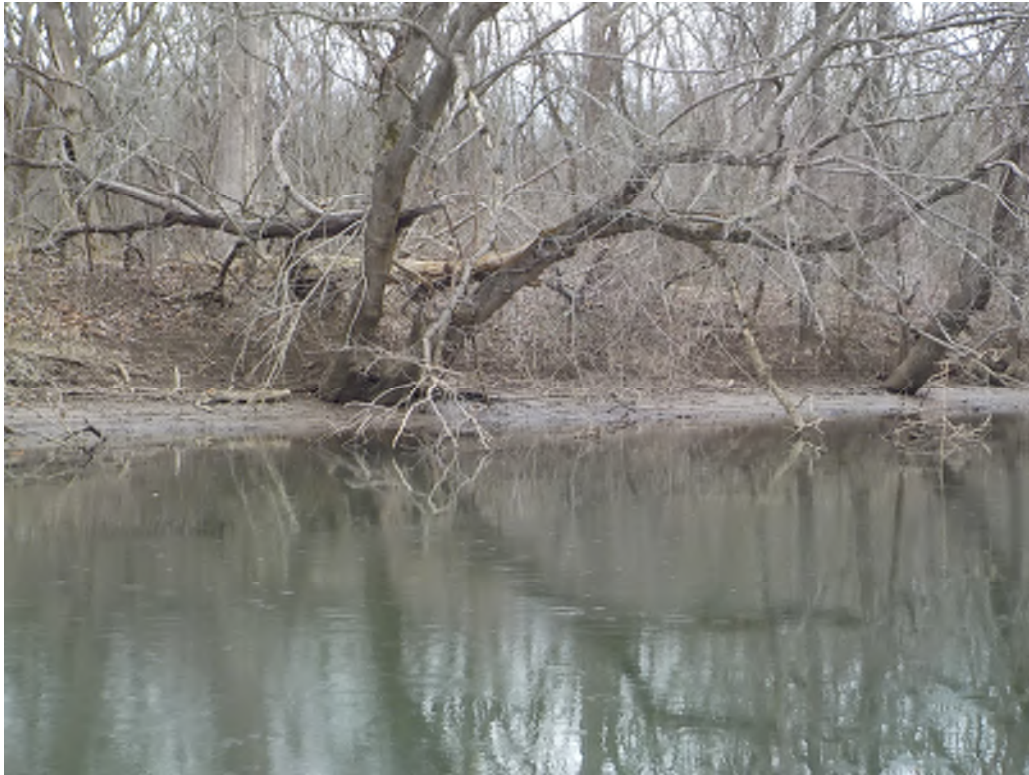
Photograph 3 – Typical low-gradient island riverbank

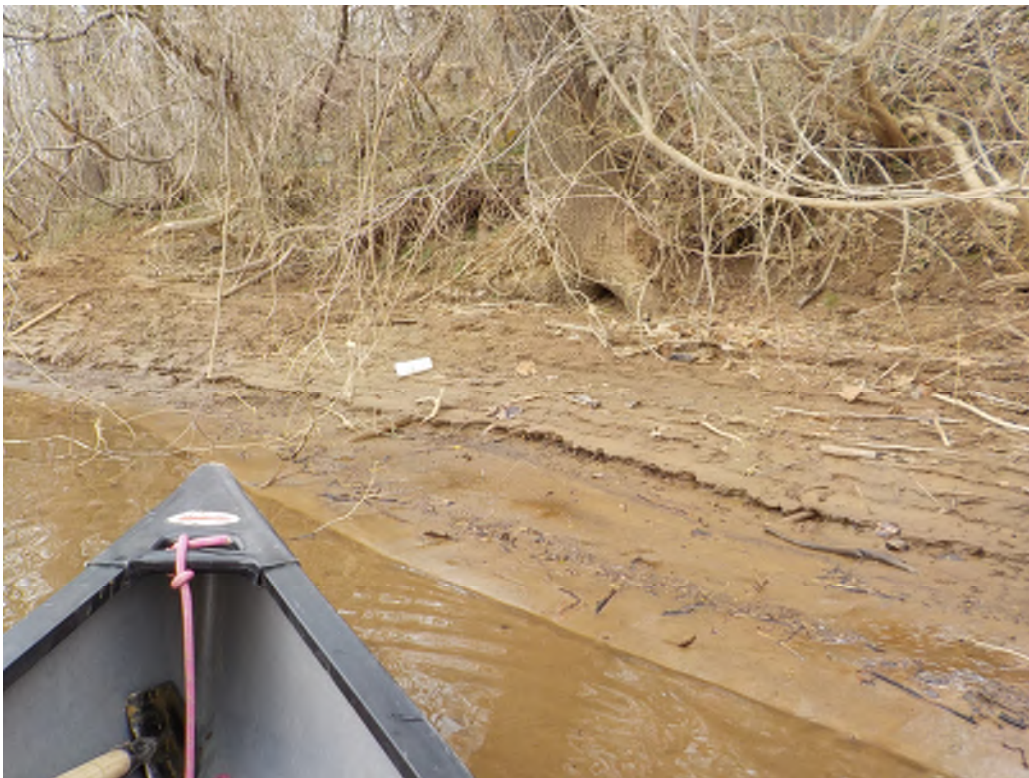
Photograph 4 – Typical low-gradient area along island riverbank

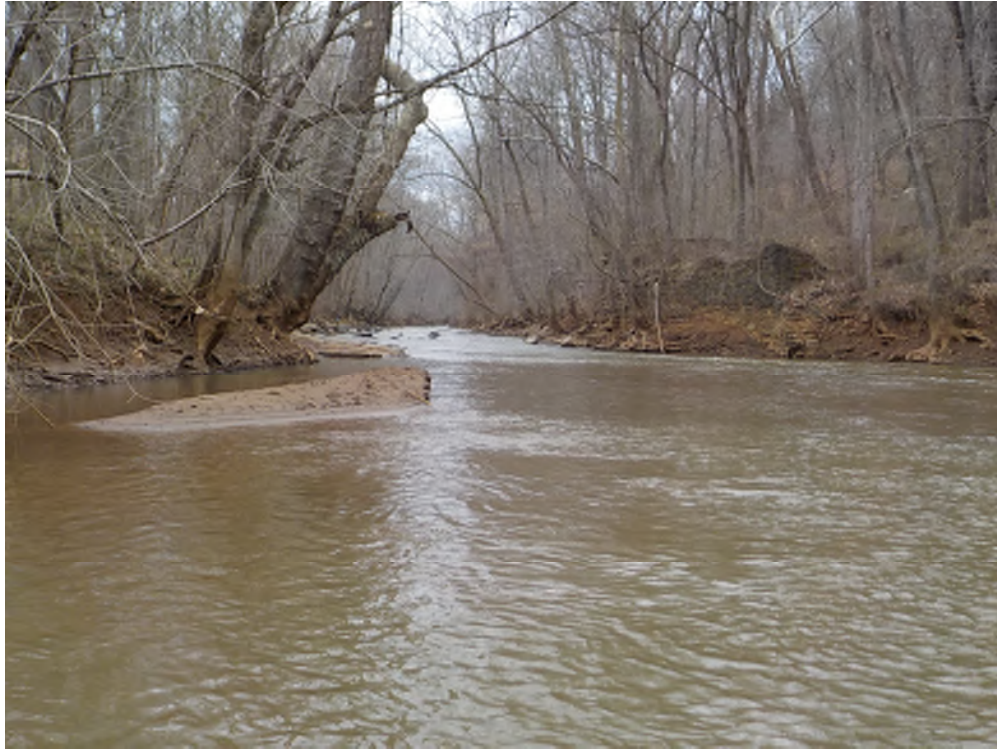
Stream channels/tributaries entering the James River within the study area (including Harris Creek, Buck Branch, and Pigeon Creek) were also evaluated. Streambanks along these channels were generally found to be steep, frequently-eroded, and often 6-10' in height. No wetlands were observed adjacent to these channels. These tributaries are incised into the larger James River floodplain.

Photograph 5 – Harris Creek (tributary), note steep streambanks and stone ruins

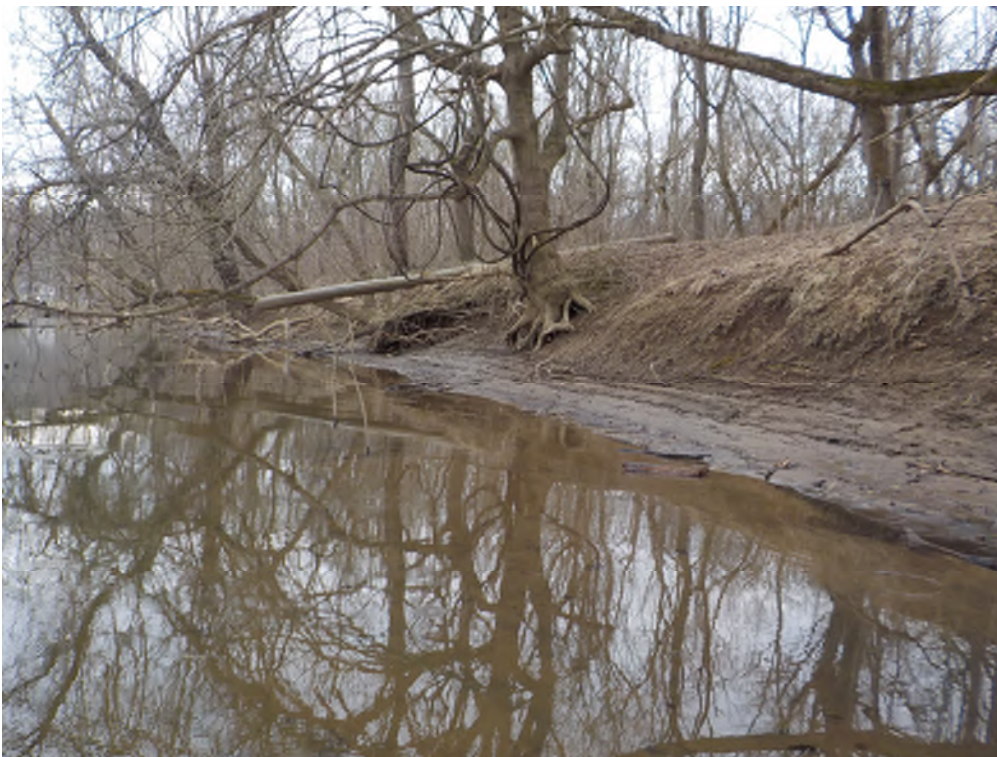
Photograph 6 – Typical island riverbank, with low-gradient depositional area

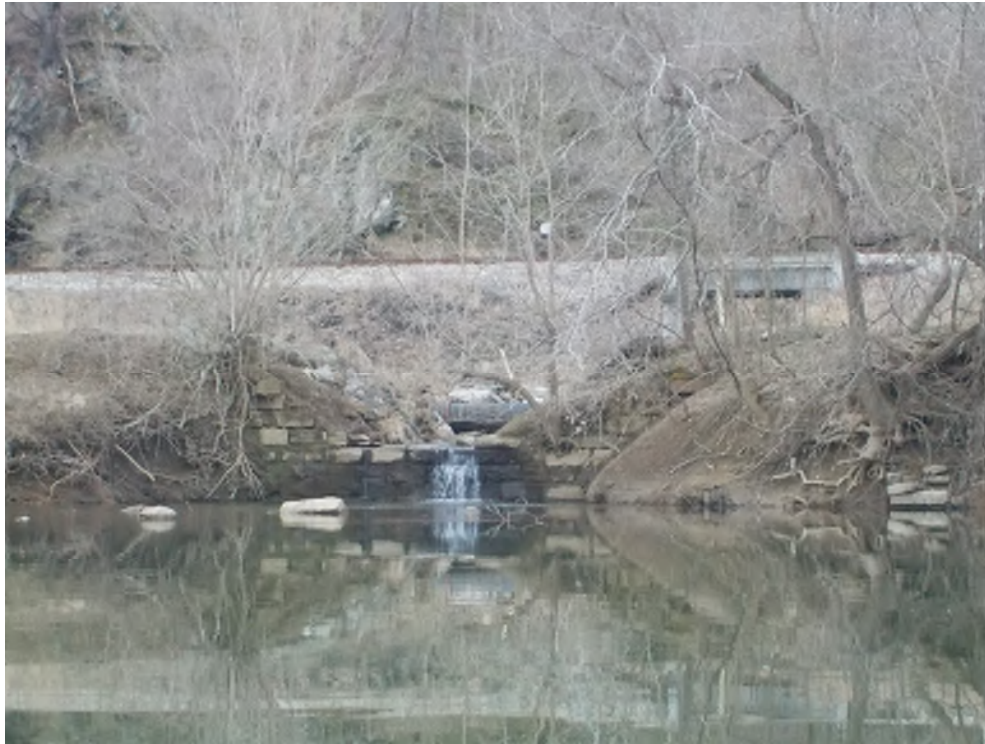
Photograph 7 – Typical riverbank (here with relic stonework from previous canal)

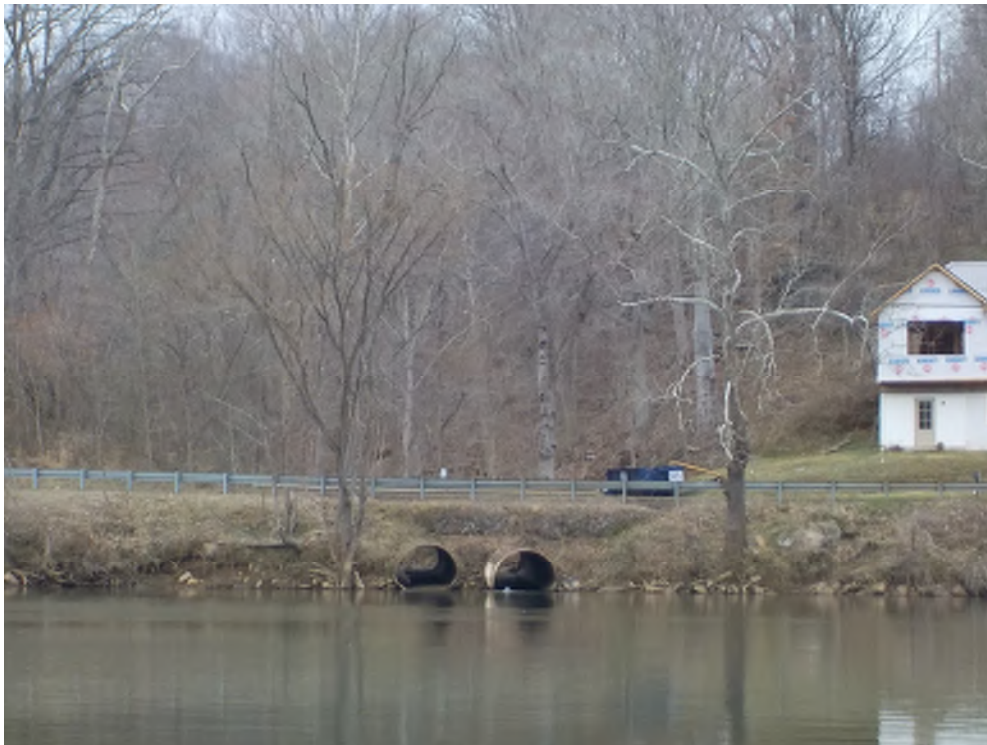
Photograph 8 – Typical riverbank, roadway, and culverts
