Holistic Approach to Reef Protection

Coral Nurseries on South Malé Atoll and Baa Atoll

Field Report

February/March 2017

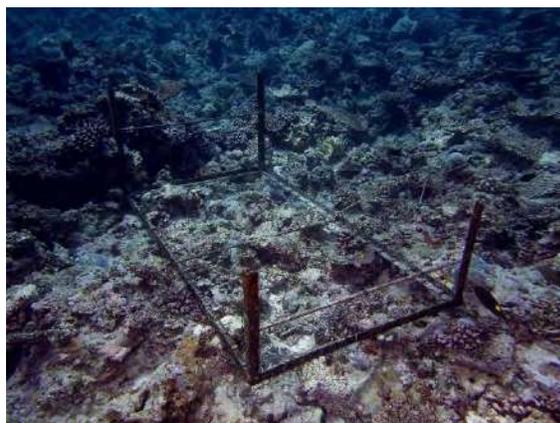
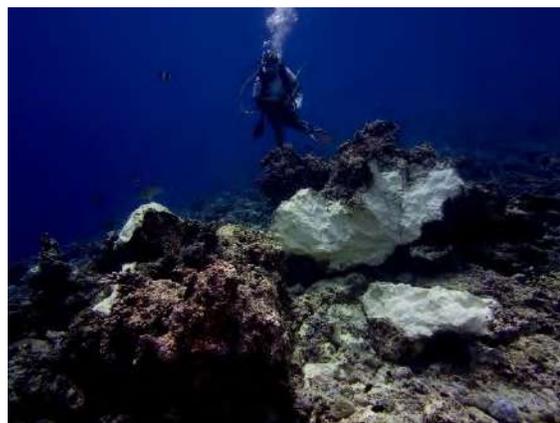
Coral Loss: Loss of all corals established in August 2016 at one nursery on a fore reef location off Marina/Naladhu due to severe weather in February 2017. The unusually strong waves overturned, shattered and removed the coral nursery tables, and also caused massive damage to surrounding reef. Large boulder 2-3 m diameter were fractured and overturned and the bottom was covered with rubble. Similar extreme wave action has not been observed at this site since 2010.

Fig. 6. Overturned table without mesh (left) and a shattered boulder coral (right) at Marina Nursery Area

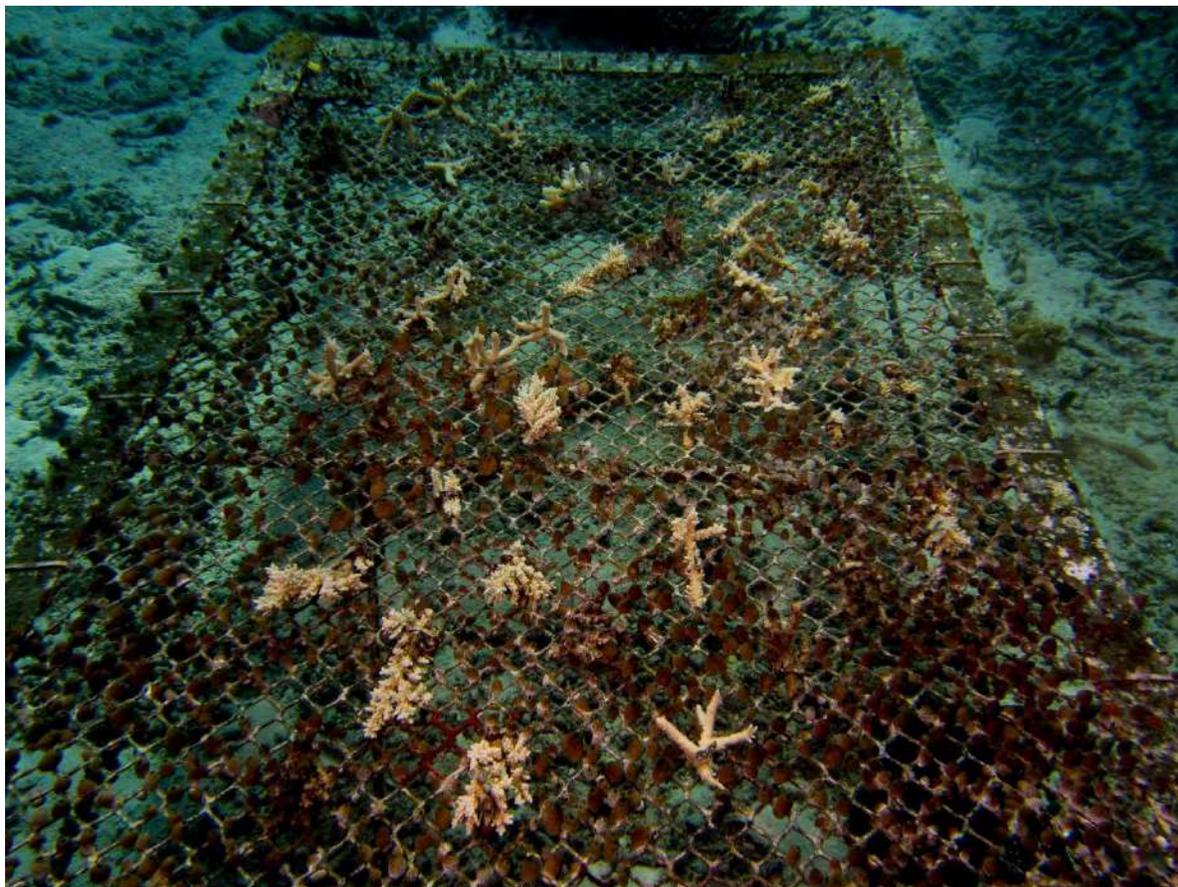
Fig. 7. A coral table at Kuda Giri covered in tunicates.

At Kuda Giri, two of the shallow tables established in August were heavily colonized by an encrusting tunicate which settled on the mesh and coral fragments. No maintenance was conducted at this site following the visit by Coral Reef CPR scientists in October. During March, Coral Reef CPR removed all of the tunicates using a toothbrush on the coral fragments and a scrub brush on the mesh tables. The two tables were also relocated slightly deeper (7 m) to try to reduce the settlement of these pest species. With regular

cleaning of the tables, additional loss due to overgrowth by algae, cyanobacteria and encrusting invertebrates could be avoided.

- Regular (fortnightly) maintenance is required on each of the nursery areas between Coral Reef CPR visits. Ropes, fragments and mesh can all easily be cleaned using a toothbrush. A larger brush can be used to scrub the mesh (avoiding contact with fragments) on the tables. This will remove all algae, sponges, tunicates etc. and will increase survival and growth rates hugely.

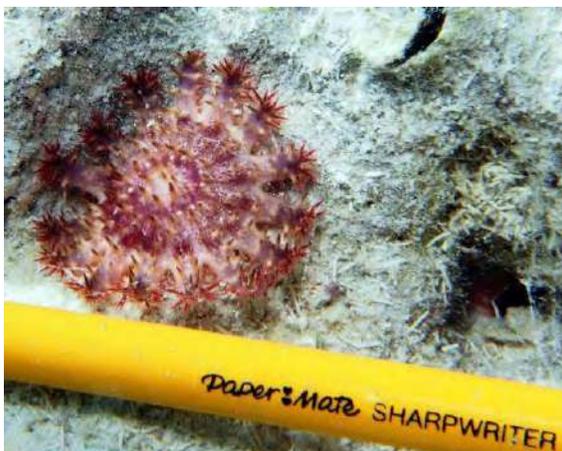
Nearshore areas on South Malé Atoll also had crown of thorns starfish, including juveniles that were moving into shallow sandy and rubble areas close to the resort. Without removal these have the potential to damage coral nurseries and are posing a risk to guests that swim and wade in the lagoon. Coral Reef CPR collected 16 starfish from shallow areas off Marina, Naladhu, Dhigu and Veli during March 2017.

Fig. 14. A juvenile COTS, 25 mm diameter, collected at Veli Water Villas (left) and a sub-adult (14 cm) at Marina jetty.

- Routine snorkel surveys should be undertaken around Marina, in the reef flat between Marina and Naladhu, near the Advanced Snorkel Area and around the water villas at Veli to search for and remove crown of thorns starfish. Their common occurrence and small individual sizes of starfish noted during the March 2017 period indicates 1) a new generation of starfish is emerging from the shallow rubble areas surrounding the resort; 2) starfish are moving through the area in search of food and may come into very shallow areas off the shore, causing a potential guest injury; and 3) there is the potential for a secondary outbreak, as the starfish we are frequently seeing are between 6 months- 2 years old. Diligent efforts to control the starfish now are critical to ensure recovery of the reefs damaged by the 2016 bleaching event.

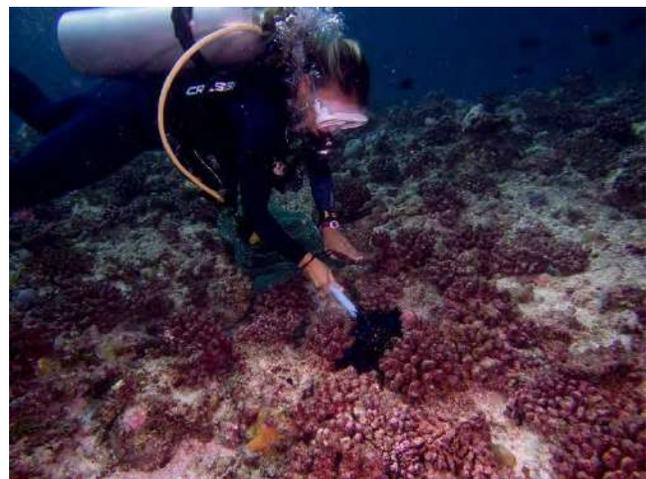
Fig. 16. Paula Berenguer, one of the Marine Biologists at Anantara Dhigu removing COTS from Stage Reef in August, 2016. This reef is currently infested with COTS and the few acroporids, *Pocillopora*, *Porites* and *Goniastrea* that survived the 2016 bleaching event are being quickly killed by the starfish. Additional efforts to control COTS are key to saving these reefs.

- Efforts to eradicate starfish from Stage Reef should be undertaken, as we observed over 75 starfish in this area during March.
