# **Resilient Pavement Structures in Texas**

Andrew Wimsatt, Ph.D., P.E.

Texas A&M Transportation Institute

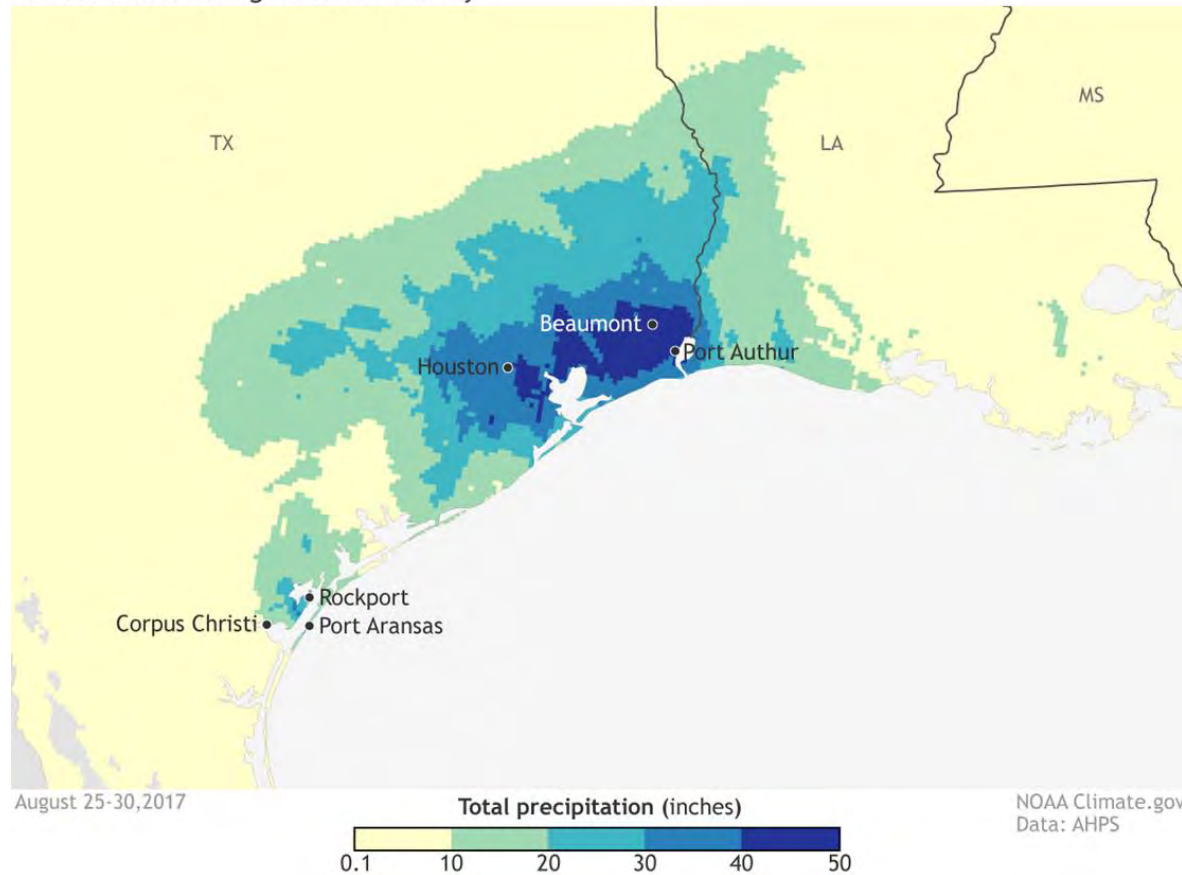
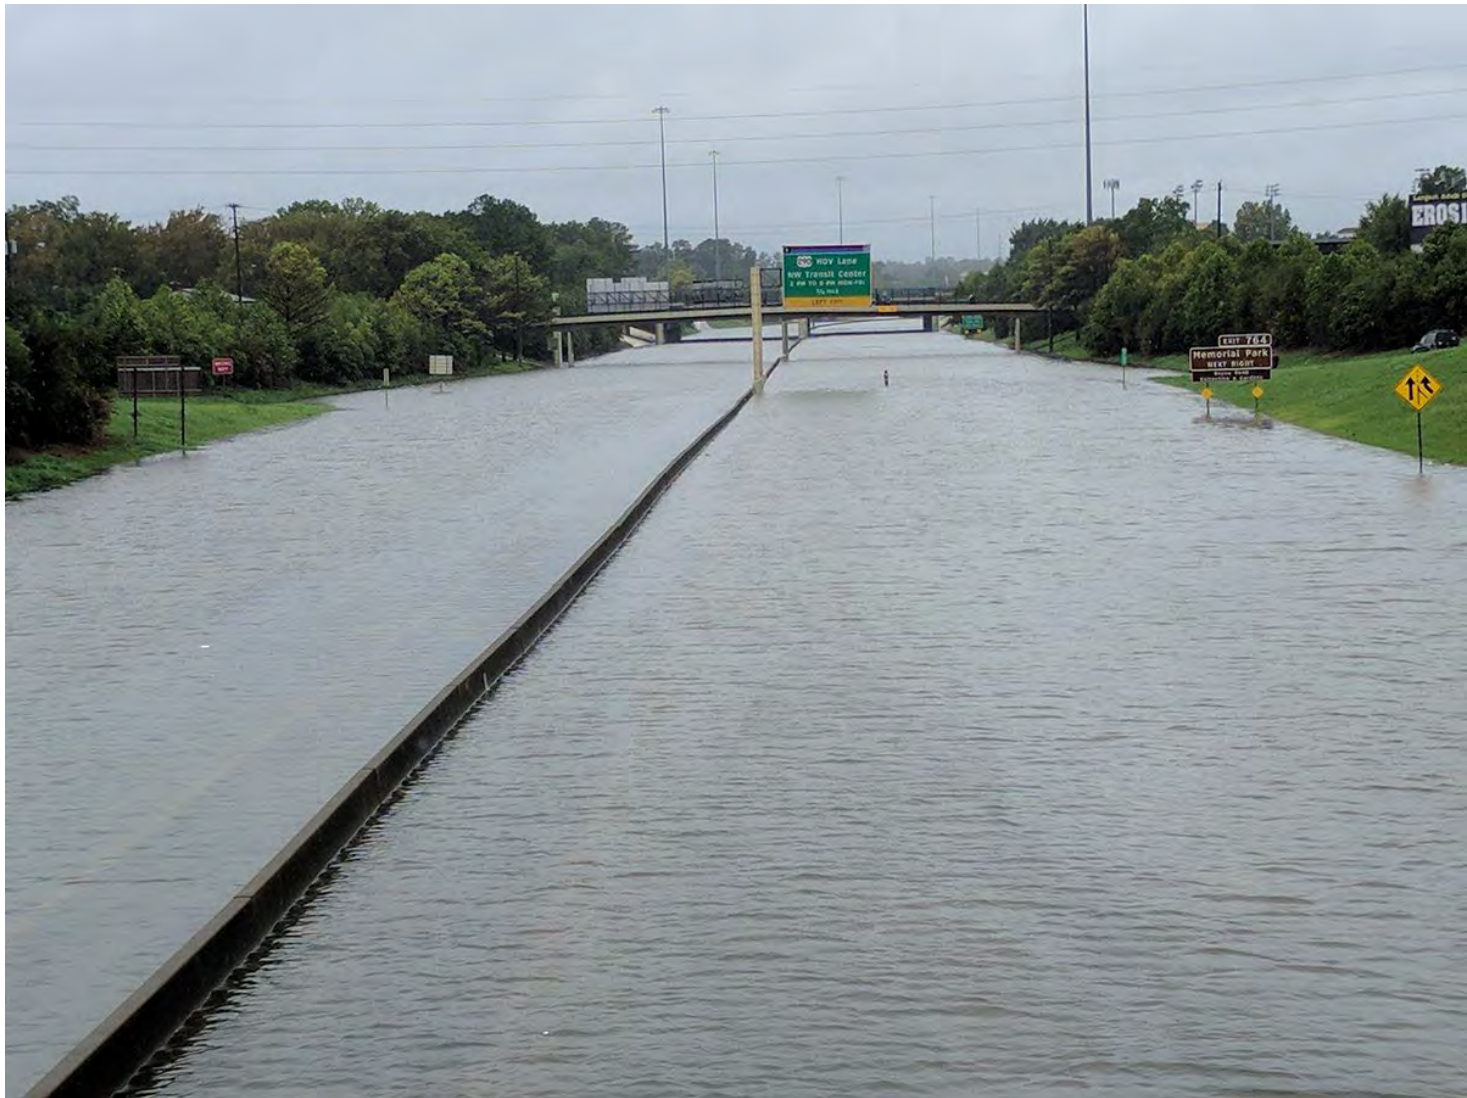
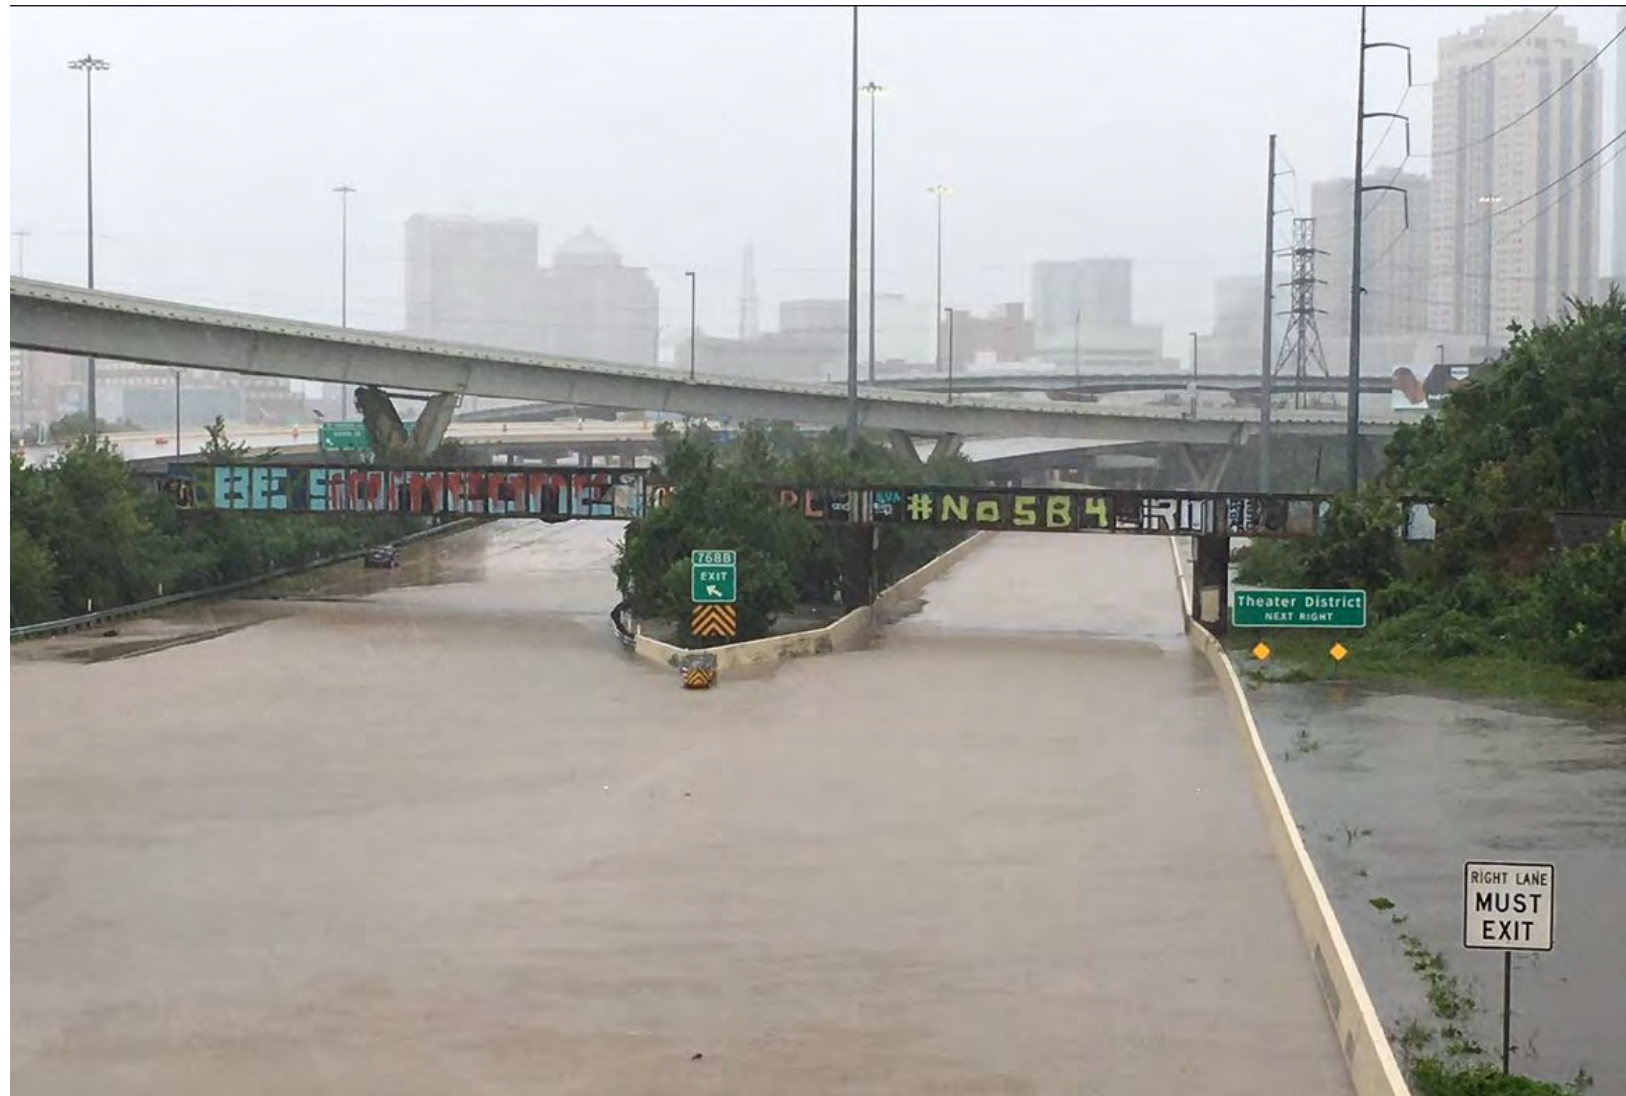
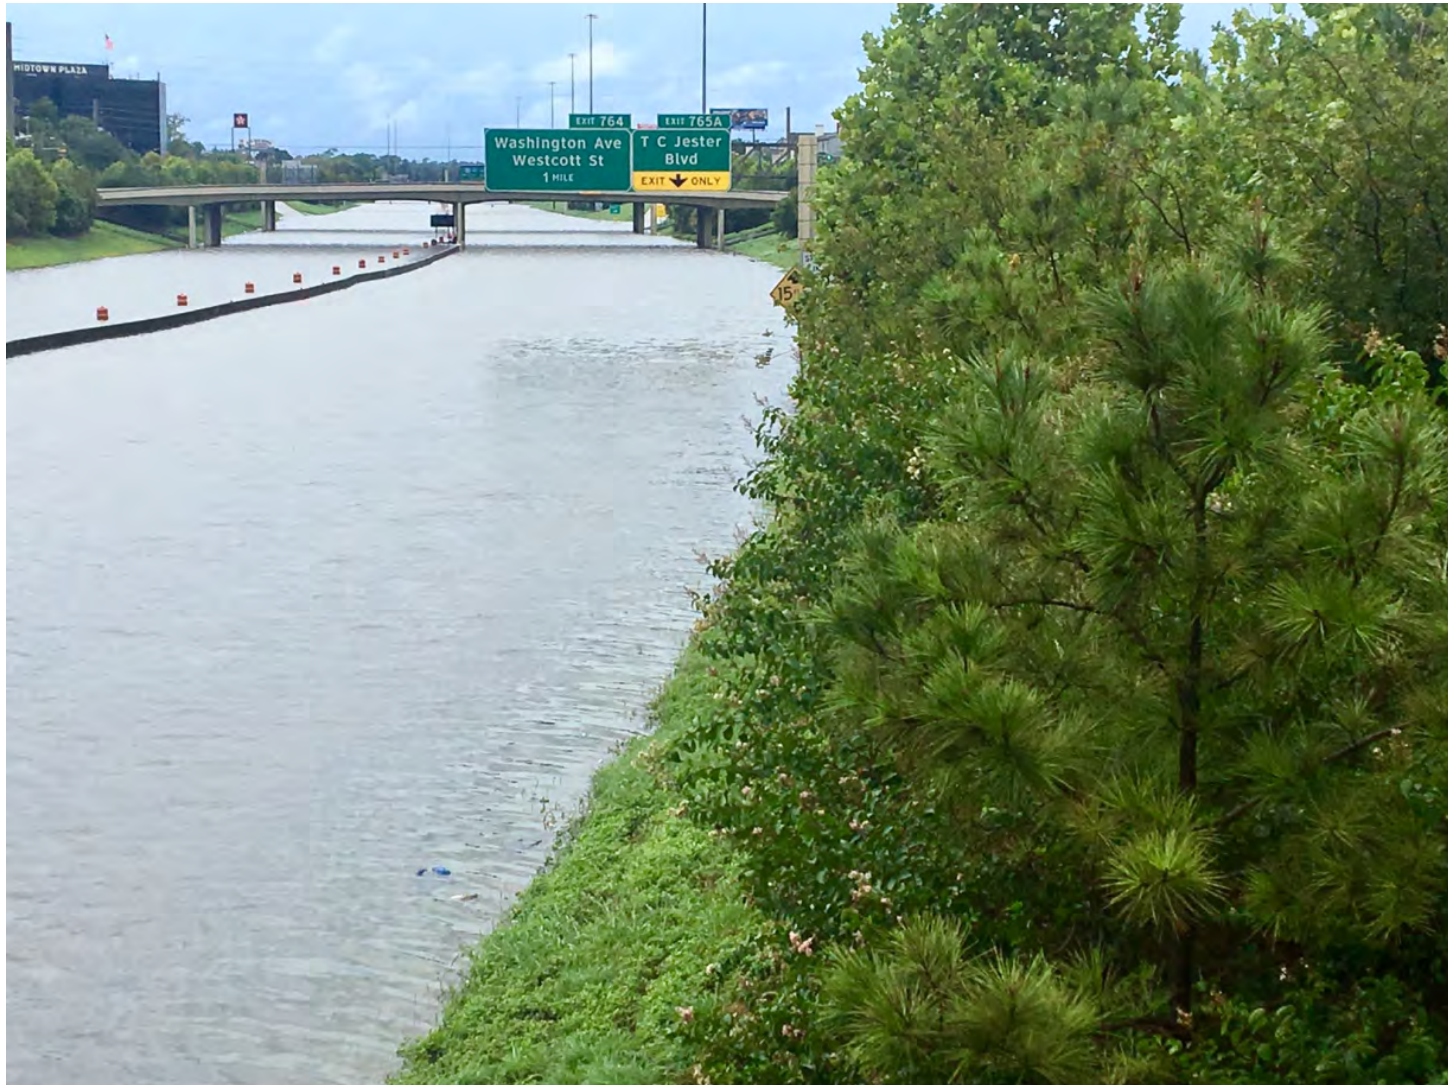
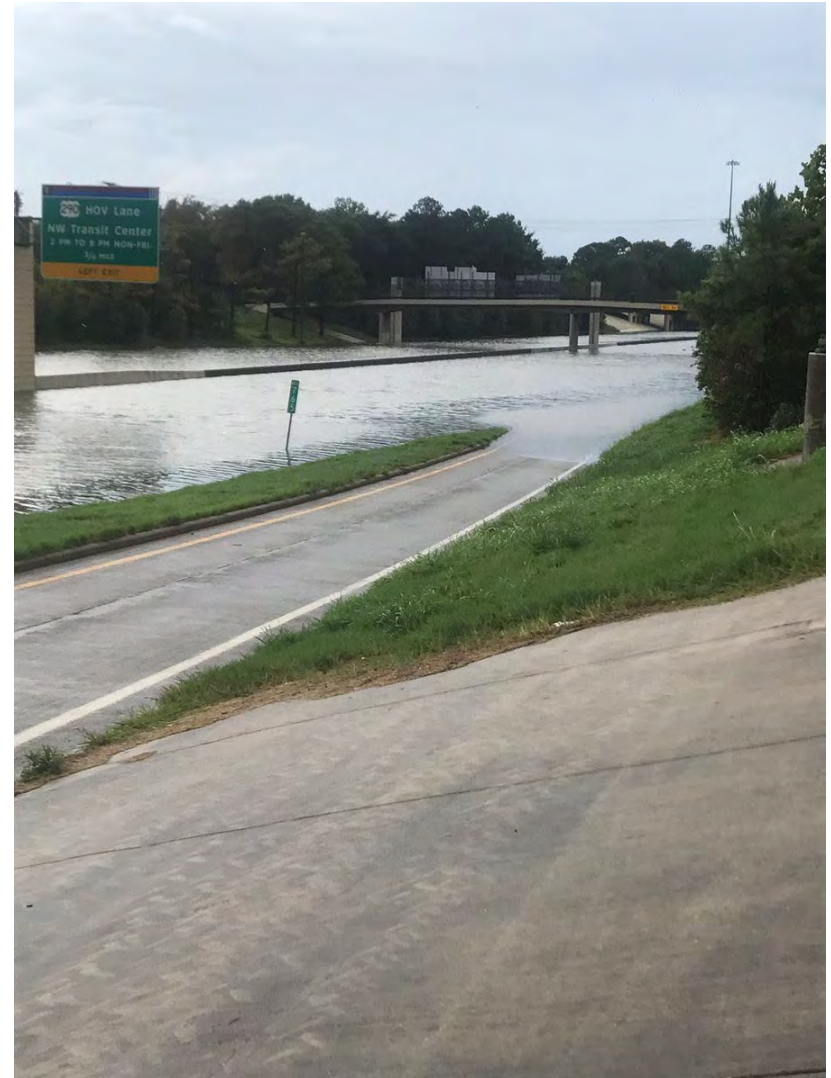
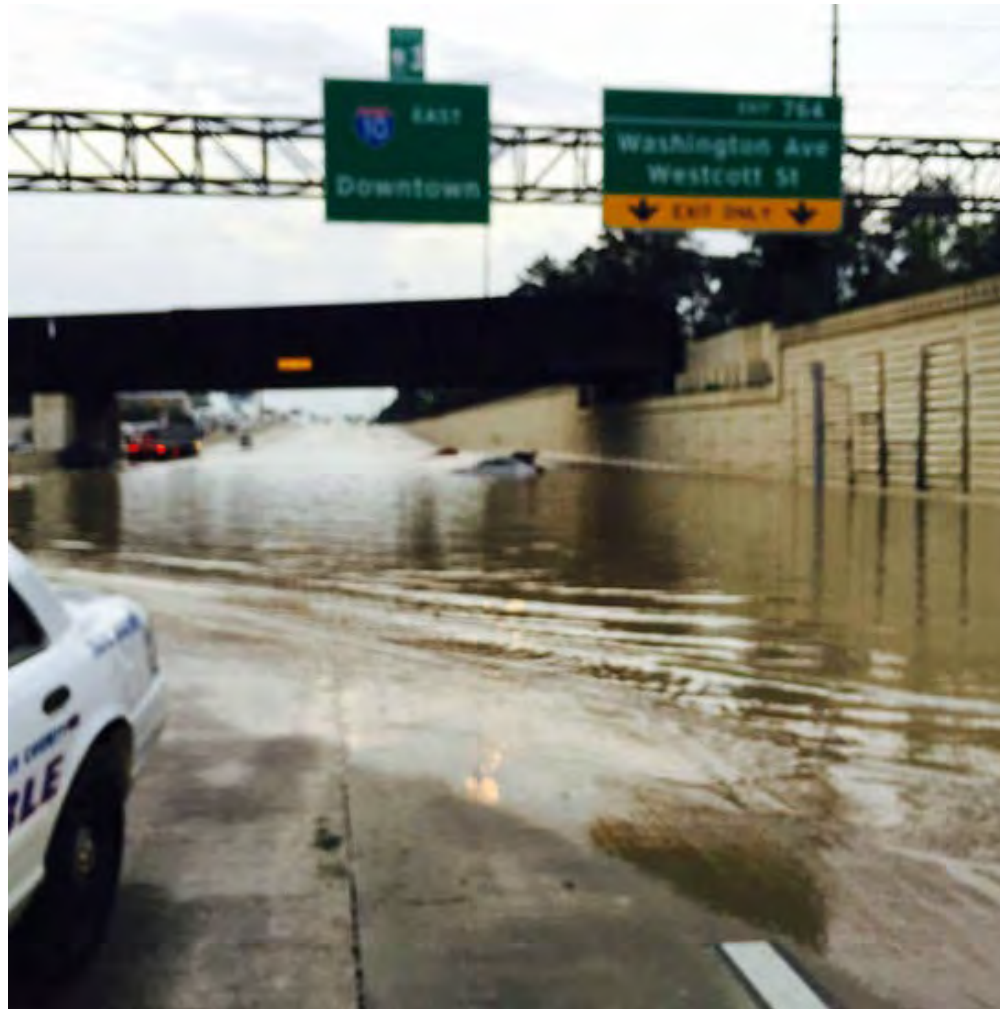
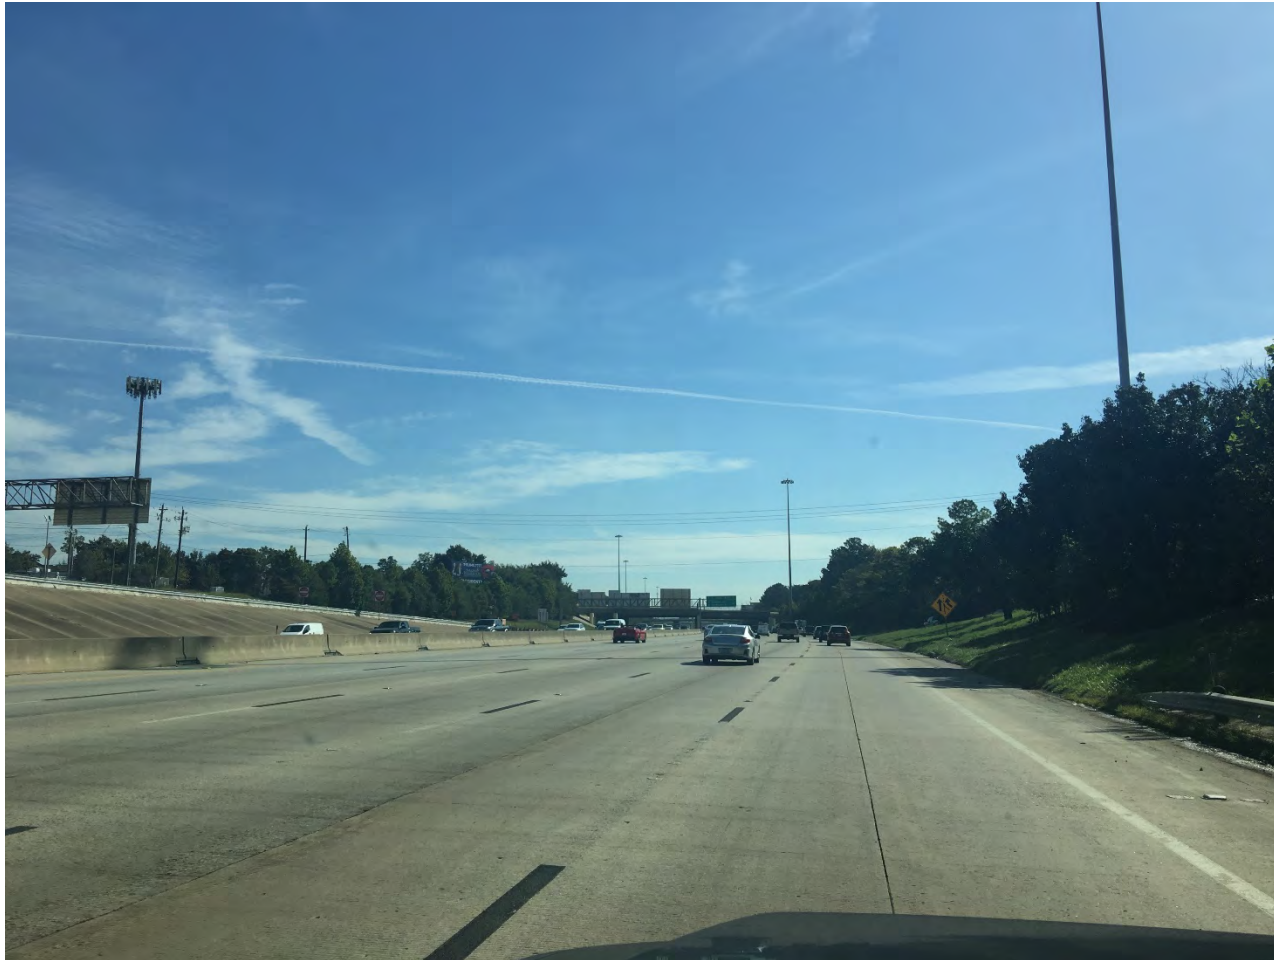
**IH 10 after Harvey, Oct 2017**

- Has been flooded *at least* three times since reconstruction
- TxDOT Maintenance Expenditures for pavement-related\* items from 2001 to 2016 on this section were \$303,113, or \$3,125/lane mile
  - Less than \$200/year/lane mile up to this point

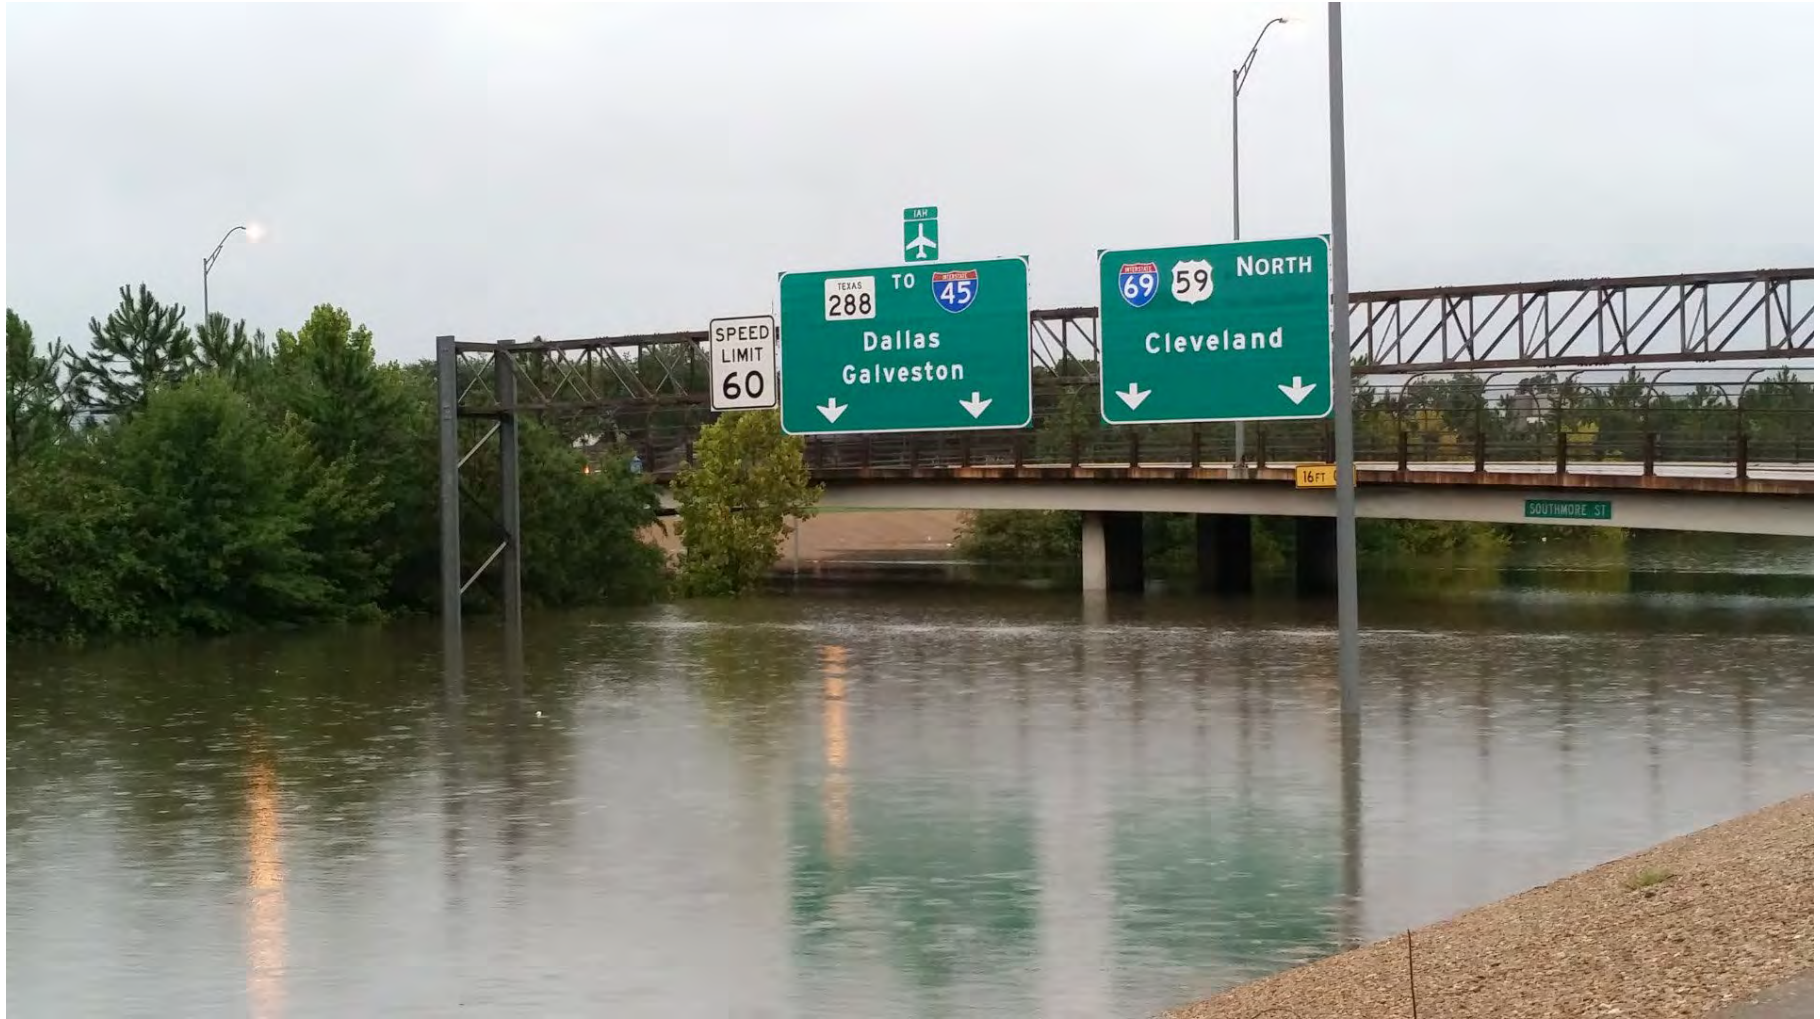
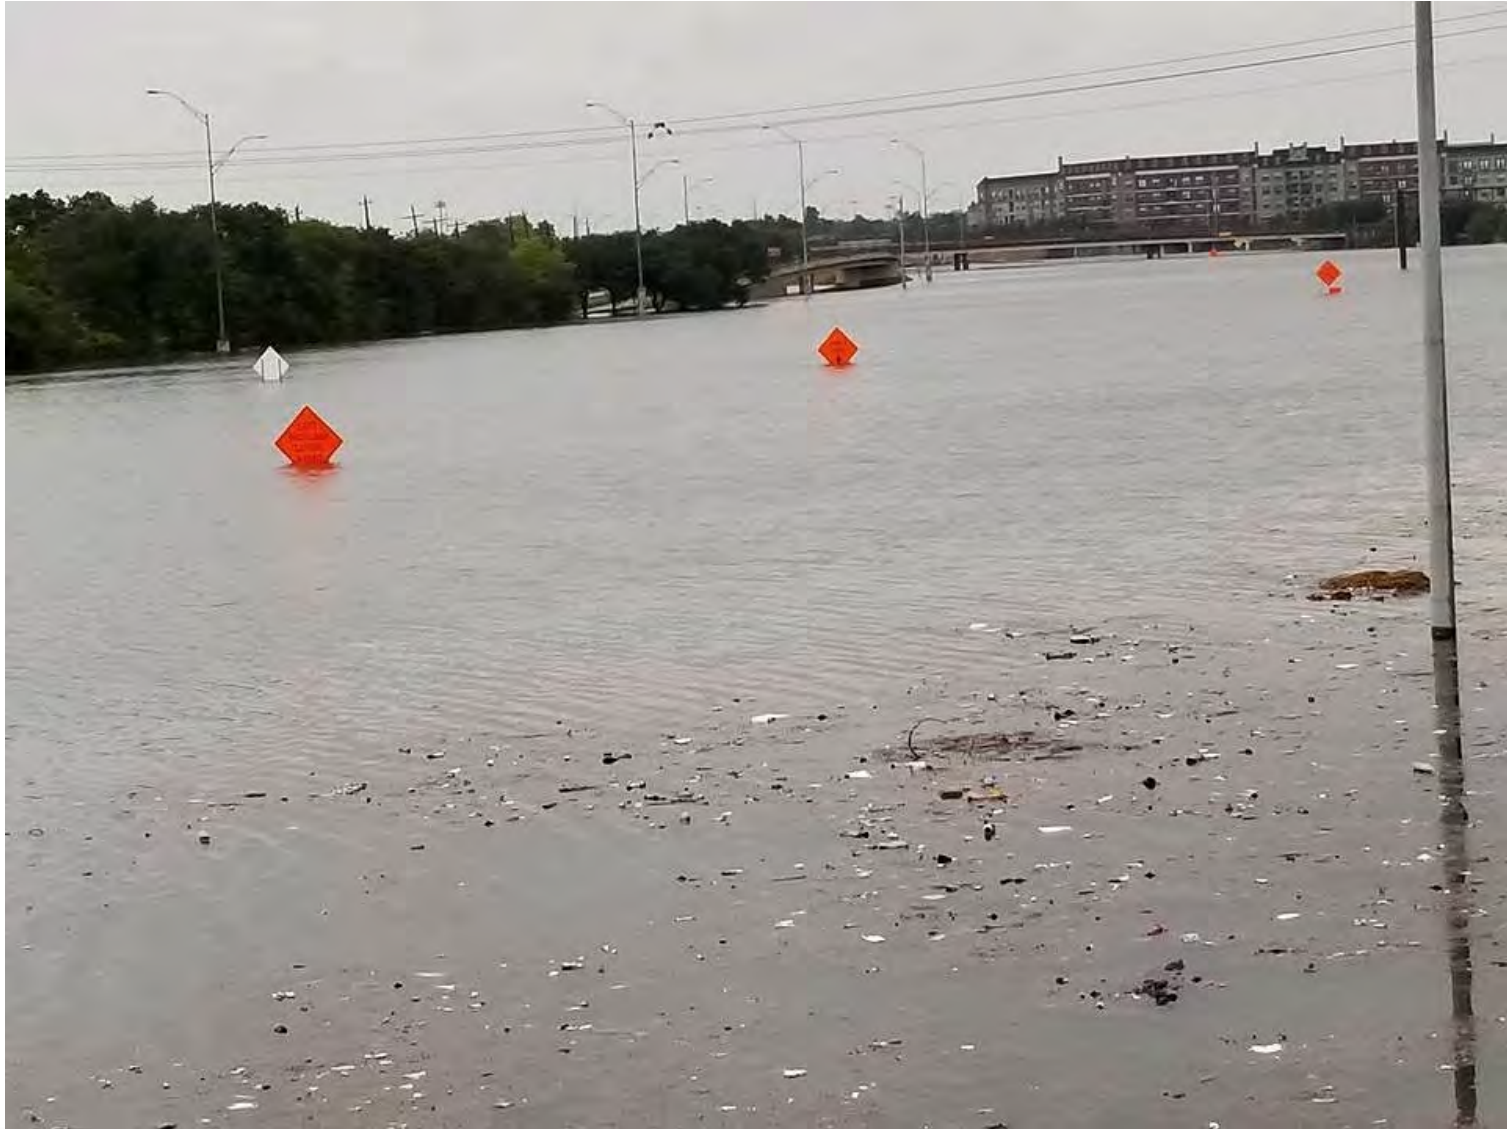
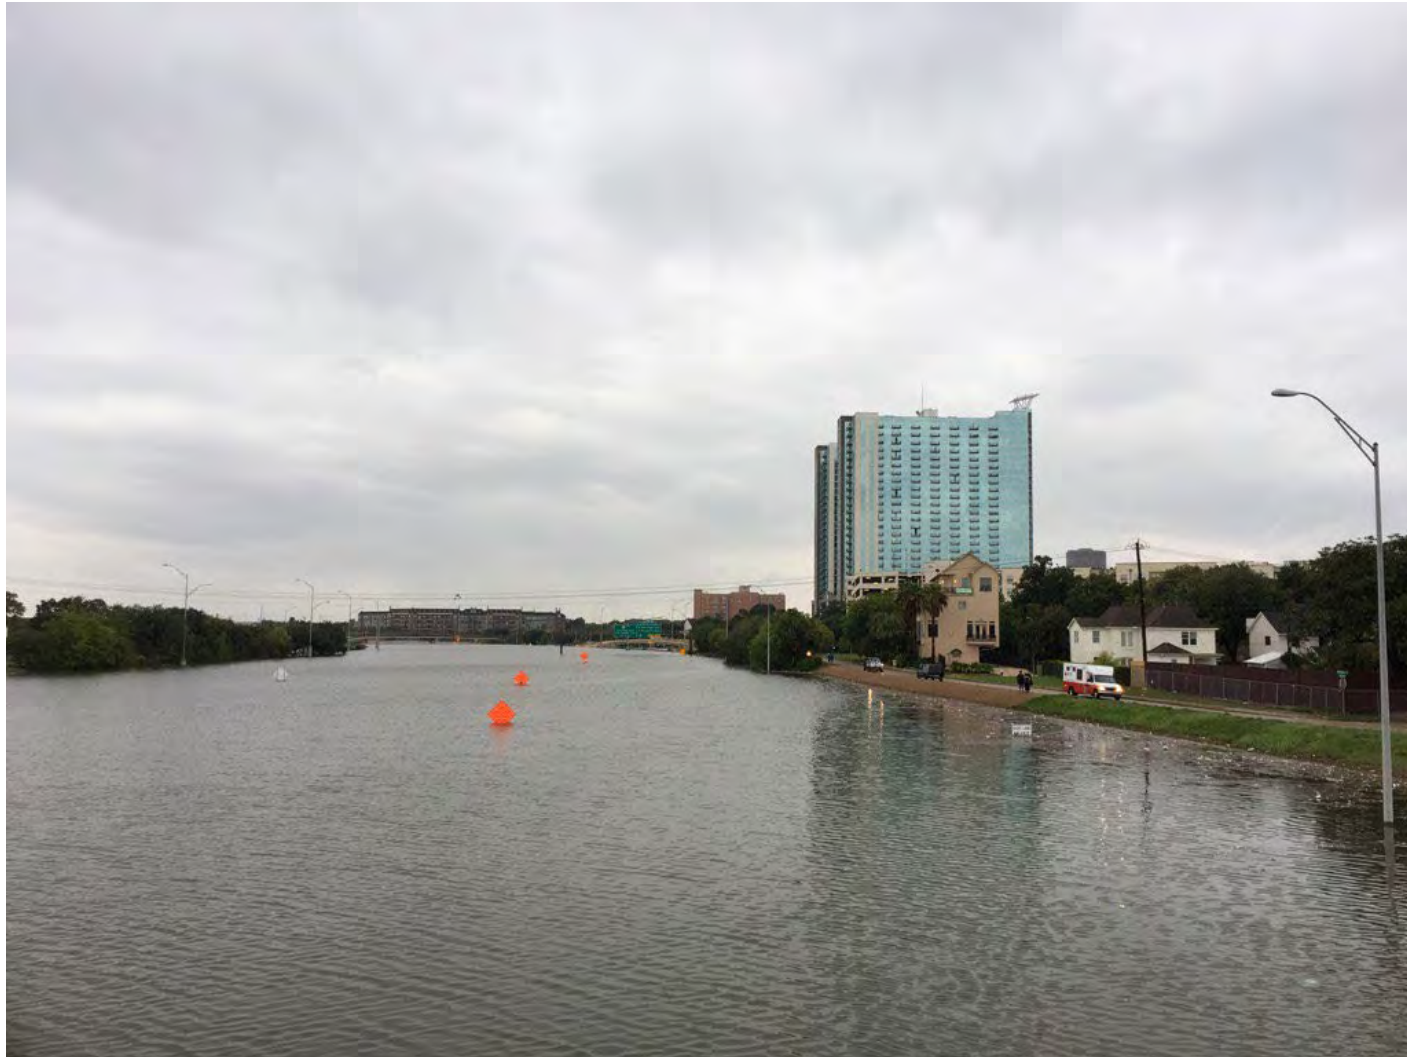
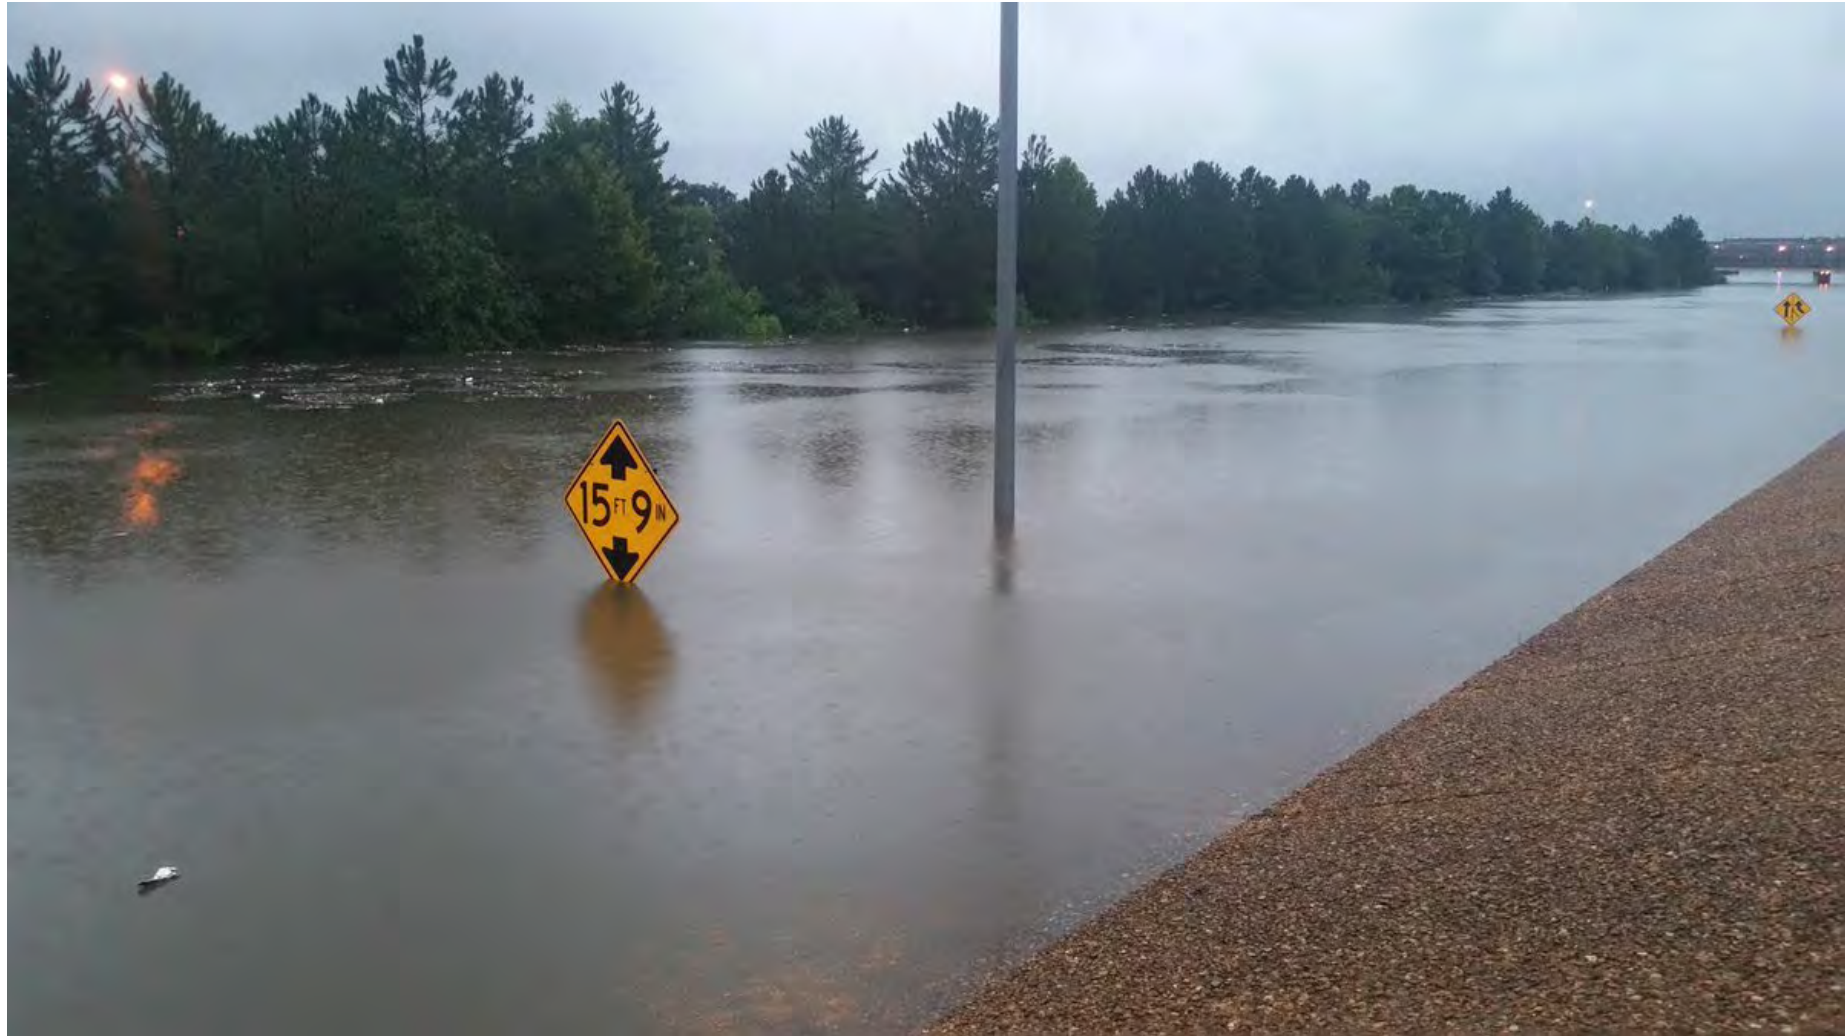
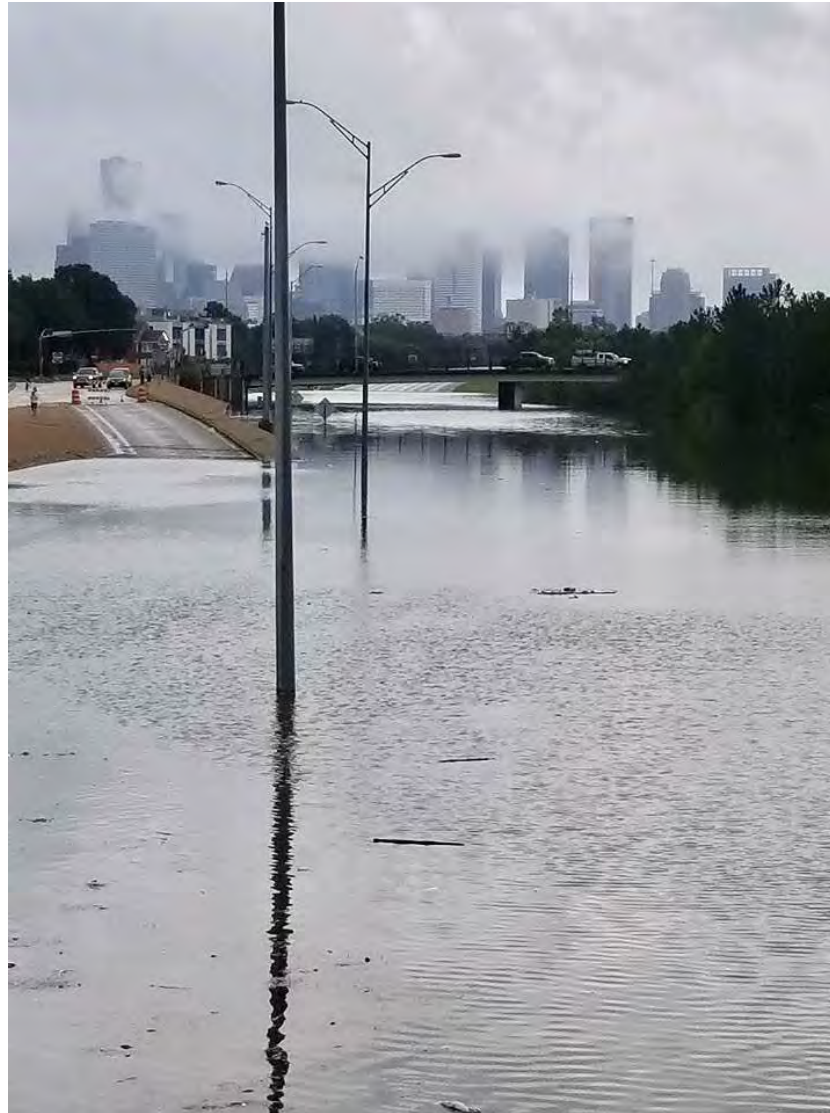
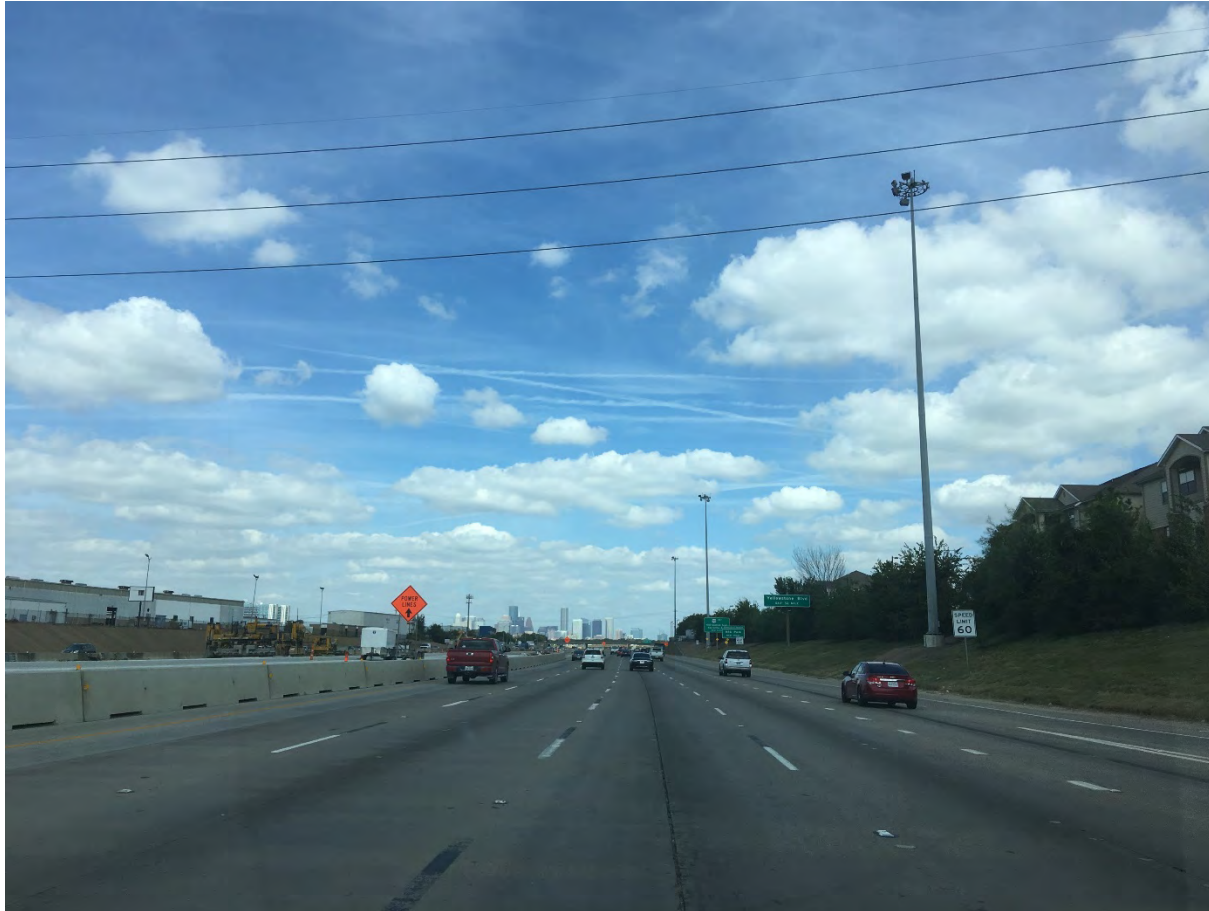
**SH 288 after Harvey, Oct. 2017**

- Has been flooded *at least* three times since it's been constructed
- TxDOT pavement\* maintenance expenditures on this section from 1993 to 2016 were \$206,598, or \$11,738/lane mile
  - \$510/year/lane mile (for a pavement well past design life)
- Note: no TxDOT maintenance expenditures are available before 1993

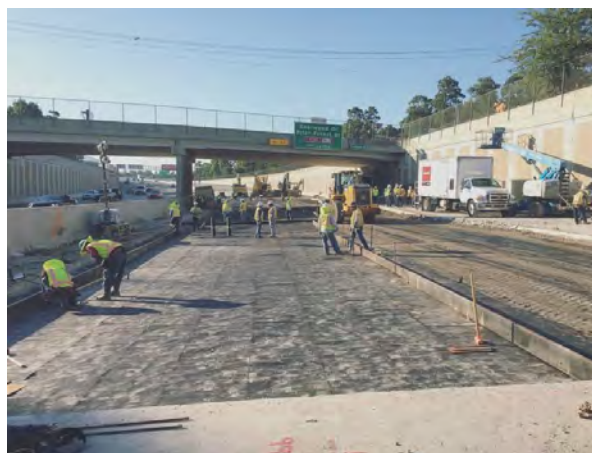
Crews repair a flood-damaged section of the southbound lanes of the West Sam Houston Tollway on September 8 in this photo by the Harris County Toll Authority
