Report  
**Village of Dryden**

# Capital Improvements Plan

130-10658-002

May 2016

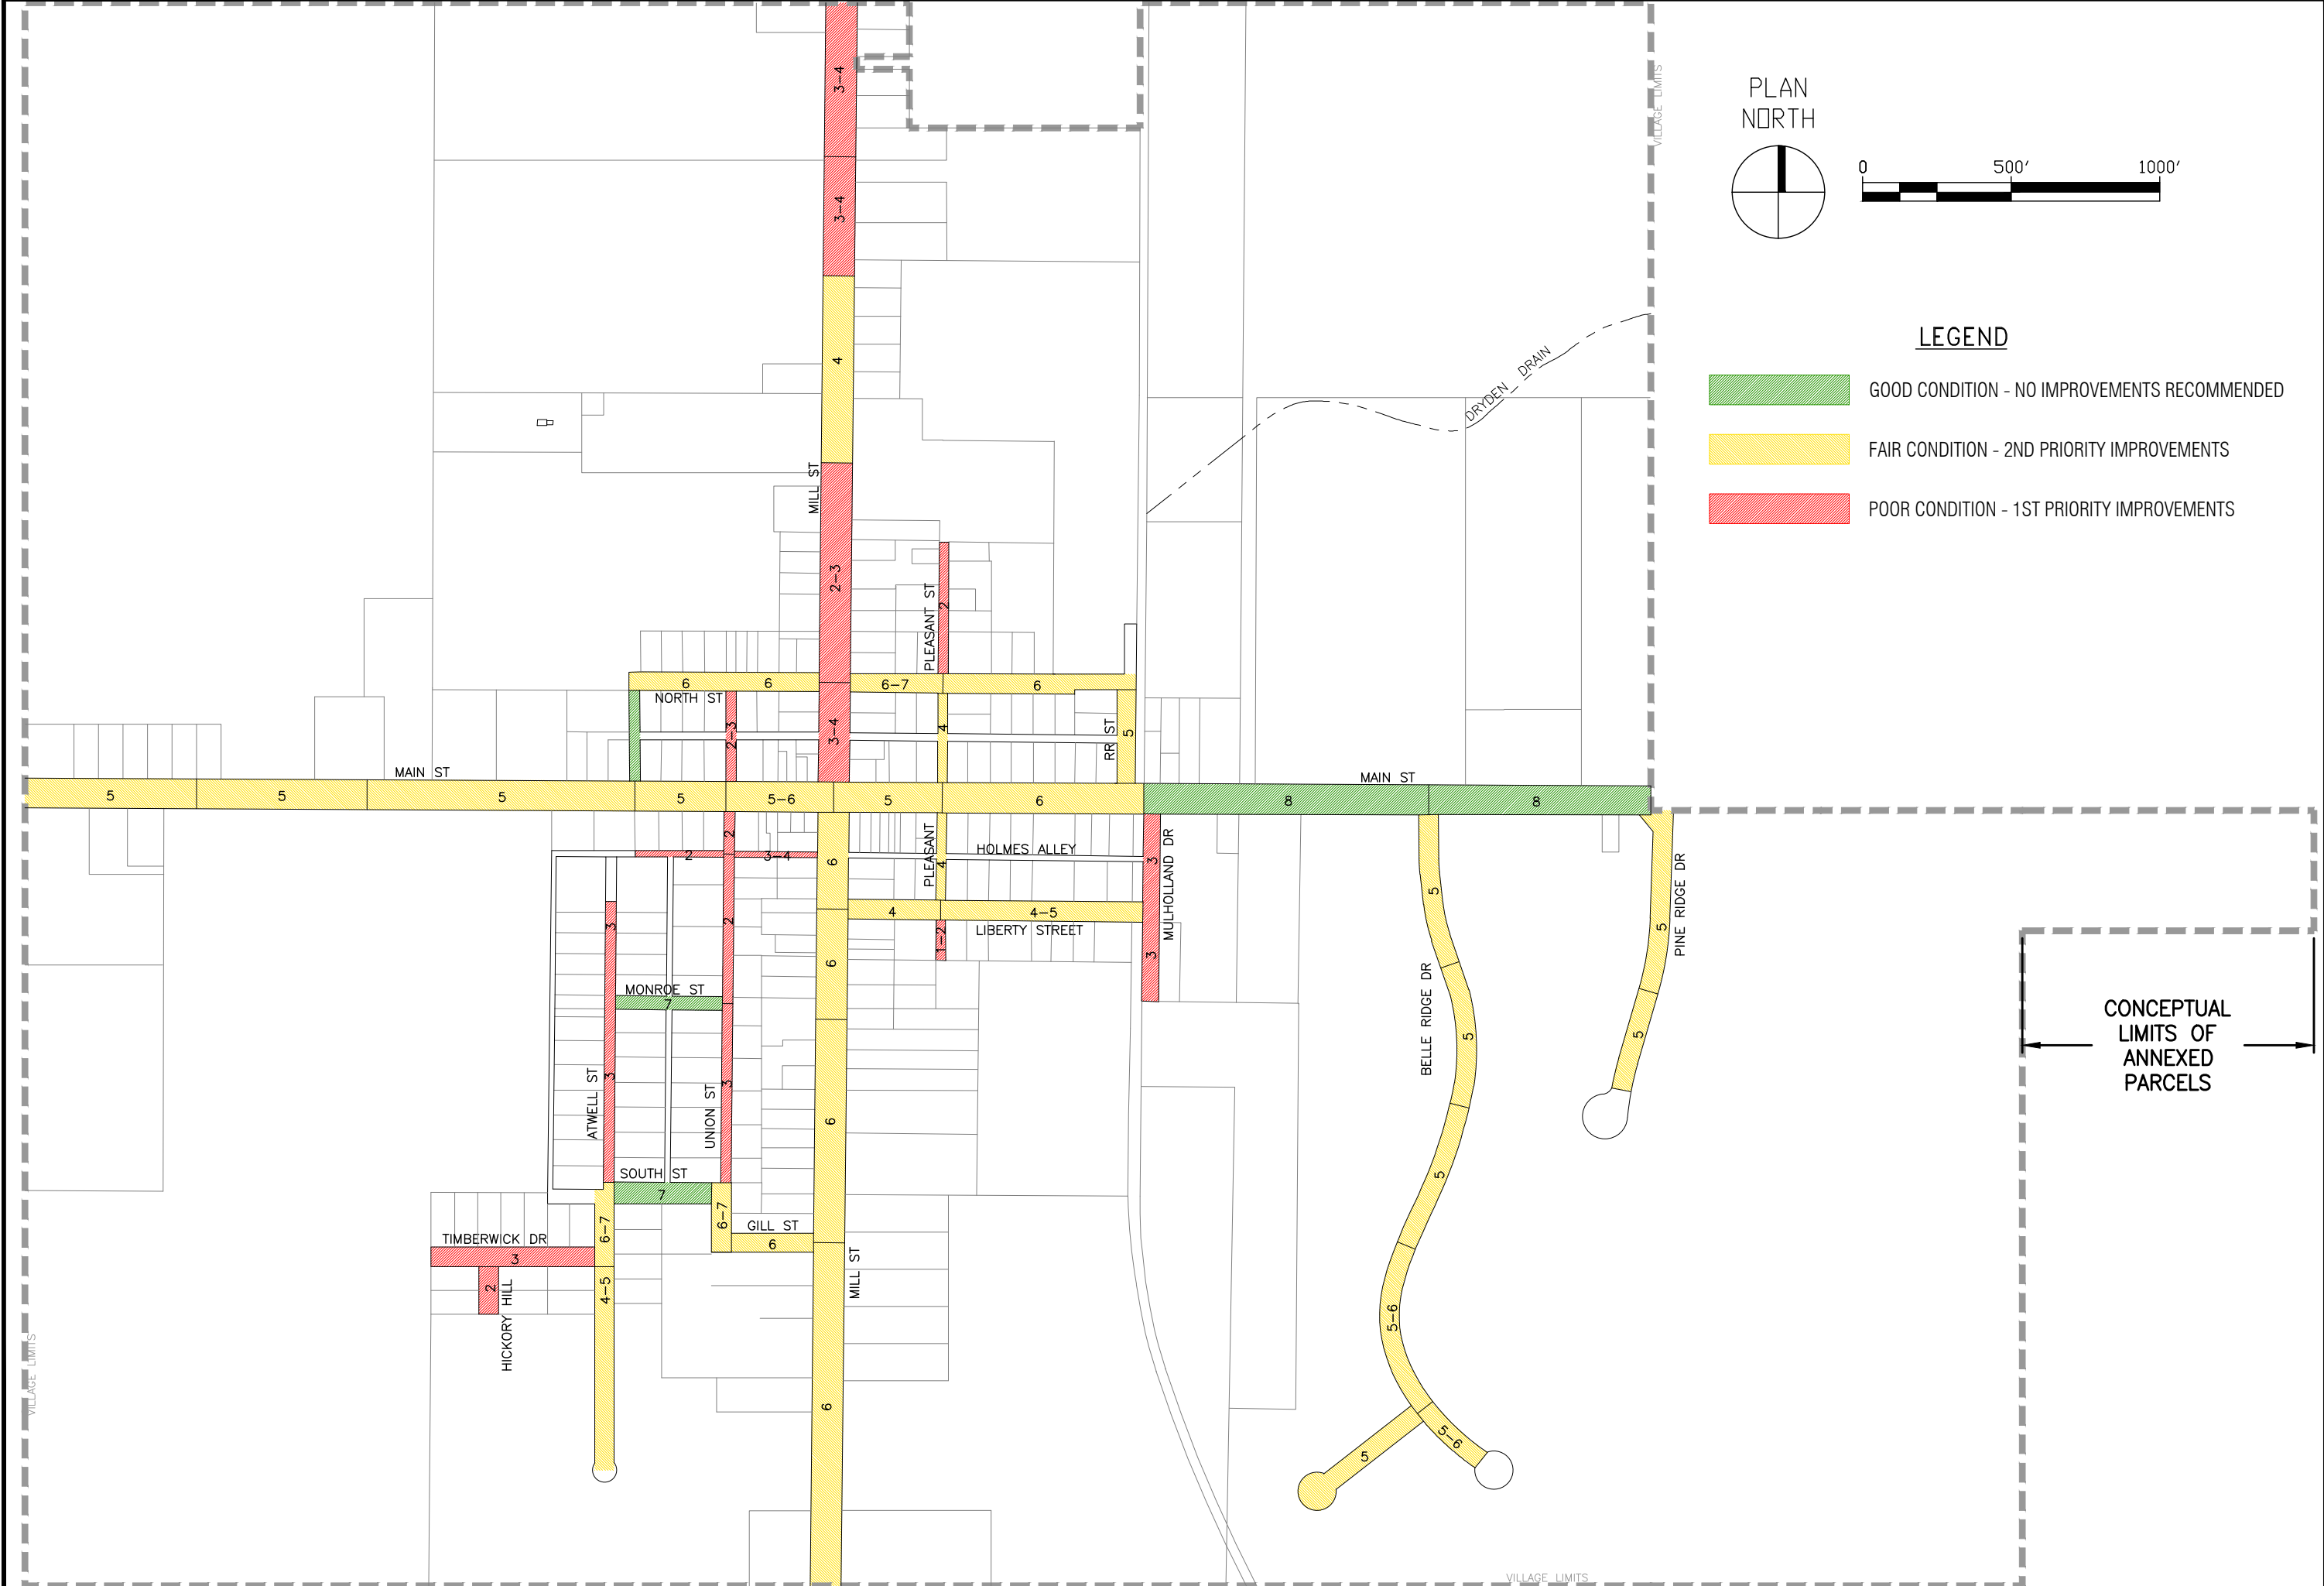
All streets and alleys within the Village limits are owned and maintained by the Village except for Main Street which is owned by the Lapeer County Road Commission but maintained by the Village. In early October 2015, LAN conducted a condition assessment of all streets within Village limits utilizing the Pavement Surface Evaluation and Rating (PASER) methodology. The PASER asphalt road condition grading procedure involves rating roads on a scale from 1-10 where a score of 1 indicates street failure and 10 indicates excellent condition. The PASER rating system was developed by the University of Wisconsin Transportation Information Center and is the selected rating system of the Michigan Transportation Asset Management Council. Appendix B includes additional details about the PASER system and tabulated information used to score each street in the Village. Figure 5 shows the PASER scores for all streets in the Village.

Figure 5 depicts road conditions with PASER ratings and a simplified prioritization of road improvements by color coding. A table showing typical road conditions for a given PASER score is shown in Appendix B. On Figure 5, roads colored red are severely deteriorated, roads colored yellow are slightly to moderately deteriorated, and roads colored green are in good condition.

The paved portions of Holmes Alley and the segment of Pleasant Street south of Liberty are in poor condition, but the low volume of use may not warrant that these sections be considered as high priority improvements. Considering the usage, Holmes Alley and the southernmost segment of Pleasant could function effectively as gravel rather than paved.

The section of Main Street from Union to Mulholland is known to have concrete pavement overlaid with asphalt which has led to 'speed bump' like transverse cracks due to differential expansion and contraction. Although the PASER score of this roadway section indicates the overall condition of the road is not critical, significant structural problems remain but are somewhat hidden by past overlays. Additionally, the nature of the issue creates an objectionable experience on what is a high use road. Unfortunately, the solution requires full depth pavement replacement as opposed to surficial treatment.

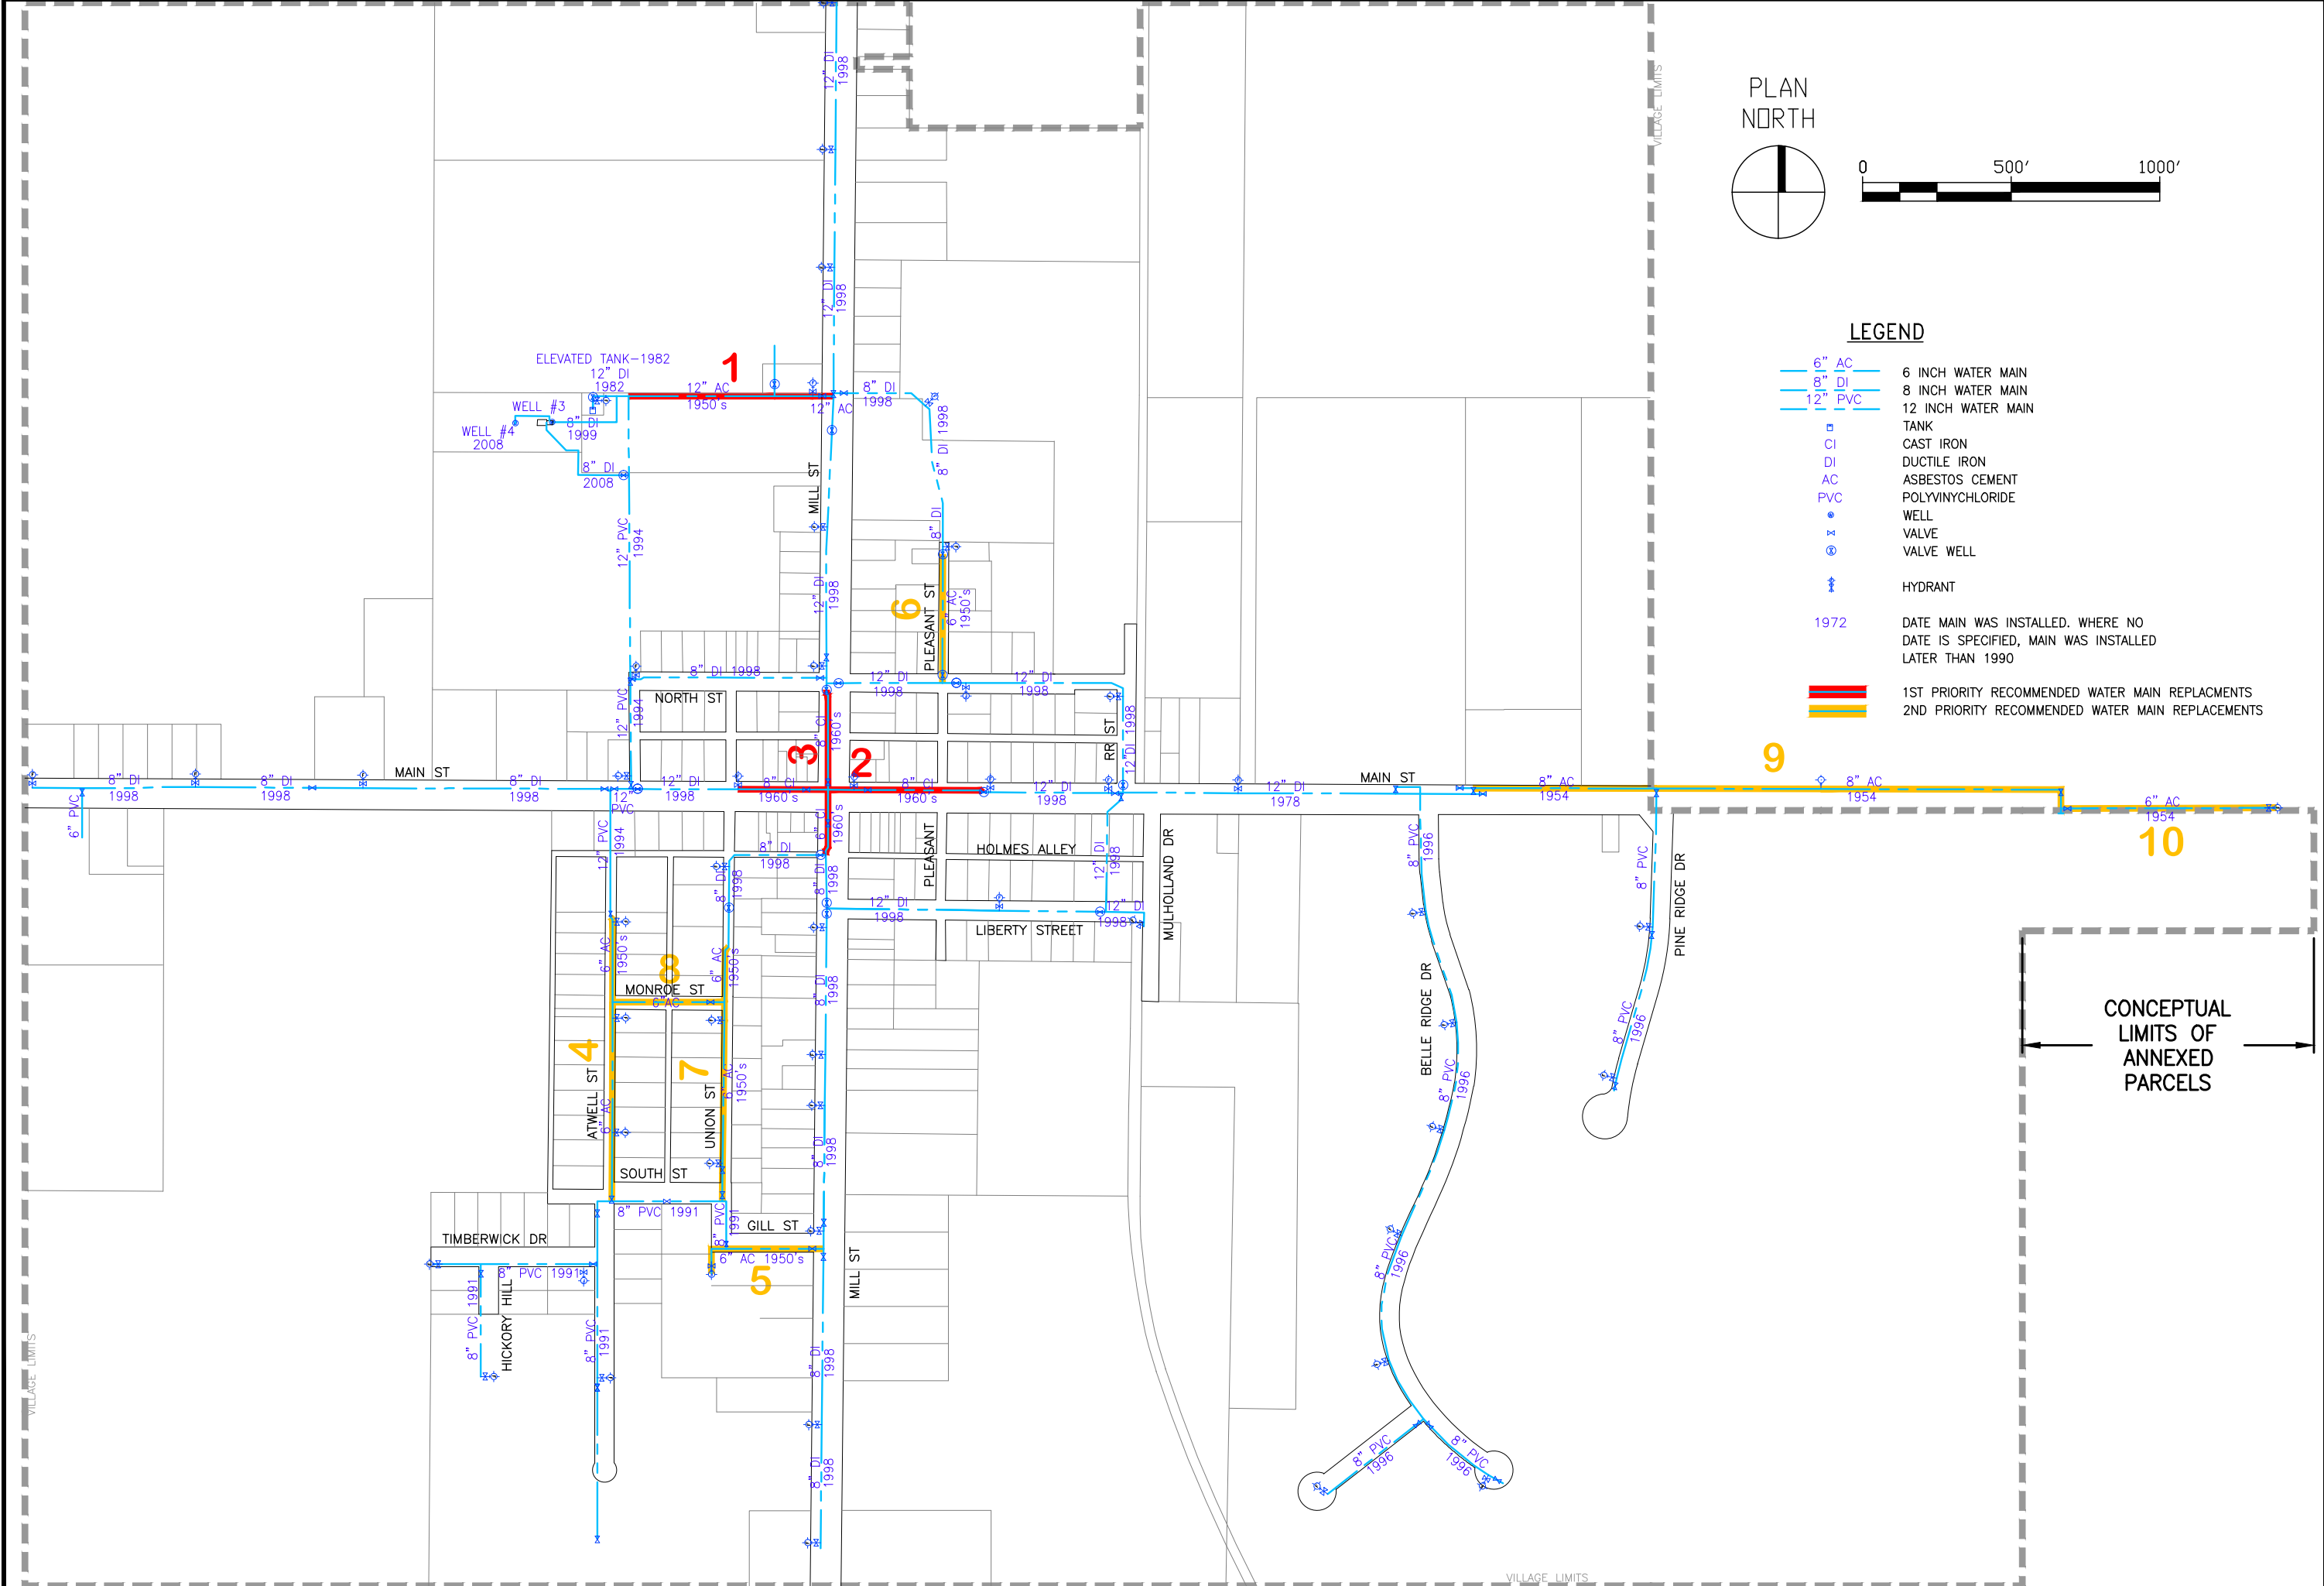
Most if not all AC mains remaining in the system were likely installed in the 1950's or earlier and have exceeded their life expectancy. Similarly, there is a 'cross' portion of 8" CI water main in the downtown area that probably was installed prior to 1970. CI pipe can also contribute to water discoloration due to rust. To date, the Village has had very few water main breaks suggesting that mains are still in reasonable condition. Therefore, LAN recommends replacement of AC and CI mains over an extended period of time, as mains begin to show signs of deterioration or when opportunities such as road replacement or funding availability arise. The following table of suggested prioritized water main replacements is taken from the 2015 Water Reliability Study.

The recommended water main replacements listed above are shown on Figure 6, categorized into first and second priorities.

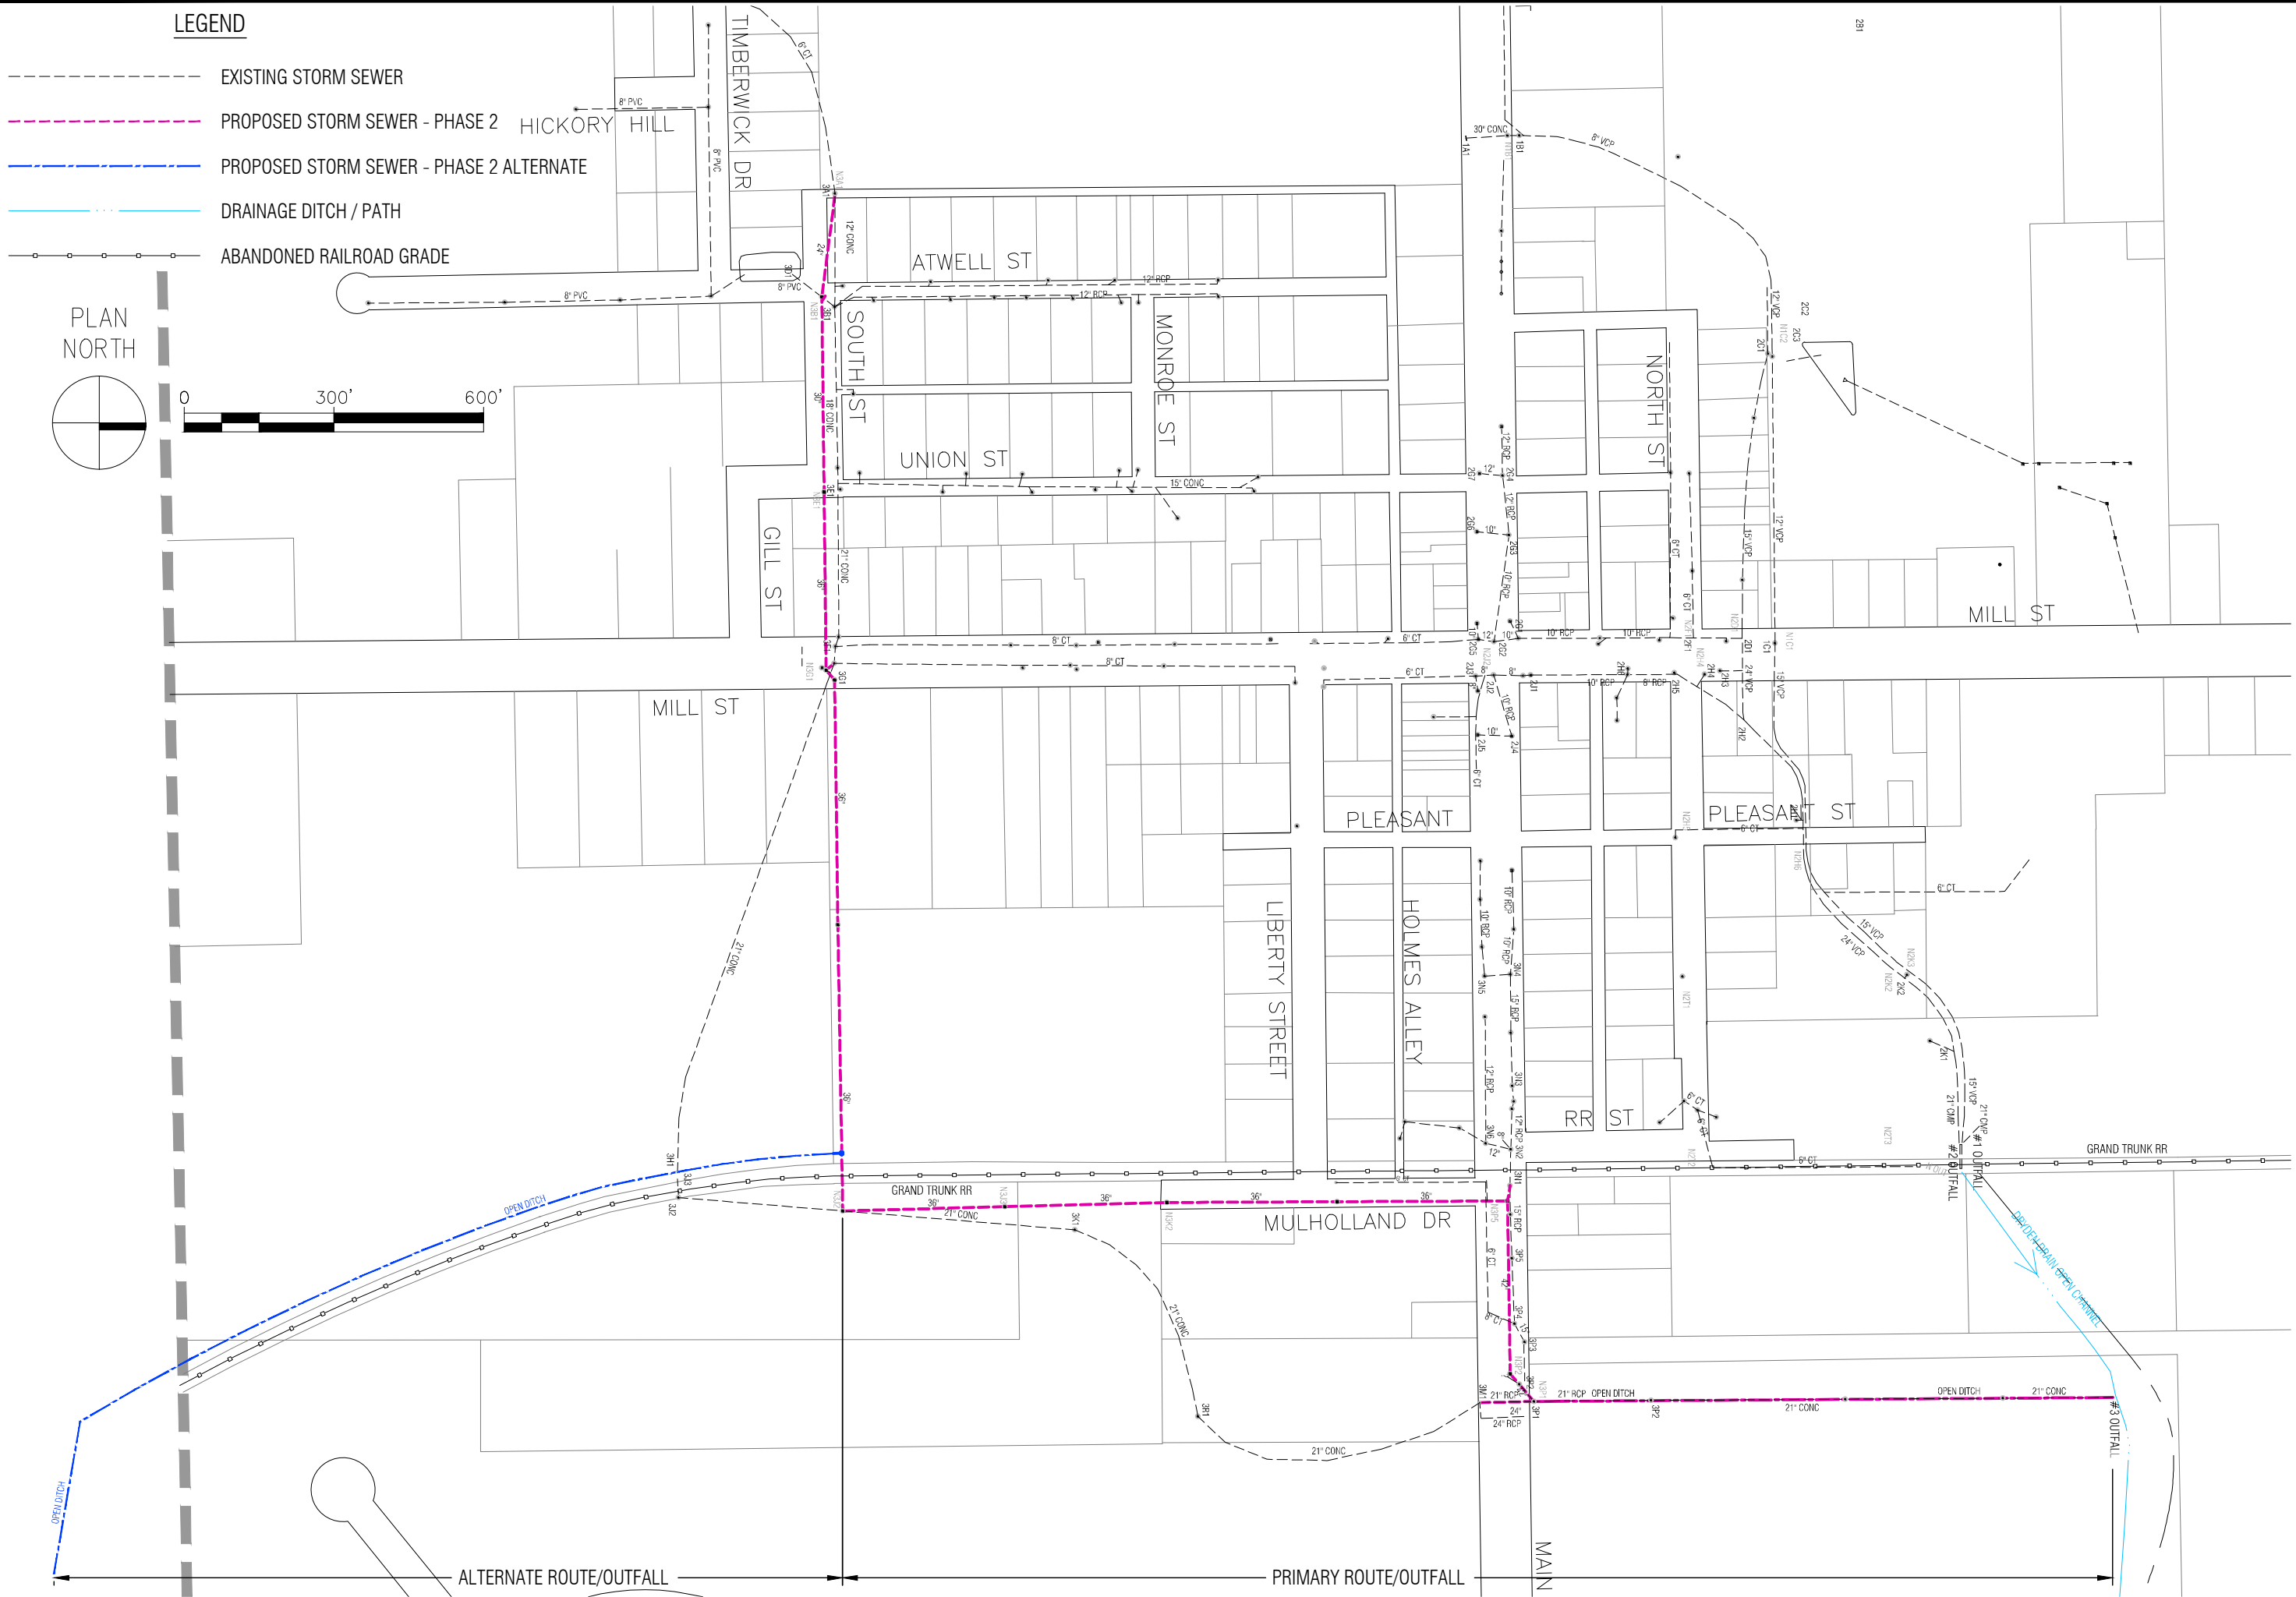
Figure:  
 8

The second recommended storm sewer interceptor project is shown in pink on Figure 8. The improvements would address flooding issues associated with the Allen Drain. Similar to Storm Sewer Phase 1, it would be best to construct the Storm Sewer Phase 2 interceptor before constructing Projects 2 and 3 so that the interceptor is in place for connection of the lateral sewers.

Note that an alternate route for the proposed Allen Drain replacement is shown on Figure 8. The alternate route presented could decrease the project cost by over \$250,000 if the appropriate easements can be acquired and elevations permit gravity flow. Due to these unknowns, costs for the primary route are used in this report, but further investigation of the alternate route is recommended during the design phase. Elevations seem to be suitable based on USGS mapping but detailed survey information would be needed to confirm.

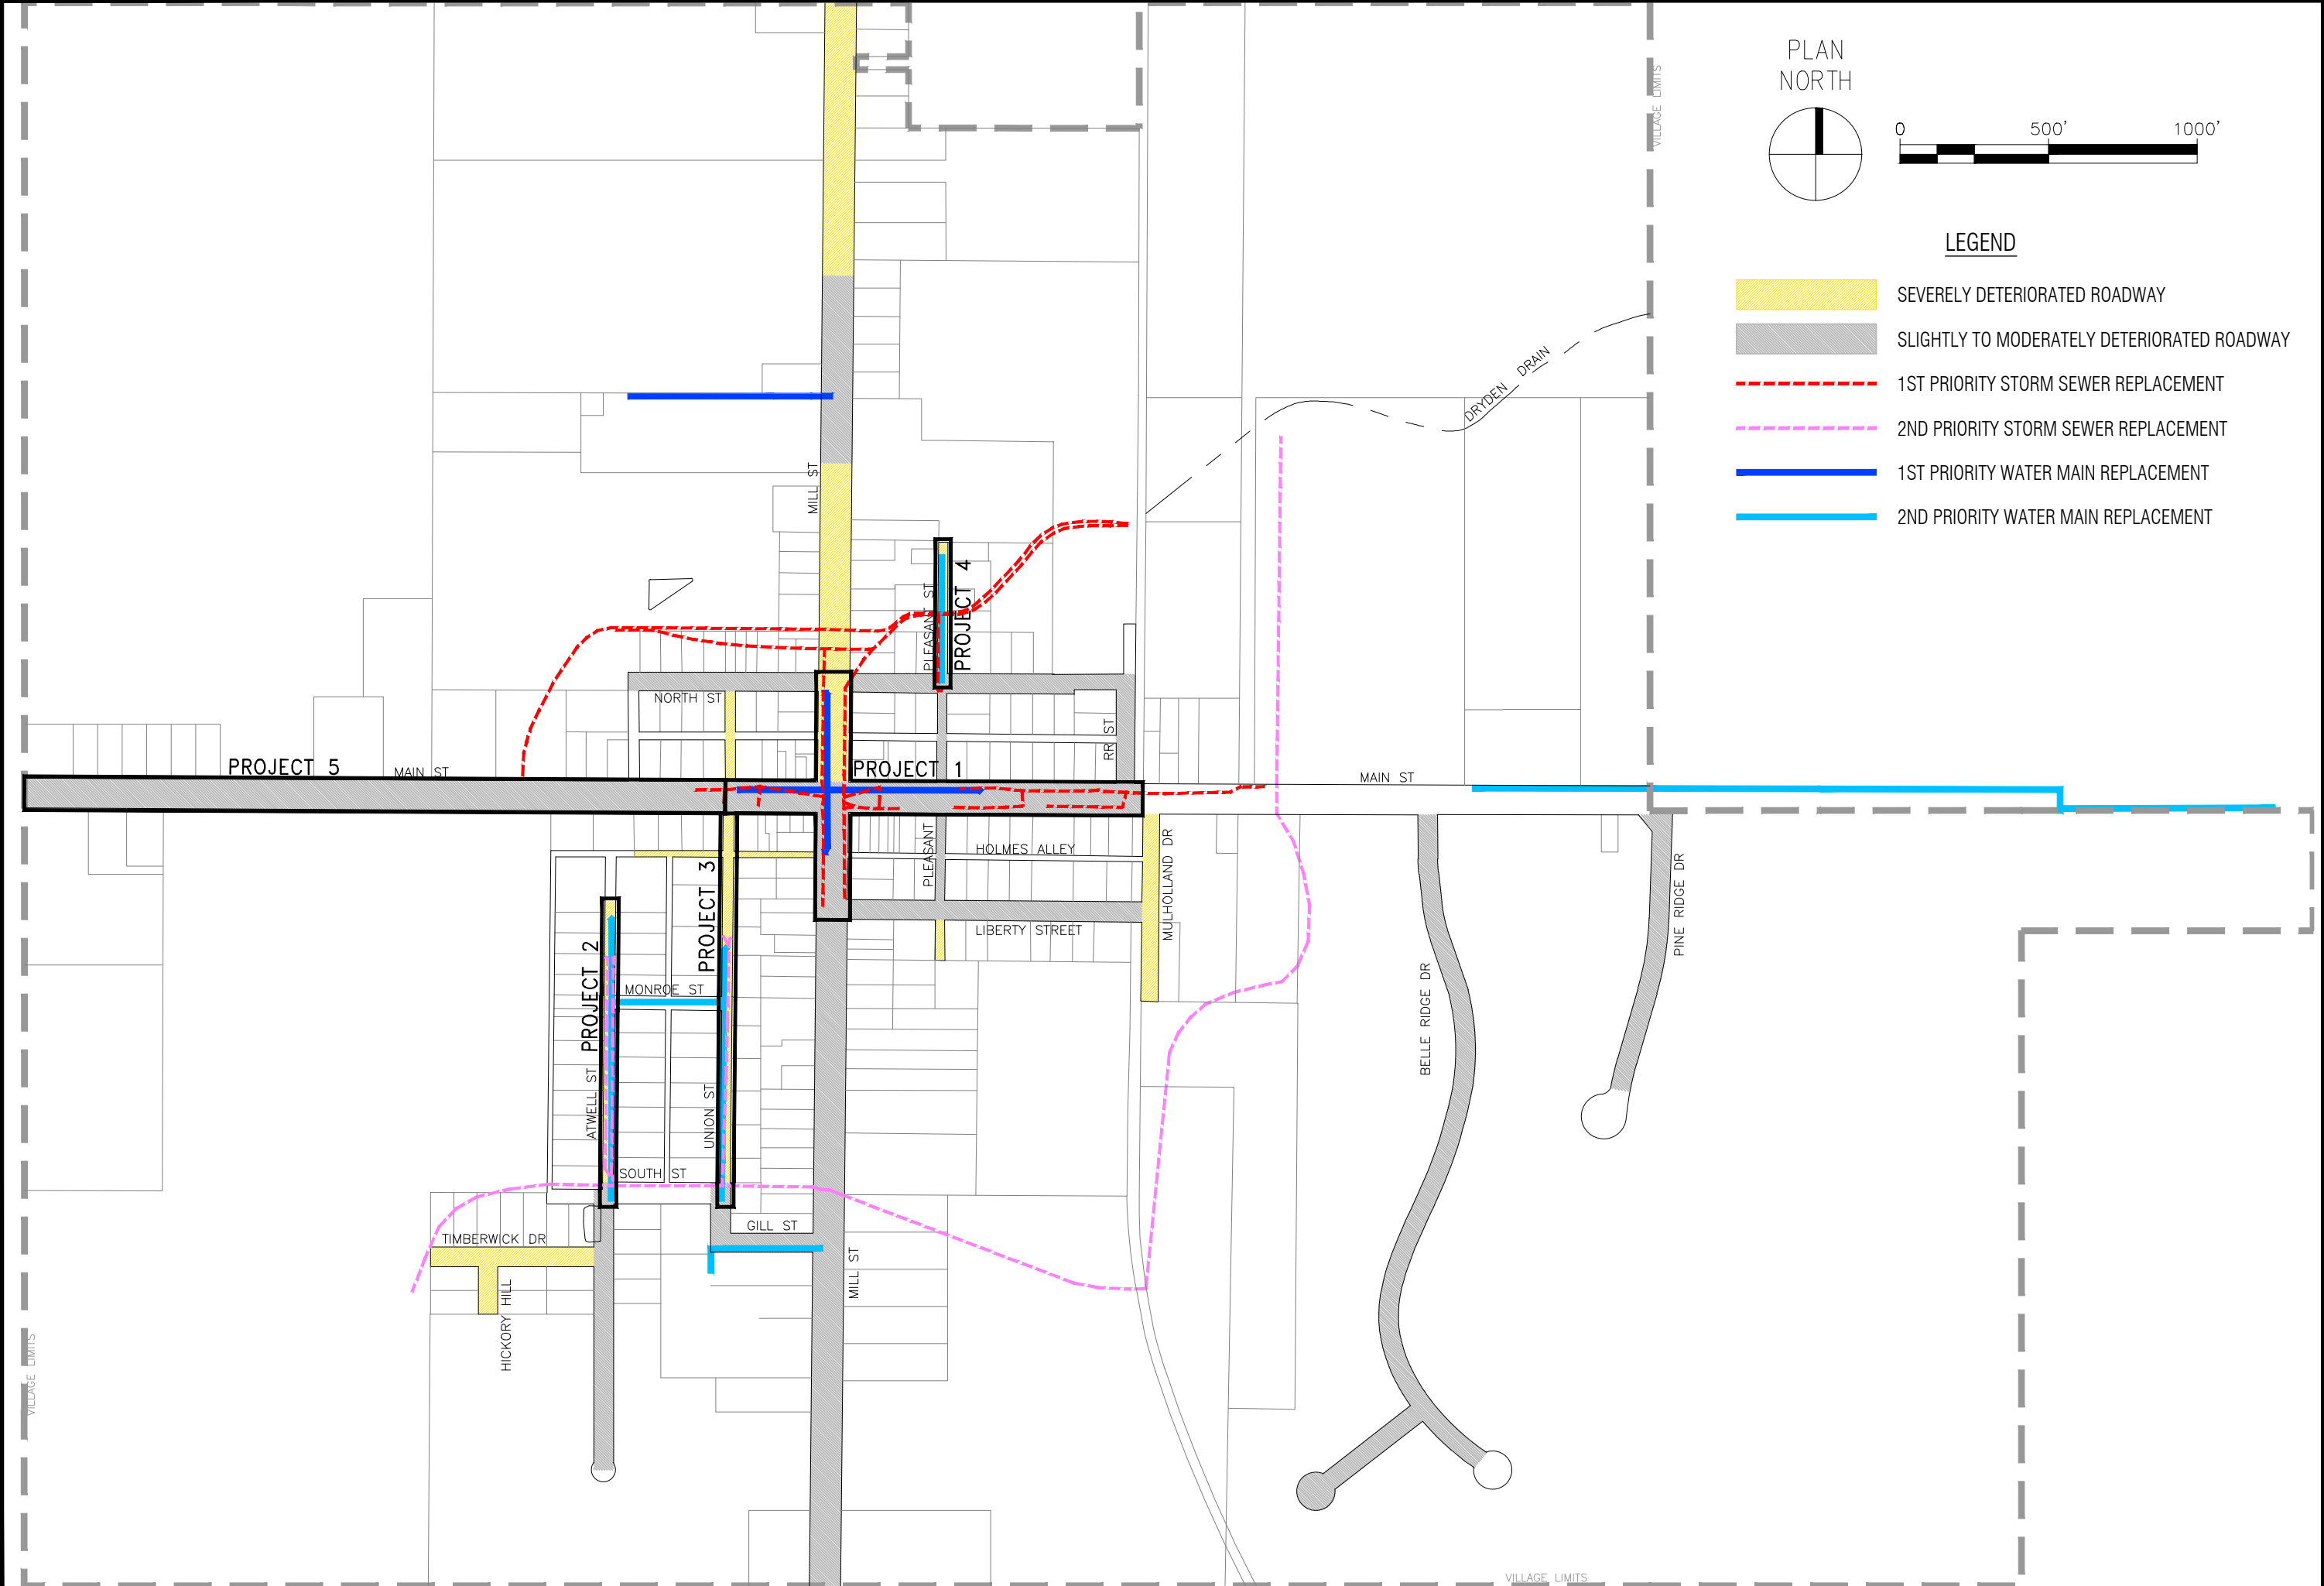
Streets categorized as severely deteriorated on Figure 9 that are not included in specific projects are recommended to be rehabilitated as funding allows. The streets include Mill Street north of North Street, Timberwick, Hickory Hill, Mulholland, and the northernmost block of Union Street.

Projects recommended for completion within the next 6 years are described below. General limits for Projects 1-5 are shown on Figure 9 and the layout for Project 6 is shown on Figure 7 as the proposed storm sewer interceptor. Details for all costs presented are included in Appendix A. The current (May 2016) ENR index is 10,315.
