COAL MINING RISK ASSESSMENT
NEATH PORT TALBOT C.B.C.
PRE-PLANNING REF. Q2020/0185
PROPOSED COMMERCIAL DEVELOPMENT
MARDON PARK
BAGLAN ENERGY PARK
PORT TALBOT
N.P.T.
SA12 7AX
15/04/2021

INTRODUCTION

G.B.V. Properties are applying to Neath Port Talbot C.B.C. for full planning permission to construct a light industrial unit with a 20,000 sq.ft. floorspace at Mardon Park, Baglan. As this is classed as a major development there has been a P.A.C. process carried out. In response to initial enquiries N.P.T. responded with a letter dated 18/12/2020. This has the pre-app. Reference Q2020/0185 and states:-

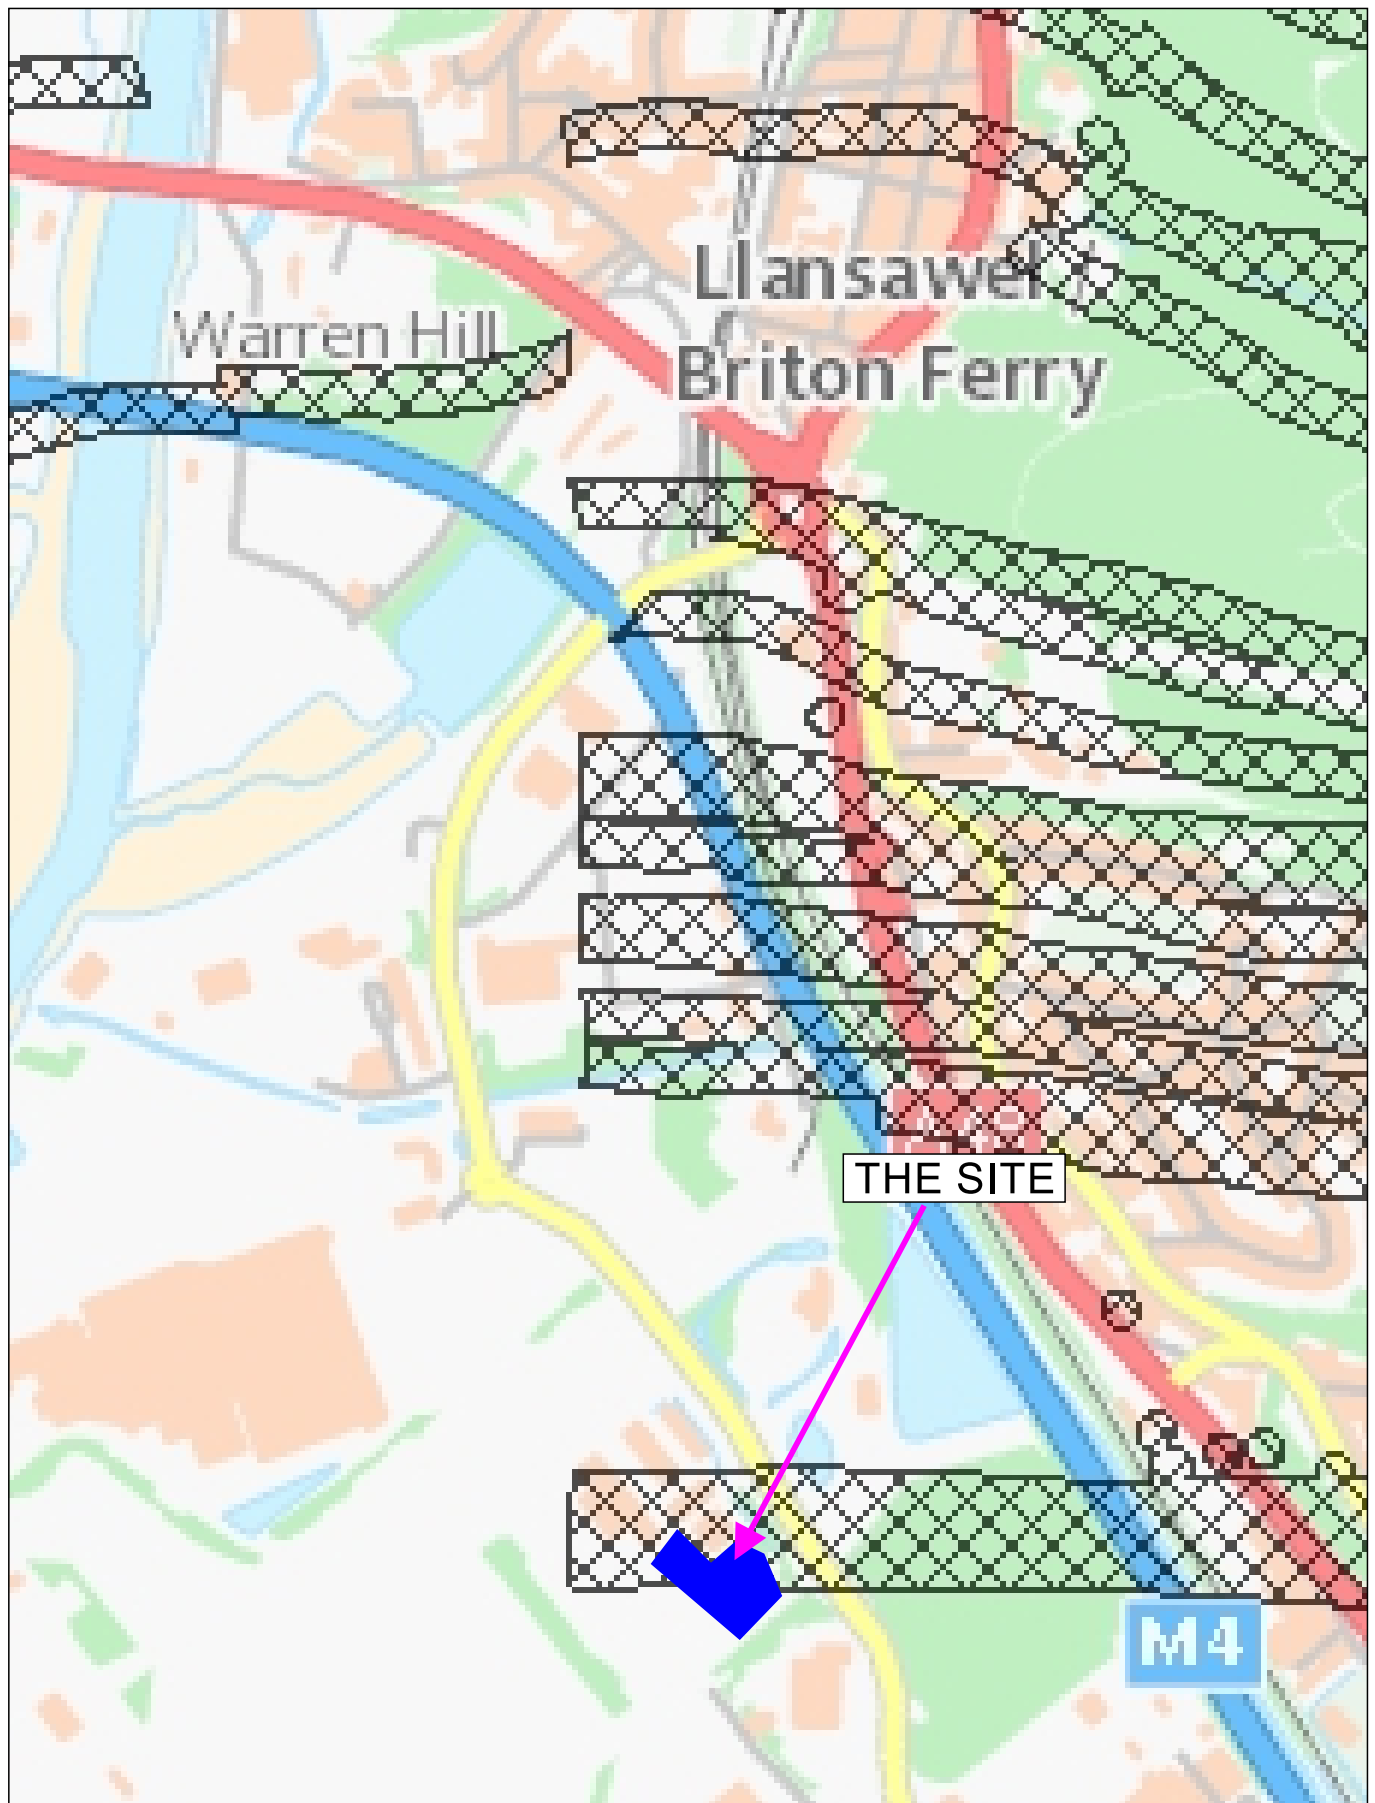
FIGURE 3

2b) The C.A. interactive viewer contains a vast amount of information from various sources, particularly on the mining data window. An extract from the planning window can be seen in Figure 3. The site partially lies on a linear belt of Development High Risk. From its appearance this would appear to be a buffer zone covering a shallow coal seam(s). There are multiple other linear areas of Development High Risk north of the site. These would appear to be buffer zones above other seam outcrops. The isolated small circular areas northeast of the site are 20m exclusion zones around mine entrances. In order to fully understand why a site has a high-risk status it is informative to study the Coal Mining Data window. This window is far superior to the planning window as it is at a larger scale. There are multiple datasets which can be turned on and off. Information that can be obtained on the viewer includes the exact orientation of adits, and any further information held on any mine entries, including names and depths. This additional information can be extremely useful to a risk assessment.

EXTRACT FROM THE COAL AUTHORITY INTERACTIVE VIEWER PLANNING WINDOW. BLACK HATCHED AREAS ARE CLASSED AS DEVELOPMENT HIGH RISK. THE SITE POSITION IS HIGHLIGHTED

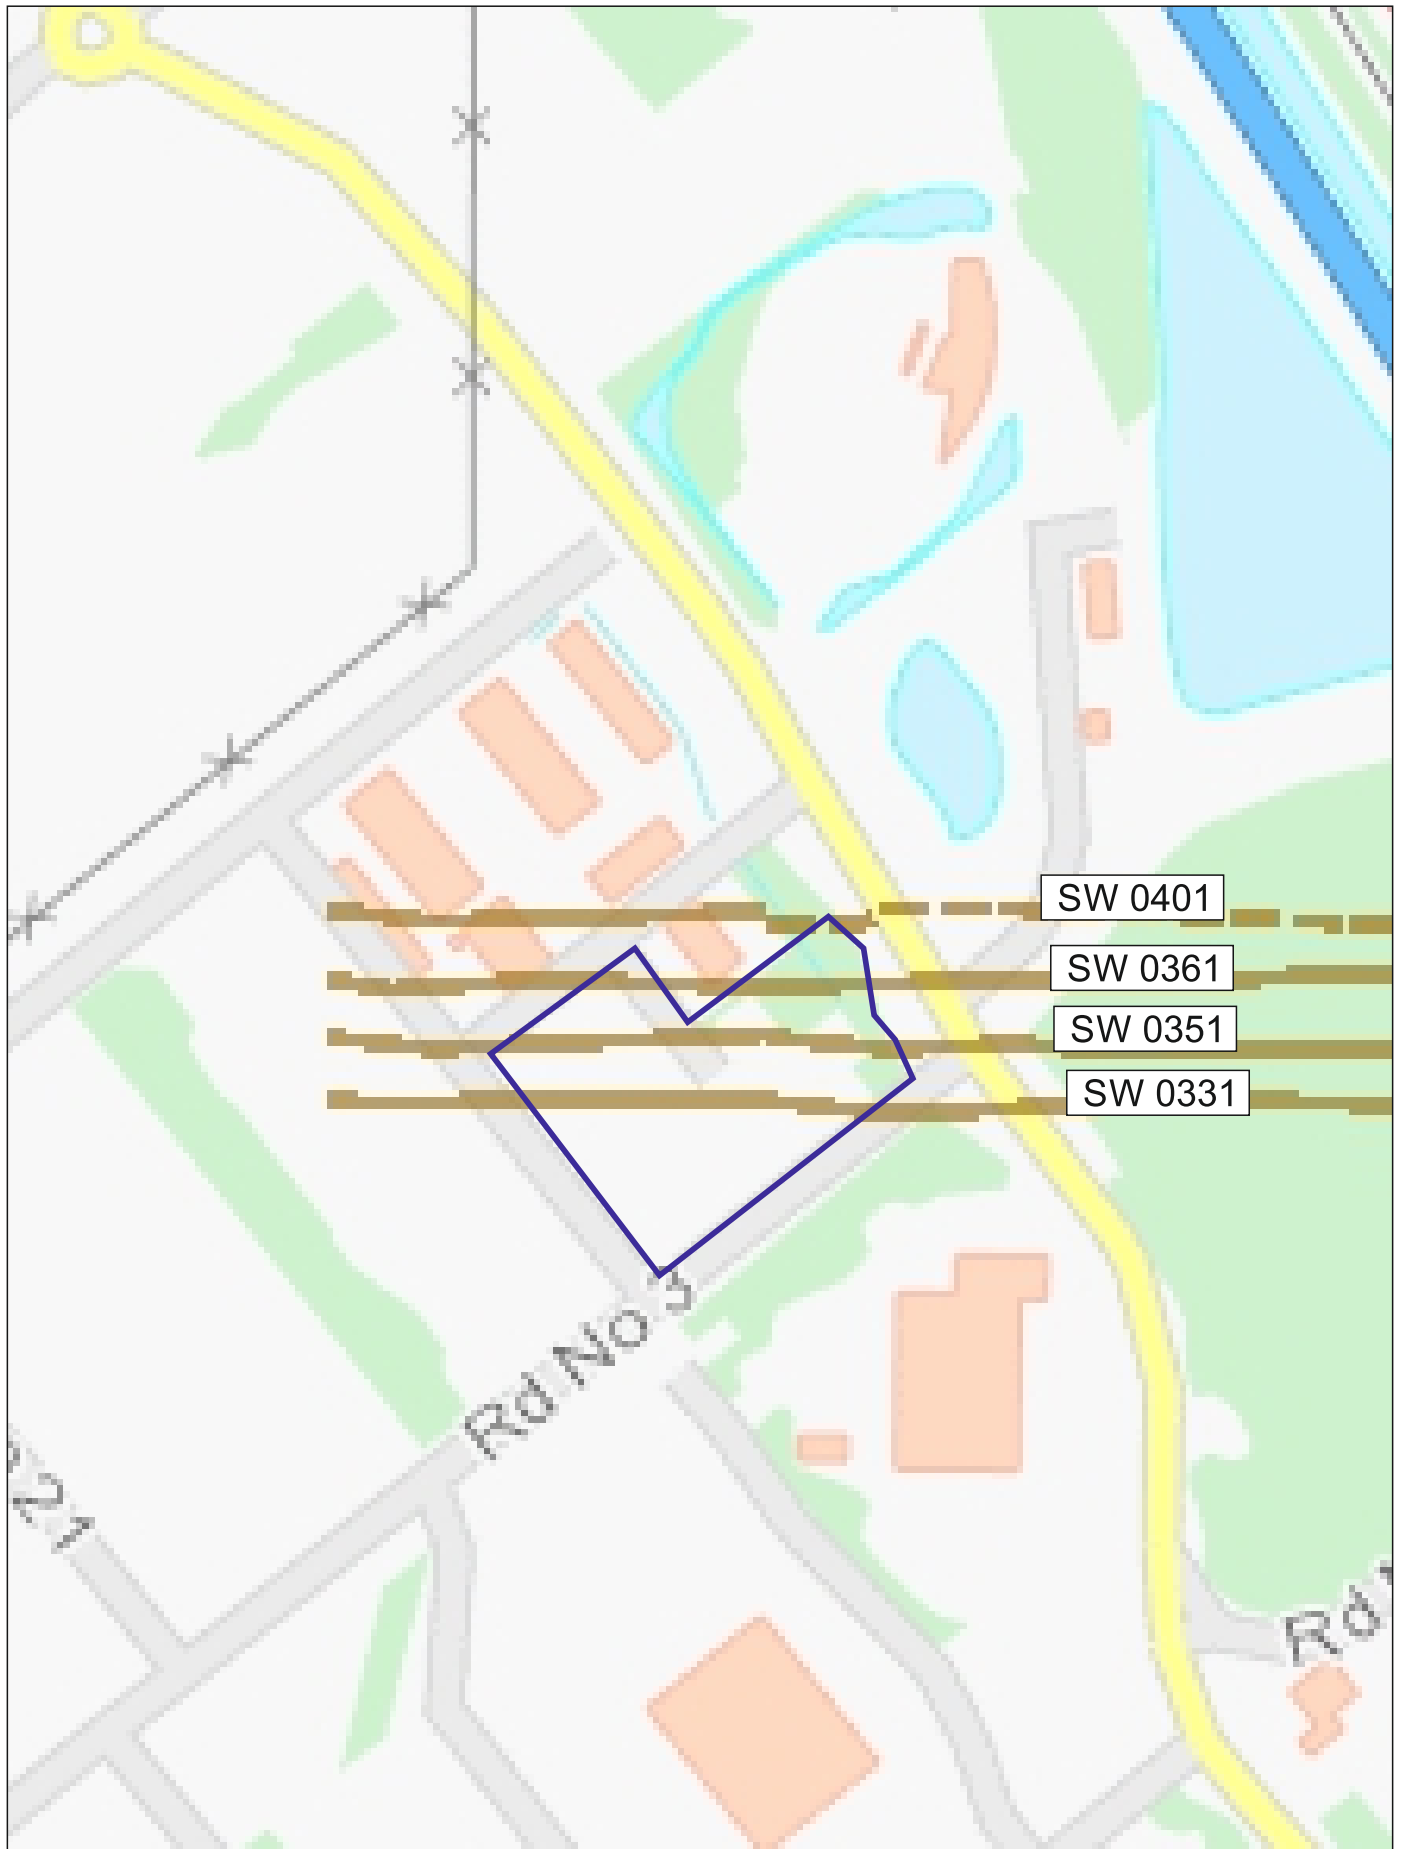
FIGURE 4

An extract from the Mining Data Window is reproduced as Figure 4 overleaf. For clarity only two sets of data are turned on in Figure 4- seam outcrops and mine entries. The brown lines are coal seam outcrops. Four outcrops run across or just north of the site. This would be the reason for the Development High Risk Area. The C.A. seam codes for these four seams have been inserted by the author. The seam north the site is SW0401 (Four Foot Seam in the C.A. Seam Directory). Going south across the site are SW0361 (Caerau), SW0351 (Red Vein) and SW0331 (Middle Nine Foot Top Leaf) furthest south. There will be no further comment on this seam nomenclature at this stage, as it is not central to this risk assessment. Dip directions are not shown on the data window. However, as the seam codes are in ascending order going north, it is safe to assume that the dip direction is to the north.

The red crosses are mine entries. There are none shown in Figure 4, but there are several approximately 500m east of the site, as seen in Figure 3. The data reveals these are Swan Colliery (two adits) and Baglan Hall and Park Collieries with four shafts between them. There will be further discussion of these in the next section.

C.A. INTERACTIVE VIEWER, DATA WINDOW. THE BROWN LINES ARE COAL SEAM OUTCROPS WITH THEIR C.A. CODES ADDED

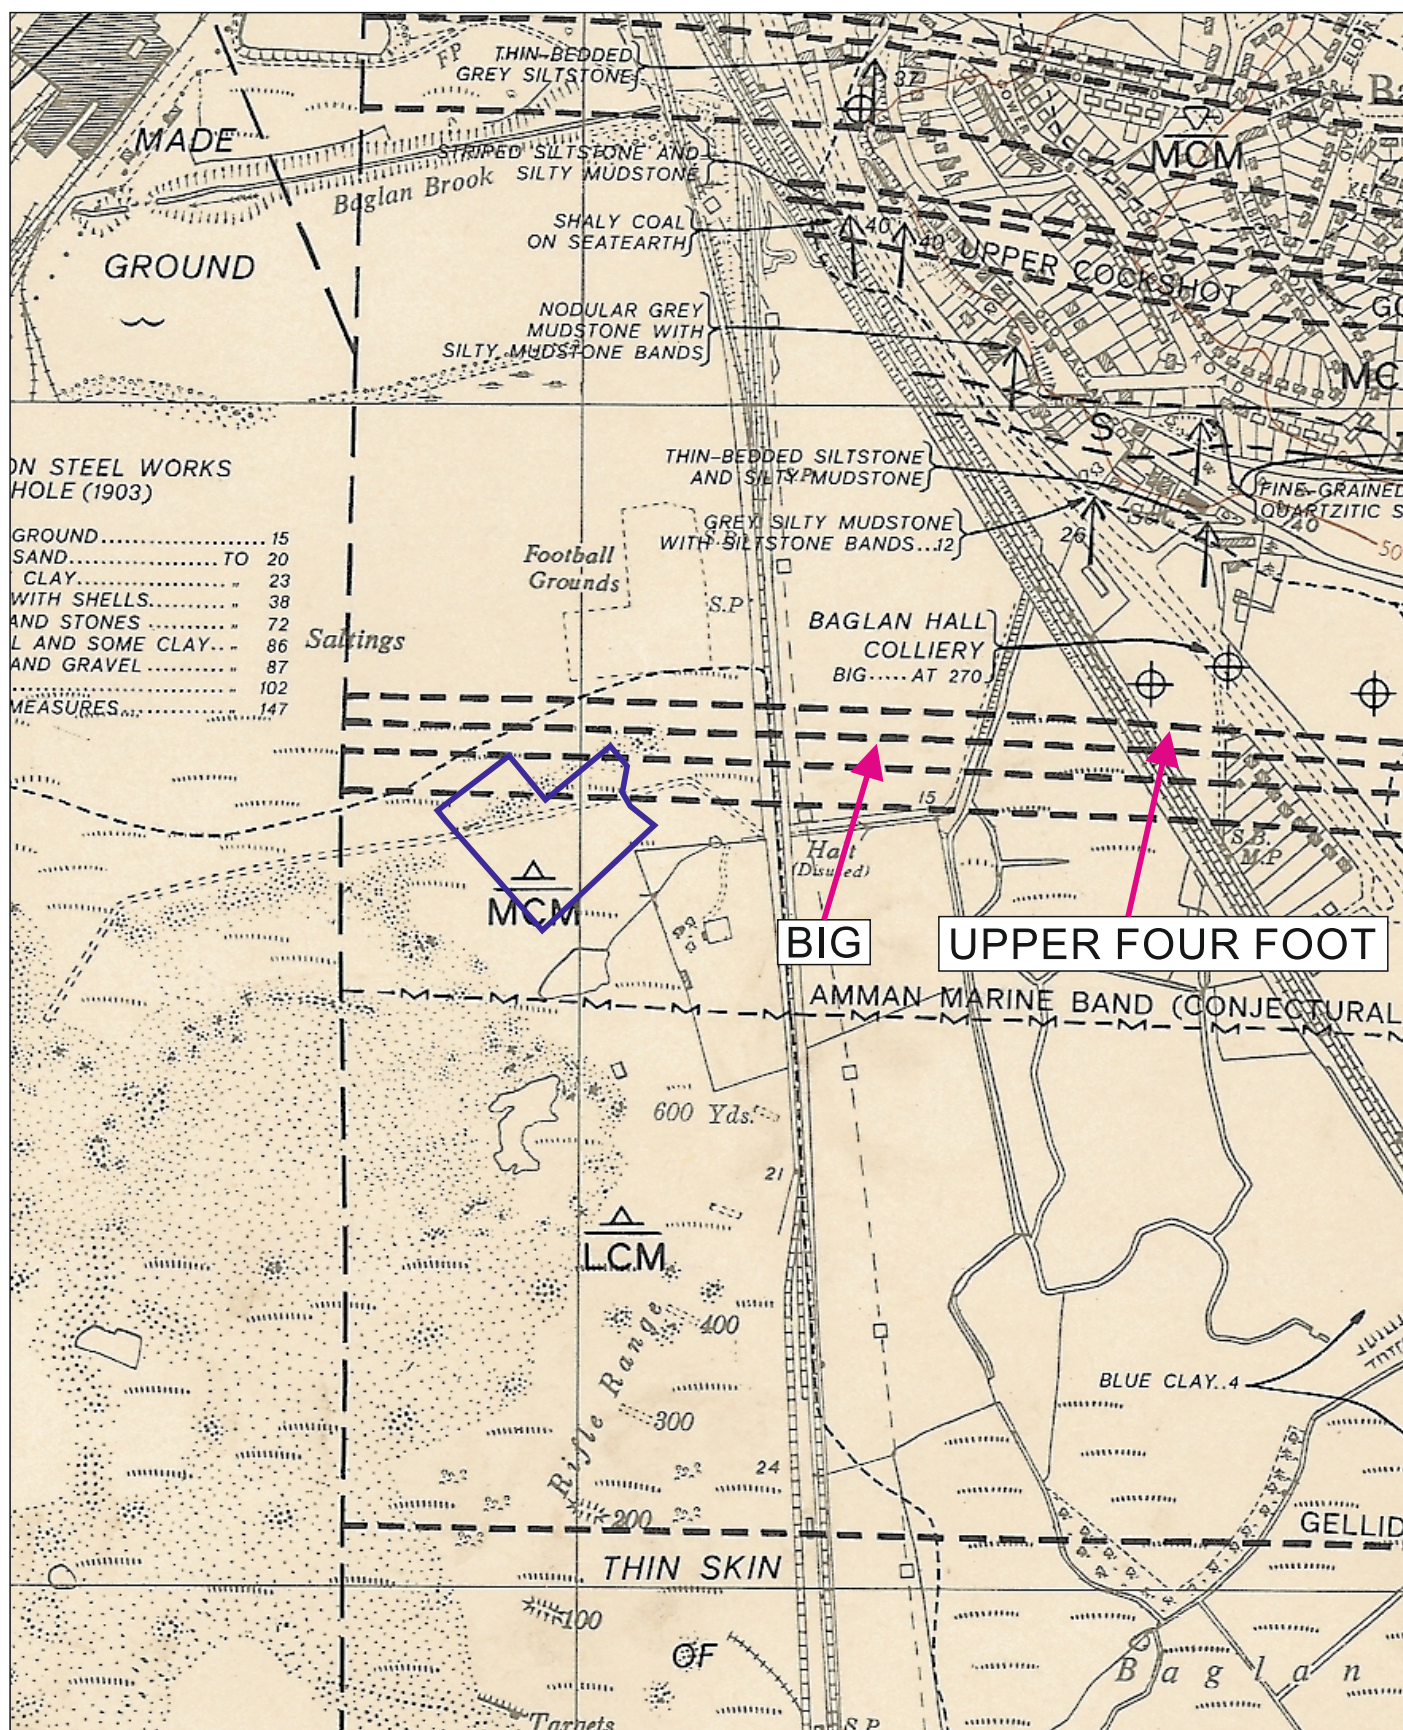
The Survey Sheet shows that the site is underlain by bedrock of the Middle Coal Measures, which are undifferentiated in South Wales. The Amman Marine Band marks the boundary with the Lower Coal Measures and the conjectural position of this is shown just south of the site. In South Wales the Middle and Lower Coal Measures are predominantly argillaceous with closely spaced coal seams, many of which were economically important in the past. The absence of these seams south of the site all the way to the outcrop of the Gellideg Seam is significant. The map shows the strata dips at between 26° and 40° to the north. The dips are all north of the shafts of Baglan Hall Colliery and would have been measured underground because of the lack of bedrock outcrops. Four seam outcrops are shown in Figure 5 in a similar arrangement to Figure 4. The reason for their truncation can be seen to be the Giants Grave Fault. The outcrops are marked further north than in Figure 4. The site footprint has been accurately positioned using georeferencing, as will be seen in the following section. Two of the seams are labelled as the Upper Four Feet and the Big, neither of which underlie the site. In Figure 6 it can be seen that the Big Seam is given a thickness of 7' (2.15m). This is very thick for South Wales, hence the name. This can be contrasted with the thicknesses of the Finery, Golden and Golden Rider, all of which were worked to the north of the site. The Upper Four feet and the two unnamed seams below the Big, which do cross the site, are unlabelled and are not assigned a thickness. This would imply they are less than 12" (300mm) thick and thus unworkable.

FIGURE 5
EXTRACT OF GEOLOGICAL SURVEY SHEET SS 79SW.
THE SITE IS HIGHLIGHTED IN BLUE.

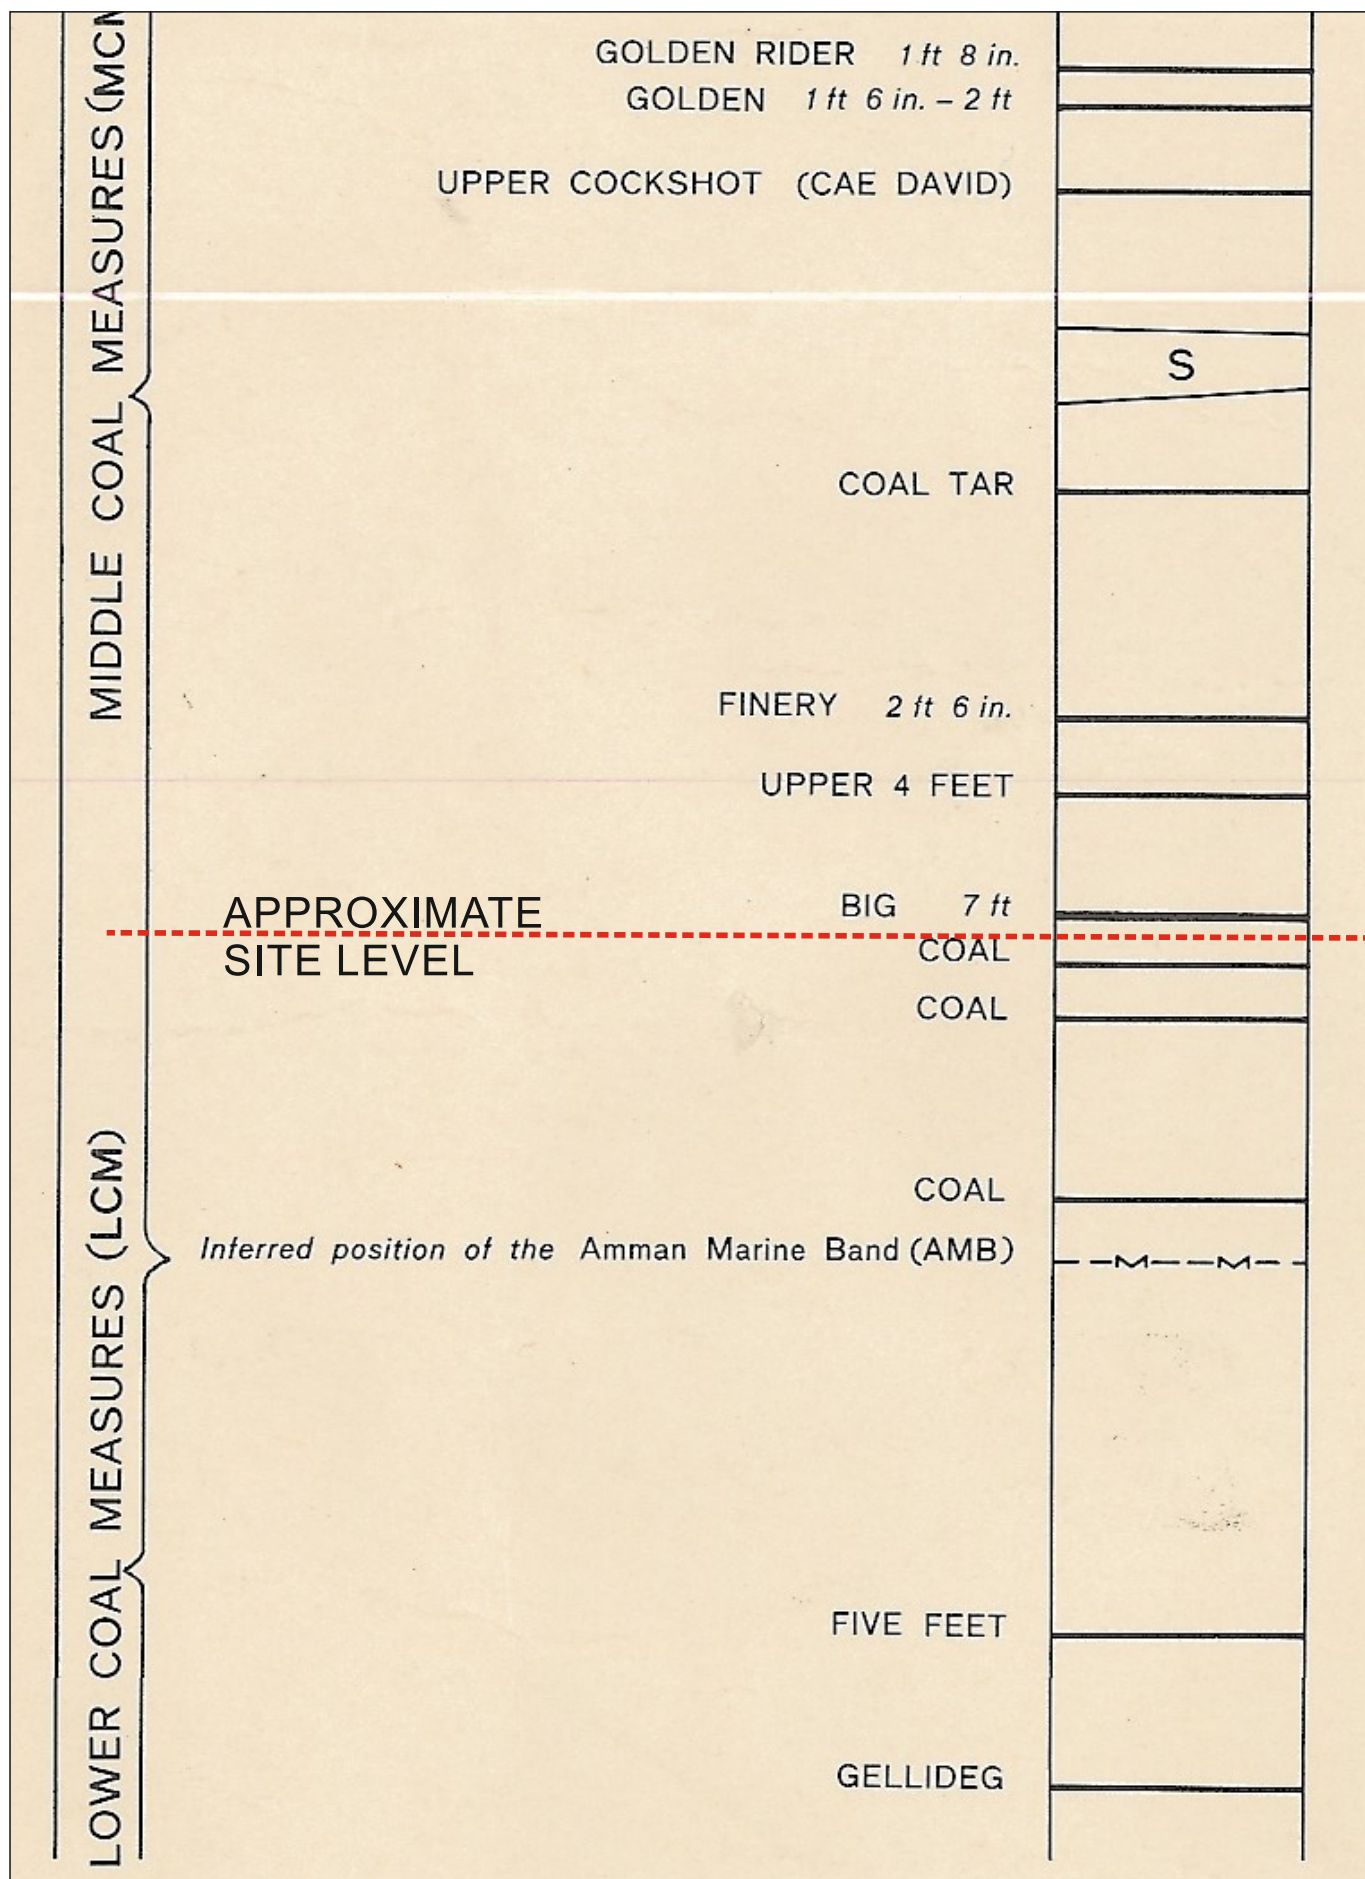
FIGURE 6
SECTION OF THE STRATIGRAPHIC COLUMN FROM SS 79SW.
THE APPROXIMATE SITE LEVEL IS SHOWN

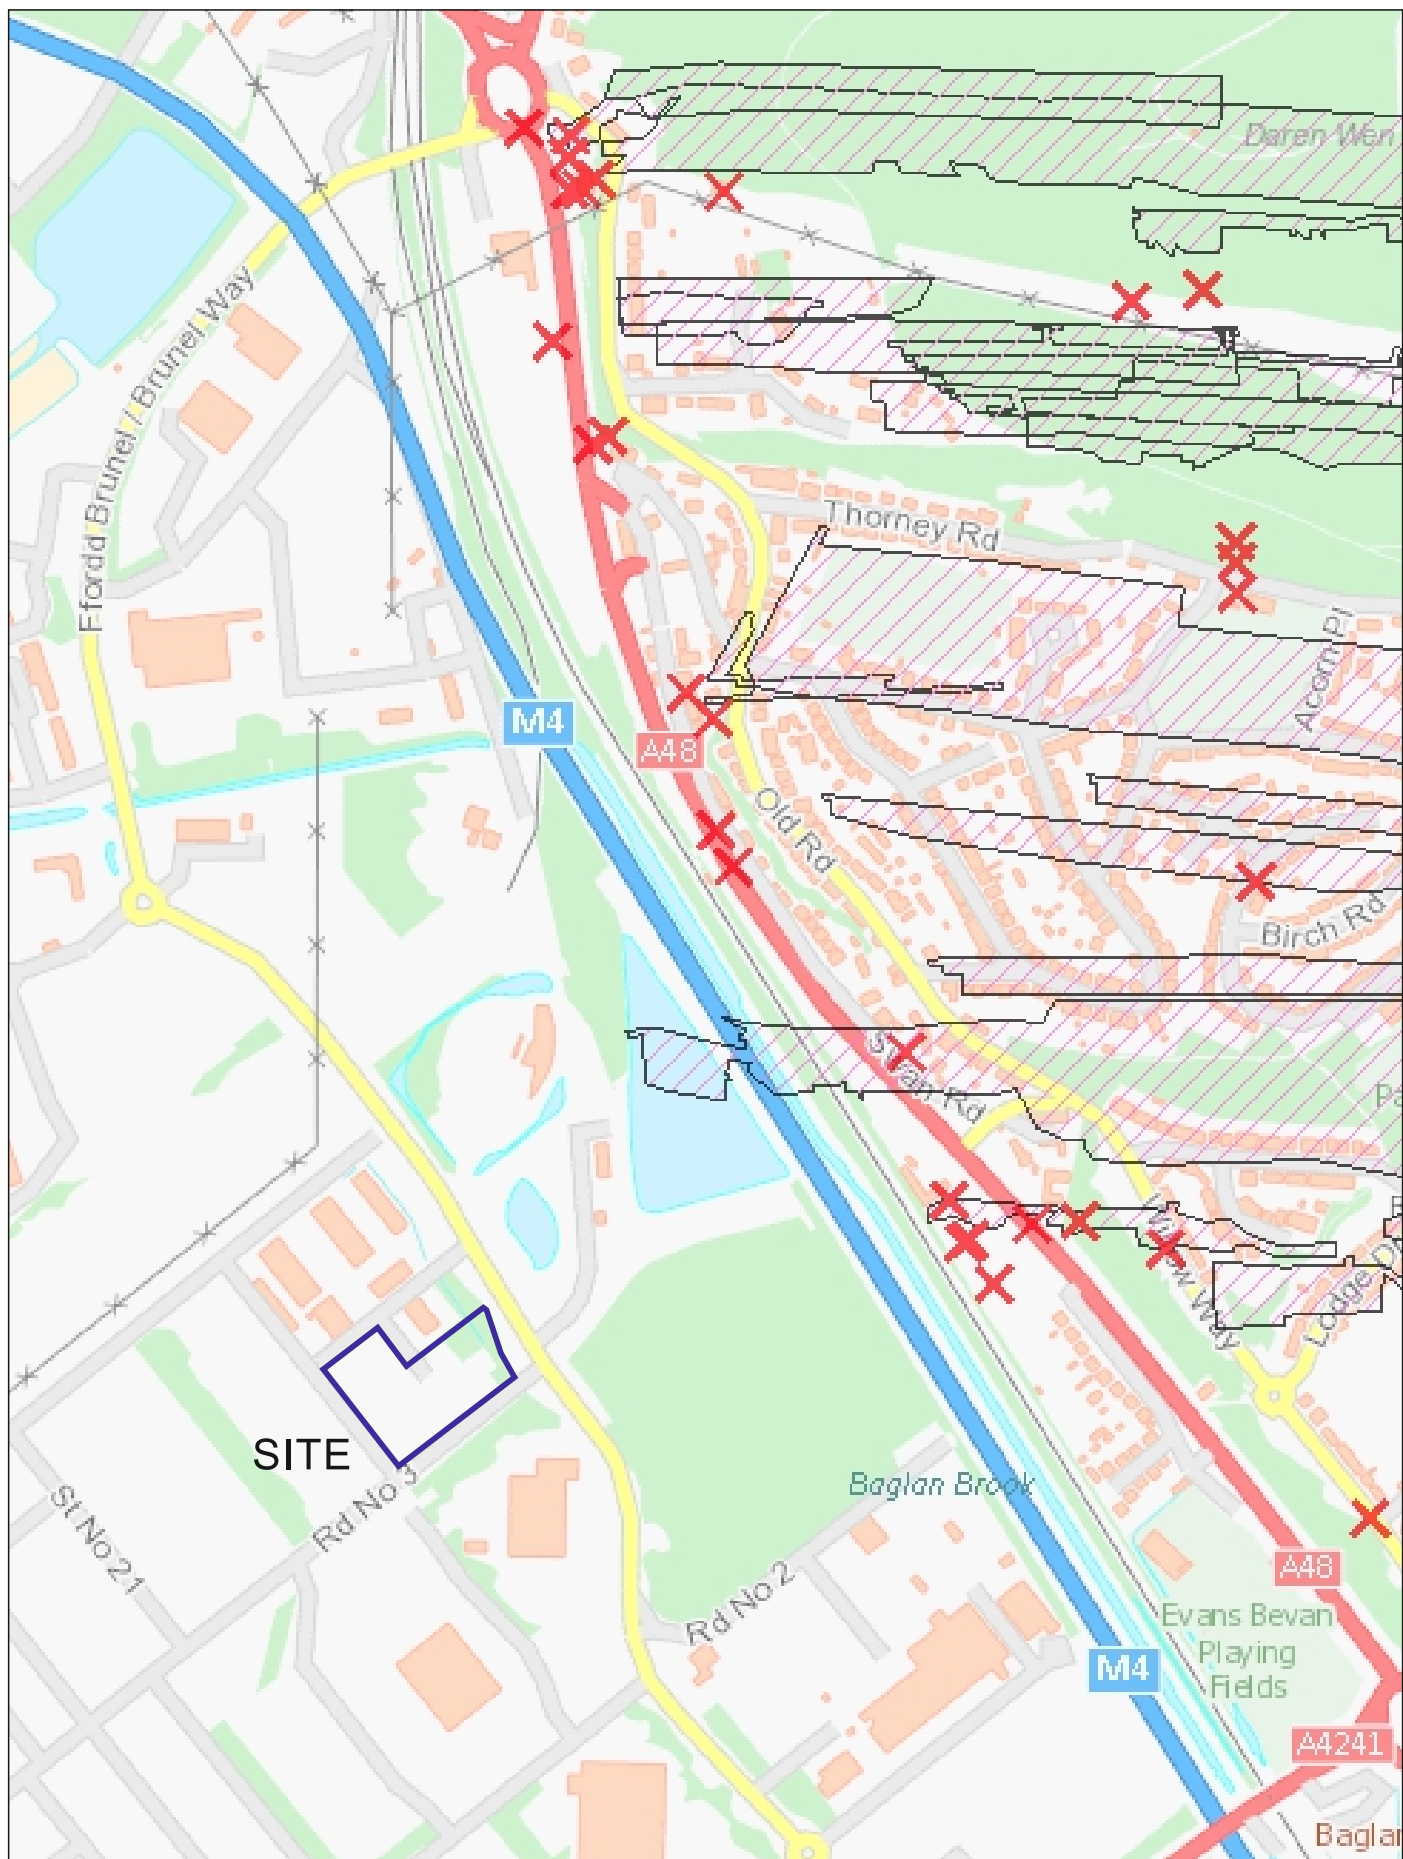
Mining archive material reveals that Swan and Park Collieries were components of Baglan Hall Colliery and the names Park and Baglan Hall are interchangeable in the records. Although under the same ownership, Swan Colliery is more distinct as it comprised of several adits working seams further up the stratigraphic succession. Because of this it is of little relevance to this assessment. Baglan/Park Colliery worked the Finery Seam and the Big Seam. These were recorded at 210' (64m) and 276' (84m) respectively in the upcast shaft. The Memoirs record the workings extended north, down a 45° dip for a distance of 16 Chains (322m). The steep dip would have encouraged "ladderback" working. Long main roadways extend laterally at a few degrees off strike, with short down dip connections. This pattern is evident in Figure 7. This is taken from the Interactive Viewer and shows recorded underground workings. Baglan Hall colliery had a chequered financial history with frequent insolvencies, finally closing in 1889. It can be speculated that haulage and drainage problems would certainly contributed to the costs of mining there. The Memoirs thus confirm the information in the CON29 and in Figure 7 that there are no recorded workings under the site.

FIGURE 7
THE DISTINCTIVE PATTERN OF UNDERGROUND WORKINGS AND
MINE ENTRIES EAST OF THE SITE SHOWN ON THE C.A. VIEWER

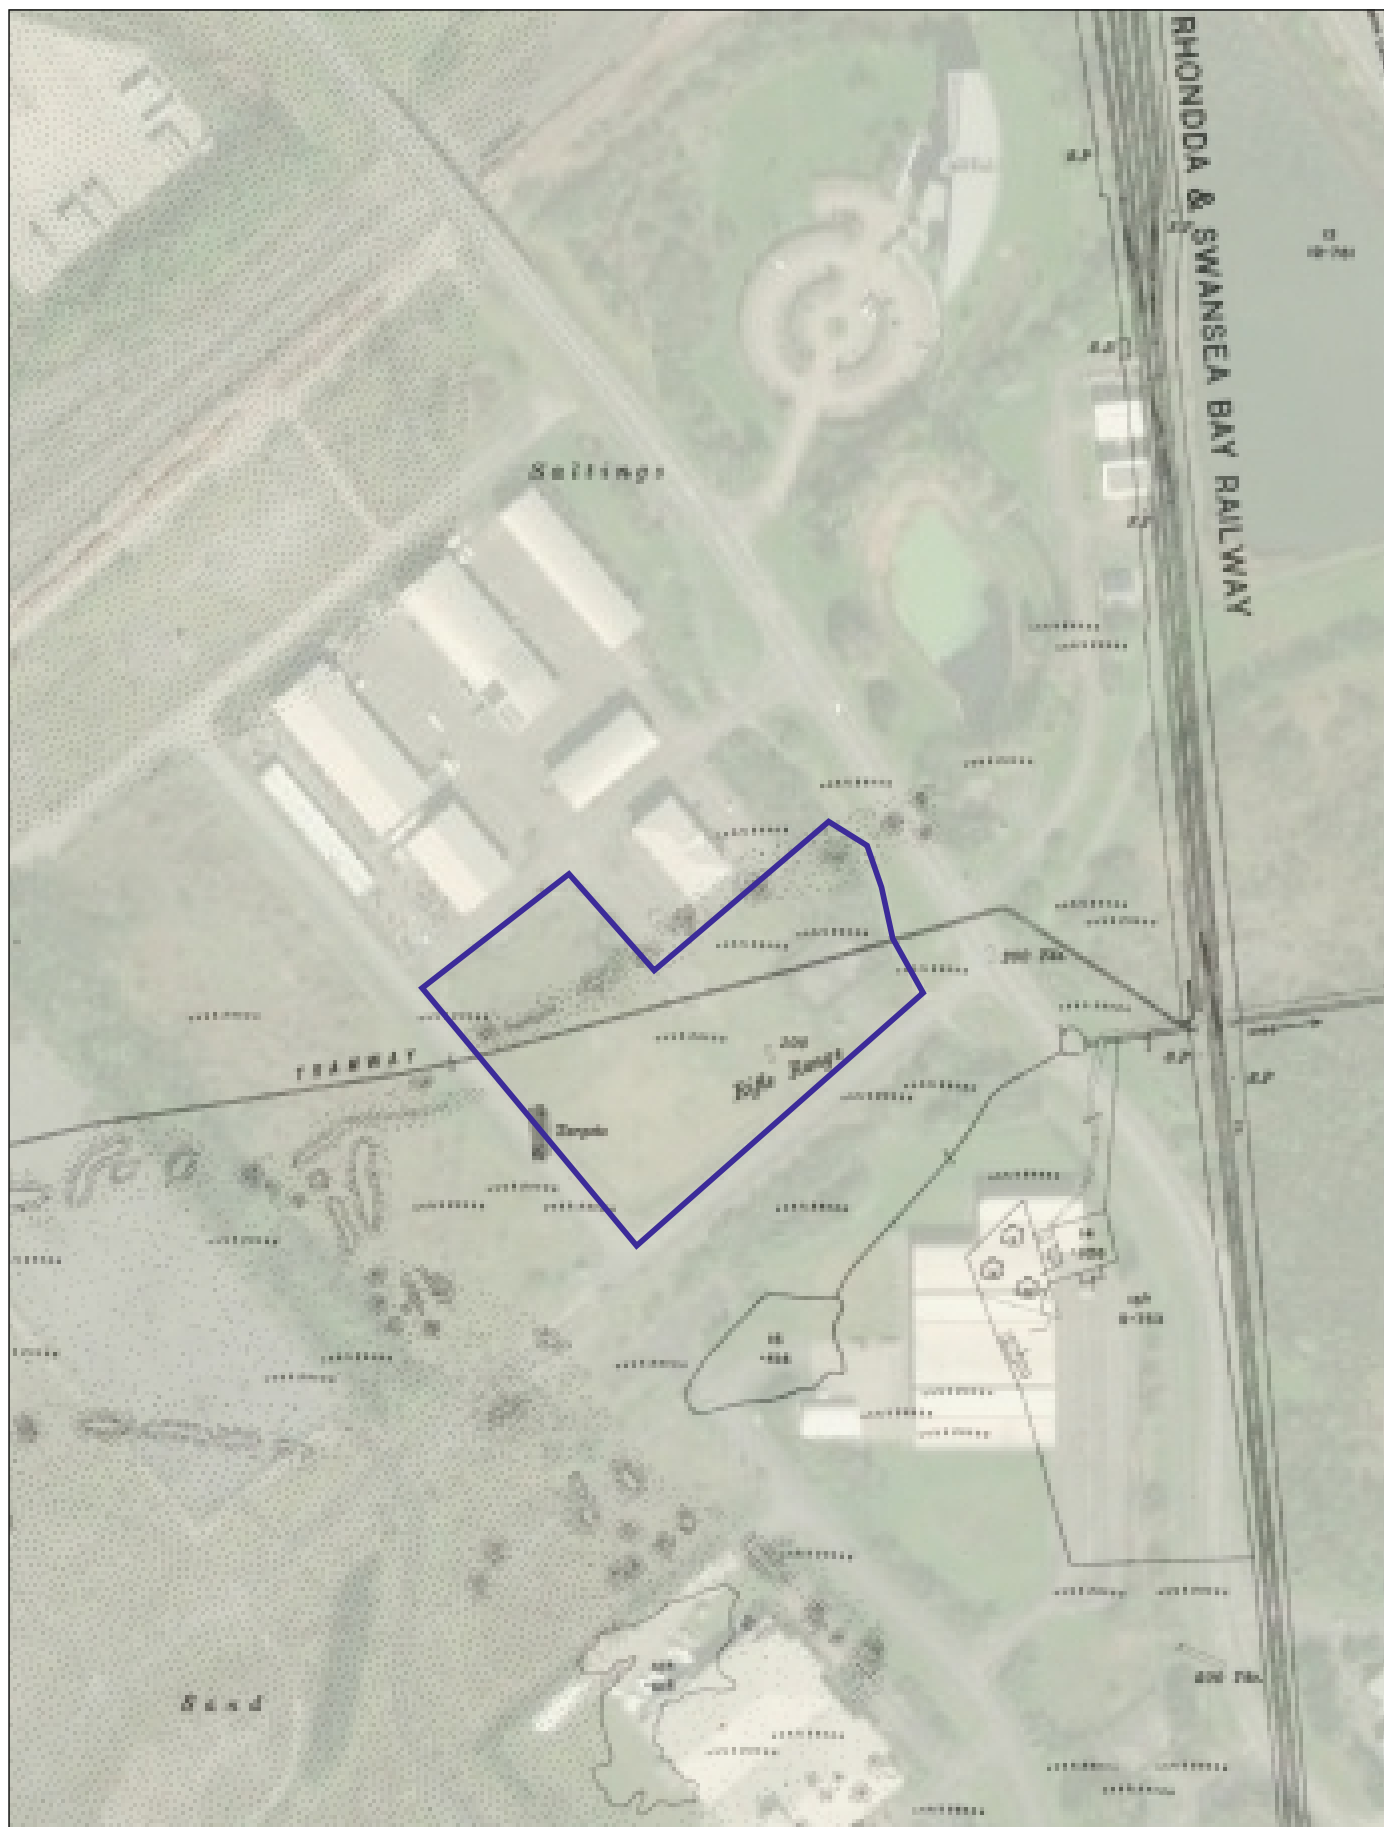
In order to position the site accurately on the older O.S. maps, and the Geological Survey map, georeferencing was used. This can be seen in Figure 9 where the outline of the site can be accurately delineated on an aerial photo and fixed on the 1914 1:2500 map. This was the earliest map available for georeferencing. This technique was also used to position the site boundary accurately on the Geological Survey Sheet. The base O.S. map for the Survey Sheet is the 1962 O.S. revision, which apart from boundary changes, is the same as the map in Figure 8. The point here is that great confidence can be placed in the positioning of the site in Figure 5.

FIGURE 9
THE 1914 1:2500 O.S. MAP GEOREFERENCED
ON AN AERIAL PHOTOGRAPH OF THE SITE
