# Restoring the underwater habitat at SEA Restaurant: Phase 1

February 2017

Phase I of the restoration of the undersea habitat surrounding SEA restaurant at Anantara Kihavah, Baa Atoll, Maldives was completed during February 2017 by Coral Reef CPR. The project included:

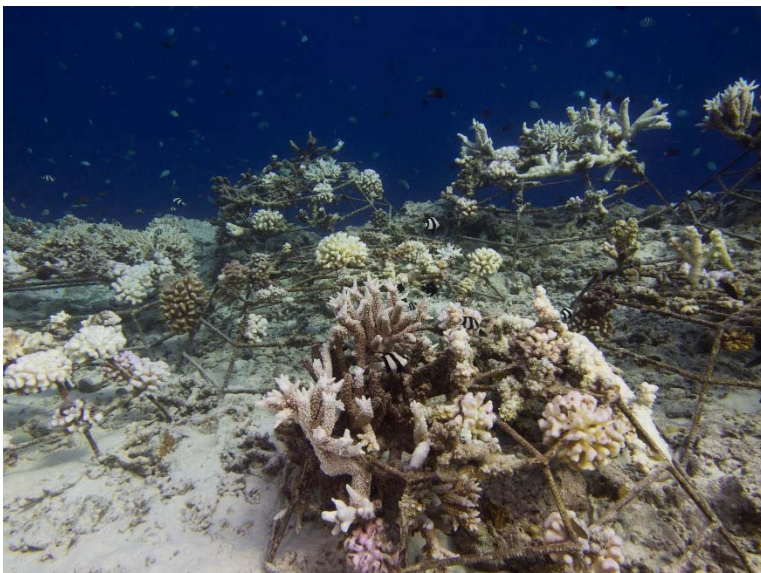
**Fig. 3. The corals that were attached to the rebar frames became severely bleached in April 2016 (right) and died during May.**

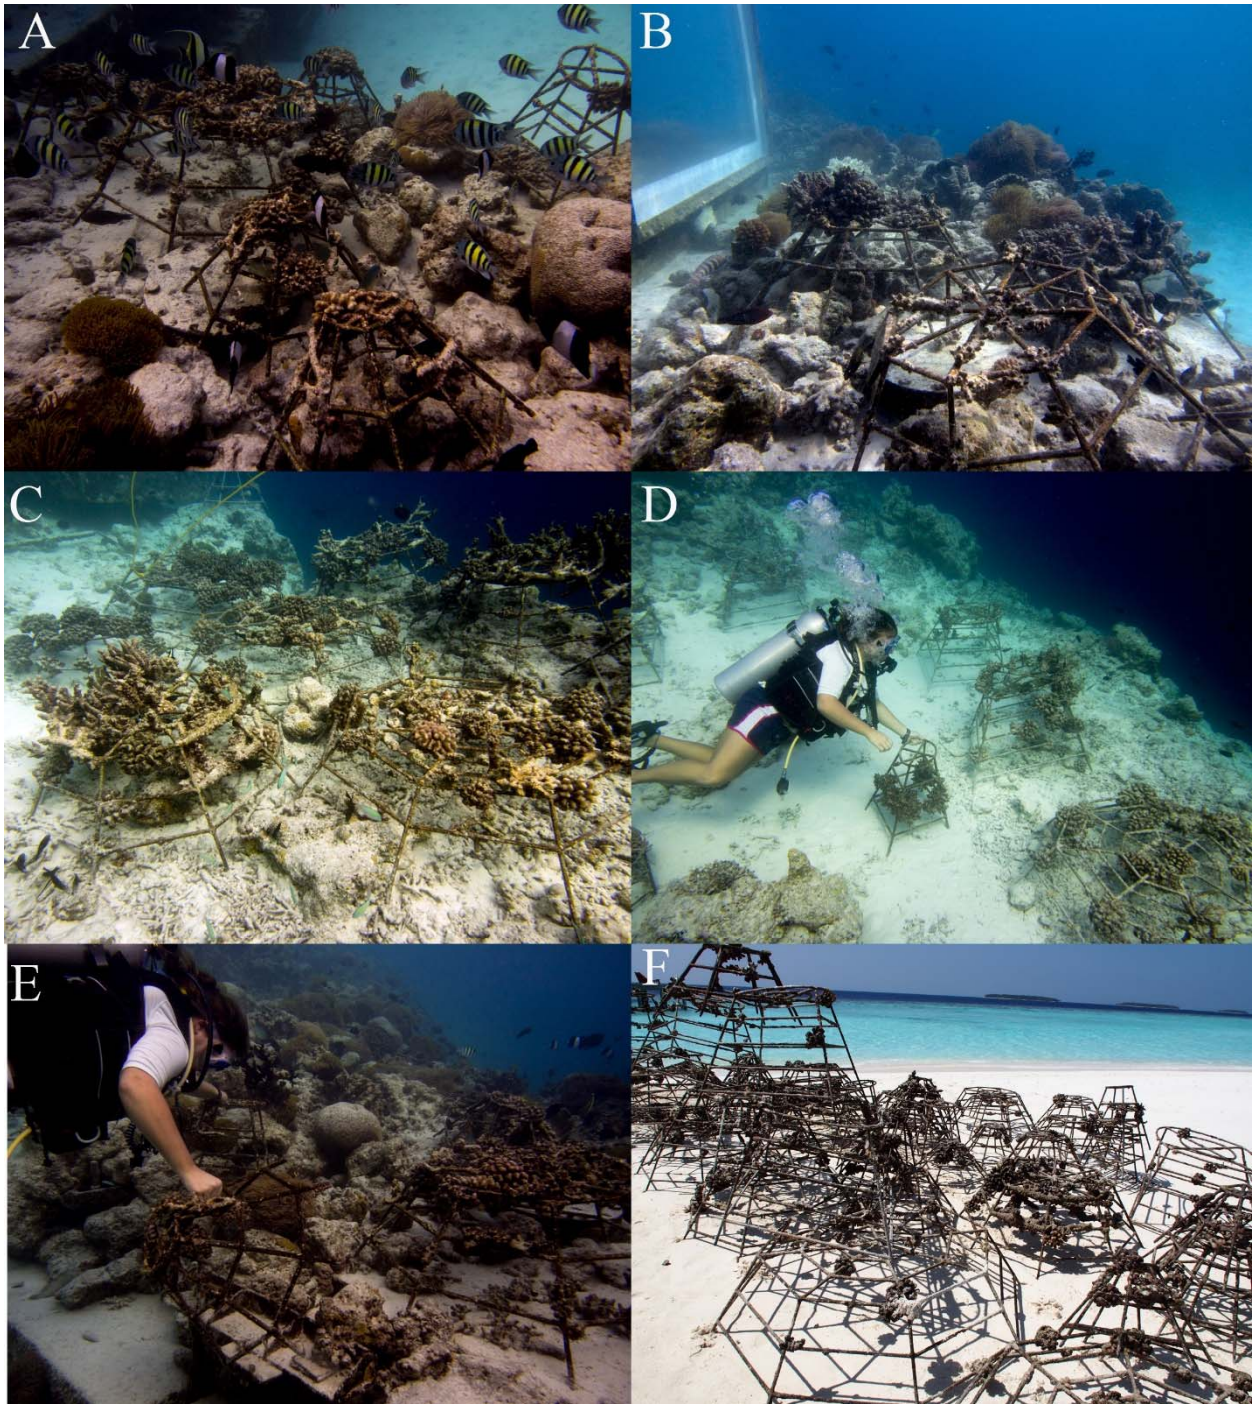
The platform in front of the main windows, reef slope and reef crest on either side of the restaurant, and the reef terrace adjacent to the drop-off on the left and right side of the restaurant had 107 metal frames of various sizes and shapes that were deployed between 2013 - 2016. Small coral branches were attached to the frames in attempt to create artificial reef habitat. During the mass bleaching in April/May 2016, 98% of the corals on these frames died, including all of the branching *Acropora* spp., *Porites*, *Echinopora*, *Pavona*, and faviid corals, and the majority of the *Pocillopora* colonies. The frames were colonized by turf algae, cyanobacteria and tunicates and these had overgrown the dead coral skeletons. Exposed metal surfaces were heavily rusted and the frames were starting to collapse.

**Fig. 4. Metal rebar “adopt a coral” frames at SEA restaurant. A-B. Frames with dead coral skeletons on the platform adjacent to the windows. C. Frames on the reef terrace, near the drop-off. D-E. Removing the frames from the habitat surrounding SEA. F. Frames on the beach at Kihavah before disposal.**

All of the skeletons and the few living corals were first removed from the frames. An attempt was made to lift these from the water onto a small boat, but strong currents made this impractical and dangerous. Subsequently the frames were transported by two divers from SEA to the shallow lagoon, and then the beach, and then disposed of by engineering.

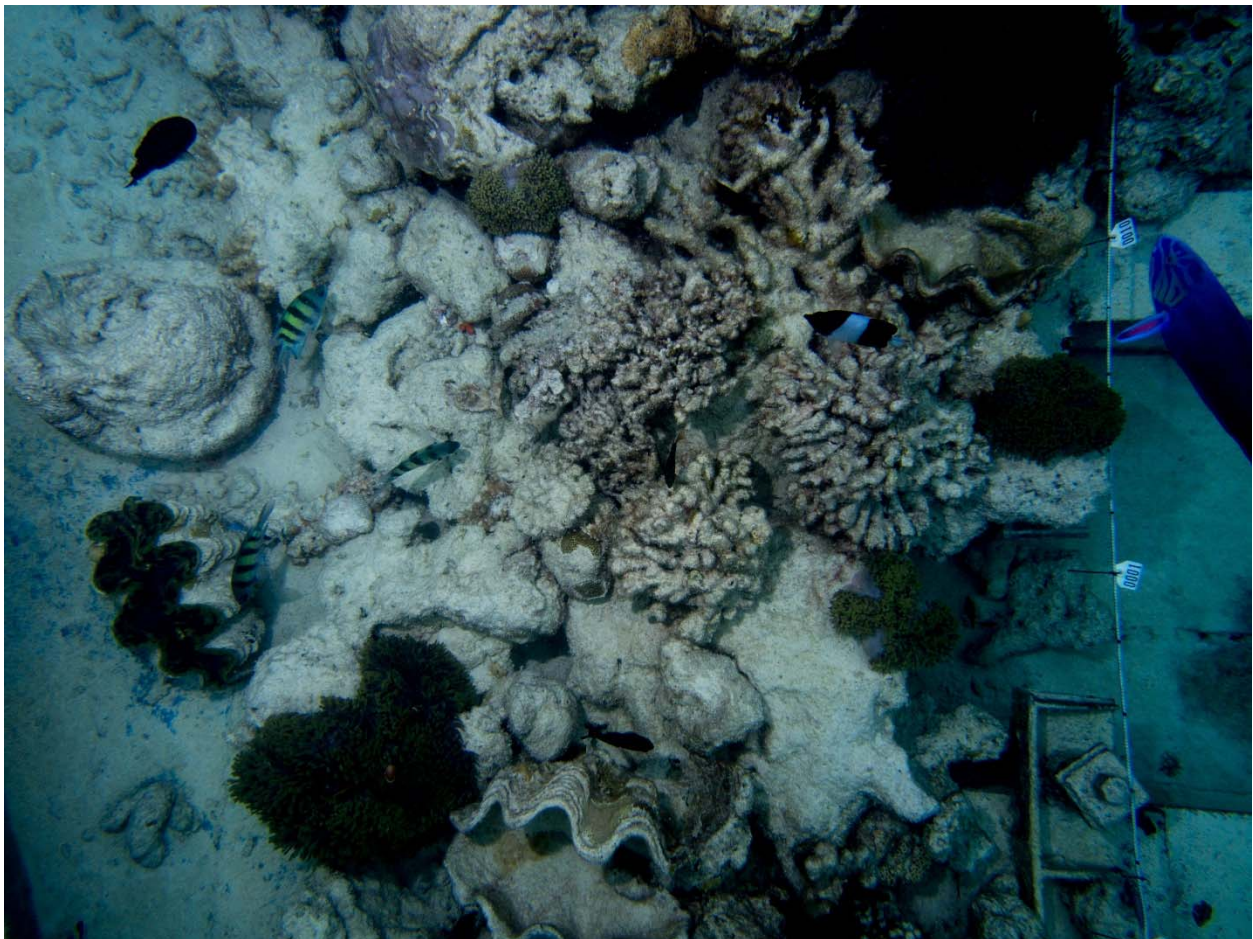
Many of the larger colonies of coral and giant clams placed directly in front of the windows had died, and the skeletons were covered in algae and sediment. These were removed and used to fill in holes further away from the windows, with the intent of creating a natural reef substrate that would allow placement of living corals and other invertebrates. Some of the larger giant clam shells were also used in creation of the reef framework, providing refuge for moray eels, crabs, lobsters or other more secretive animals. Much of the dead coral rubble was also moved away from the windows and placed on other parts of the cement platform (out of direct view from inside the restaurant) that was formerly uncolonized as this would provide three-dimensional structure and increase the extent of high relief habitat that could support motile invertebrates and fish. Prior to the current restoration, much of the platform lacked any organisms and was a flat low-relief substrate with an absence of life.

**Fig. 5. Much of the cement platform near the windows was covered with dead giant clams and dead branching and boulder coral skeletons (above). These were removed to allow placement of living organisms.**

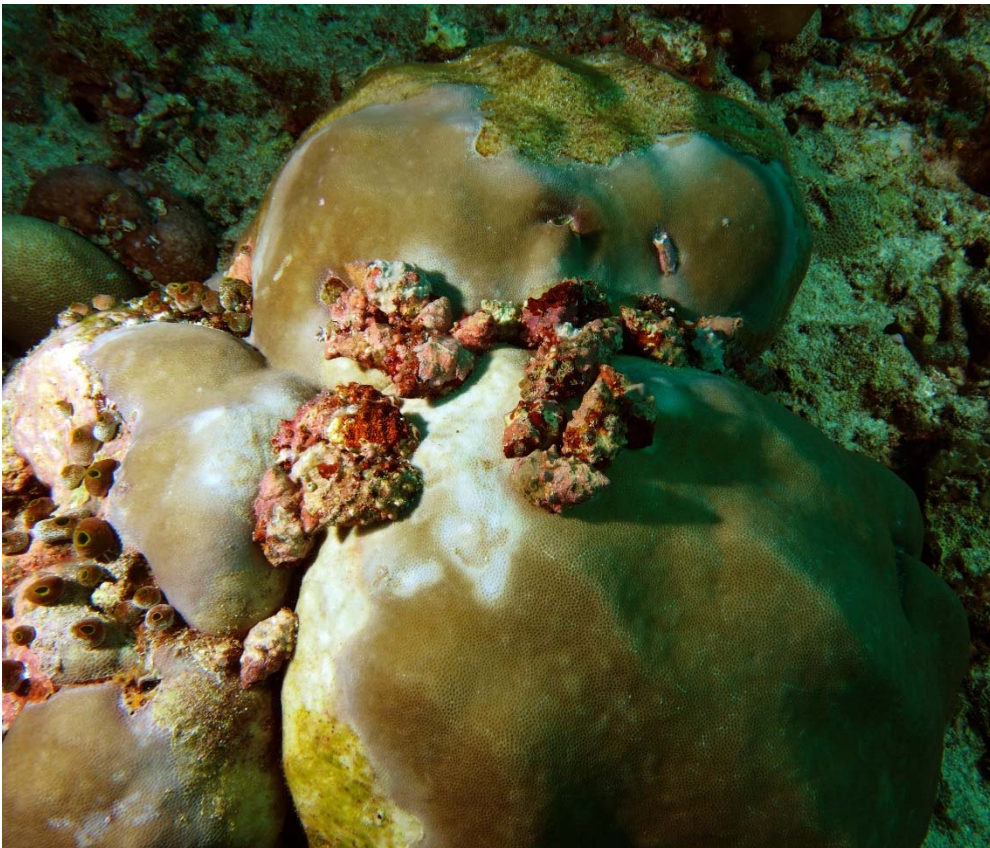
*Drupella* tend to feed on branching corals, concentrating within tightly branching species at the base of the colony and progressively eating their way up the branches. Many of the infested colonies identified in Kihavah were missing most of their tissue at the bases of the branches and only the branch tips were surviving. *Drupella* were also observed on boulder corals such as *Porites*, presumably because their preferred food has become rare since the bleaching event.

**Fig. 6. A colony of boulder coral (*Porites lobata*) that is infested with *Drupella* snails.**

Each coral that was brought into the site was carefully searched for *Drupella* and all snails were removed. On the last day a thorough removal effort was undertaken to eliminate any remaining snails that had been missed. In total, 574 snails were removed from affected corals.

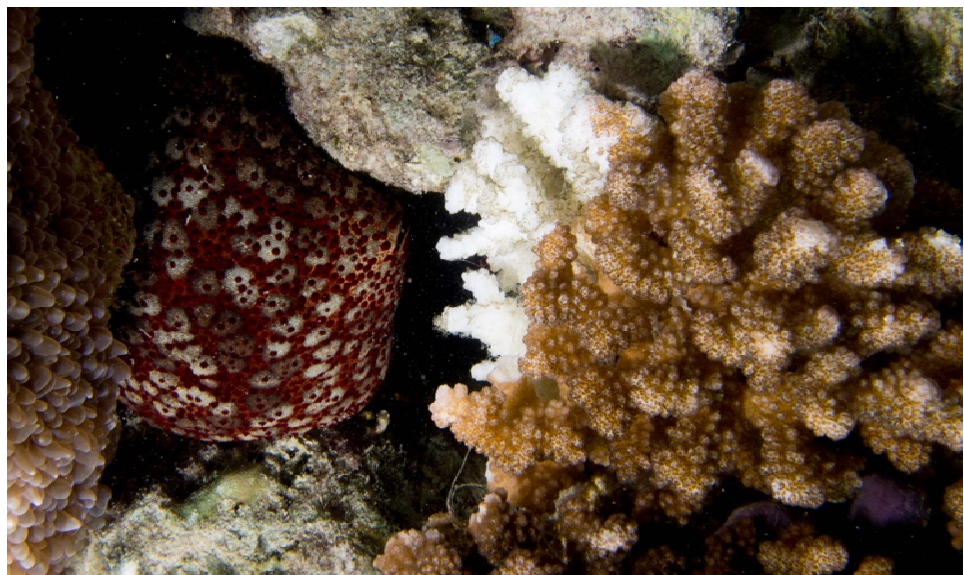
*Culcita* was found to be a serious pest during the restoration project, as numerous individuals moved onto the platform and were seen eating a number of the corals brought into the site. All cushion stars in the area immediately surrounding SEA were removed at the beginning of the project, with additional animals removed as they migrated onto the platform. During the last week of the restoration, a larger area was searched for *Culcita*. In total 87 *Culcita* were removed from the surrounding area.

**Fig. 8. A cushion star on the cement ledge at SEA. The starfish has eaten a portion of the cauliflower coral that was transplanted onto the site.**

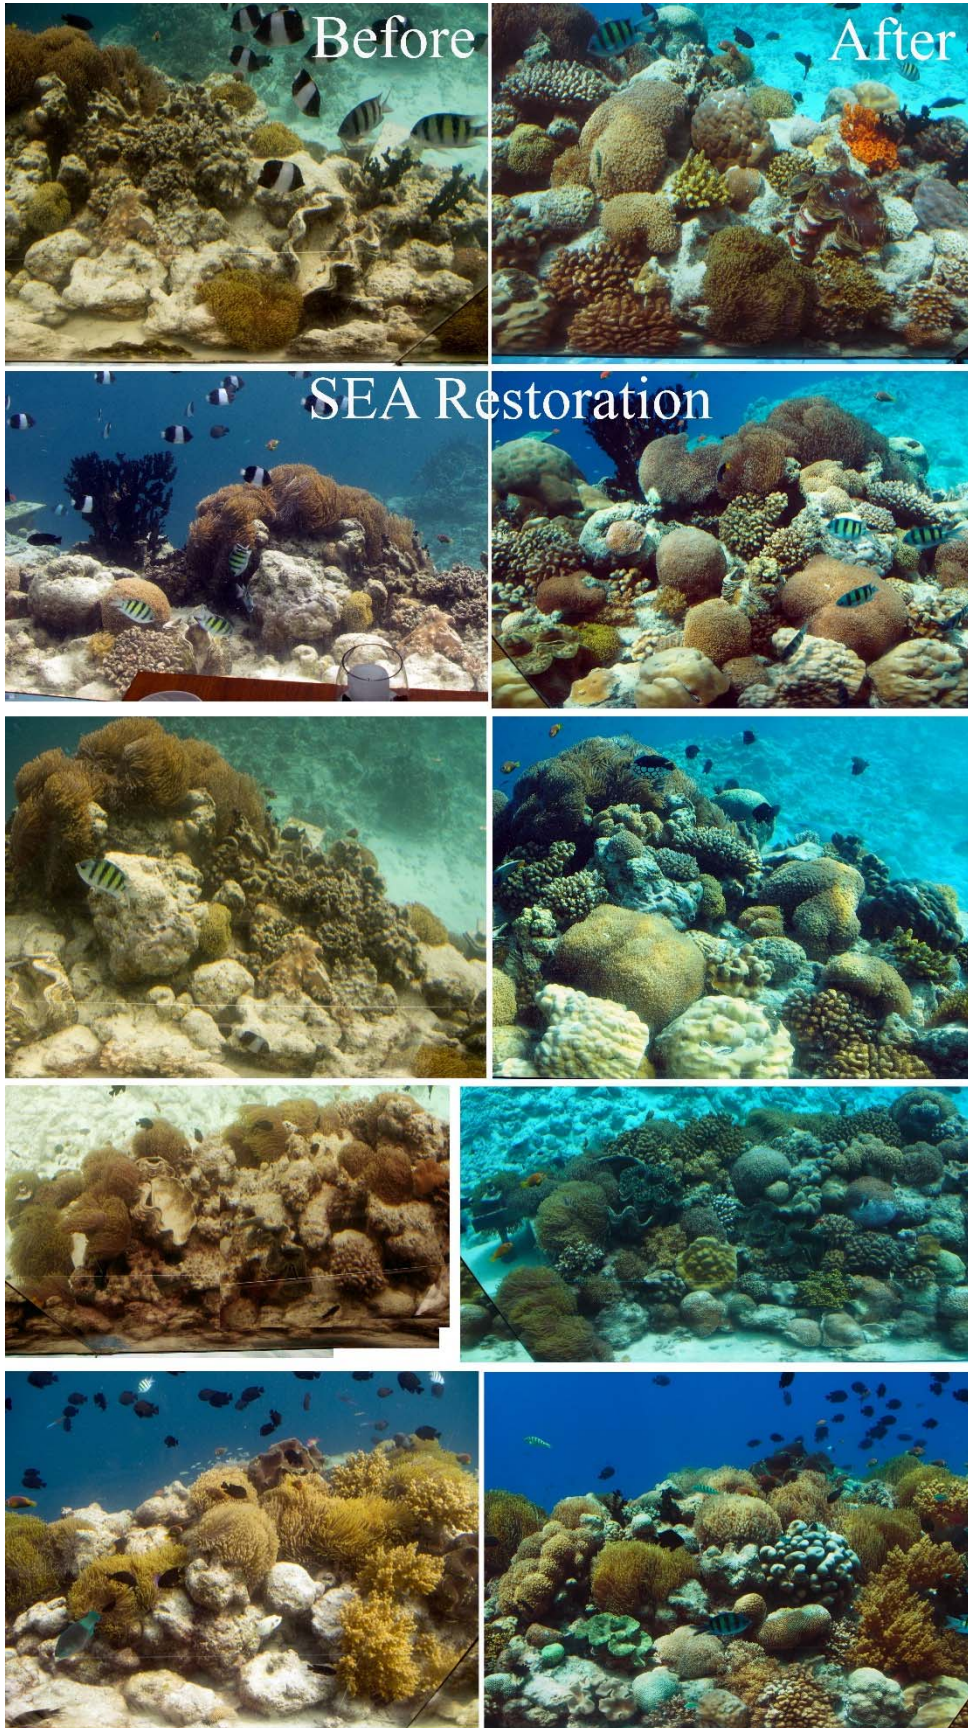
**Fig. 15.** A series of images showing the exact same location before (left) and after (right) the restoration. All of the images were taken from inside SEA, looking through the glass.
