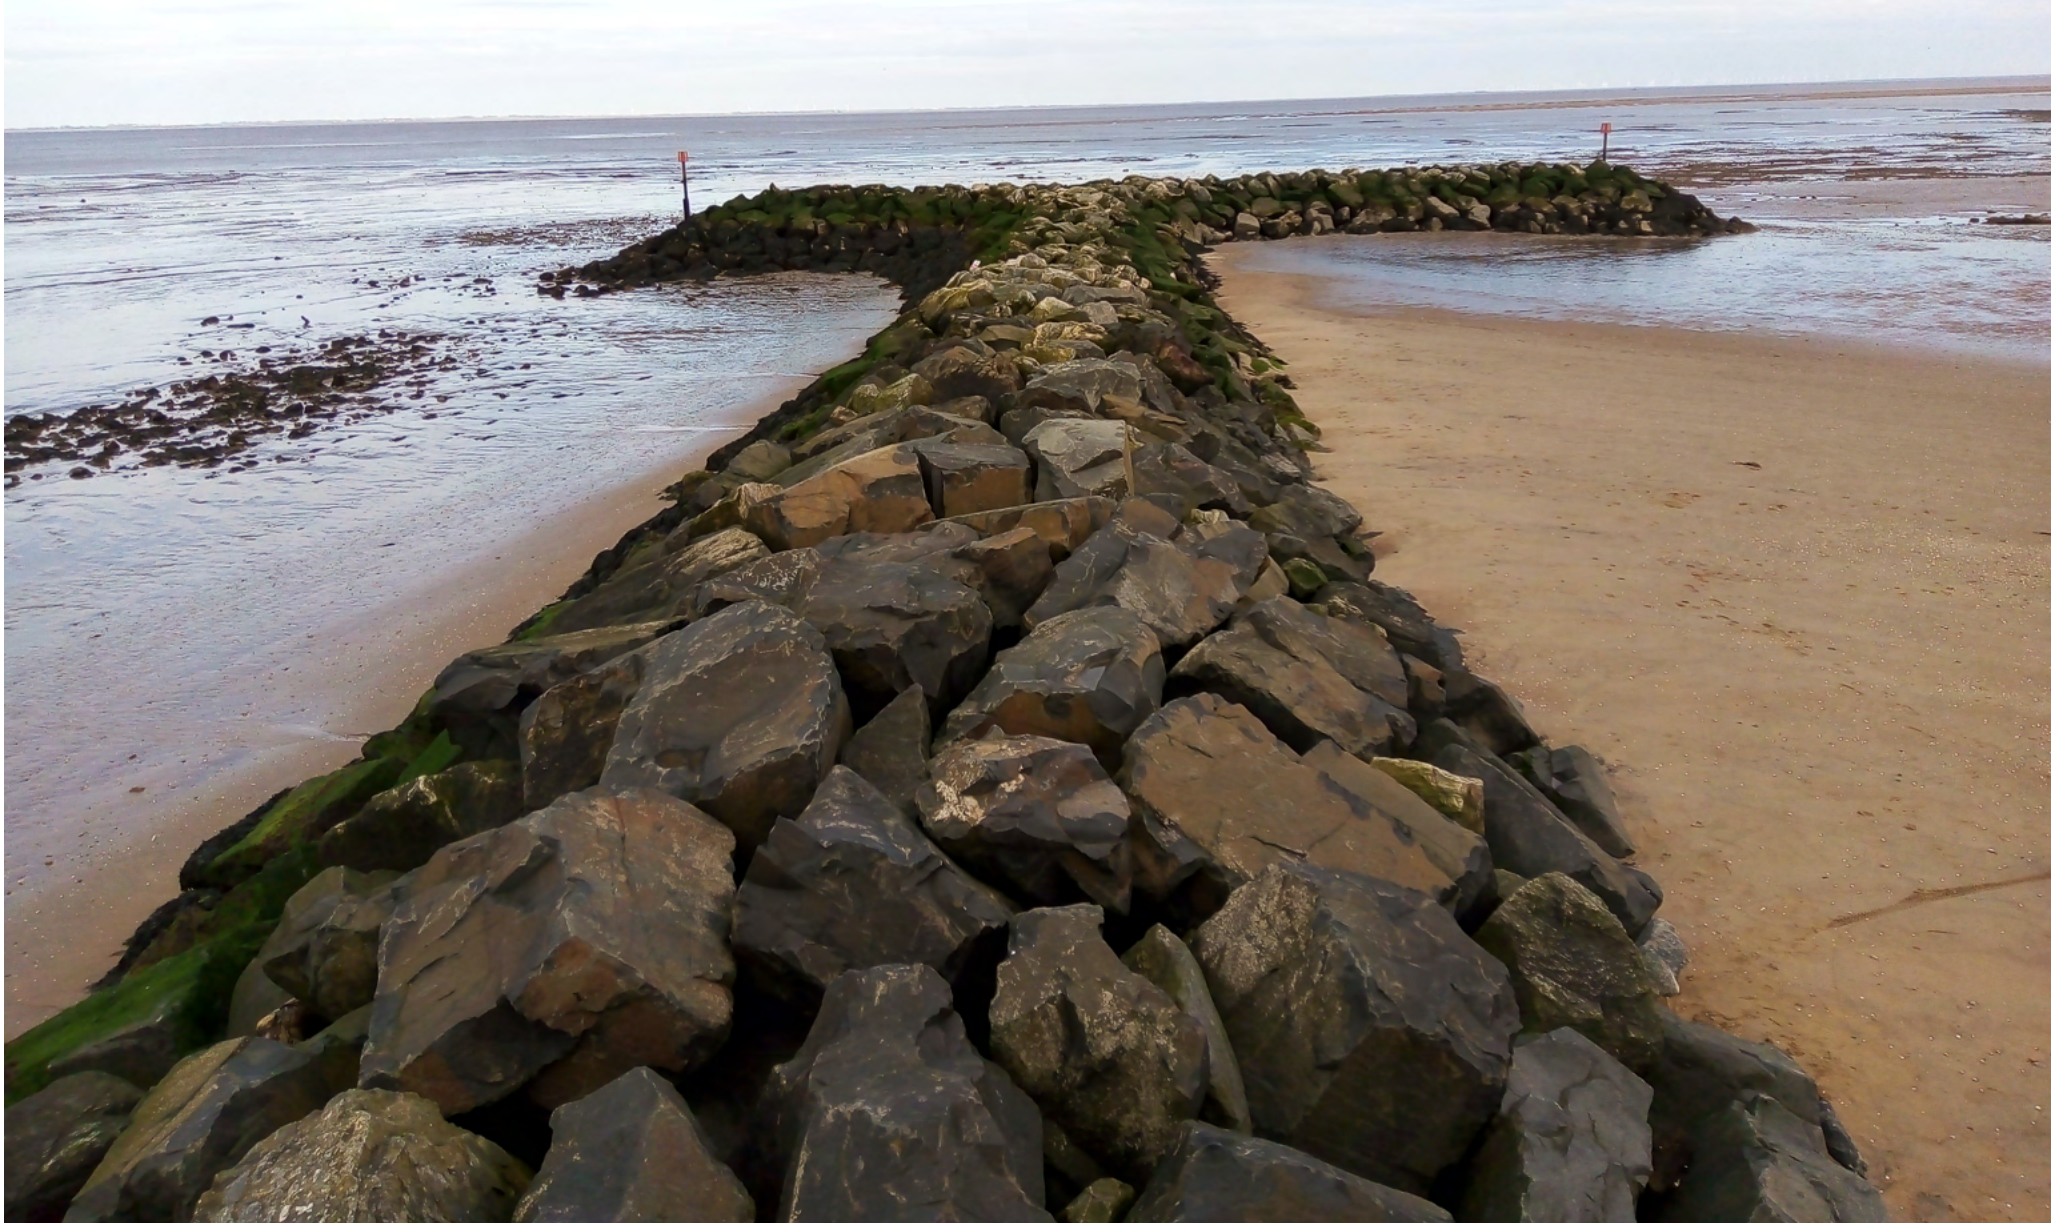
The renewed terminal groyne at the north end of Cleethorpes, a key element in the coastal defence of the town. This fish tailed stone groyne is designed to prevent tidal scour of the sea wall defences, push tidal streams offshore and prevent loss of sand by longshore drift to the north. In this image longshore drift is predominantly from right to left, south to north, and you can see the build up of sand to the right / south.

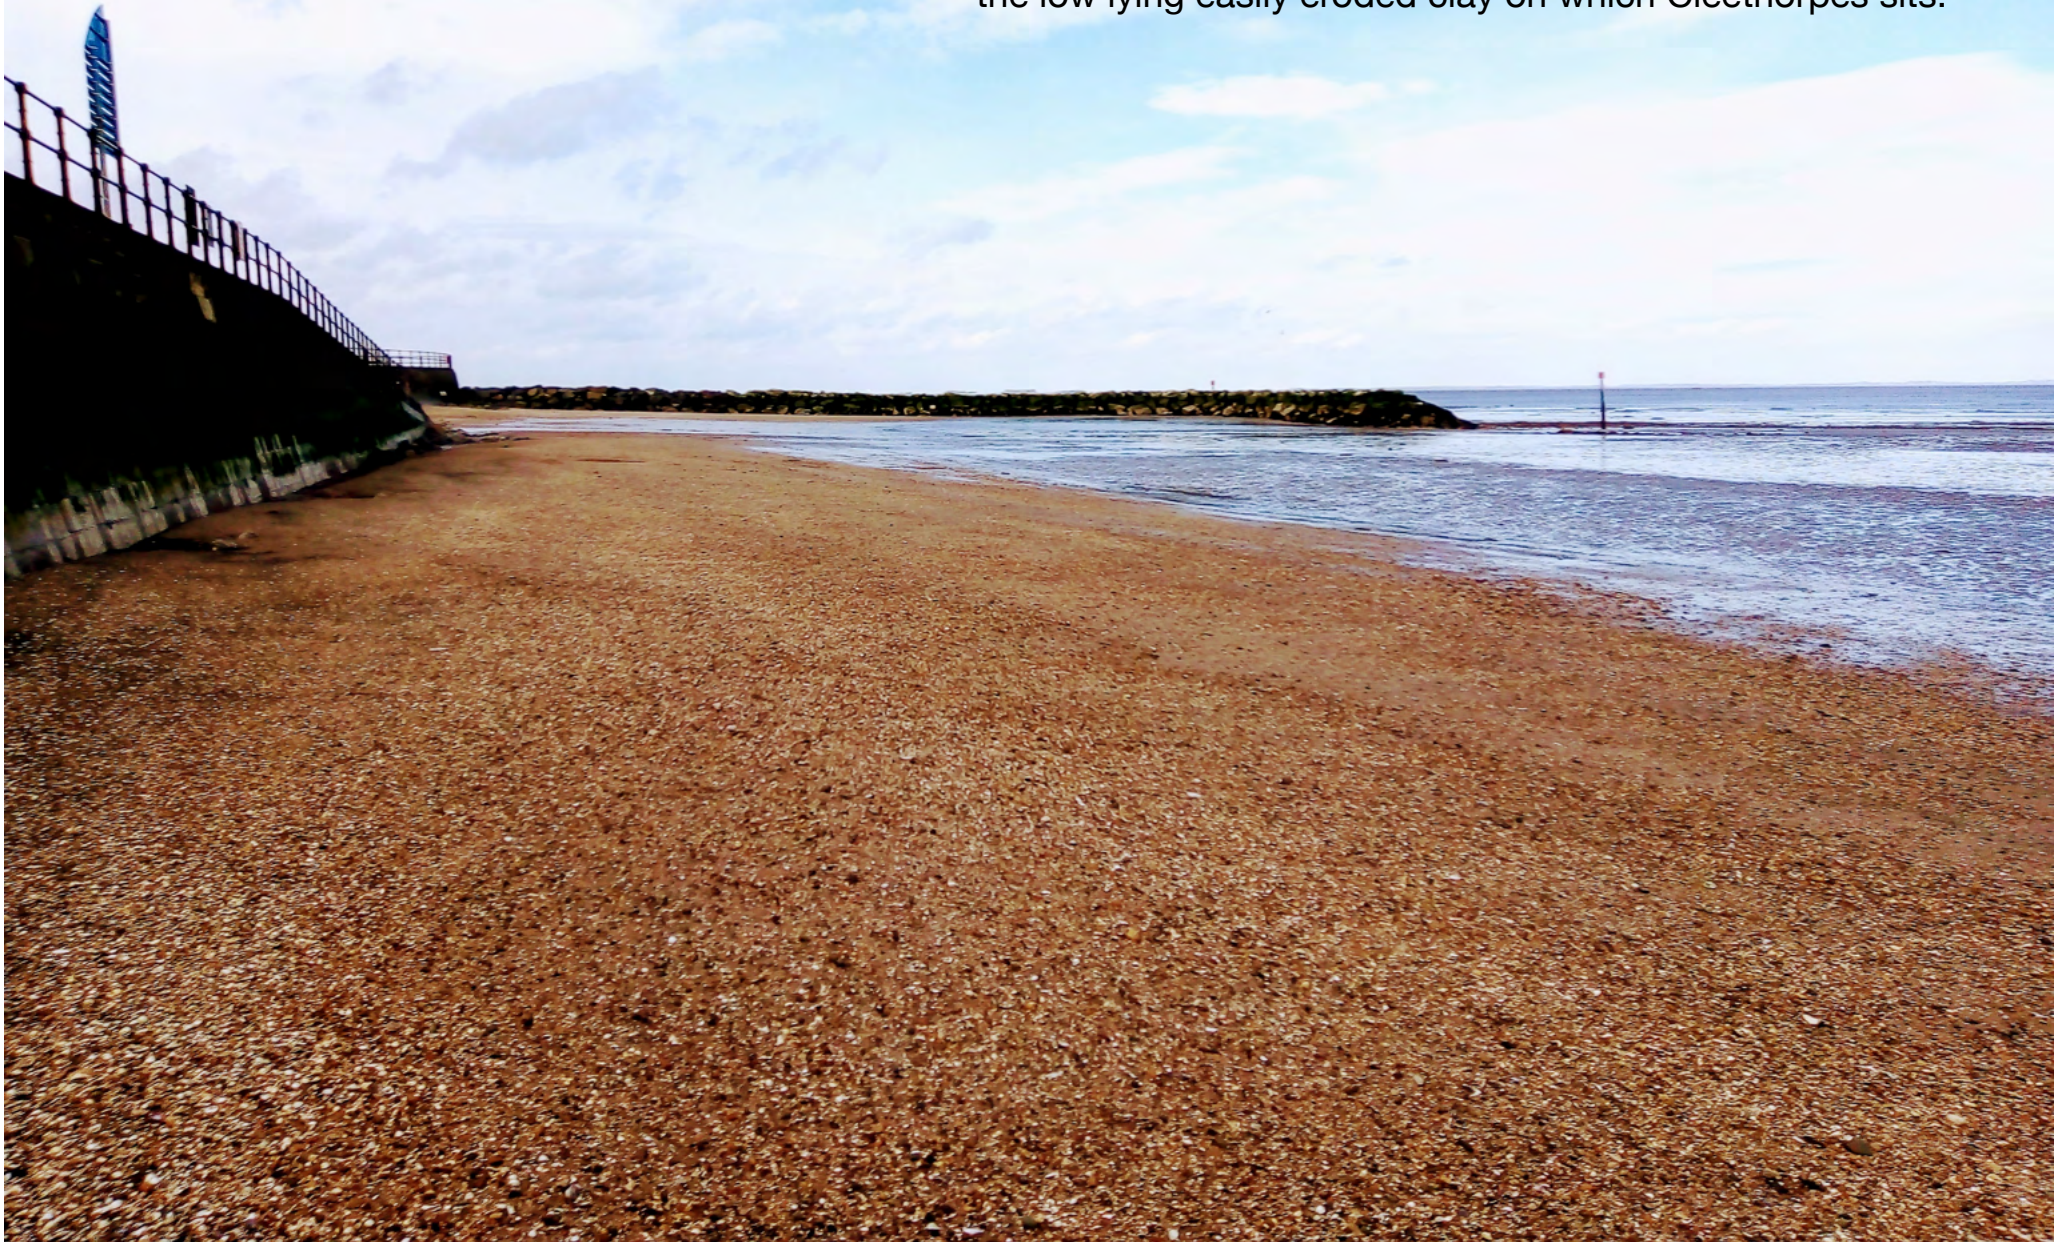
A view north towards the terminal groyne showing the build up of sandy beach material. This sand has two main purposes, firstly to enhance the attractiveness of the town as a tourist destination and secondly to help absorb wave energy at high tide to help defend the resort from marine erosion. To the left is the seawall defences of the north promenade, built to protect the low lying easily eroded clay on which Cleethorpes sits.

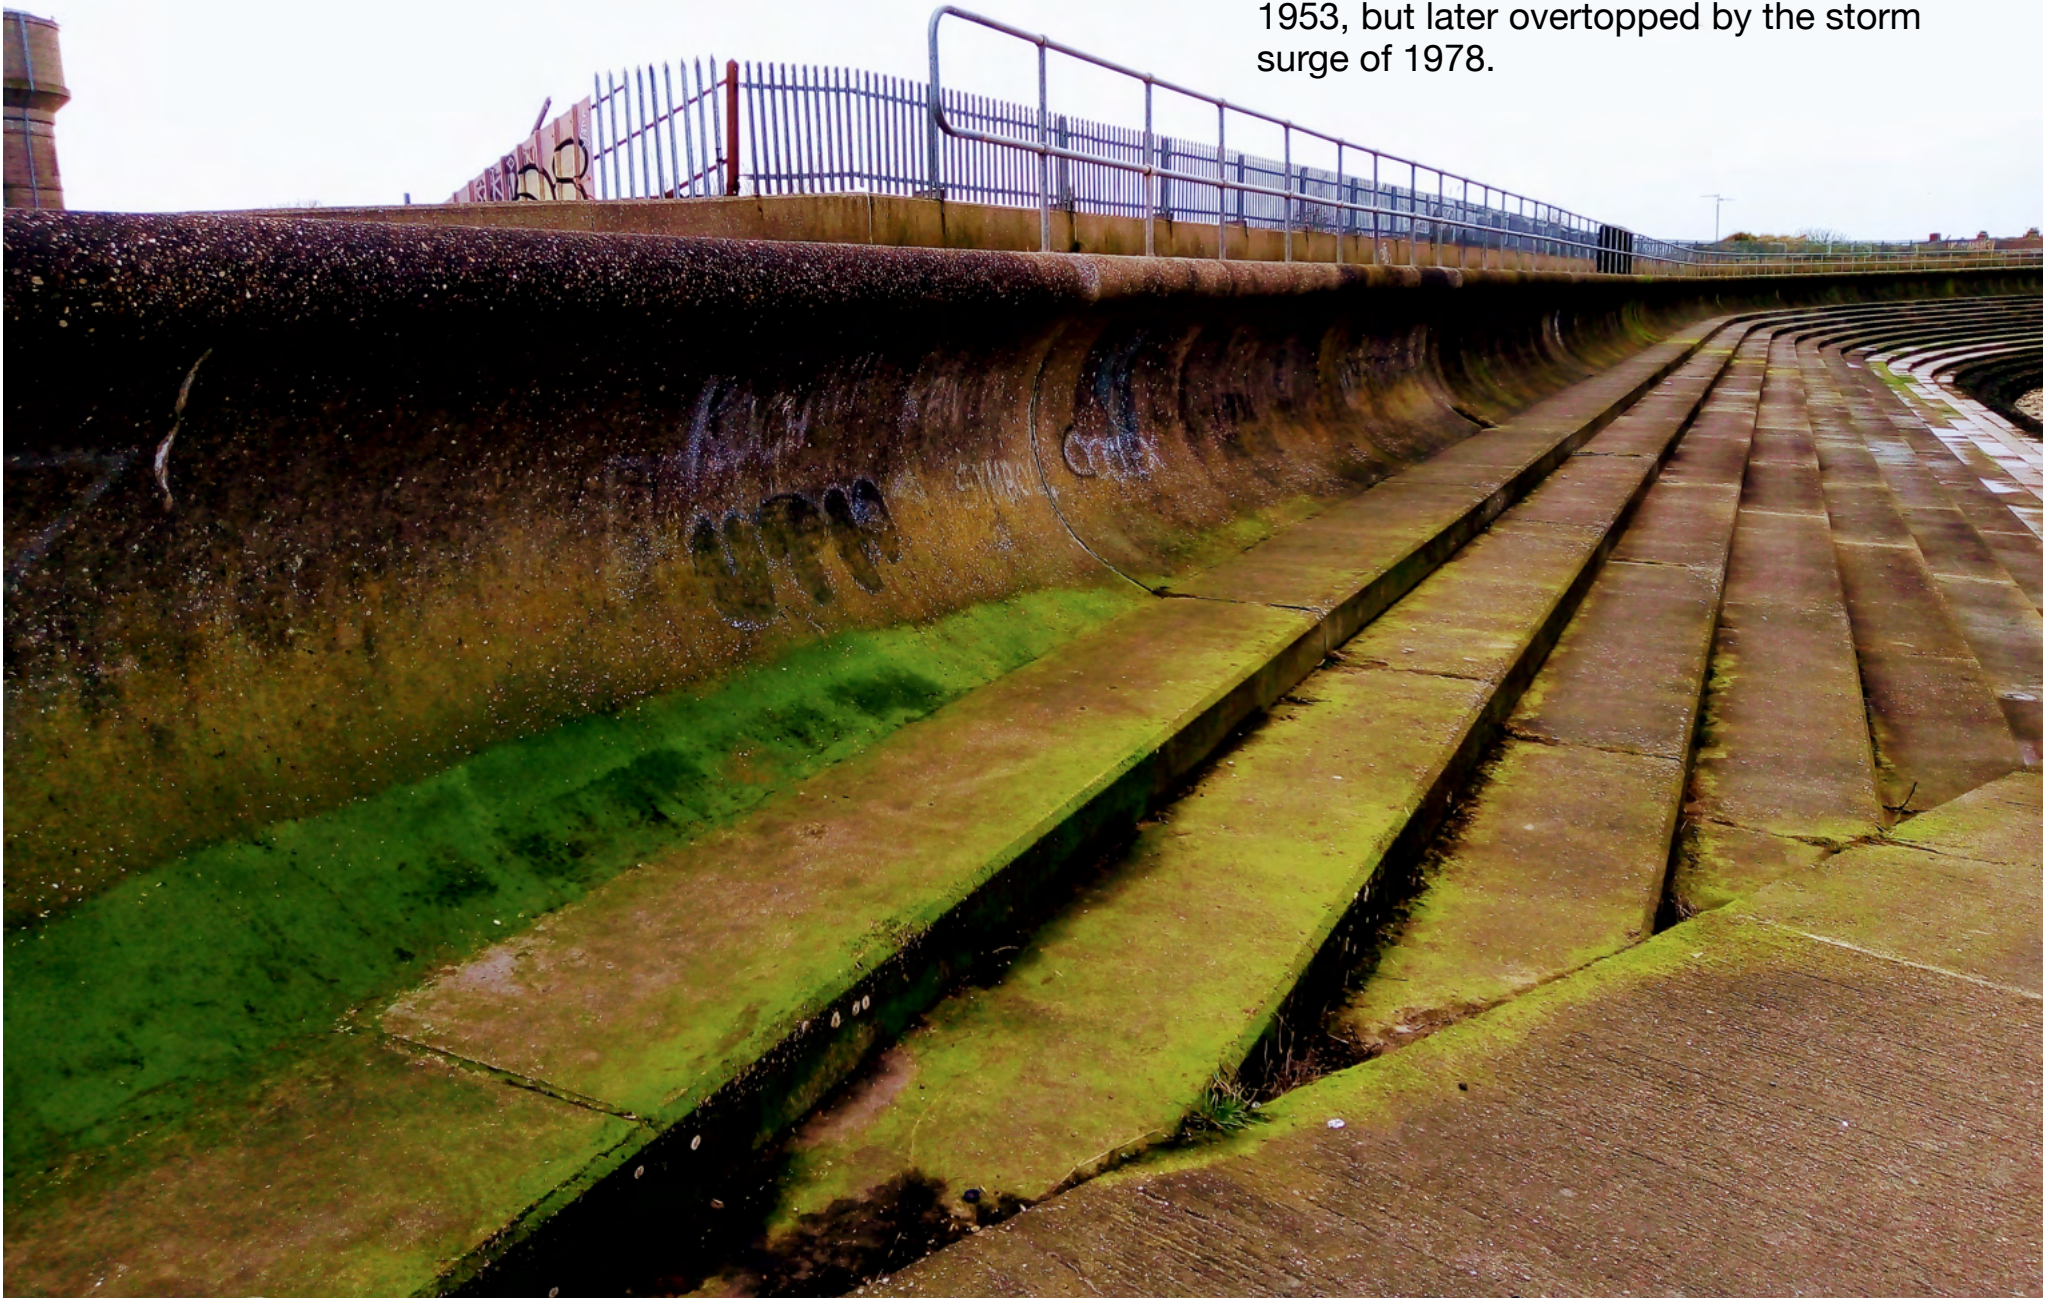
Beyond the terminal groyne to the north and stretching from Cleethorpes to Grimsby is a stepped concrete coastal defence topped with a curved wave wall to deflect wave energy. This was built after the floods of 1953, but later overtopped by the storm surge of 1978.

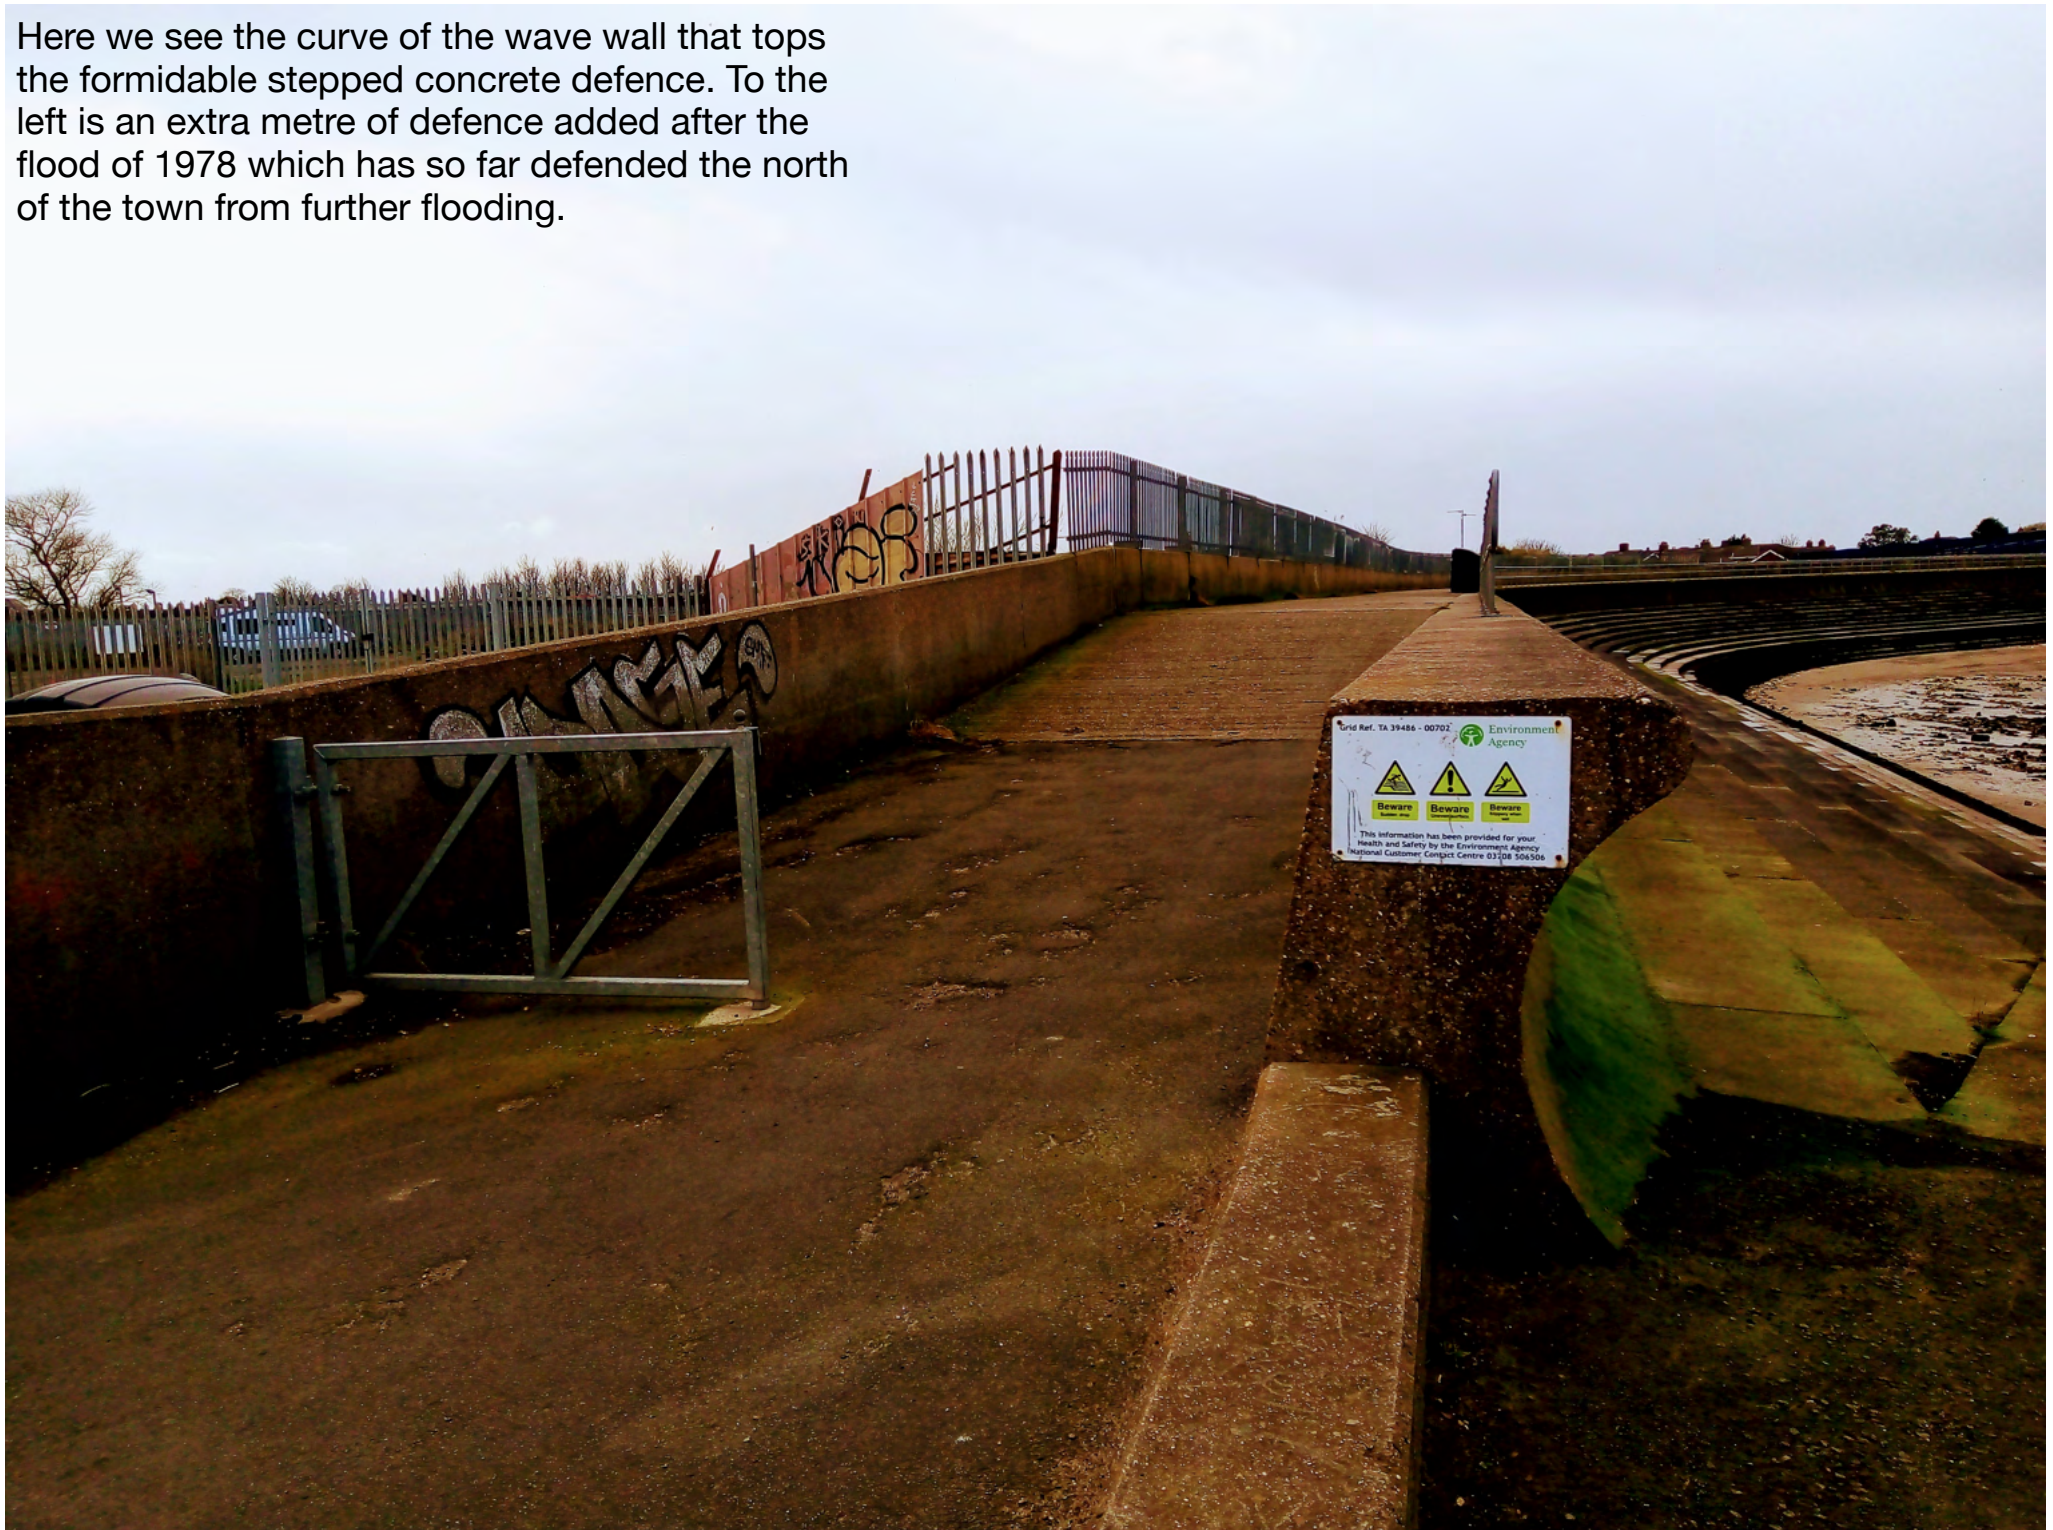
Here we see the curve of the wave wall that tops the formidable stepped concrete defence. To the left is an extra metre of defence added after the flood of 1978 which has so far defended the north of the town from further flooding.

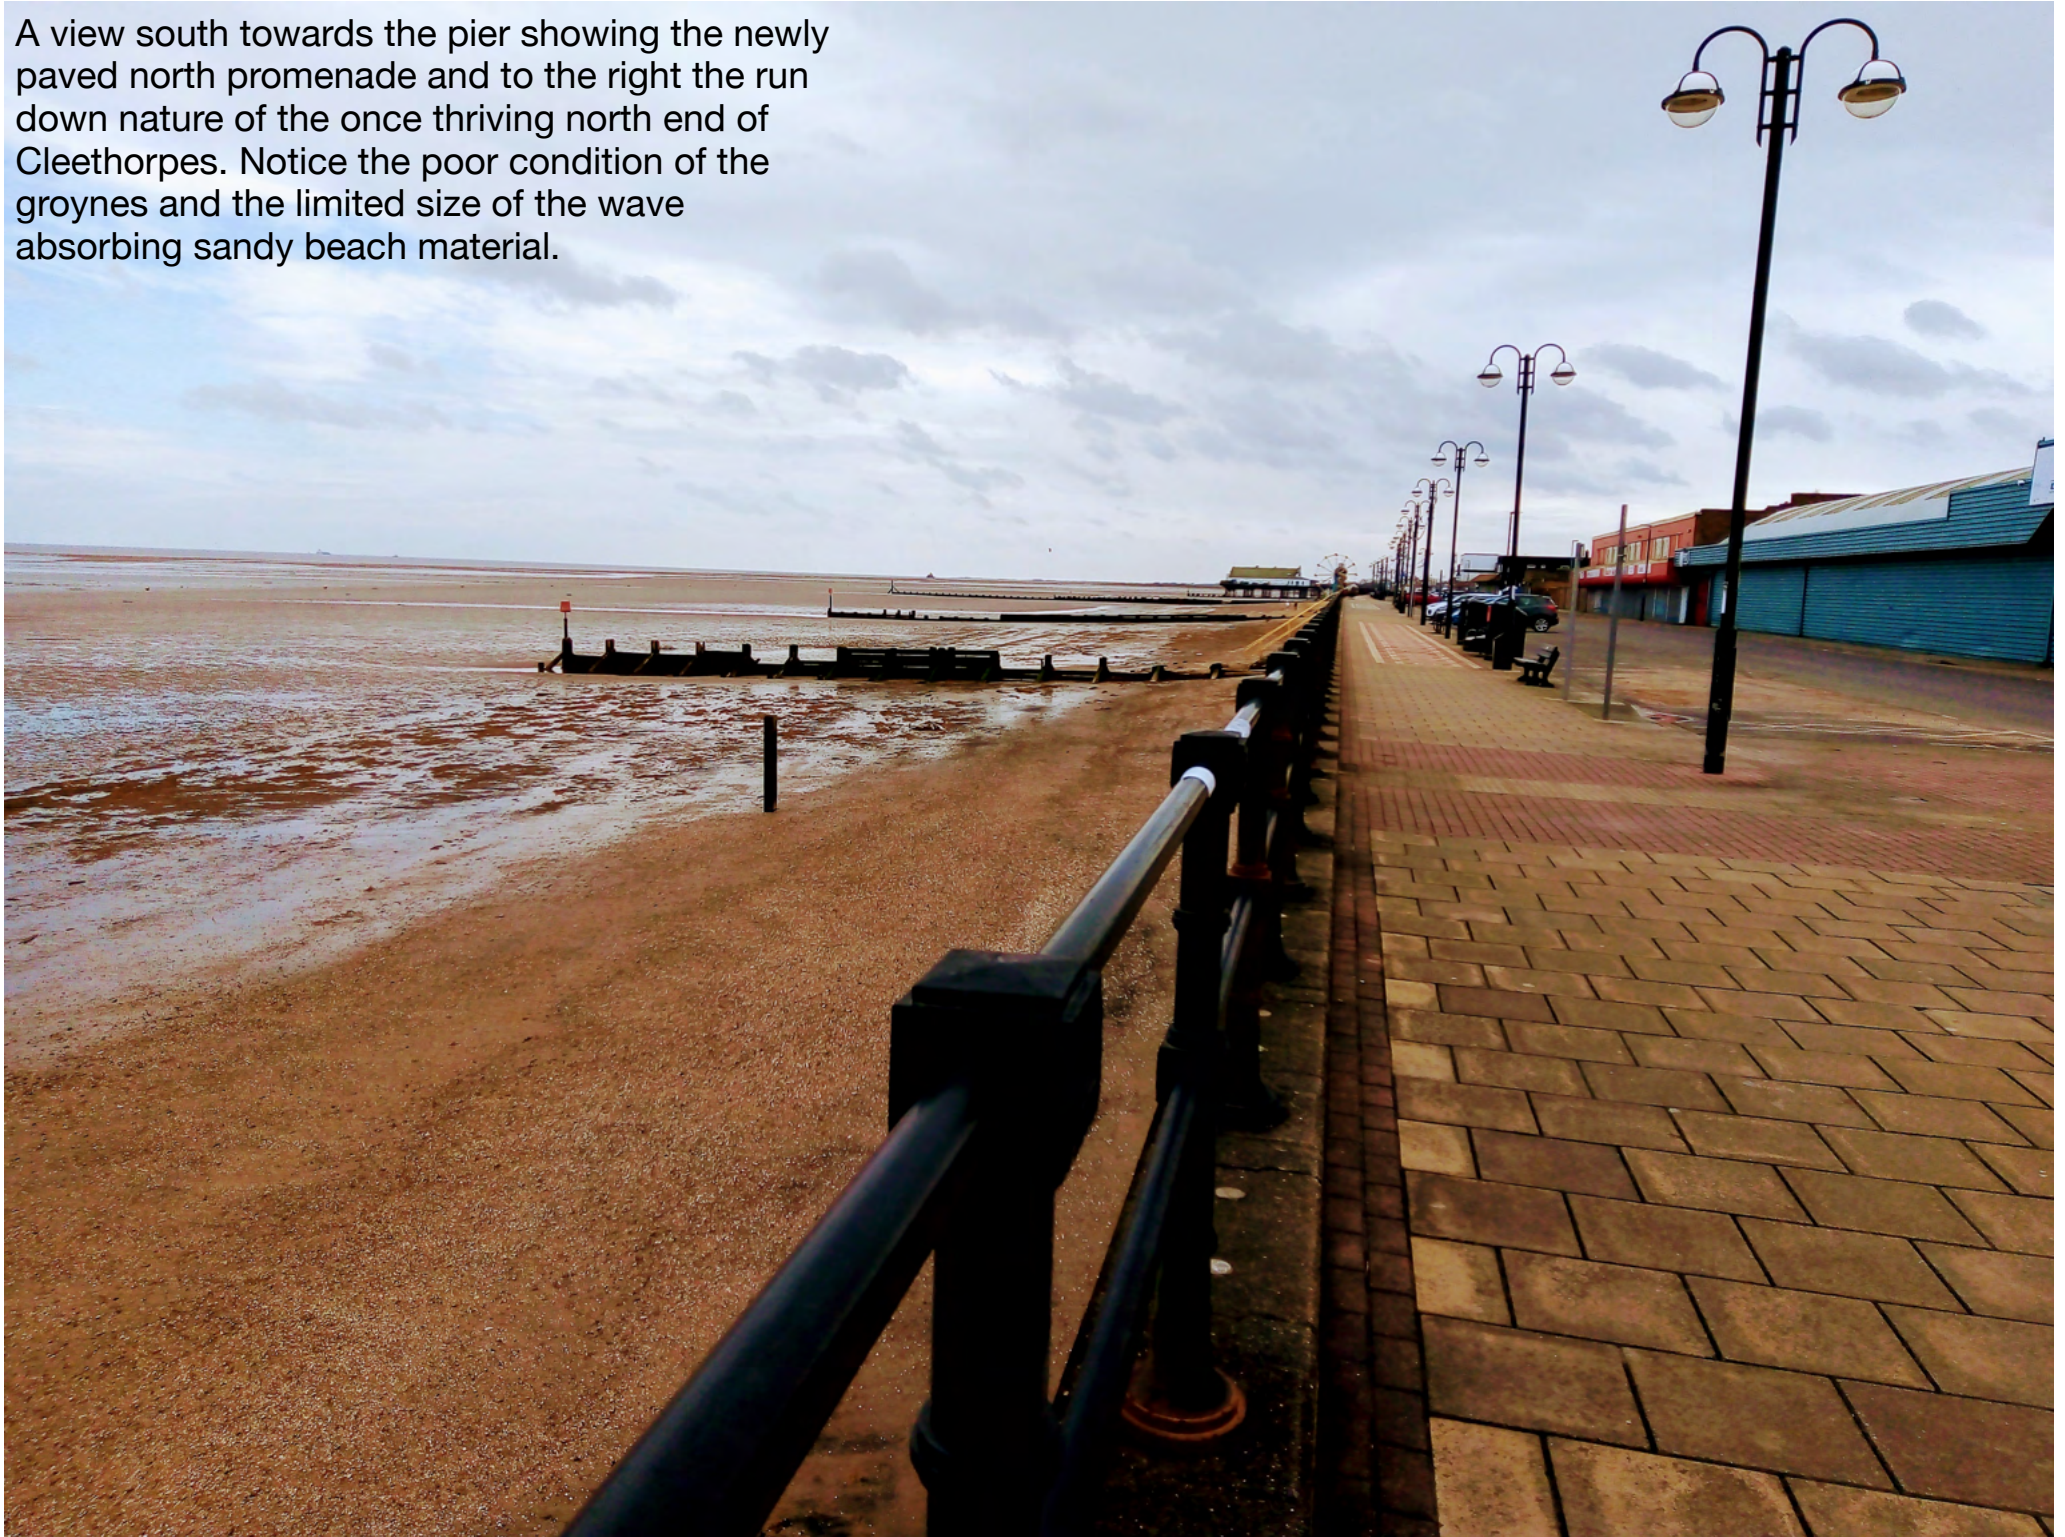
A view south towards the pier showing the newly paved north promenade and to the right the run down nature of the once thriving north end of Cleethorpes. Notice the poor condition of the groynes and the limited size of the wave absorbing sandy beach material.

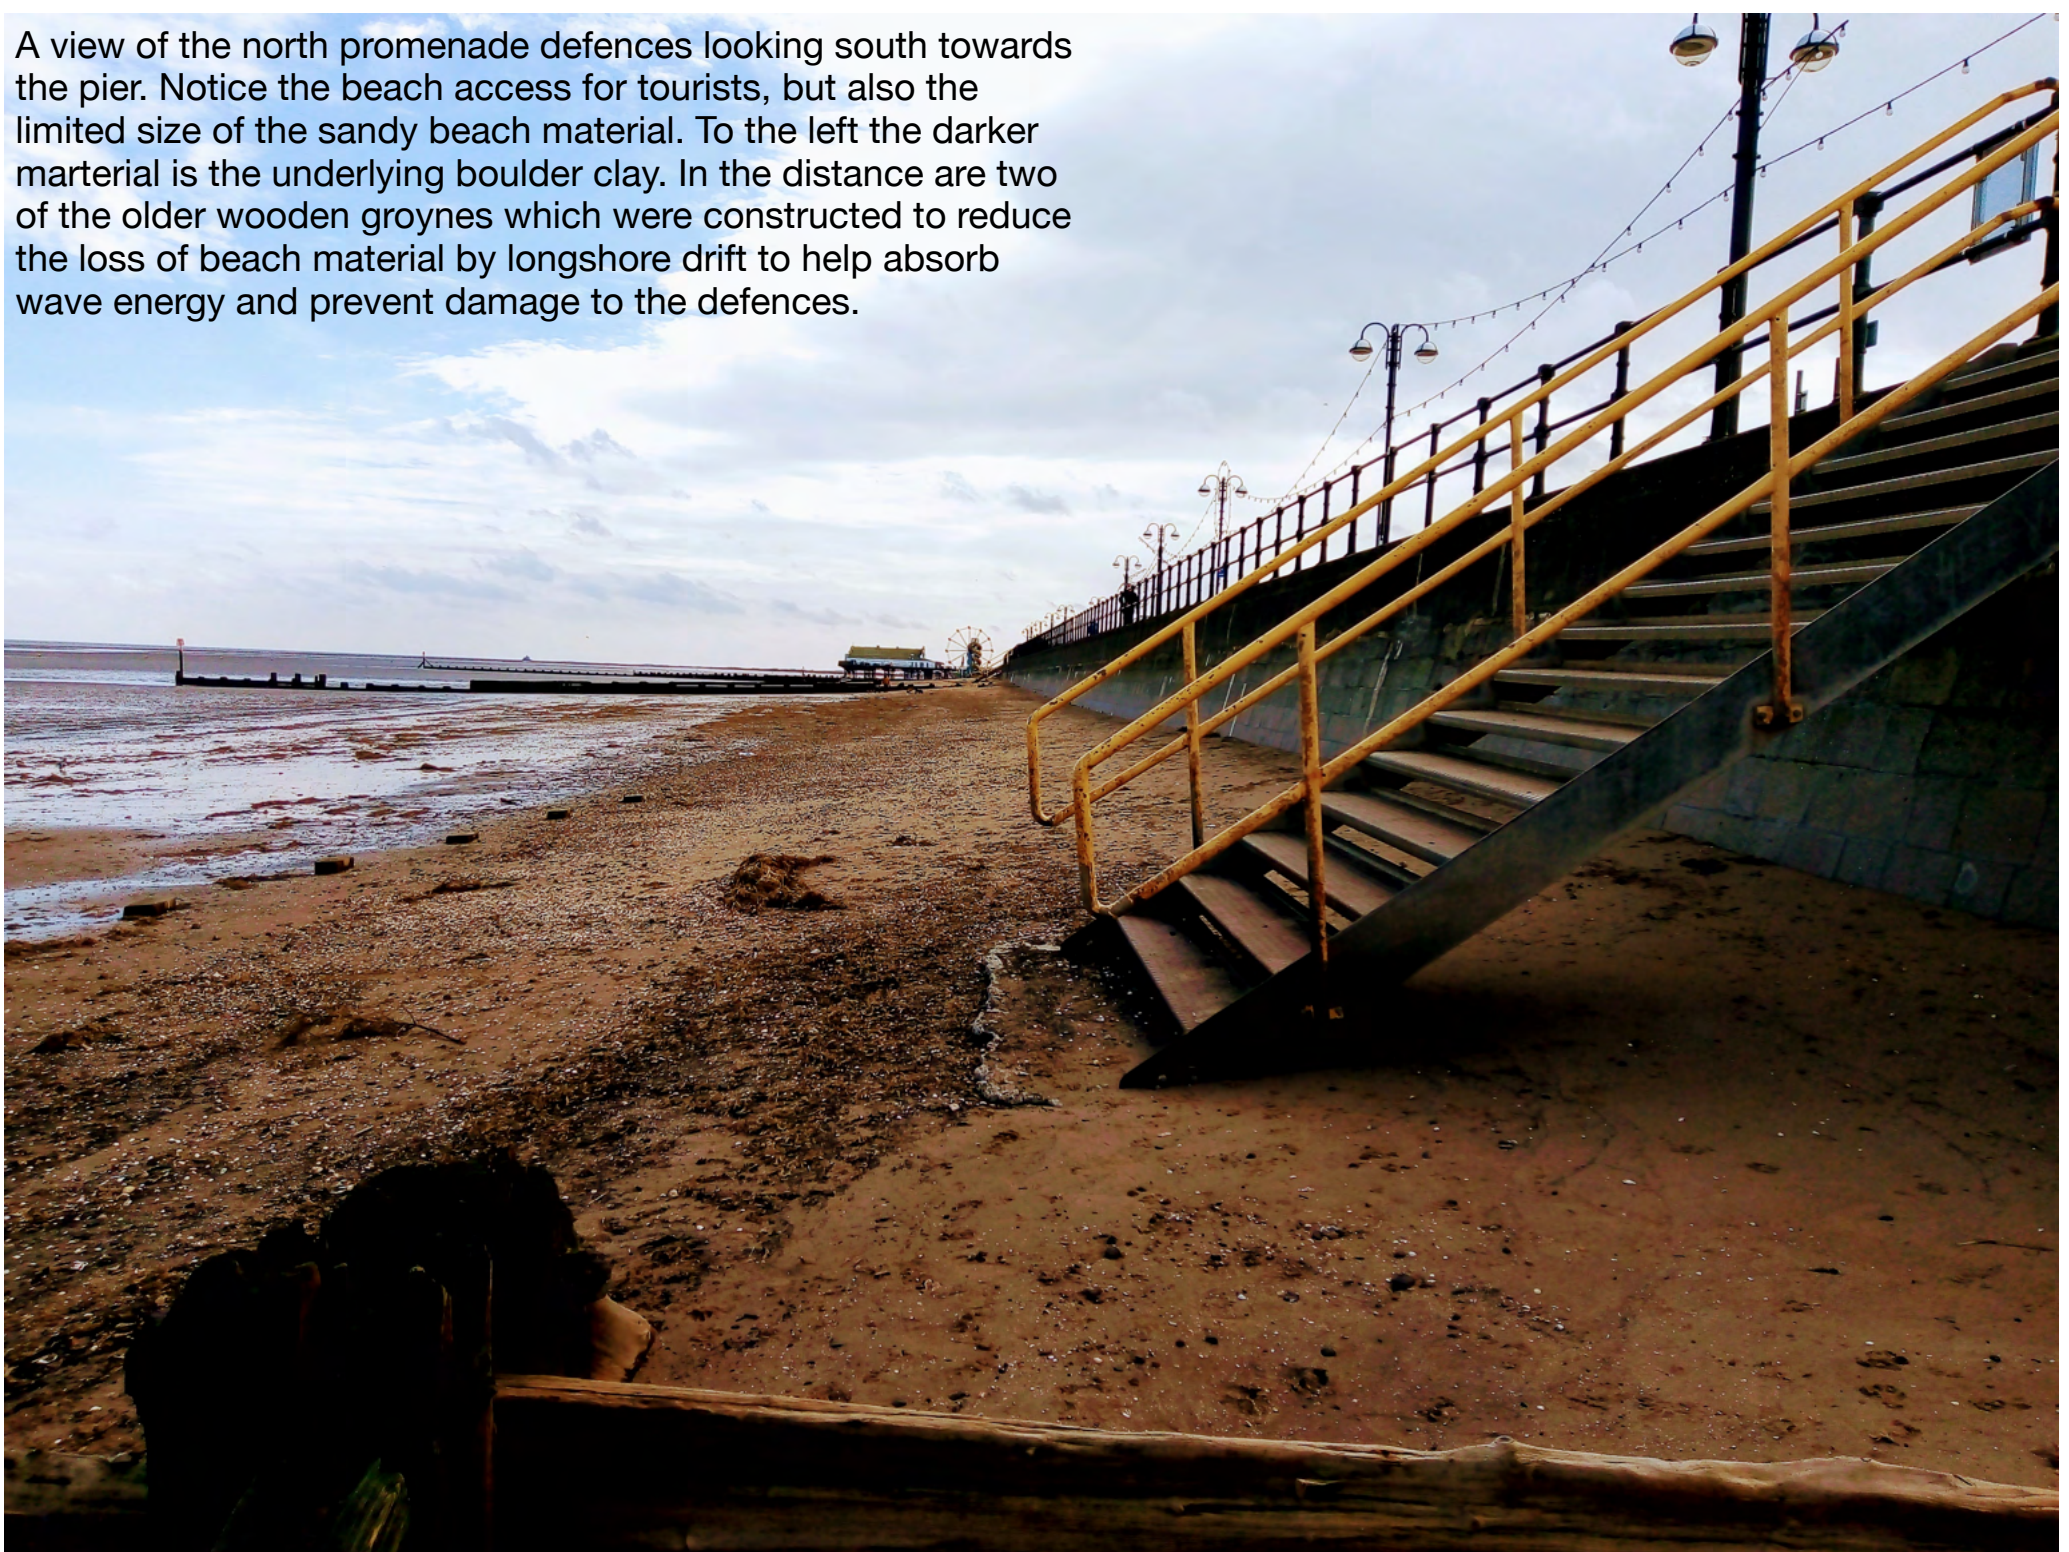
A view of the north promenade defences looking south towards the pier. Notice the beach access for tourists, but also the limited size of the sandy beach material. To the left the darker marterial is the underlying boulder clay. In the distance are two of the older wooden groynes which were constructed to reduce the loss of beach material by longshore drift to help absorb wave energy and prevent damage to the defences.

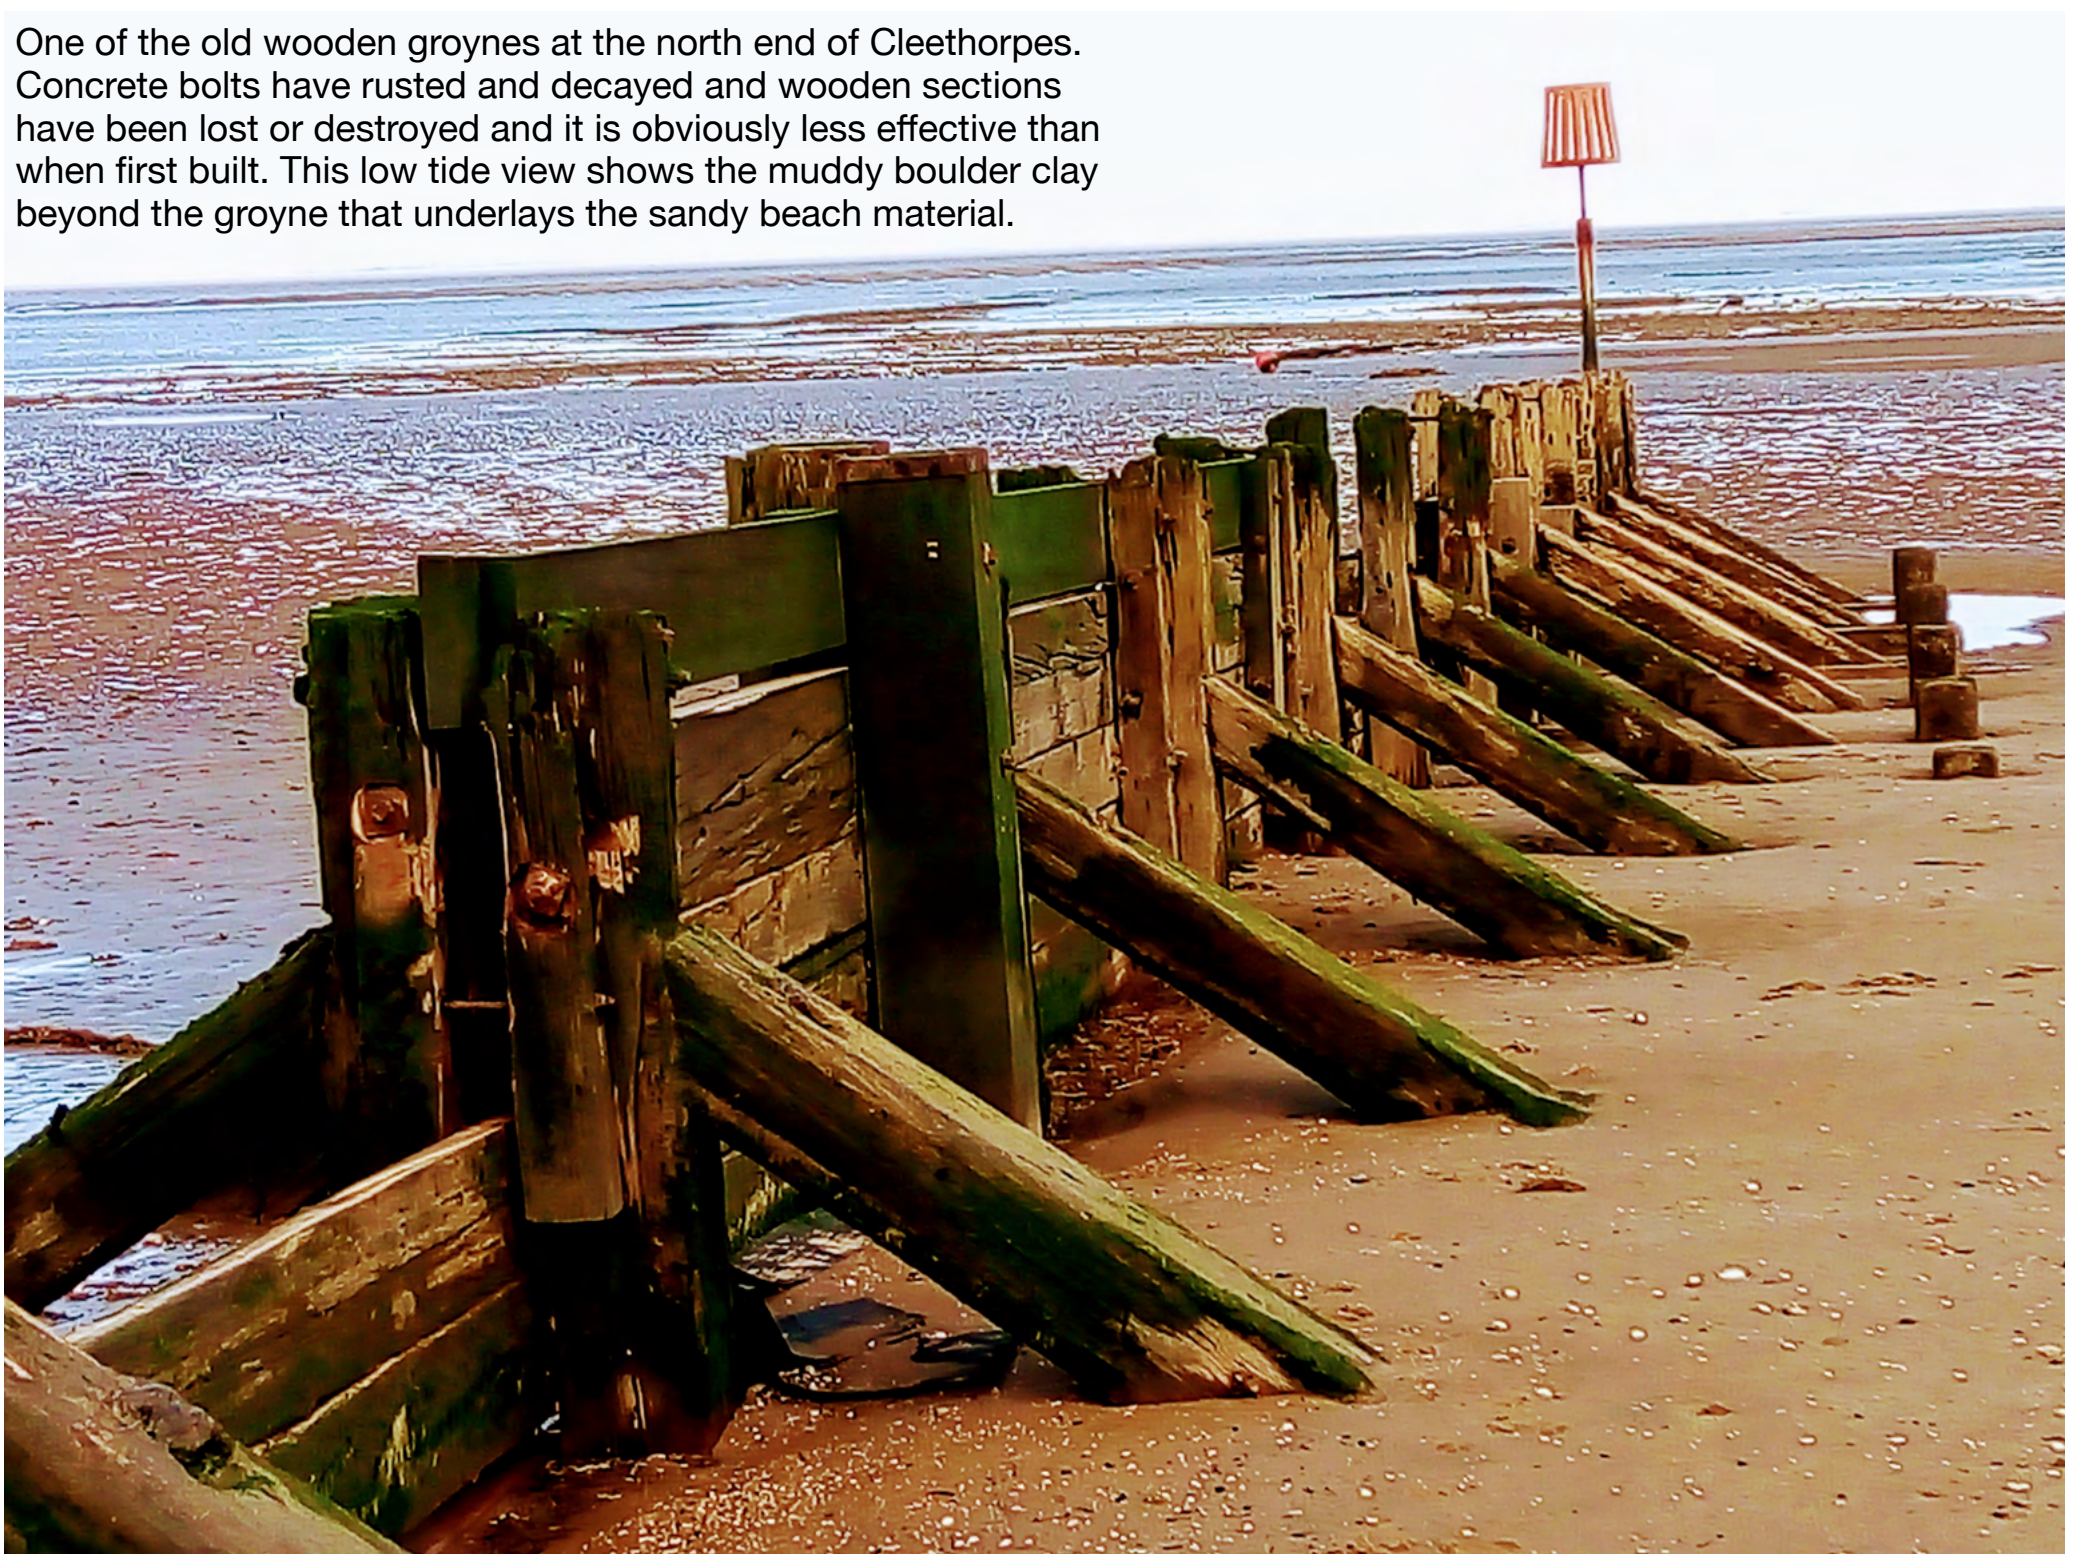
One of the old wooden groynes at the north end of Cleethorpes. Concrete bolts have rusted and decayed and wooden sections have been lost or destroyed and it is obviously less effective than when first built. This low tide view shows the muddy boulder clay beyond the groyne that underlays the sandy beach material.
