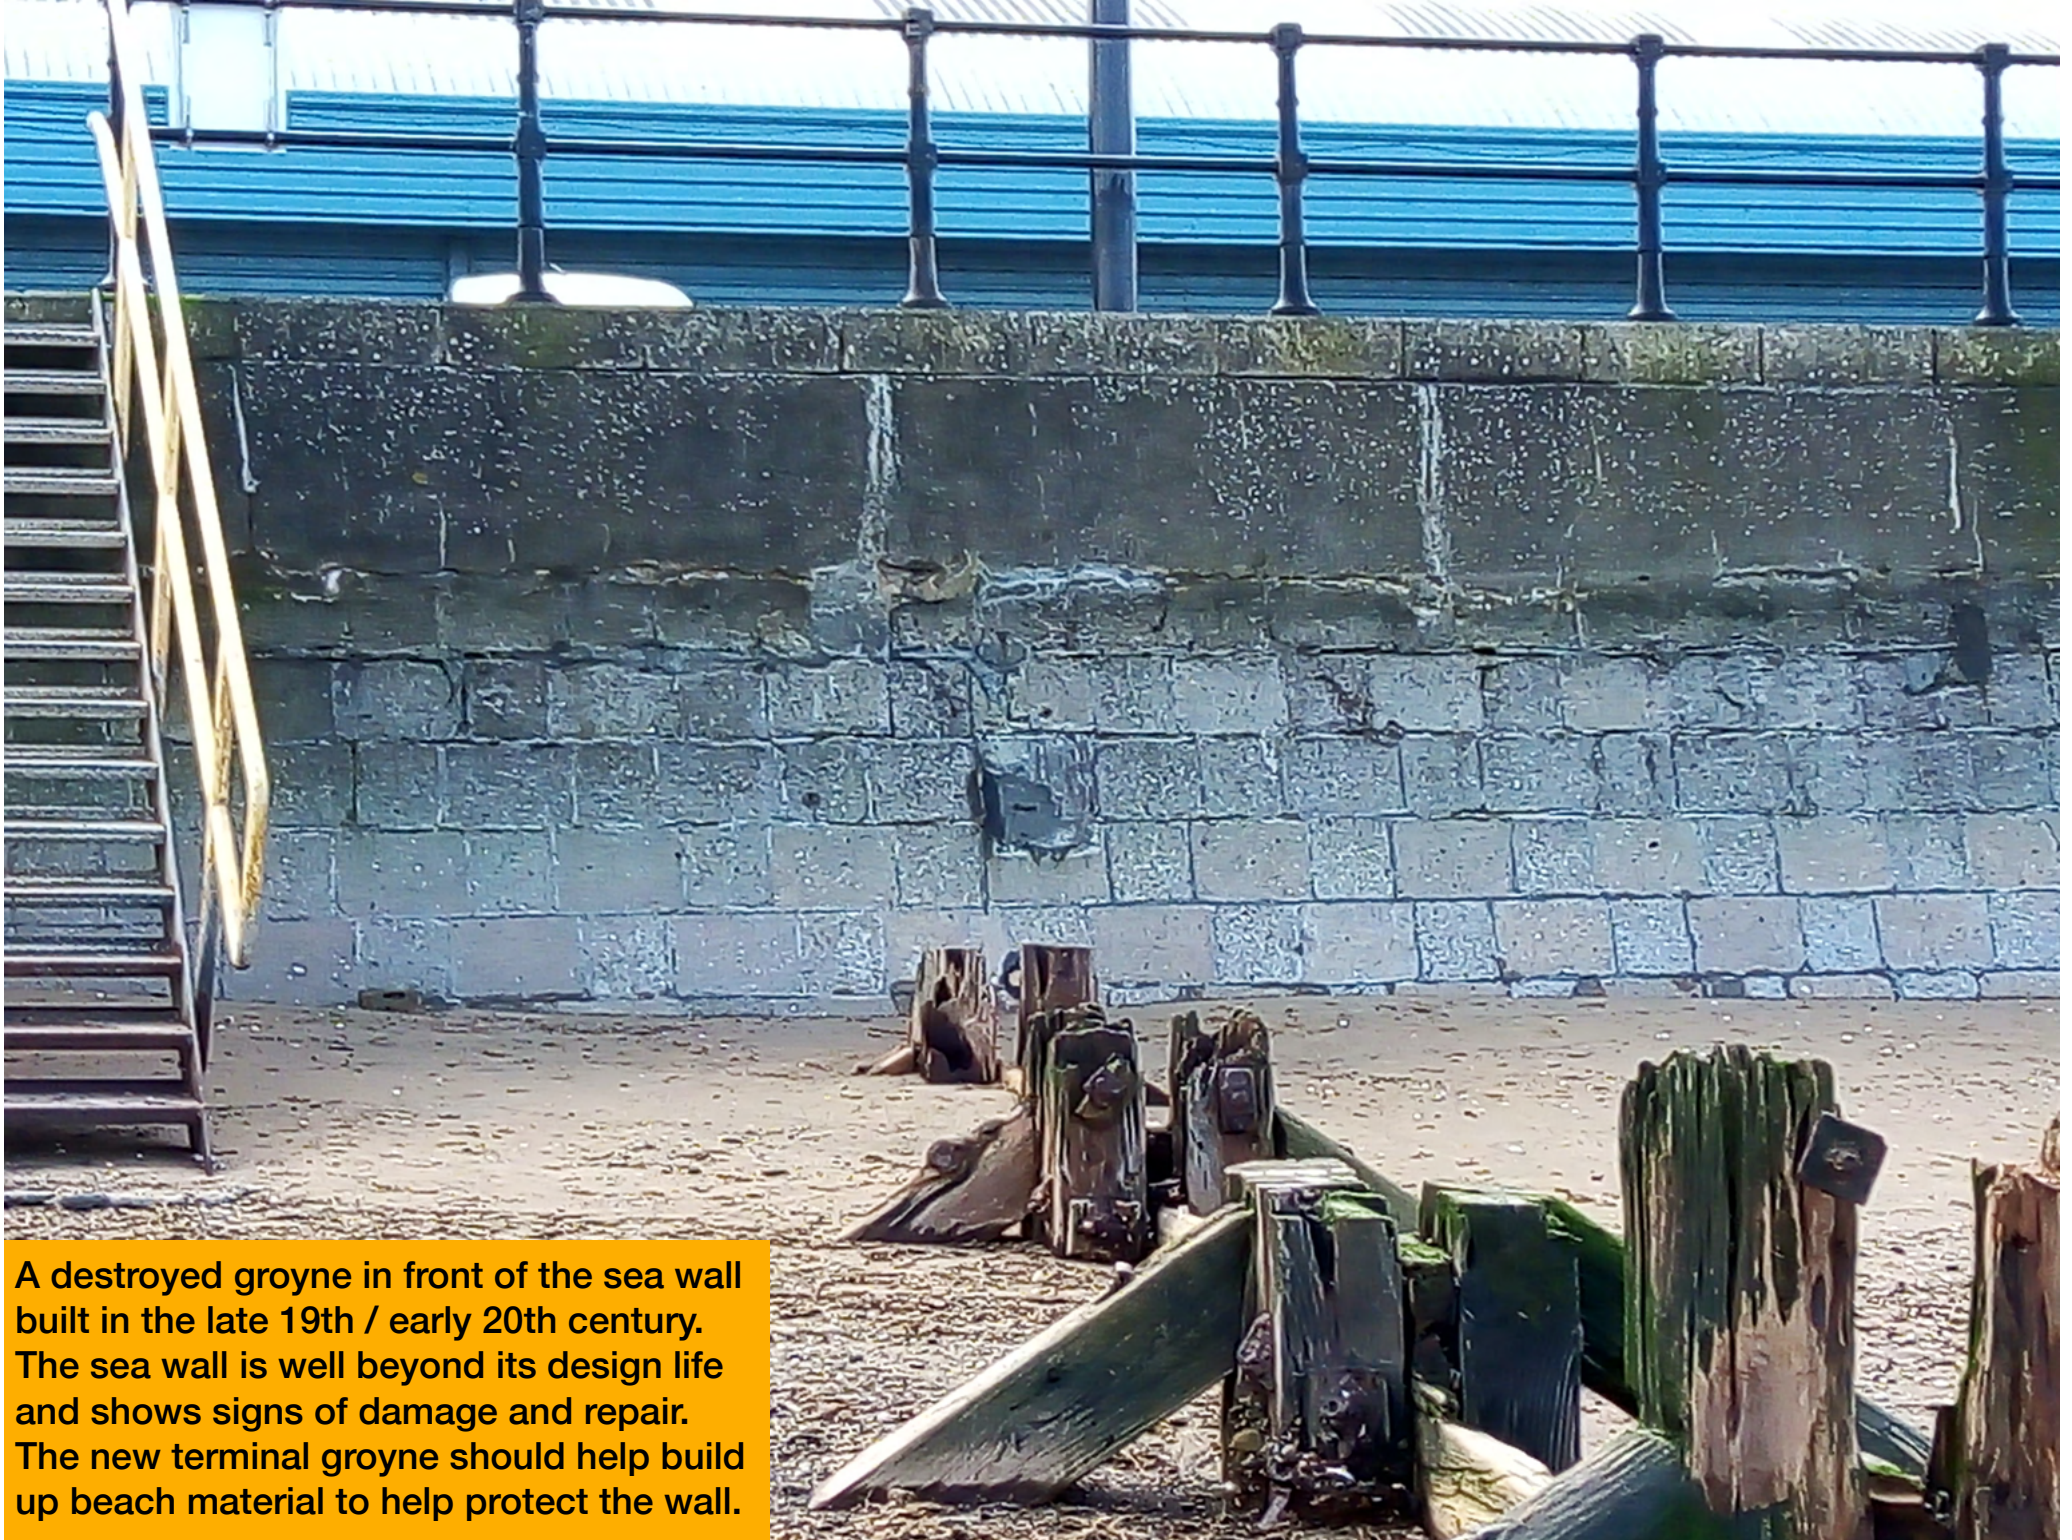
A destroyed groyne in front of the sea wall built in the late 19th / early 20th century. The sea wall is well beyond its design life and shows signs of damage and repair. The new terminal groyne should help build up beach material to help protect the wall.
