# 2009

# Church Ditch Master Plan

#### Ecological Resource Consultants, Inc.

Church Ditch Water Authority

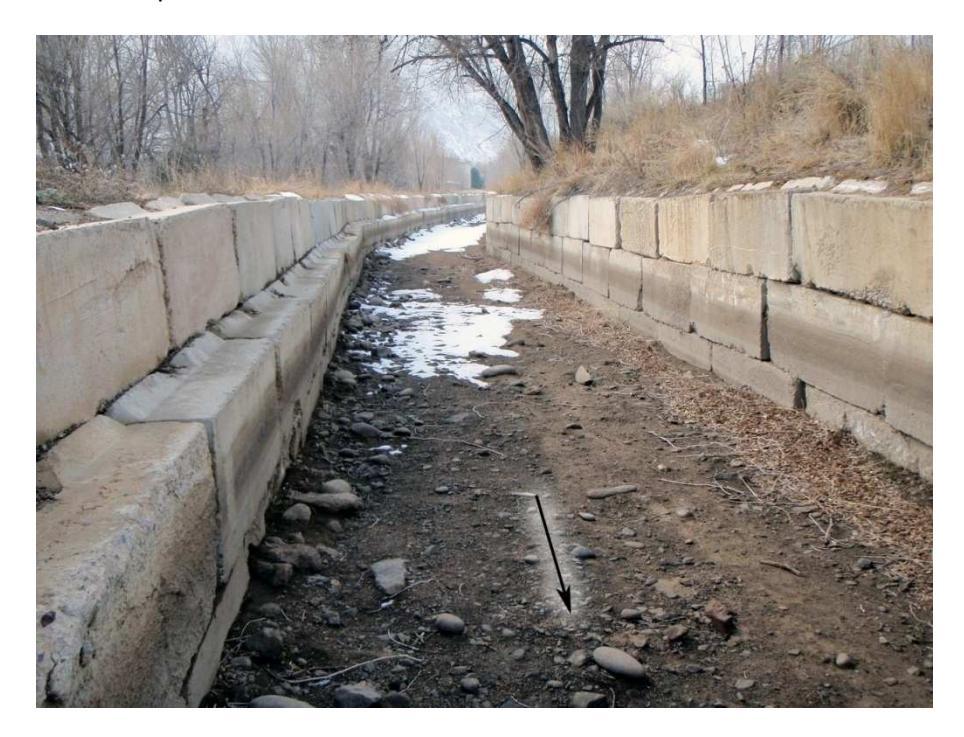
#### PHOTO 1 - DITCH LINING

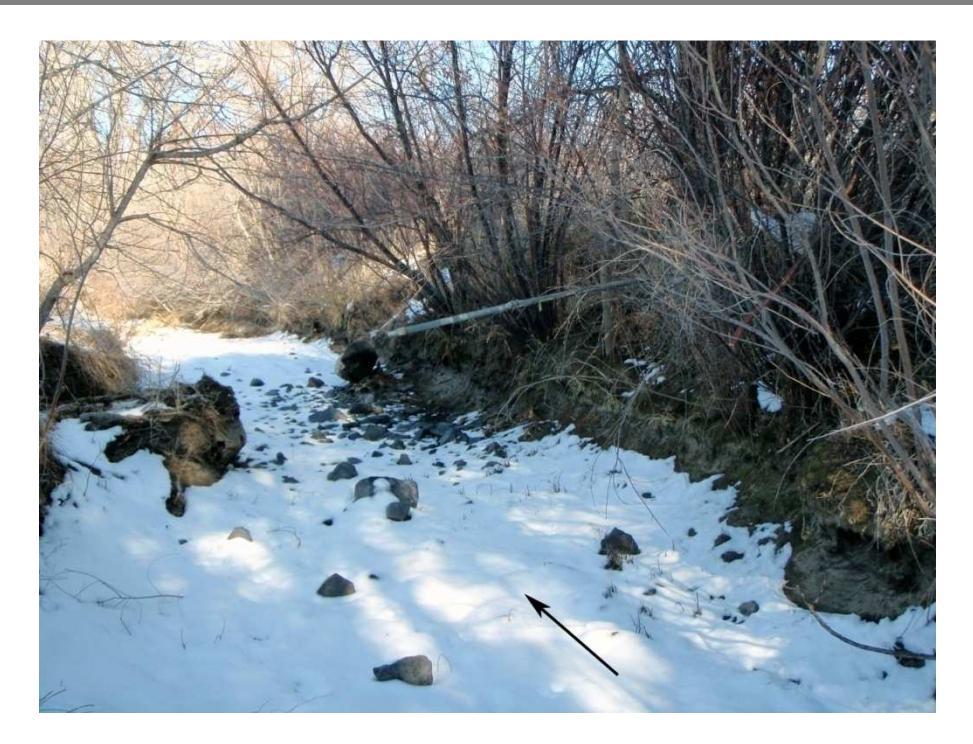
PHOTO 2 - VEGETATION AND SEDIMENT IN THE CHANNEL MAY DECREASE DITCH CAPACITY

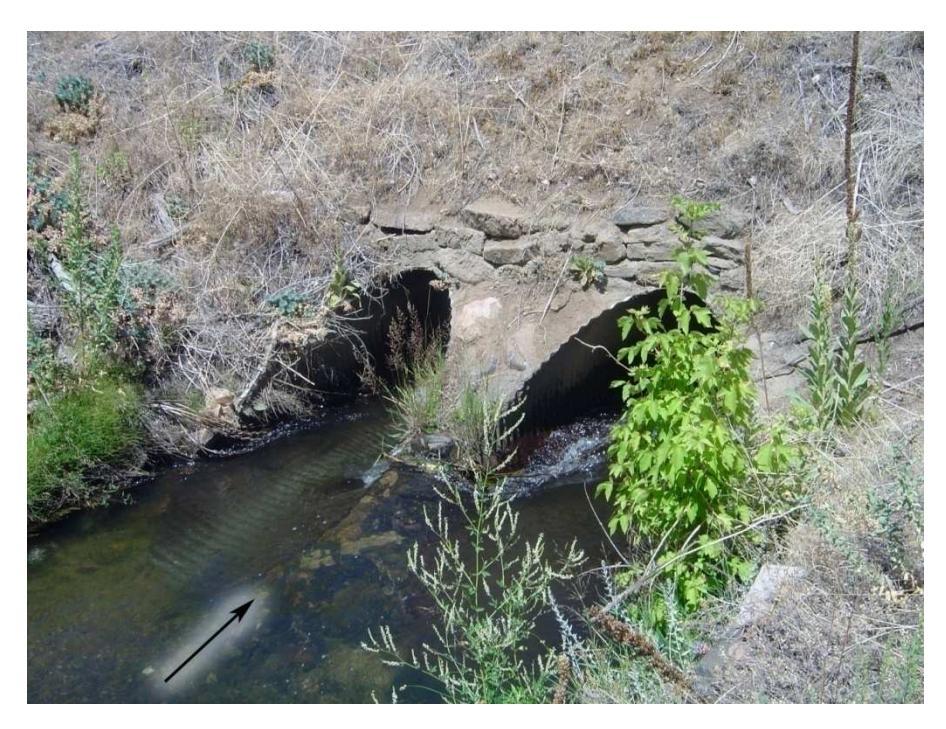
PHOTO 3 - DOUBLE CULVERTS AND INADEQUATELY SIZED STRUCTURES CAUSE A LOSS IN DITCH CAPACITY

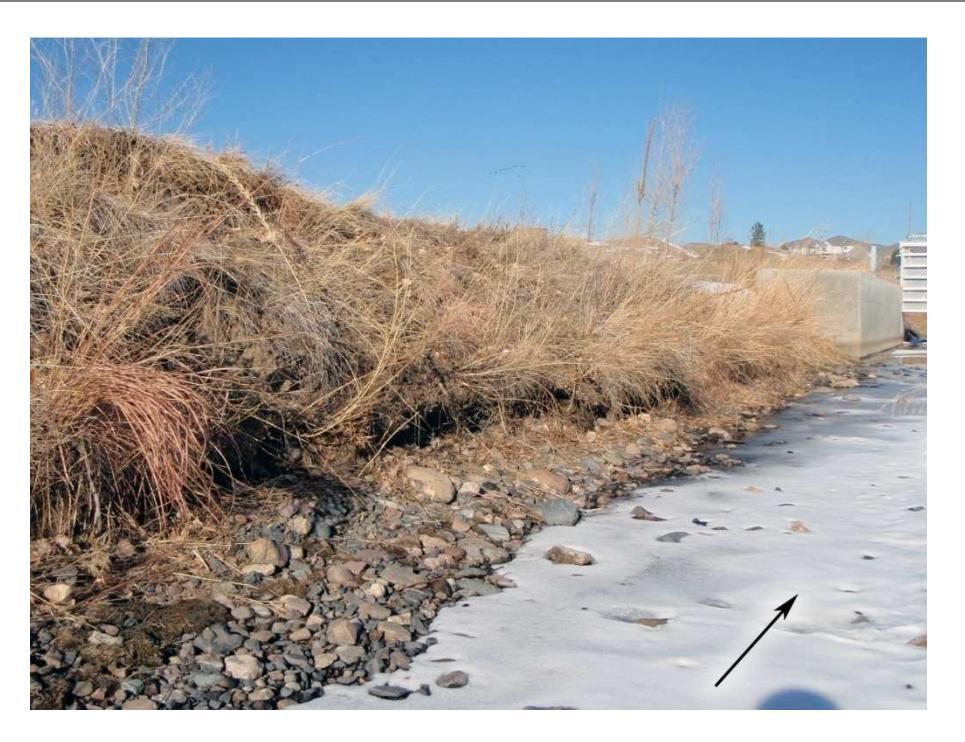
PHOTO 4 - UNDERCUTTING HAS OCCURRED ALONG THE DITCH IN AREAS THAT HAVE STEEP BANKS AND INADEQUATE ARMORING

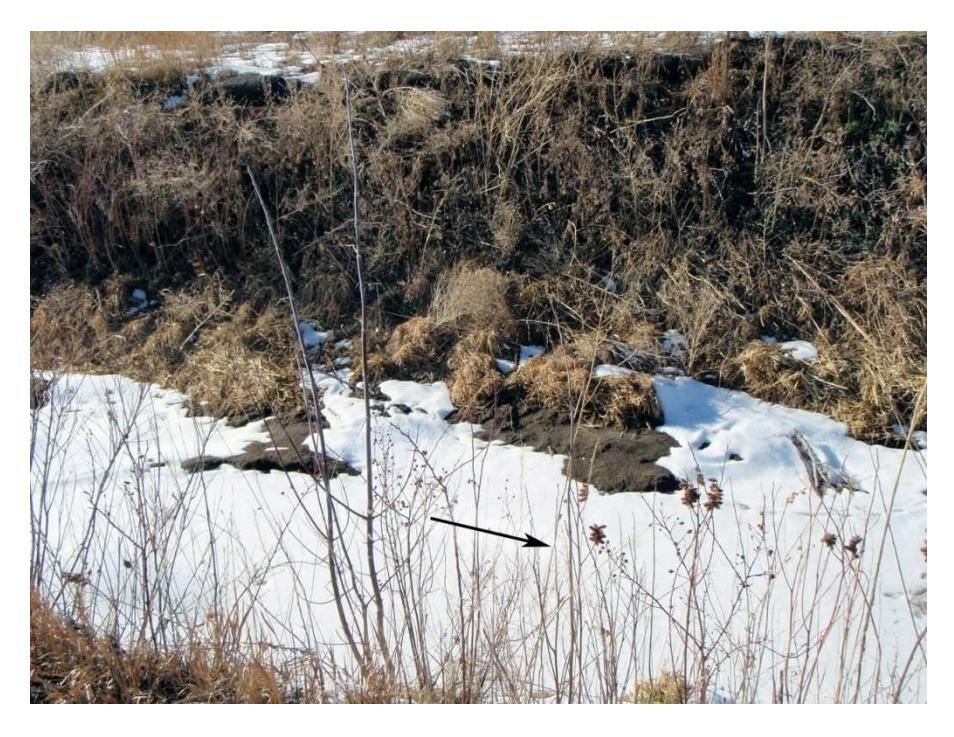
PHOTO 5 - SEDIMENTATION ALONG THE CHANNEL BOTTOM CHANGES THE SLOPE AND CROSS SECTION OF THE CHANNEL AND DECREASES THE DITCH'S CAPACITY

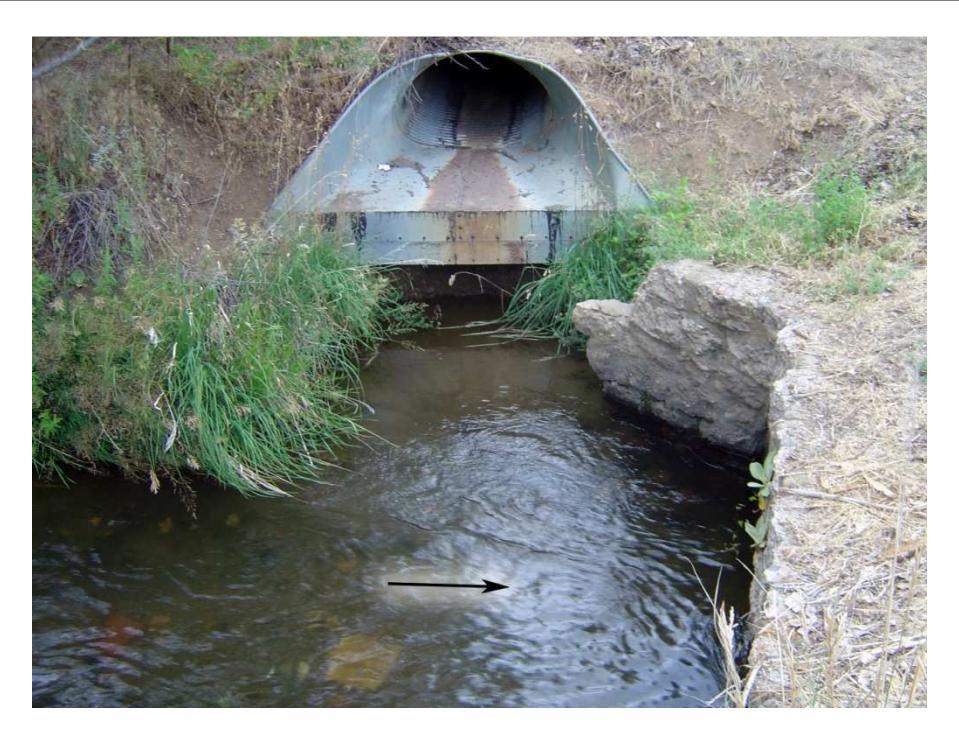
PHOTO 6 - STORMWATER ENTRY POINTS CAN DECREASE THE QUALITY OF THE WATER IN THE DITCH AND IMPACT DITCH CAPACITY

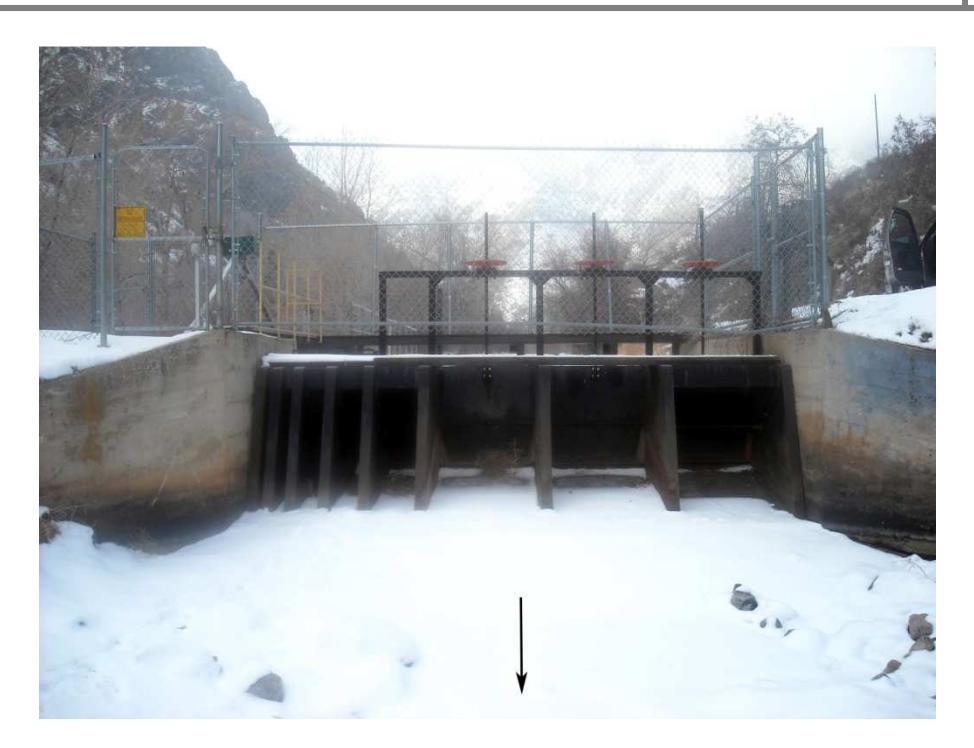
PHOTO 7 - GATES LOCATED AT THE HEAD WORKS DO NOT CLOSE PROPERLY AND LEAK AND ARE MANUALLY OPERATED

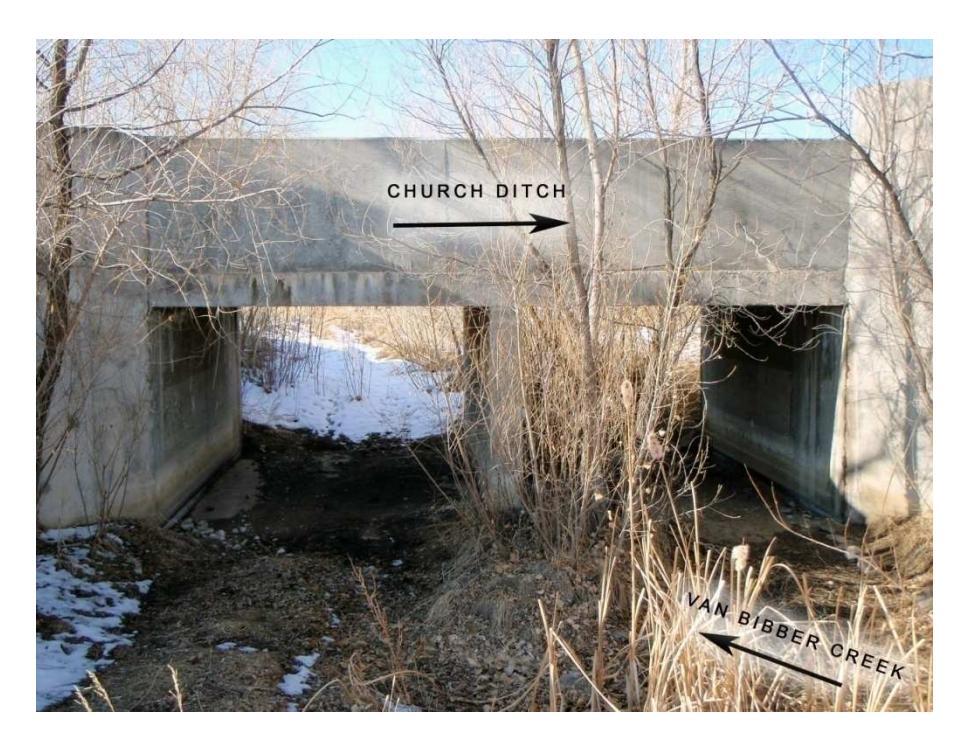
PHOTO 8 - LEAKING AT THE STRUCTURE CROSSING VAN BIBBER CREEK HAS CAUSED COMPLAINTS FROM ADJACENT PROPERTIES

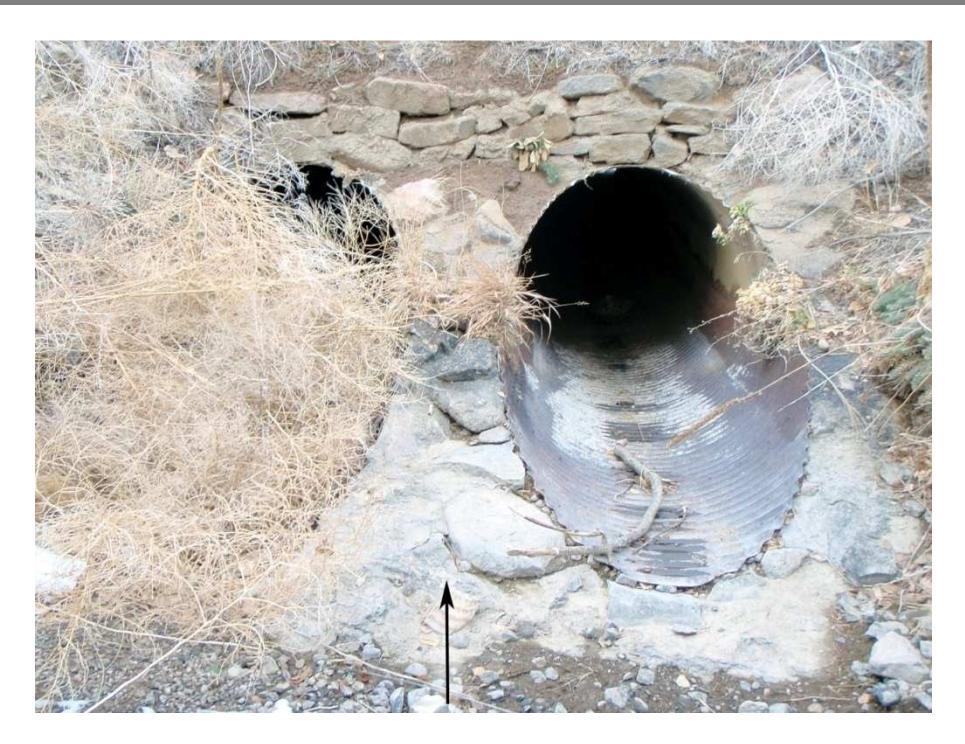
PHOTO 9 – MANY STRUCTURES ALONG THE DITCH DO NOT ALLOW FOR THE PASSAGE OF DEBRIS AND CAUSE BLOCKAGES

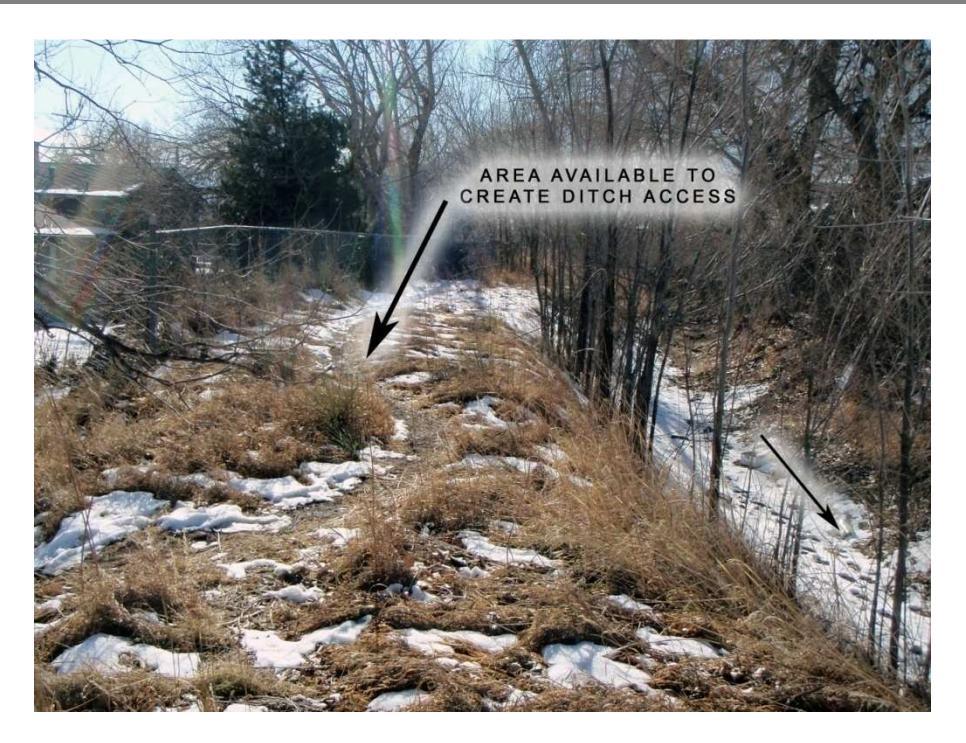
PHOTO 10 - IN SOME AREAS, CONSTRUCTING A ROAD ADJACENT TO THE DITCH IS NOT POSSIBLE DUE TO THE PROXIMITY OF PRIVATE PROPERTY AND/OR EXISTING STRUCTURES

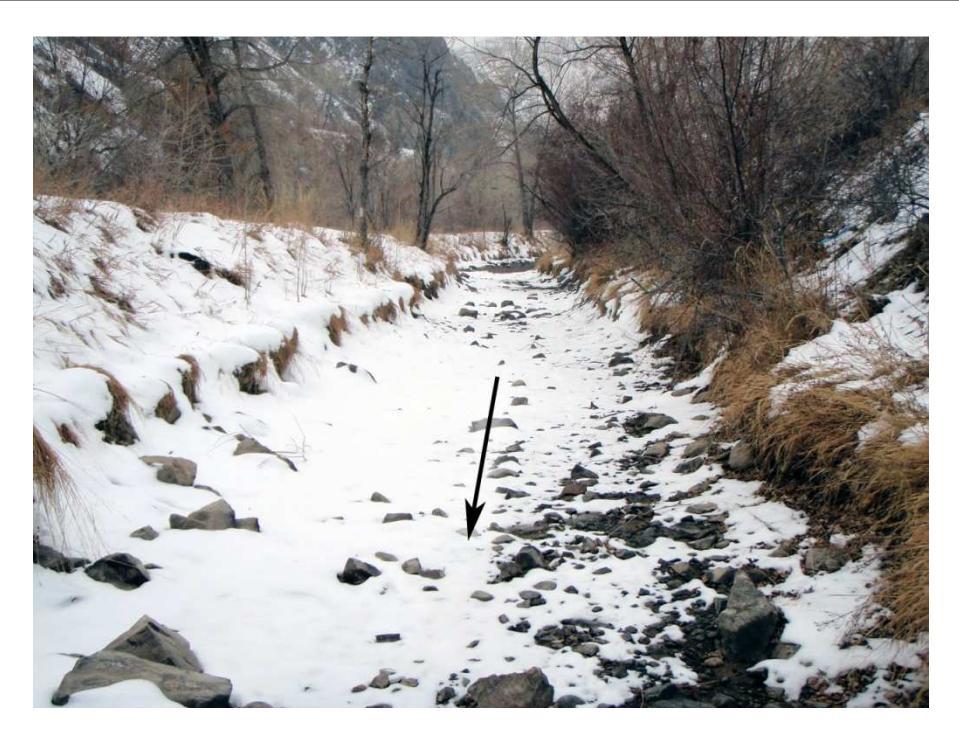
PHOTO 14 – EROSION AND UNDERCUTTING IS PRESENT ALONG THE BANKS OF THE CHANNEL BETWEEN THE HEADWORKS AND THE MEASURING FLUME

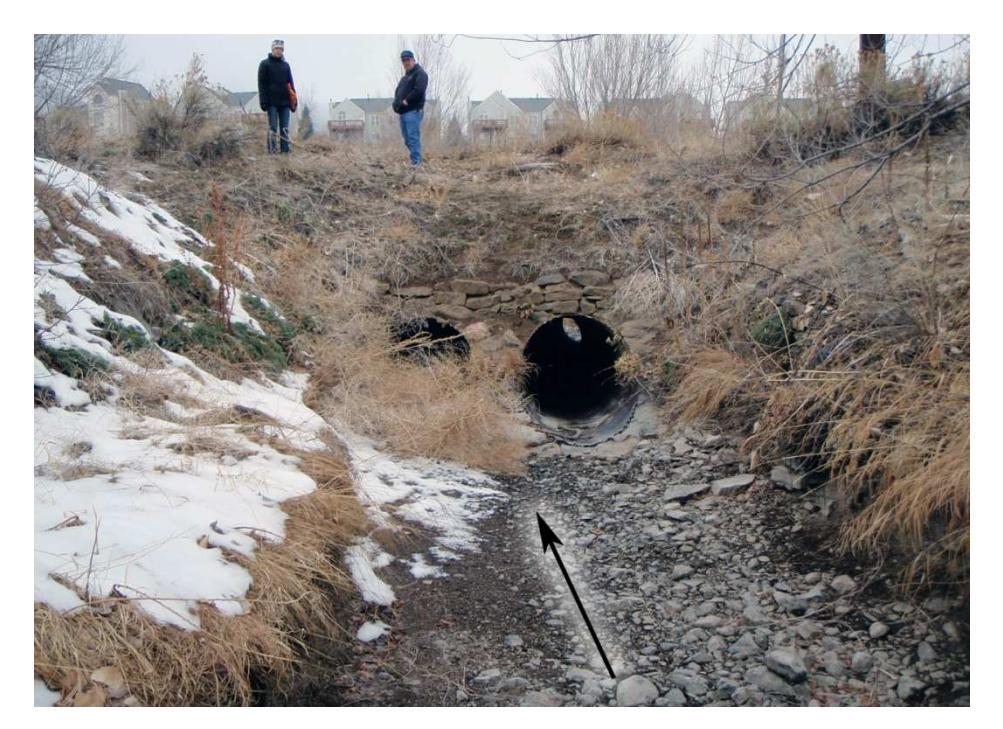
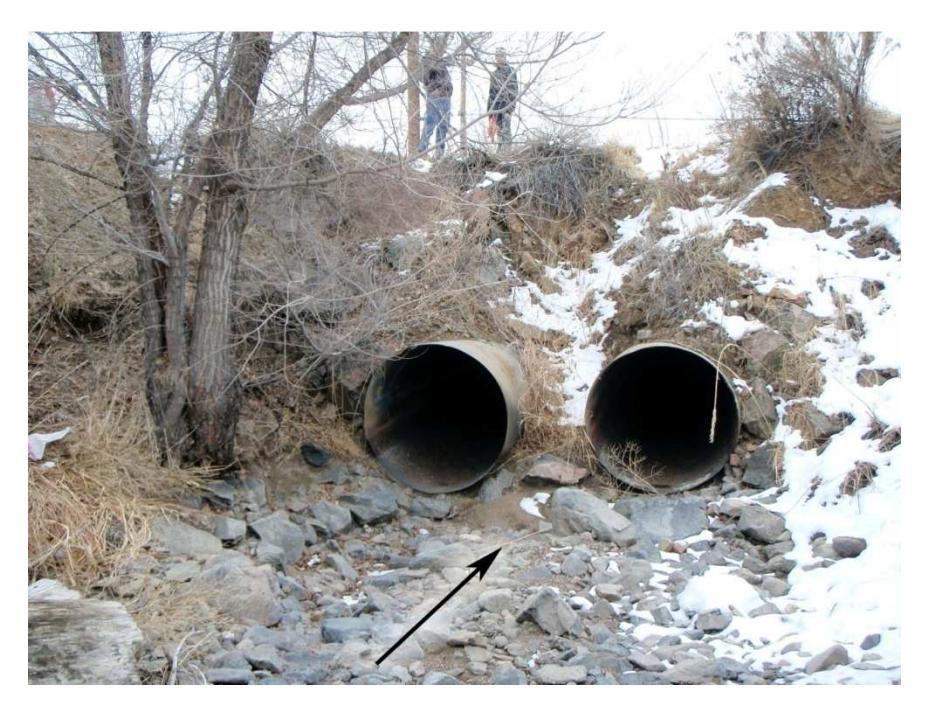
This area consists of a double 48" CMP culvert under 8<sup>th</sup> Street in Golden, CO. The double culvert designs may cause capacity and blockage issues. There is some erosion along the banks of the ditch on both the upditch and downditch sides. Although the erosion is not severe now, it may need to be addressed in the future.

PHOTO 16 - UPDITCH END OF THE DOUBLE 48" CMP CULVERT UNDER 8TH STREET

PHOTO 17 - DOWNDITCH END OF THE DOUBLE 48" CMP CULVERT UNDER 8TH STREET

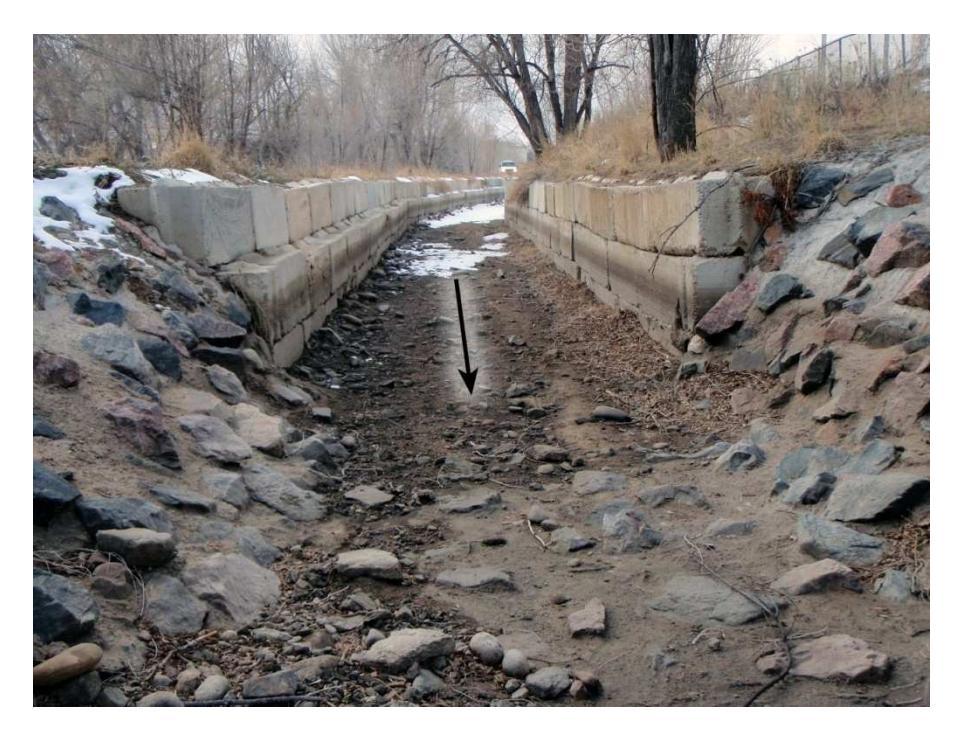
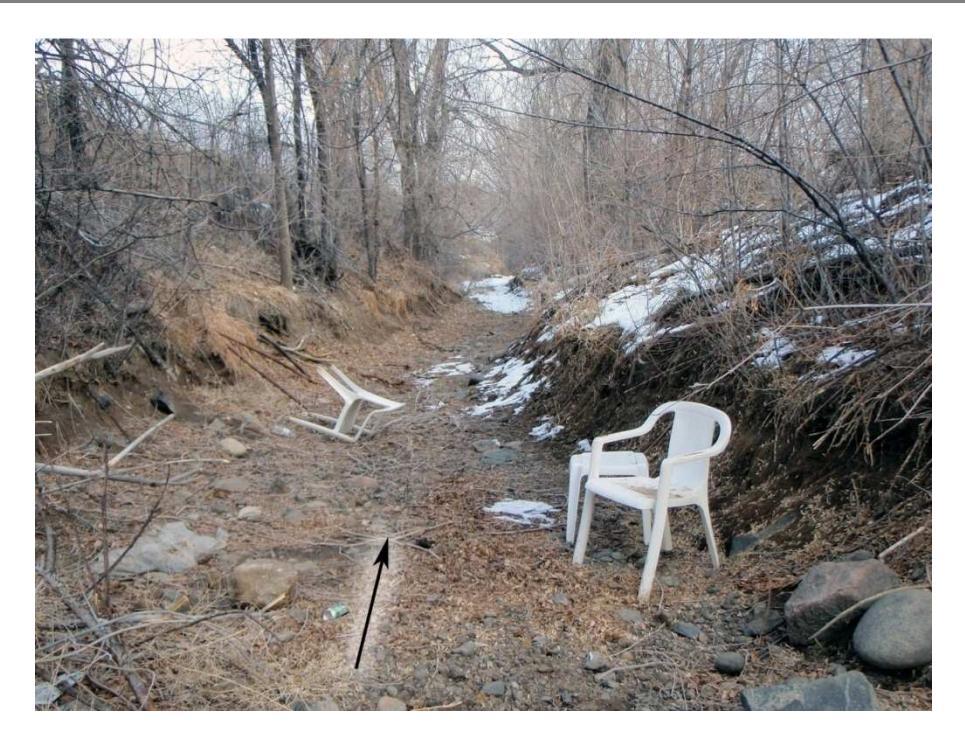
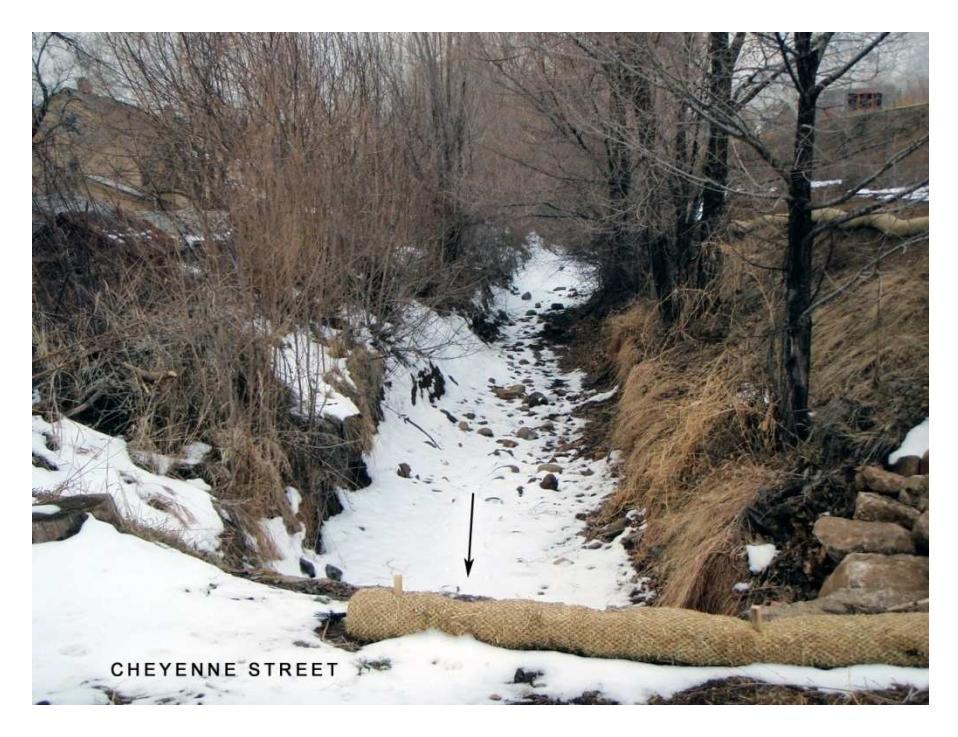
This area lies downditch of an already lined length of ditch. The CDWA has received complaints of seepage from local residents and ditch capacity concerns have been raised by the CDWA. Heavy vegetation is present along both banks of the ditch and debris is present within the ditch. The heavily vegetated banks combined with the ditch's close proximity to the adjacent roadway makes maintenance access very difficult. The extent of the seepage for this area has not been measured. No complaints of seepage along the lined length of the Ditch have been received by the CDWA from local residents.

PHOTO 18 - EXISTING DITCH LINING AND TRANSITION LOCATED UPDITCH OF THIS AREA

PHOTO 19 - CHURCH DITCH DOWNDITCH OF EXISTING DITCH LINING - LOOKING DOWNDITCH

PHOTO 20 - CHURCH DITCH BETWEEN ILLINOIS STREET AND CHEYENNE STREET - LOOKING UPDITCH

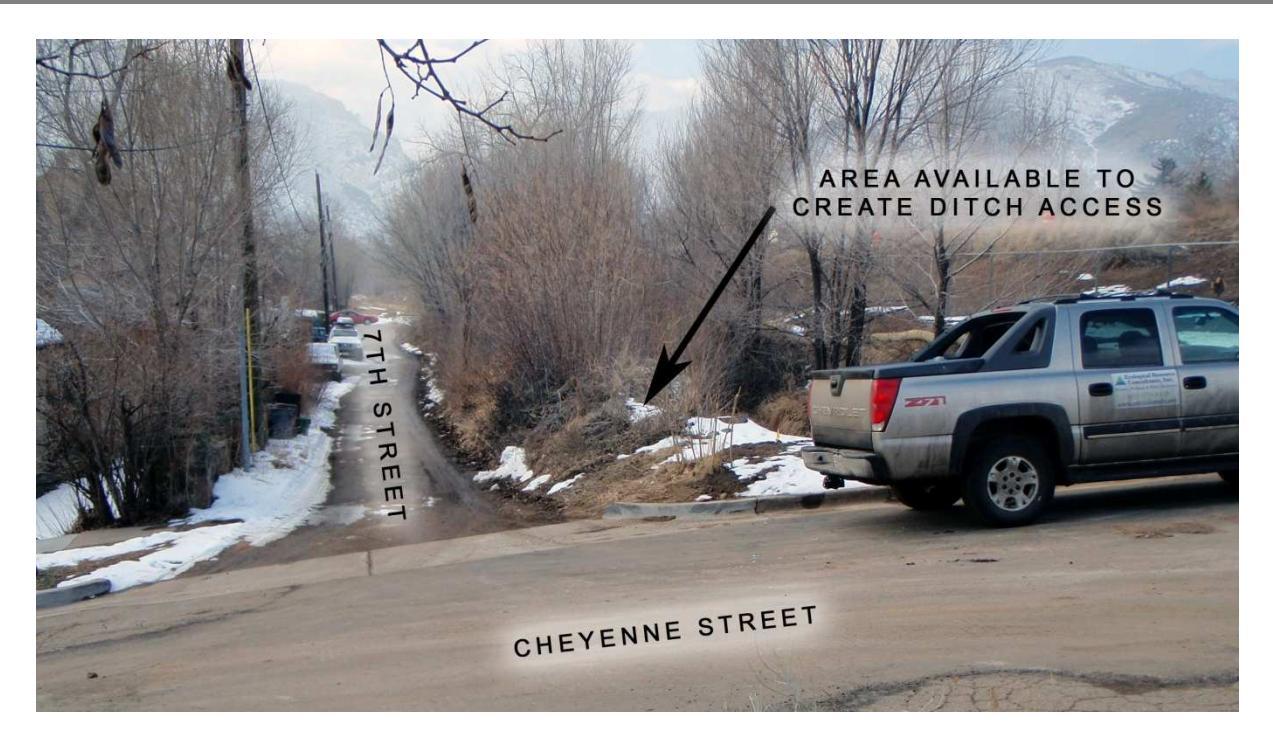
#### PHOTO 21 - LIMITED AREA EXISTS TO CREATE DITCH ACCESS AT THIS LOCATION

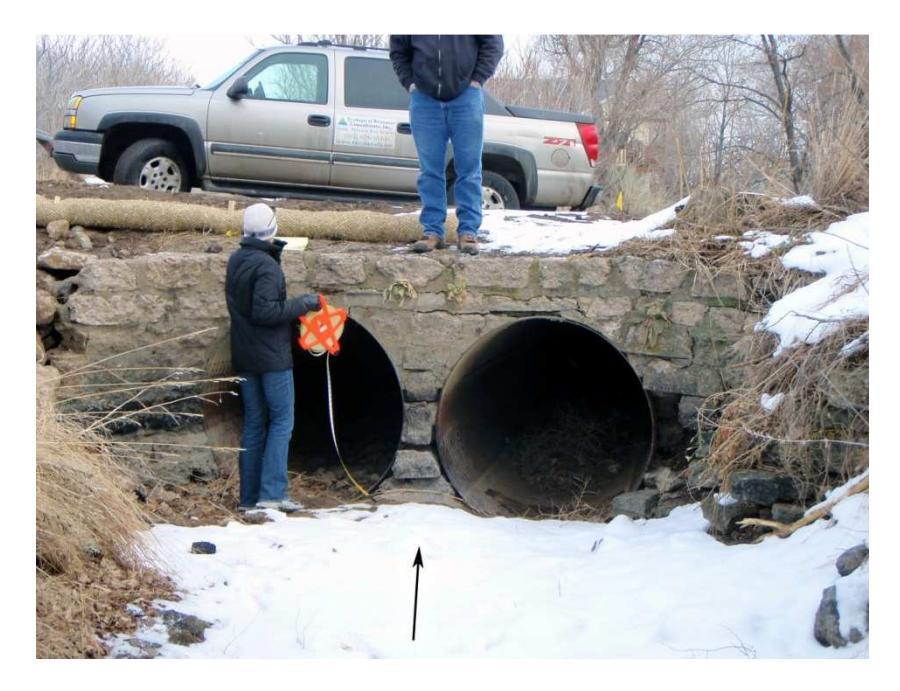
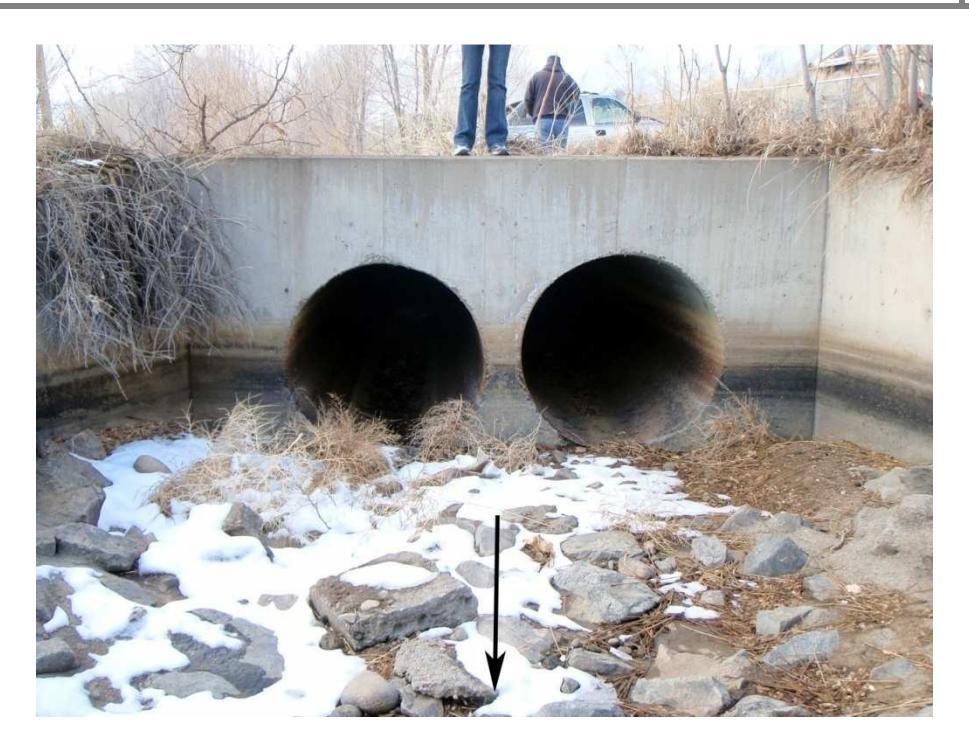
This area consists of a double 48" CMP culvert under Cheyenne Street. The double culvert designs may cause capacity and blockage issues. There is some erosion along the banks of the ditch on both the upditch and downditch sides. Although the erosion is not severe now it may need to be addressed in the future.

PHOTO 22 - UPDITCH END OF DOUBLE 48" CMP CULVERT UNDER CHEYENNE STREET

PHOTO 23 - DOWNDITCH END OF DOUBLE 48" CMP CULVERT UNDER CHEYENNE STREET

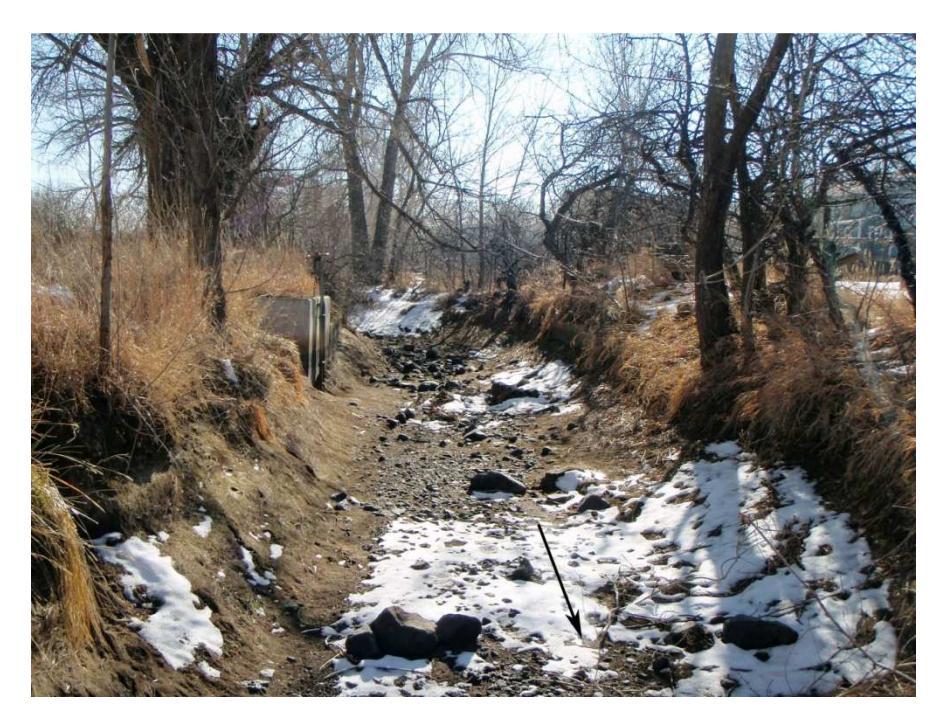
This area begins at W. 50th Avenue and proceeds north to W. 54th Avenue. The bank is actively eroding and bank undercutting is present along most of the ditch. Sedimentation from this erosion is present. Debris is collecting along the bottom of the ditch and may lessen capacity. The ditch's close proximity to private property makes maintenance access impossible. Historically, maintenance has required employees to walk the ditch and manually removing debris.

PHOTO 31 - SEDIMENT BUILD UP IN THE BOTTOM OF THE DITCH IS A RESULT OF EROSION ALONG DITCH BANKS

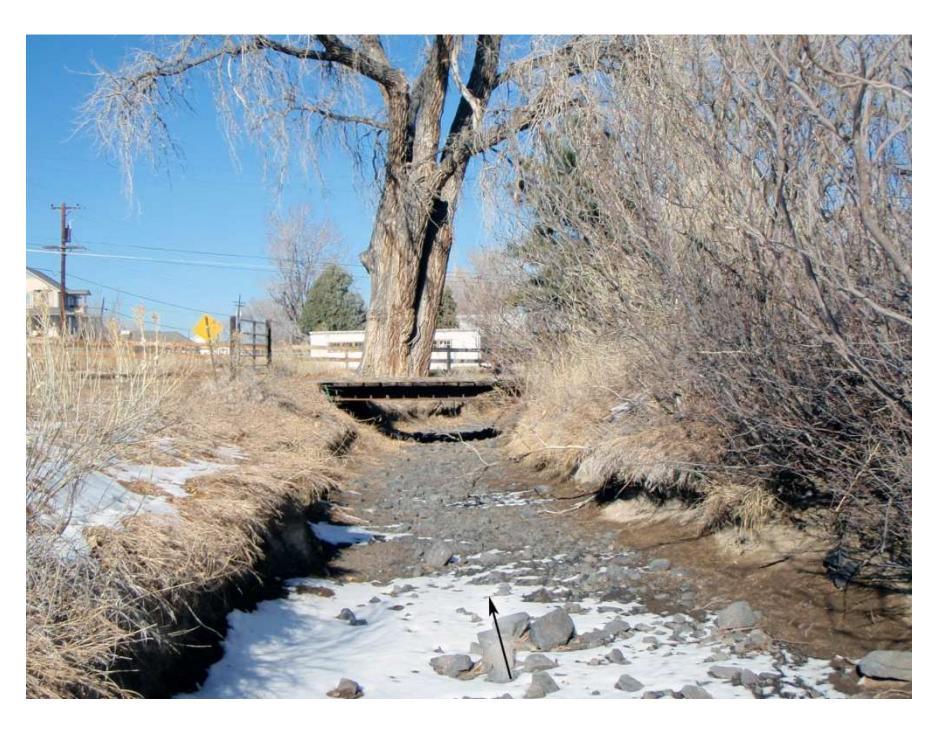
PHOTO 32 – EROSION AND CROSSINGS ALONG THE CHURCH DITCH

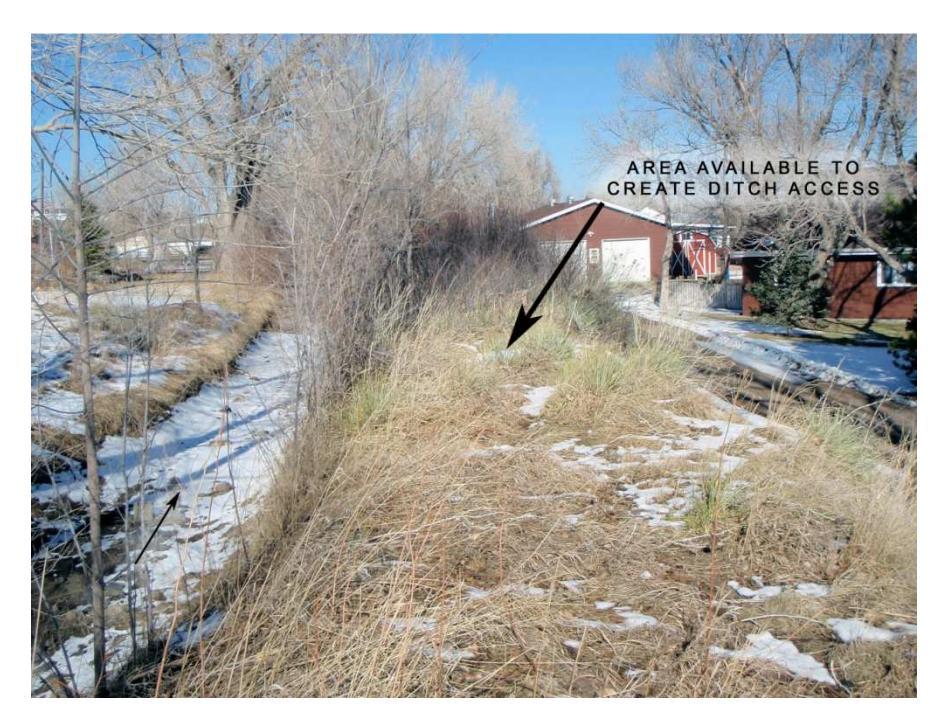
PHOTO 33 – ACCESS TO THE DITCH IS NOT POSSIBLE DUE TO ITS PROXIMITY TO PRIVATE PROPERTY

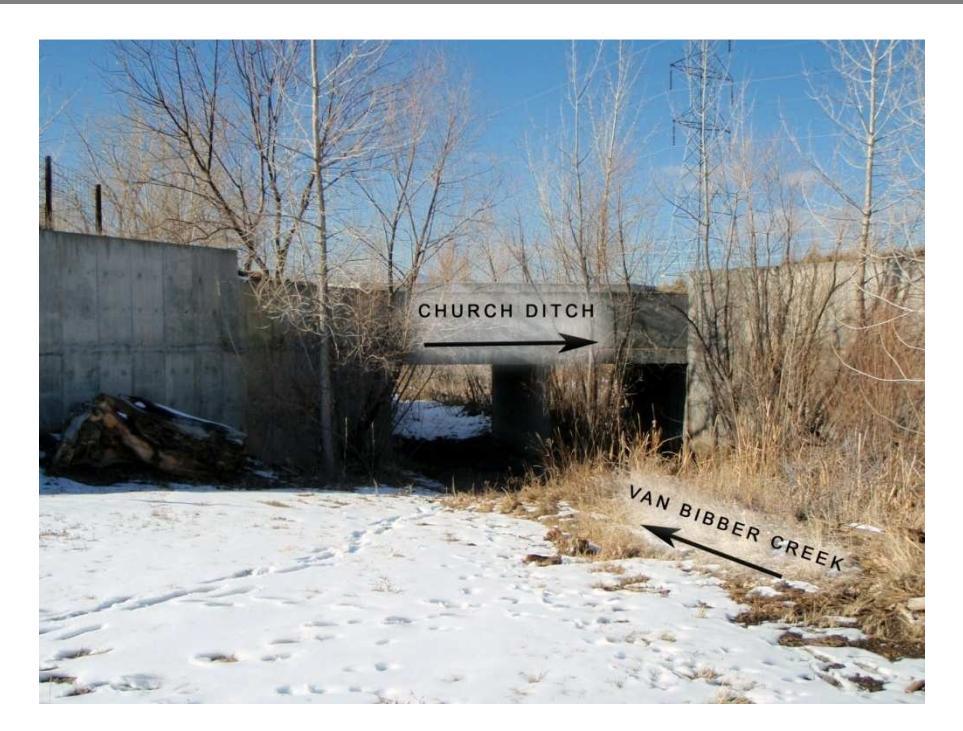
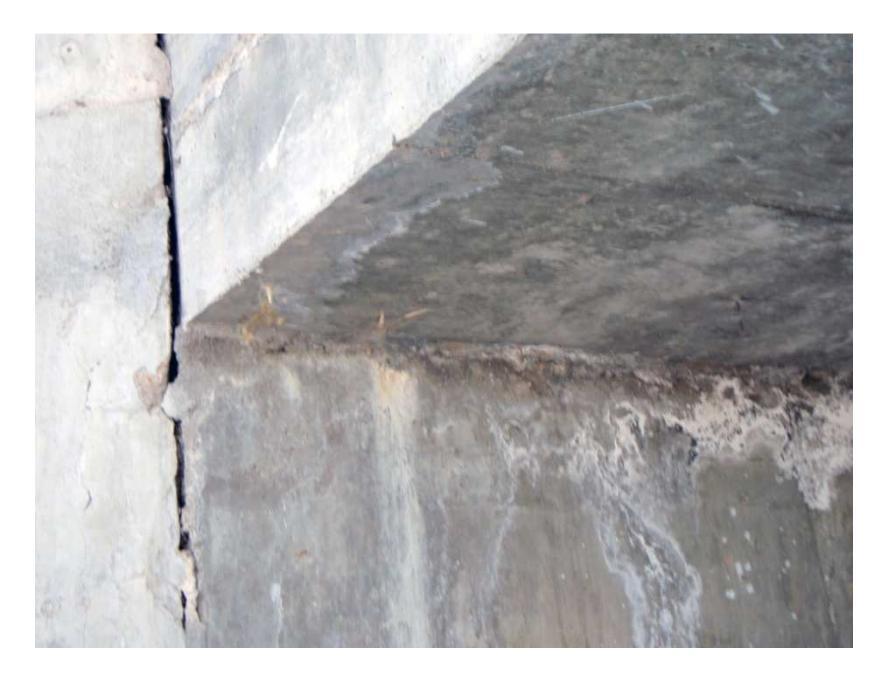
This area consists of a double concrete box culvert structure that allows the Church Ditch to cross over Van Bibber Creek. There have been complaints, from local residents, regarding leaking at this structure. Visual indications of leaking at the joints are present.

PHOTO 34 – CONCRETE STRUCTURE OVER VAN BIBBER CREEK

#### PHOTO 35 – TYPICAL SIGNS OF LEAKING AT JOINTS

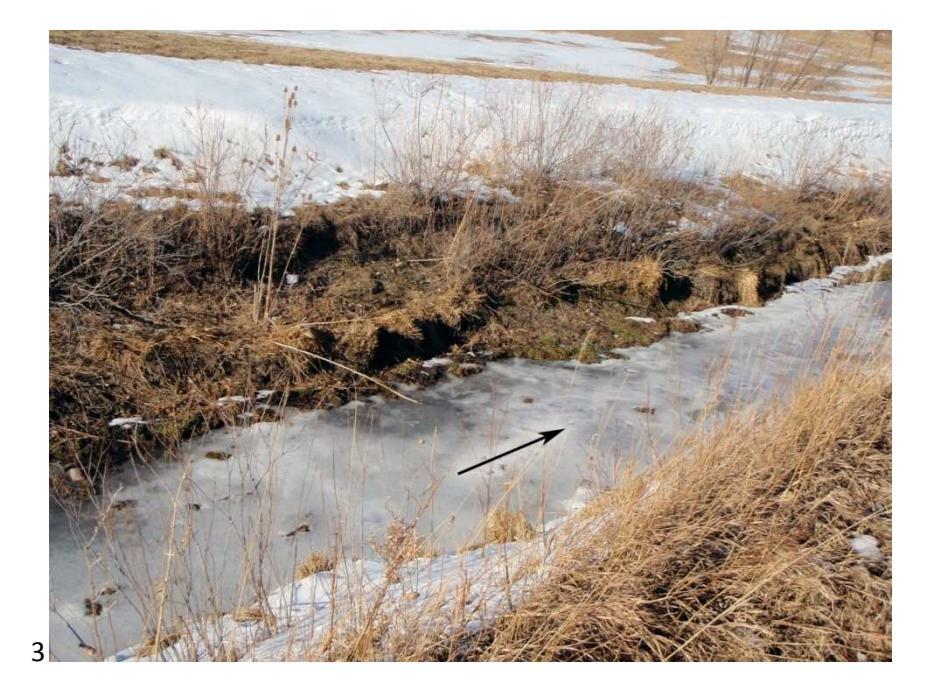
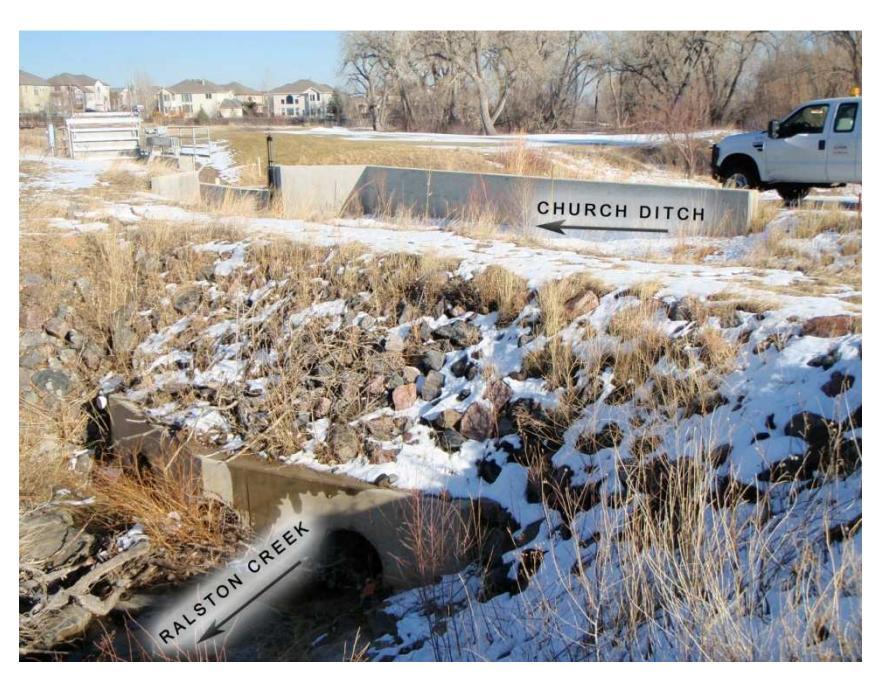
This area consists of a length of open ditch that runs through the West Woods Golf Club. It includes pedestrian bridge crossings, road crossings and the Ralston Creek crossing. Active erosion is occurring on many of the ditch banks and has led to bank undercutting and sedimentation along the ditch bottom. Concern was raised during the inspection that the embankment along the Church Ditch's ditch left as it crosses over Ralston Creek may not be adequate and may fail during a large storm event.

### PHOTO 37 - EROSION TYPICAL OF THIS LENGTH OF THE DITCH

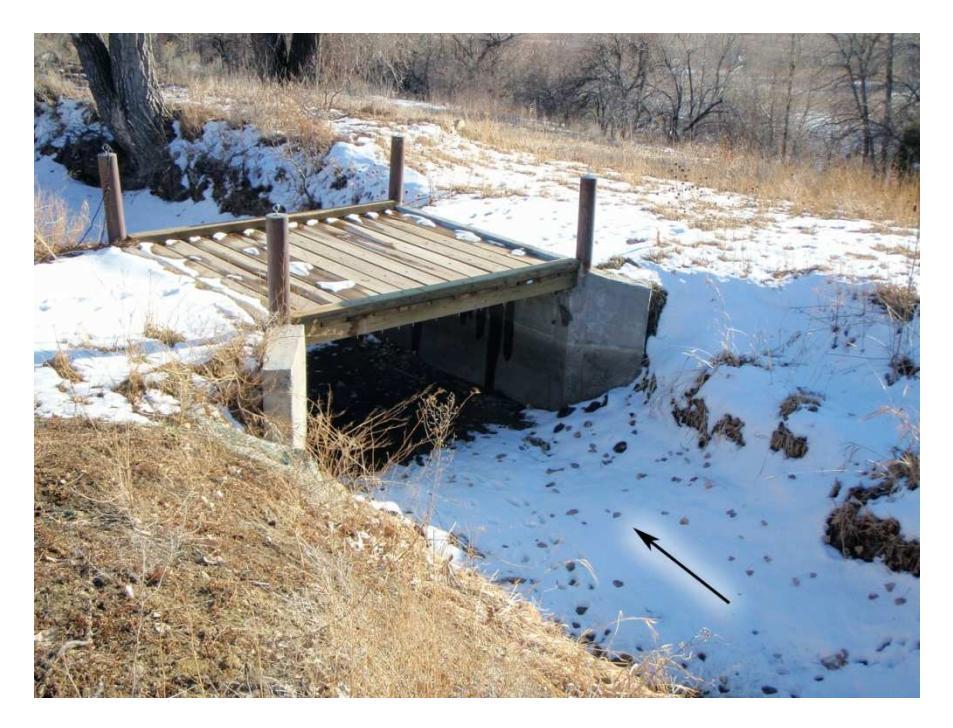
A 10'x4.5' bridge crossing was constructed without CDWA's consent or the determination of its impact on the Church Ditch. This area is located on private property owned by Tom Campbell.

PHOTO 39 – BRIDGE CONSTRUCTED OVER CHURCH DITCH ON THE TOM CAMPBELL PROPERTY

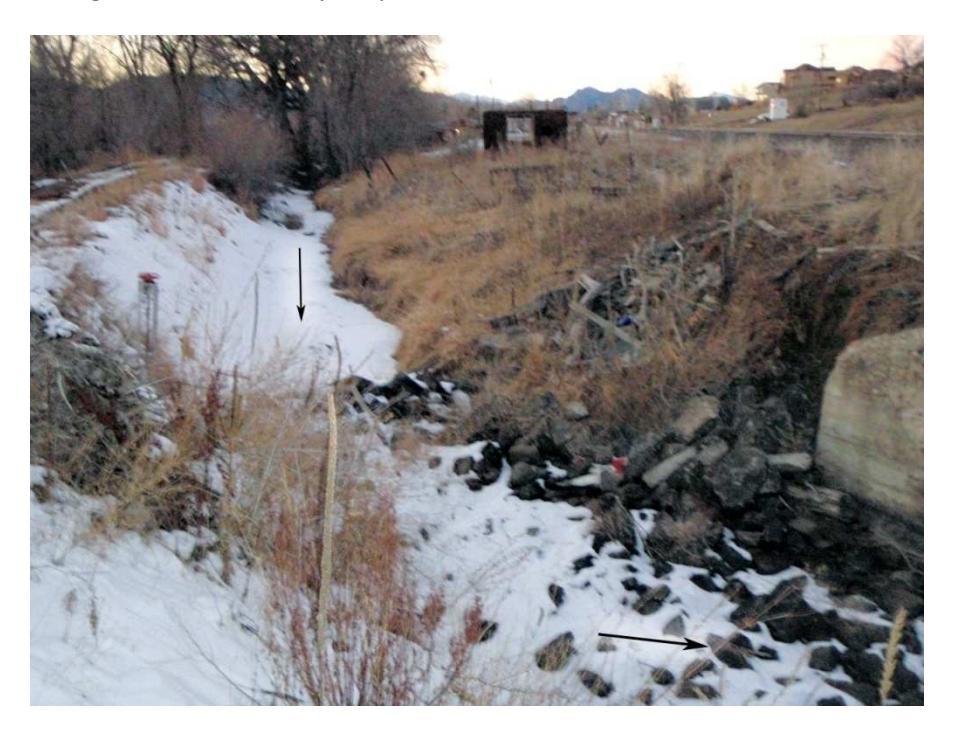
PHOTO 40 – DEBRIS HAS BEEN DISCARDED BY RESIDENTS ONTO THE DITCH BANKS UPDITCH OF THE RAILROAD CROSSING

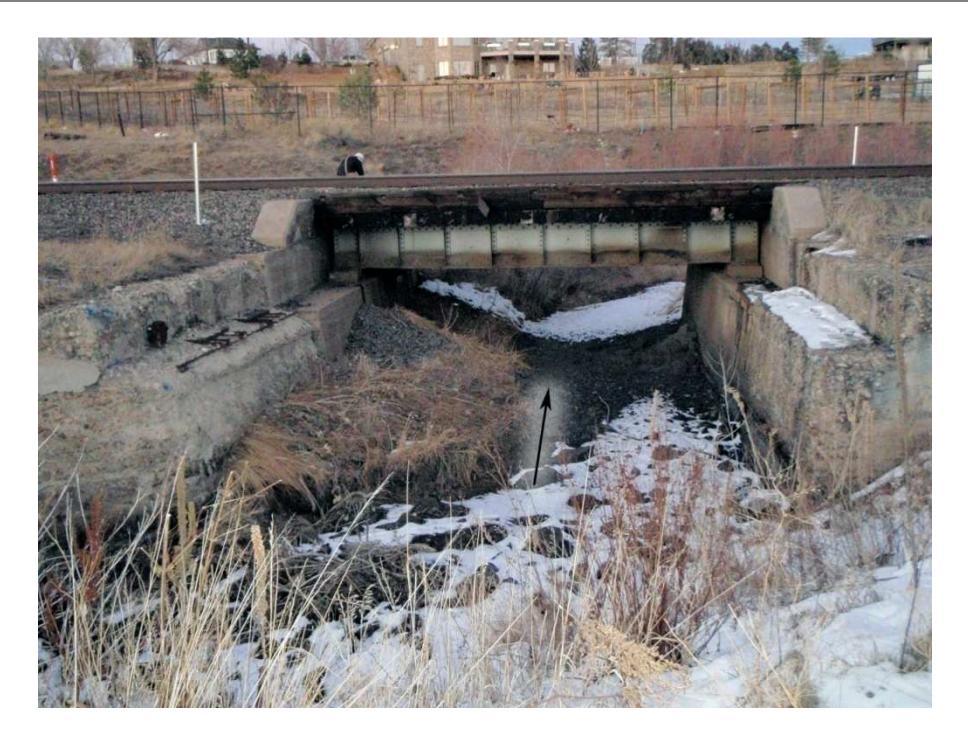
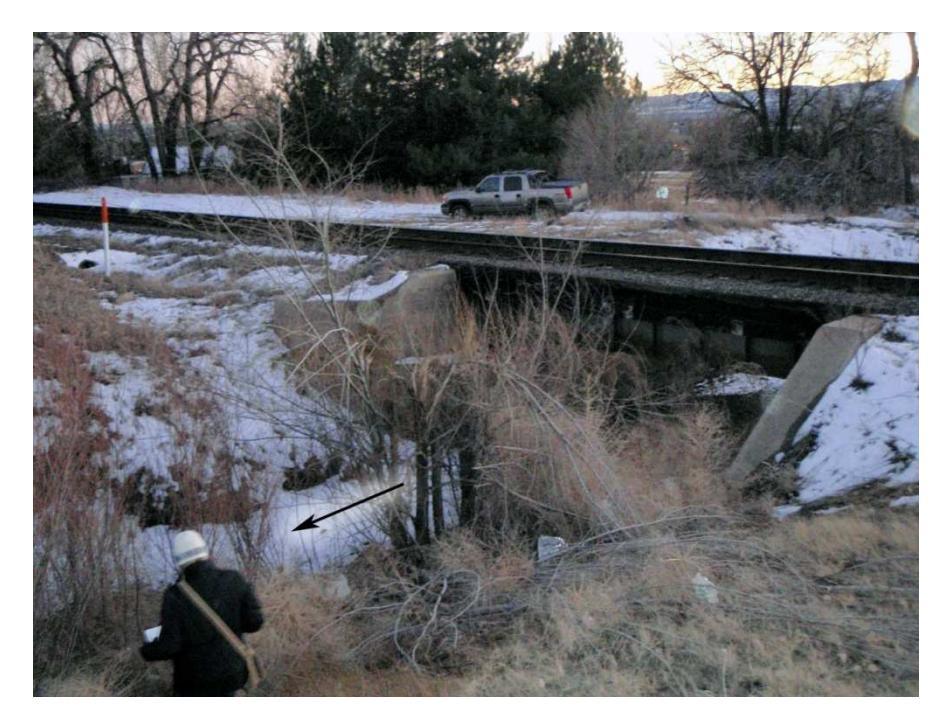
A railroad track owned by the Burlington Northern Santa Fe Railway crosses the Church Ditch in this area. The Ditch flows south east and then turns northeast to flow under the crossing. It then turns southeast as it leaves the crossing and continues southeast. Debris has been deposited by residents on both banks upditch of the crossing. Heavily vegetated banks and sedimentation is apparent on both the upditch and the downditch ends of the crossing. There are concerns that the crossing may cause capacity issues. A more in depth analysis, including a HEC-RAS model, may be needed to determine the full impact of the alignment on ditch capacity.

PHOTO 41 – UPDITCH END OF RAILROAD CROSSING

PHOTO 42 – DOWNDITCH END OF RAILROAD CROSSING
