# 2009

# Church Ditch Master Plan

#### Ecological Resource Consultants, Inc.

Church Ditch Water Authority

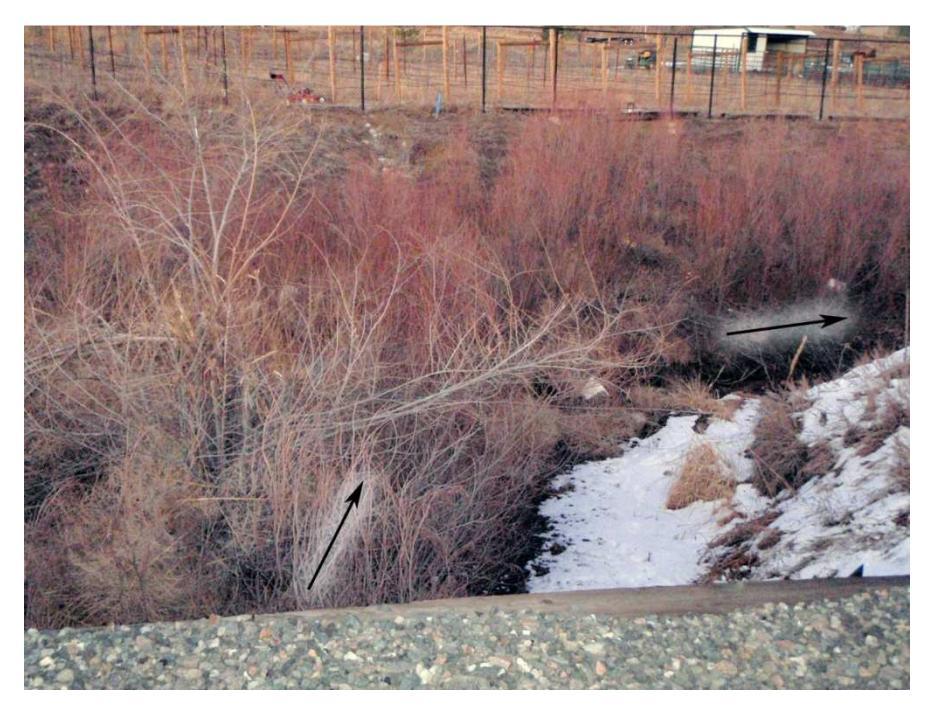
PHOTO 43 – VIEWING THE DITCH FROM THE DOWNDITCH END OF THE RAILROAD CROSSING THE EXCESS VEGETATION LOCATED IN THE FLOW AREA IS APPARENT

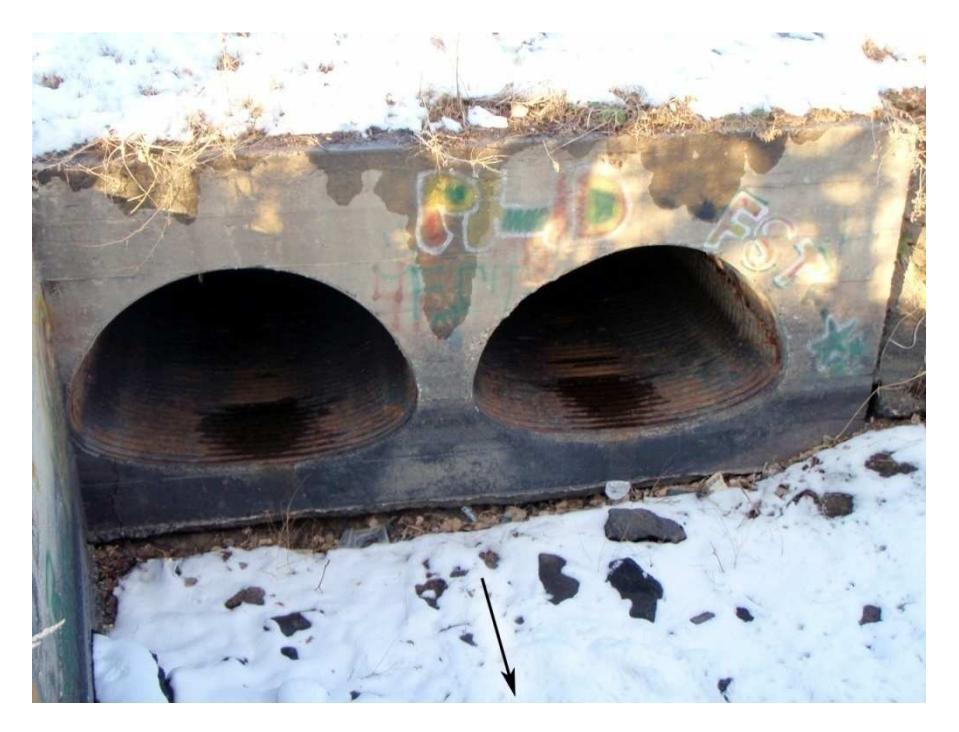
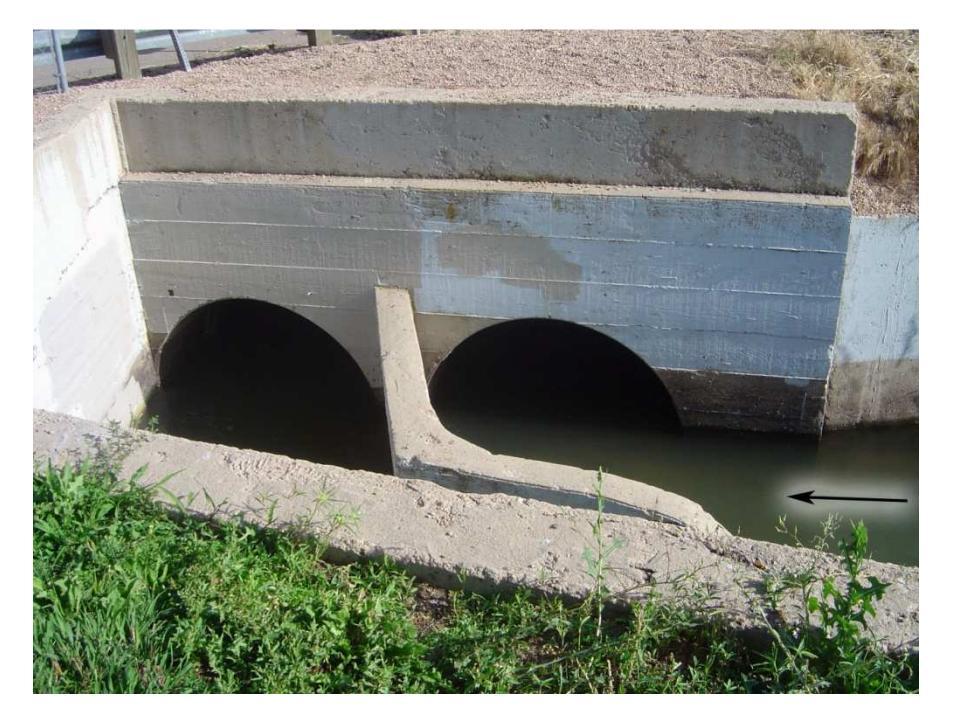
This area consists of a double 55" concrete box culvert that crosses under W. 74th Avenue. A wall is located between the two pipe openings on the upditch side and splits the flow between them. The ditch flows east until taking an approximately 90° turn to flow south through the culvert. Upon leaving the culvert, the ditch takes another approximately 90° turn and again flows east. Some active erosion is occurring upditch and downs ditch of the culvert and has caused bank undercutting. In the past, blockages have occurred at the upditch end of the culvert primarily when the Ditch is brought online on if someone was not there before the flow reached it to remove debris. The blockage has been large enough to stop flow in the ditch completely. A more in depth analysis, including a HEC-RAS model, may be needed to determine the full impact of the culvert alignment.

PHOTO 45 – DOWNDITCH END OF 55" DOUBLE CULVERT UNDER W. 74<sup>TH</sup> AVENUE

PHOTO 44 – UPDITCH END OF 55" DOUBLE CULVERT UNDER W. 74<sup>TH</sup> AVENUE

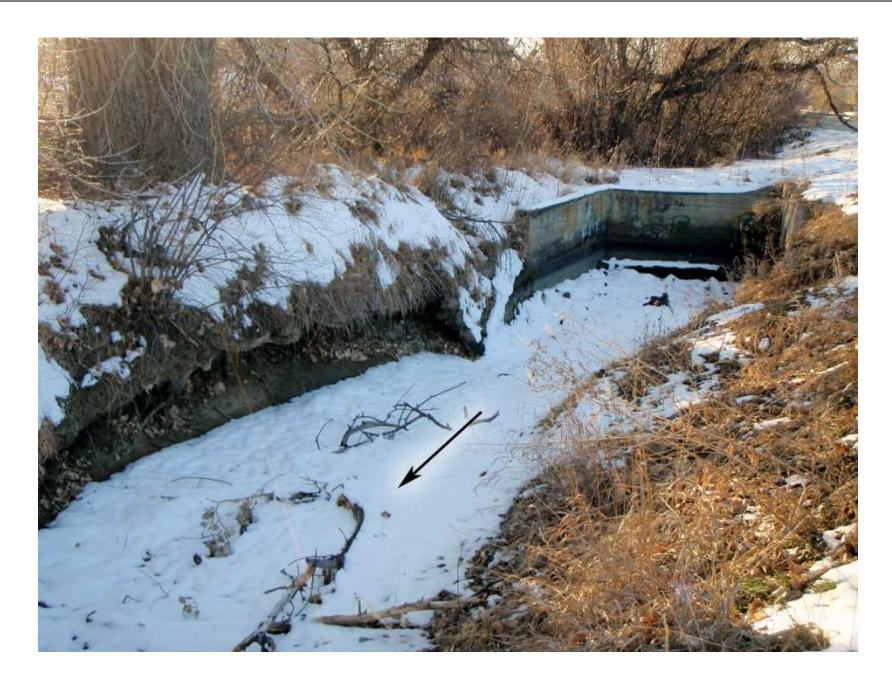
PHOTO 46 – A SHARP BEND, LIKE THIS ONE SEEN LEAVING THE DOWNDITCH END OF THE CULVERT, CAN ALSO BE FOUND ON THE UPDITCH END OF THE CULVERT

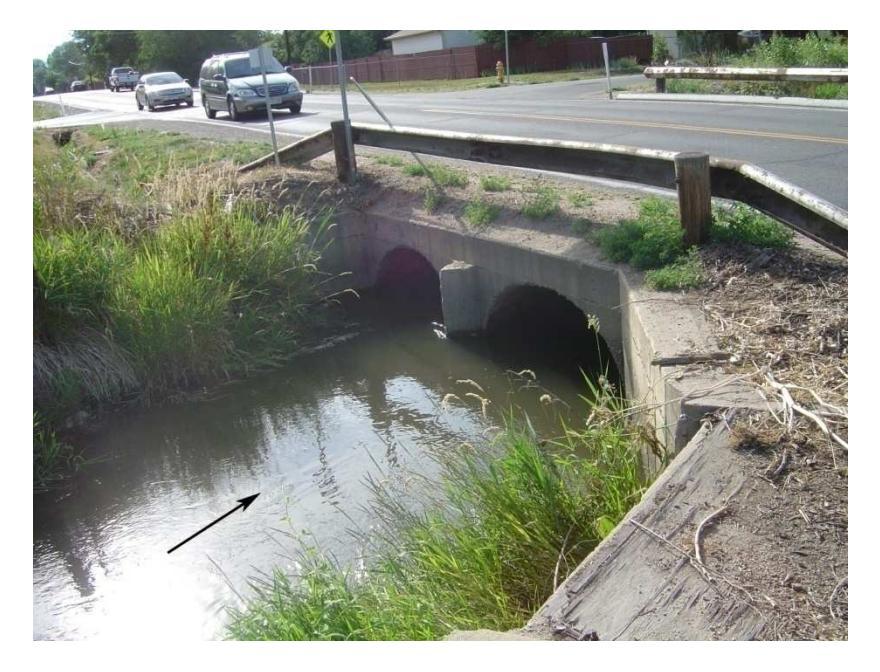
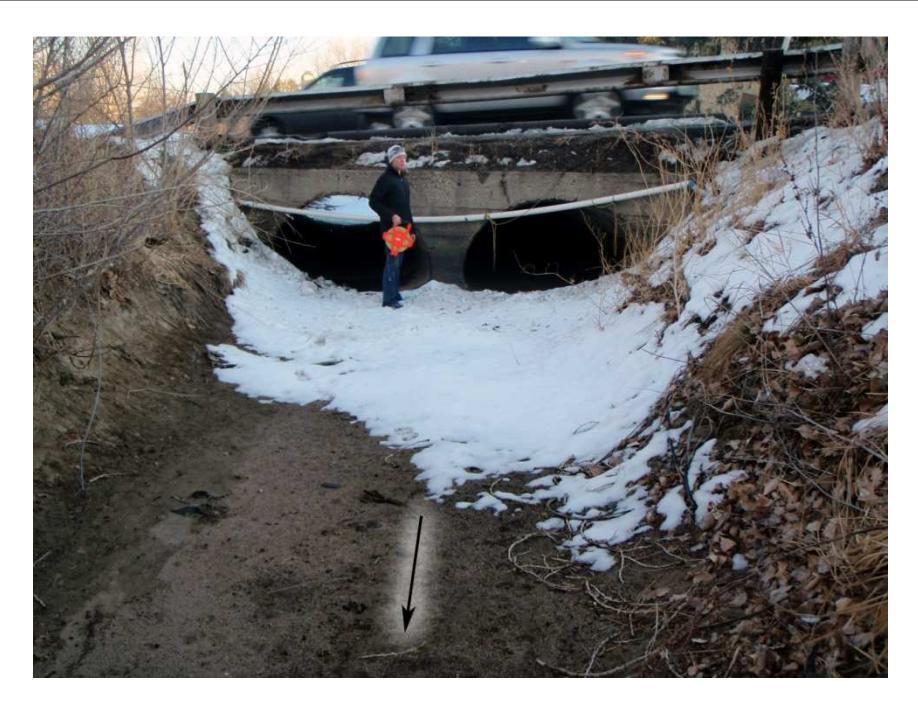
This area consists of a double 48" CMP culvert under W. 80<sup>th</sup> Avenue. The double culvert design may cause capacity and blockage issues. There is some erosion along the banks of the ditch on both the upditch and downditch sides. Although the erosion is not severe now it may need to be addressed in the future.

PHOTO 47 – UPDITCH END OF 44" DOUBLE CULVERT UNDER W. 80<sup>TH</sup> AVENUE AT NEWMAN STREET

PHOTO 48 – DOWNDITCH END OF 44" DOUBLE CULVERT UNDER W. 80<sup>TH</sup> AVENUE AT NEWMAN STREET
