ECO-HYDROLOGICAL ANALYSIS & RESTORATION PLANNING

SOMERS BRANCH OF THE PIKE RIVER

March, 2014

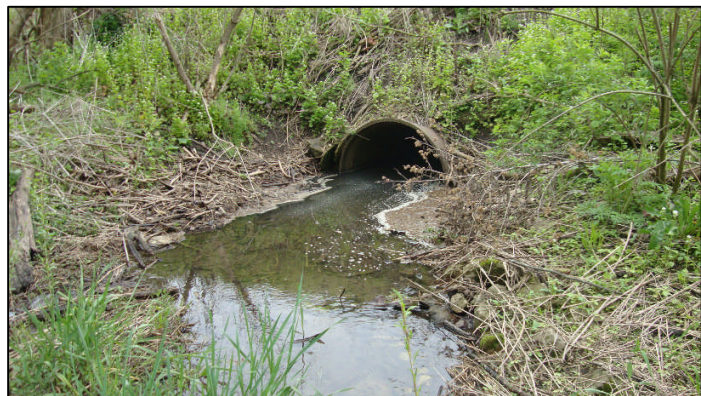
Culvert under Canadian Pacific Railroad bed at Neumiller Woods, spring, 2012

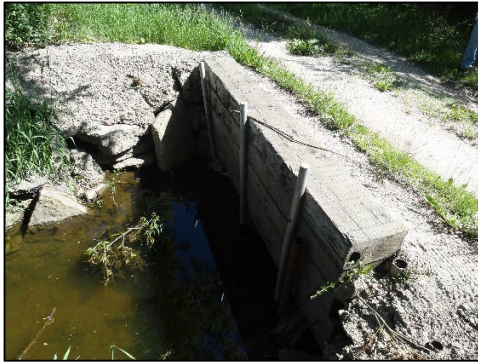
Culverts under Maintenance access drive east of C.-P.R.R tracks, spring, 2013

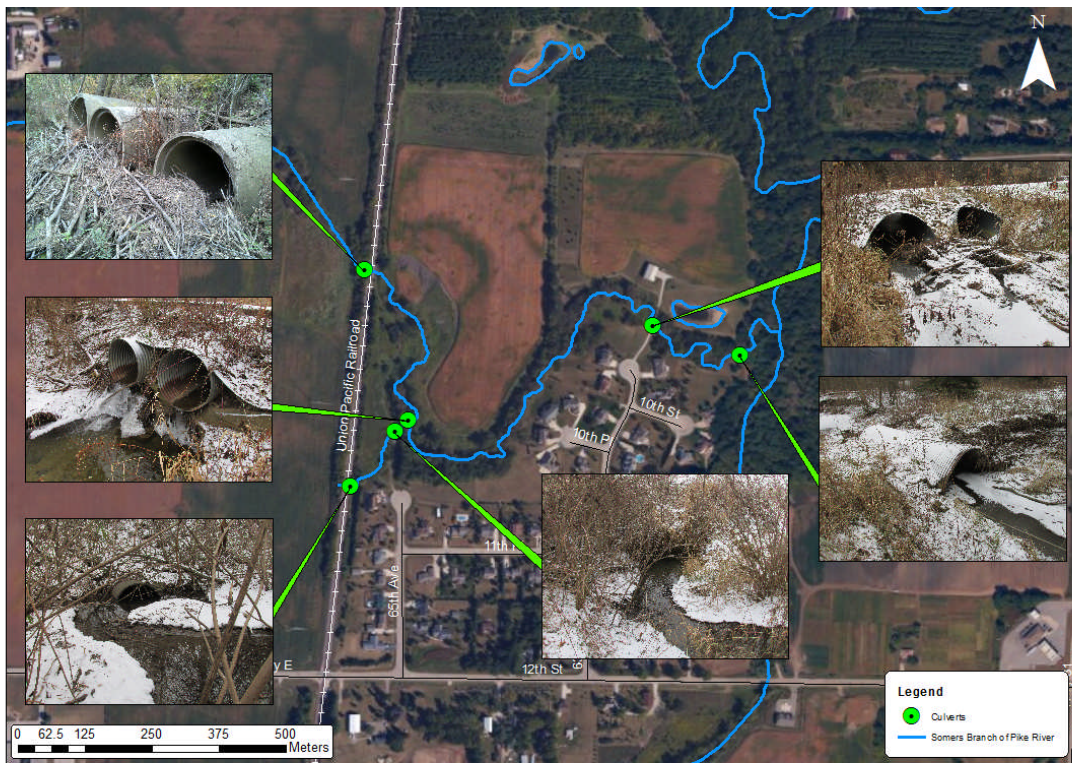
Figure 17- Stream Crossings and Culverts on Somers Branch near Union Pacific RR to Confluence with Pike River

under the Union Pacific Railroad also appear to be undersized (Figure 17) and collect debris, which can also reduce their capacity. Other small culverts under private driveways also collect debris.

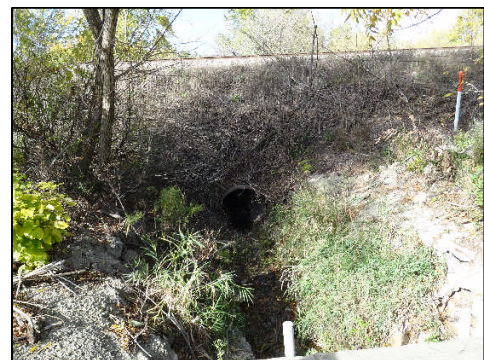
As mentioned above, the consequences of restricted flows resulting from undersized culverts can be observed both in flood elevation levels and in stream sedimentation and erosion patterns. The decrease in peak flows at the Canadian Pacific (CP) Railroad, as shown in Table 1, are due to the limited capacity of the 48-inch diameter culvert crossing beneath the railroad and the resulting floodwater detention storage that occurs upstream.

48 inch culvert under of C.-P.R.R tracks, from Gitzlaff side facing west, spring, 2013

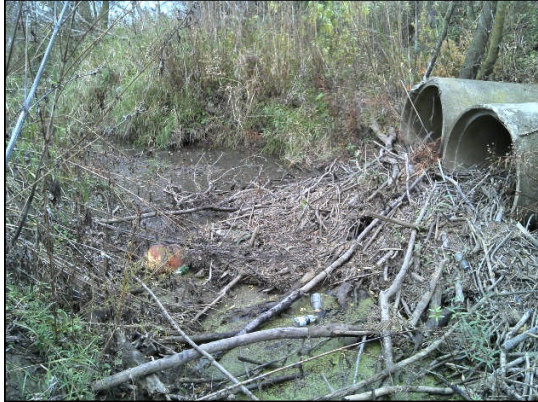
Woody debris under of Union-Pacific RR tracks, on west side of tracks fall, 2013

Areas of tree falls and woody debris were noted on our October 2013 field review and on Figure 22. The most conspicuous area of debris is trapped west of the Union Pacific Railroad (see photos on to left). The culverts are set high and debris accumulates at this point. *Salix fragilis*, or crack willow, is an introduced species that has become naturalized and is the most common willow in southern Wisconsin (The University of Wisconsin-Green Bay, 2004). This dominant tree on the stream is very hardy in wet areas and holds soil on the banks. However once it matures into a multiple branched tree, the soft wood cracks under its weight and falls to the streambed creating debris.

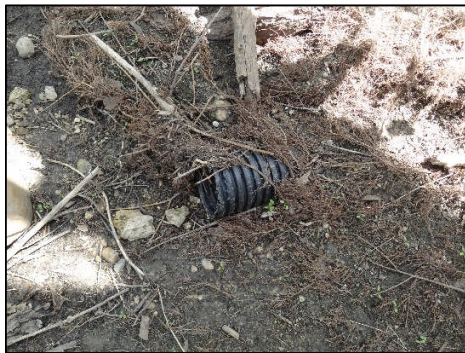
Drain tile outlets into Somers Branch from the south field at Gitzlaff, above and right

Seven tile locations were found on the south side of the stream, and one tile on the north side of the stream. Some are newer plastic pipe as shown on the photo to the left, others were clay tile that would be an older installation. There were multiple other suspicious areas that appeared as washout areas or eroded channels on the north but we could not confirm tile in them. Tile lines can become buried over time. As shown on Figure 26 drain tile lines are also present adjacent the Gitzlaff property on both the east and west fields south of the stream. These tiles drain the former wetland areas and facilitate agriculture.

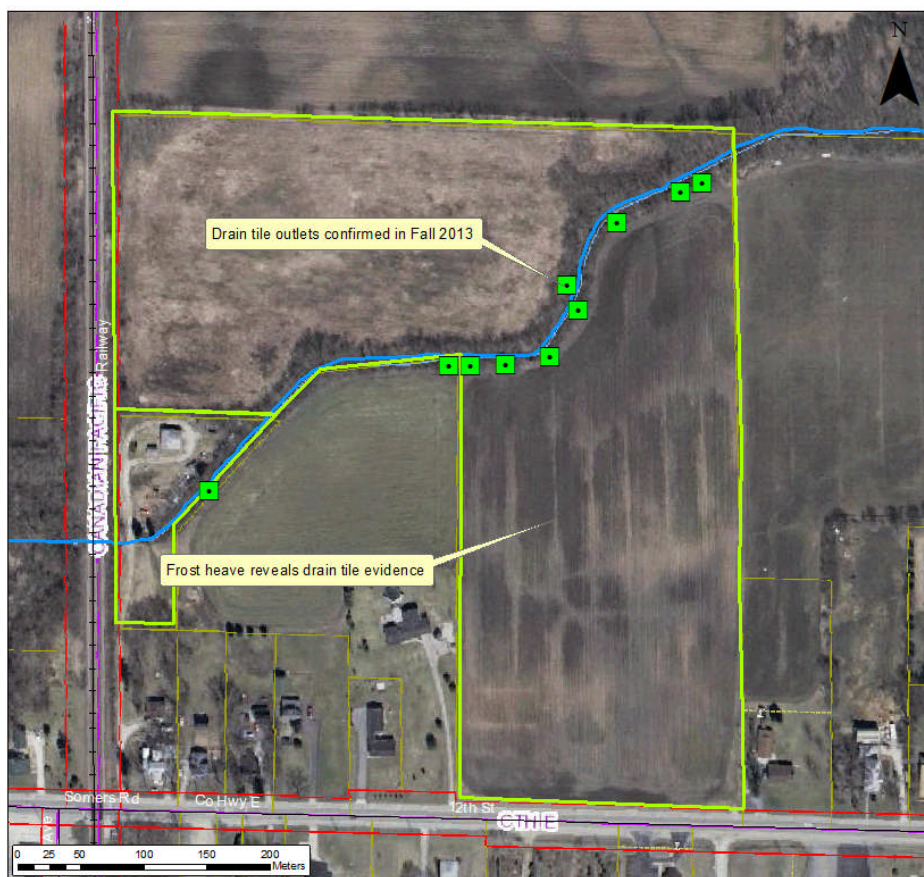
Figure 26—Gitzlaff Drain Tile Locations
(Data Source: 2005 aerial, Kenosha Co., 2013 field reconnaissance)

Sub surface drain tiles are visible in the south field of Gitzlaff on the Kenosha County 2005 aerial (Figure 26). Drain tiles are characteristic on aerial photos as regularly spaced white lines running perpendicular to the stream as an artifact of winter frost heave in a plowed field. They are not noticeable on the north field as there is permanent plant cover by 1990. Rachel Samerdyke of the U.S. Fish and Wildlife Service assisted us in locating tile outlets entering into the stream on November 13, 2013.

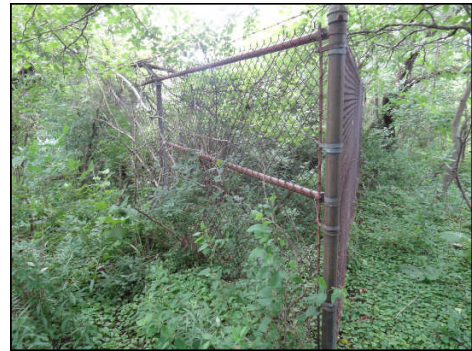
Maintenance yard fence blocks access to north side of Gitzlaff

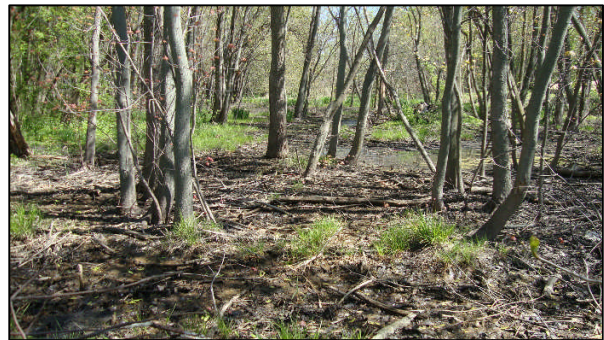
Woody debris in Neumiller Woods
