### Architectural and Structural Needs Assessment The Towers, 1110 3rd Avenue North Fargo, North Dakota Issued: May 15, 2018

Re: Architectural and Structural Needs Assessment for The Towers Condominium

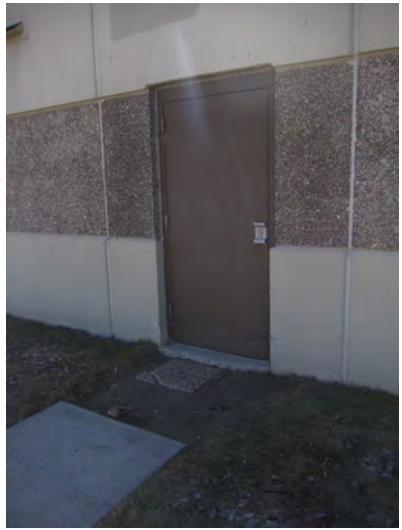
*Exit door from stair/passage at the east tower. A stoop should be provided.*

**Sidewalks & Drop-off** The sidewalks and drop-off along the north and east side of the building are in good condition. The missing section of concrete outside the exit door at the east end of the exit passage at the east tower should be replaced. Upon review of the existing drawings it does not appear a stoop was provided at this exterior door. Without a stoop the concrete is subject to heaving which could prevent the exit door from opening, which may be why it was removed. It is recommended a concrete stoop and cap be added at this door.

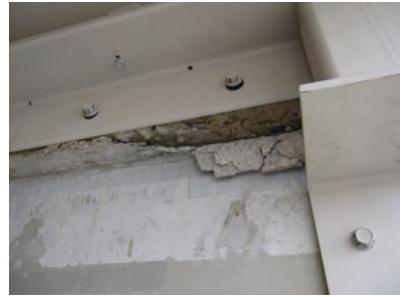
*Deteriorated portion of original precast balcony.*

**Remaining Portion of Concrete Balcony** The portion of the original concrete balcony that remained is deteriorating in some locations. T.F. Powers Construction Co. is working with Vector Construction to identify, evaluate and repair the concrete where deterioration is occurring.

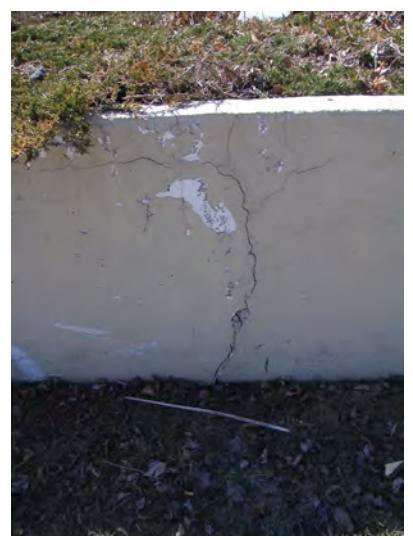
Vertical crack at raised planter wall.

**Cast-in-Place Concrete Foundation** Due to the footings being below grade, SSE could not observe the conditions of them. The foundation walls for the raised planters have some vertical cracks in them and are generally in fair condition. These cracks should be sealed from the inside of the planter to prevent water infiltration which can lead to freeze thaw cycles which may can deteriorate the concrete quickly.

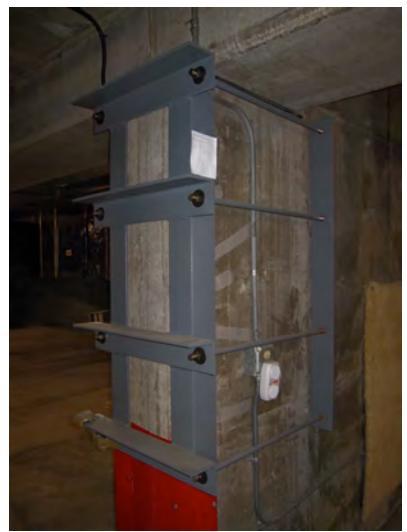
Cast-in-place concrete column reinforced with steel angles and tie rods.

**Cast-in-Place Concrete Columns** Some of the concrete columns in the parking garage area have previously been reinforced with steel angles and tie rods. Due to not seeing the condition of the columns at the time of the repairs, SSE cannot say for certain that the repairs are sufficient, but no newer looking cracks could be found. The remaining columns in the parking garage appeared to be in generally good condition.

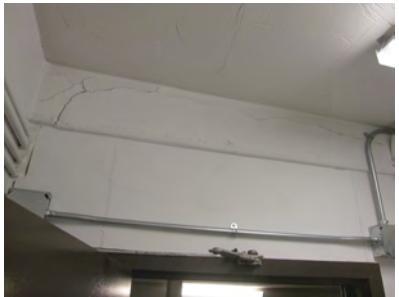
Cracks at 9<sup>th</sup> floor laundry room.

**Precast Concrete Plank (Roof & Floor)** At many levels the precast floor plank has some cracks in the laundry room area. Most of the cracks are just shrinkage cracks because this area is framed with 4" solid precast slabs. These cracks are not a structural concern. There are also some cracks at the transition from the 4" solid slab to the 12" precast plank. This is likely due to having two elements of much difference stiffnesses right next to each other. Also at this transition point there is grout on the face of the 12" plank that has some shrinkage cracks in it. These are all serviceability issues and not structural issues; therefore, no action is required.

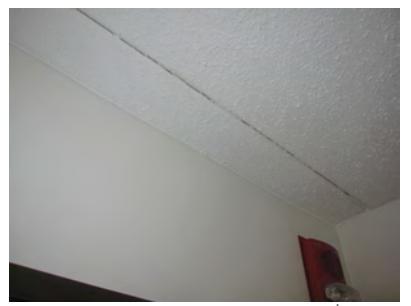
Crack in the sealant joint at the 5<sup>th</sup> floor west corridor.

The majority of the plank on the upper levels is not exposed so SSE could not observe the conditions of it. In most of the hallways there are cracks in the sealant joint between pieces of planks. This is a serviceability issue and not a structural issue.

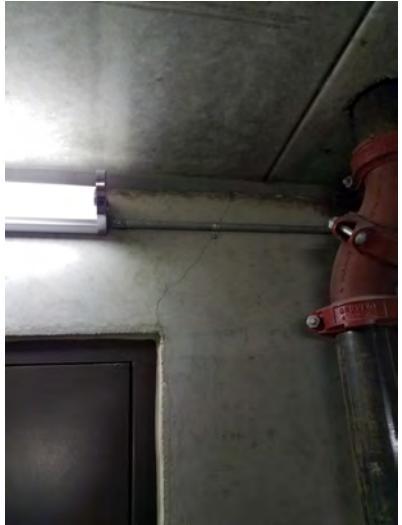
Minor cracking at stair shaft precast wall.

Interior Precast Concrete Wall Panels The only interior precast walls that could be observed were in the stair shafts. The majority of these walls have minor cracks in them and are in generally fair condition. There are some concrete spalls at the top of the walls where the hollowcore plank bears on top of the walls. SSE does not feel any action is required at this time, but these walls should be monitored over time for additional cracks or spalls.

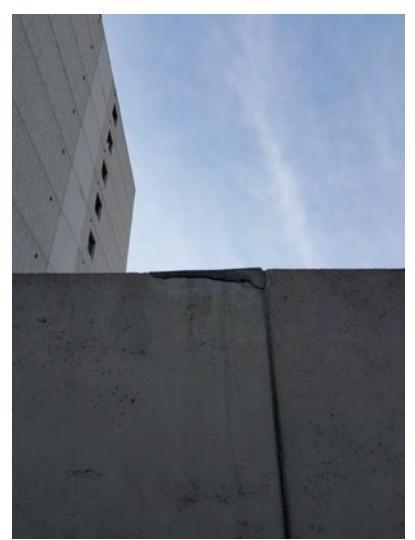
Patched precast panel on the north side, west end.

On the north side 1<sup>st</sup> level precast wall there is a concrete spall at the top of the wall towards the west end. It appears this may have been patched in the past. This spall should get removed and patched. The condition of all exterior concrete patches completed in 2005 should be evaluated.

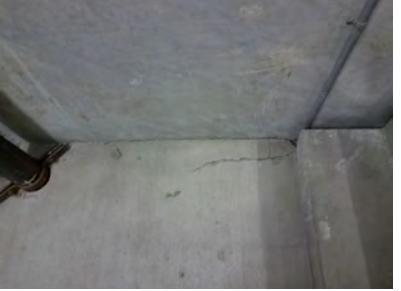
Spalling at stair floor.

**Stairs** At some of the concrete stair landings by the hallway doors, there are spalls in the concrete floor on the north and south sides. These spalls occur when there isn't a gap between the stairs and the precast wall. The spalls are likely occurring due to minor building settlement as the west and east shaft walls settle due to having more load on them and the north and south shaft walls not settling due to having minimal load on them. This differential movement causes the concrete to pop up at the areas with no gaps. The stairs span parallel to the stair direction, so this concrete spall is not a structural concern.

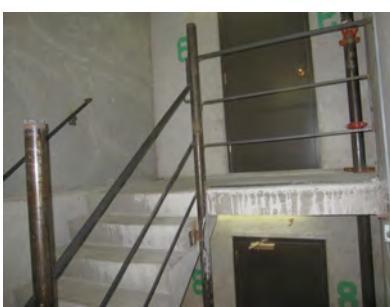
Noncompliant railing/guardrail at east and west tower stairs.

**Miscellaneous Metals** The railings at the east and west stairways are in good condition, but do not meet current building code or accessibility requirements. Noncompliant issues include, but are not limited to, insufficient guardrail height, handrail graspability, and opening limitation.

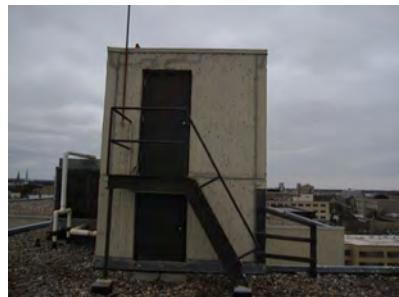
Wood guardrail at the bottom of the ship's ladder.

The wood guardrail at the bottom of the ships ladder is not secure and may provide a false sense of security. The wood guardrail should be removed and replaced with a new 42" high, painted steel guard of adequate strength and attached in accordance with the code. The guard should extend at least 30 inches beyond the bottom landing of the ships ladder.

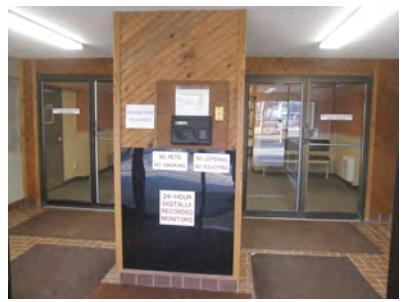
Wood paneling at the entrance vestibule.

**Woods, Plastics and Composites** Wood paneling at the main entrance and the wood ranch style baseboard at the residential floors are in good condition but have a dated appearance. The diagonal wood paneling and wood base should be replaced as part of an overall updating of the interior commons spaces.

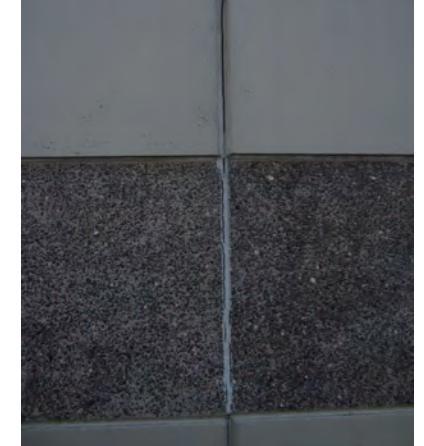
The sealant joint failures at the garage walls appear to be a result of movement in the precast concrete wall panels. From the ground it was difficult to evaluate the condition of the sealant joints at the upper 9 floors, but Jeff Ellenson thought they appeared to be in good condition and thought it might be 5-years before they needed to be replaced.

Failed garage level sealant joint, north elevation.

Jeff Ellenson suggested replacing the lower garage level joints first and periodically evaluate the joints at the upper 9 floors, but not replace them until they show signs of failure or leaks are reported. The sealant joints at the upper 9 floors could be replaced at one time or continue with the phasing by replacing the east, west and south side joints next and the north side last. Following the meeting Brian spoke to Pat St. Denis with T.F. Powers to get his opinion of the sealant joints at the upper 9 floors. In Pat's opinion the joints all appeared to be in about the same condition. Pat thought the joints on the north side of the building might be in a slightly better condition than those on the south side.

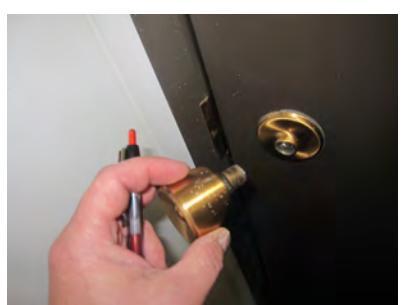
Door knob at the inner west stairway door on the  $6^{th}$  Floor of the west tower.

The 6<sup>th</sup> floor inner west stair doorknob comes off in your hand when you try to pull the door open. The door closer at the inner west stair door is leaking. The oil from inside the closer has dripped down the face of the door. The oil can stain the carpeting, clothing and personal belongings of those passing through the door.

To meet the accessibility requirements, all doorknobs should be replaced with commercial grade lever door handles.

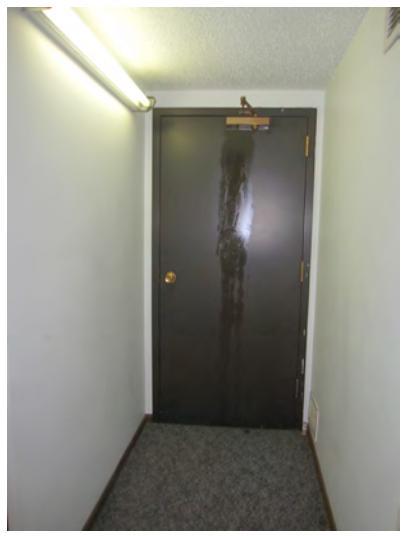
Leaky closer at the inner west stairway door on the  $7^{th}$  Floor of the west tower.

More importantly, when the oil drains from the cylinder, the closers ability to control the door is lost. If this were to occur, the door would swing freely and could lead to injuries, as well as, costly damage to the door and frame.

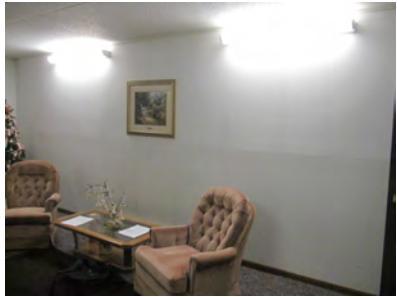
Horizontal ridging at 2<sup>nd</sup> floor elevator lobby.

**Gypsum Wallboard Assemblies** The gypsum wallboard assemblies at the elevator lobbies and corridors have some minor cracking and joint ridging. Ridging is a linear deformation or small hump at panel joints usually caused by compression of the panel edges.

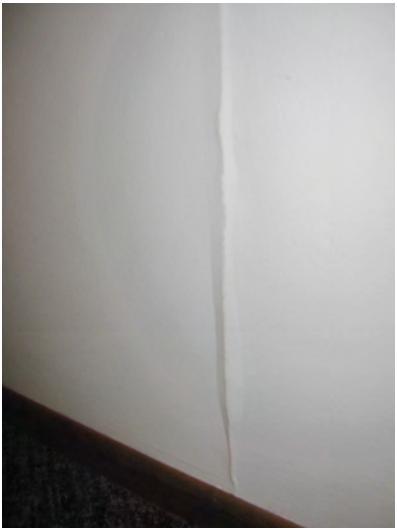
Vertical ridging at east corridor of the  $2^{nd}$  Floor.

The proper use of control joints will accommodate stresses within and placed upon the gypsum board minimizing the chances for the development of cracks and joint ridges. No control joints were observed in the gypsum wall assemblies at the lobbies or corridors. The existing light fixtures wash the wall with light, which casts shadows accentuating the ridging. So, I would first consider replacing the light fixtures with a fixture that provides a more diffused light. The application of texture, quality paint with the proper sheen and color and wall coverings are methods for masking minor imperfections.

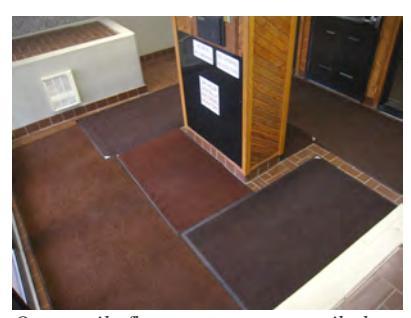
Quarry tile floor at entrance vestibule nearly completely covered with walk-off floor mats.

**Quarry Tile** The quarry tile at the entrance vestibule is dated and limits color scheme options. The tile though durable doesn't remove dirt, snow and water from your shoes making walk-off floor mats necessary, which can pose a tripping hazard and are a maintenance hassle.

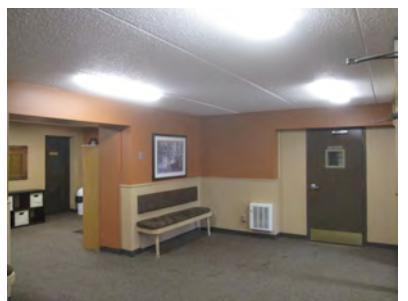
Outdated paint scheme.

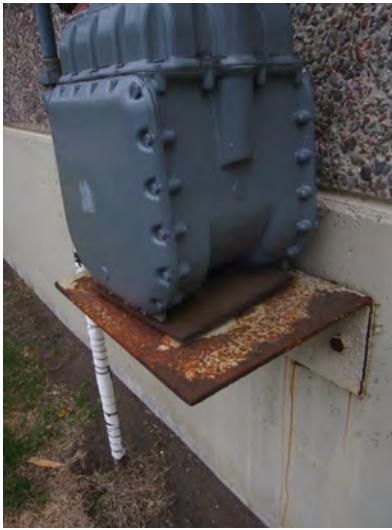
Rusting gas meter bracket.

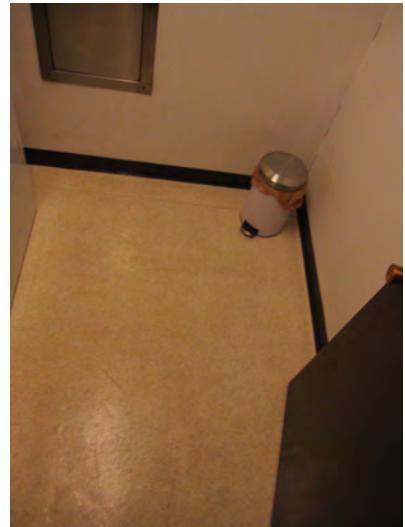
Typical laundry room sheet vinyl floor.

**Sheet Vinyl Flooring** The sheet vinyl flooring found in the Laundry Rooms at Floors 1-9 and the toilet room outside the 8<sup>th</sup> floor conference room is worn, dated and the poorly located seams are coming apart. The sheet vinyl should be replaced with new quality sheet vinyl. Sheet vinyl is an appropriate floor finish in a laundry room because it is a solid sheet with few (or no) seams and therefore less opportunity for water to seep through. Sheet vinyl is durable, provides good scratch and stain resistance and is resistant to water damage, easy to clean and relatively inexpensive.

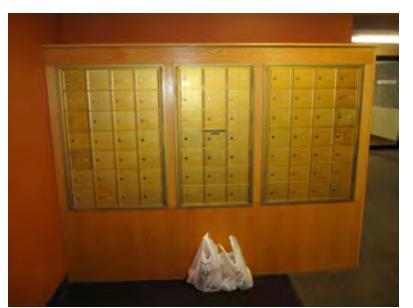
*The existing post office at the elevator lobby.*

The existing recessed, front loading, cube style, post office boxes mounted in the piece of oak casework at the elevator lobby do not meet the current USPS standards, but you are not required to replace them, provided they are not modified.
