Noisy Timing Gears

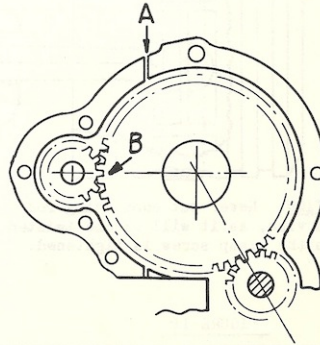
The noise in an engine is almost always eliminated after rebuilding a Model T motor and replacing the crankshaft and camshaft gears. However, when noise is still prevalent, it is usually caused by the generator gear not having been adjusted correctly.

If this is the case with your Model T, fear not -- there is an adjustment provided. The timing gear cover (#3017) shown in the accompanying drawing (left side) may be adjusted by placing the correct thickness gasket at point "A" where it joins the motor block. The clearance at point "B" should be from .002 to .004; so, the thickness of the gasket you select should take into consideration this tolerance range.
