THE MODEL T FORD

ITS REPAIR,
SERVICE, AND
RESTORATION

Repairing and Installing the Horn Switch

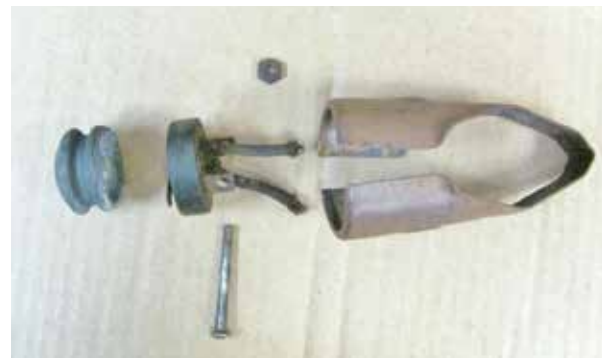
The Ford horn switch for the later cars is a rather simple contact switch; the components are shown in the photo below. Remove the long bolt and nut to allow the switch housing to spread, then remove the button and switch contacts. Carefully expand the housing just enough to remove it from the steering column.

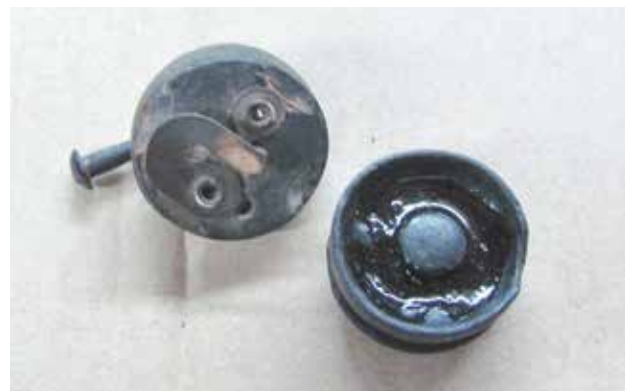
Once the pieces have been cleaned and inspected, take note of the button condition. The button is made of Fordite material (same as used on the steering wheel rim). While strong, sometimes the button 'lug' on the reverse side of the button that contacts the brass ribbon can be cracked, damaged, or worn too much; this can cause the button to be loose and prevent satisfactory contact. On the button in the photo below, a tiny hole was drilled and the trimmed-to-length shank of a large head round upholstery tack was driven into the center. Then super glue was poured around it to keep it fastened. Now the inside of the button has a good contact point for pushing on the brass ribbon switch.
