# RESERVE STUDY REPORT

PREPARED FOR

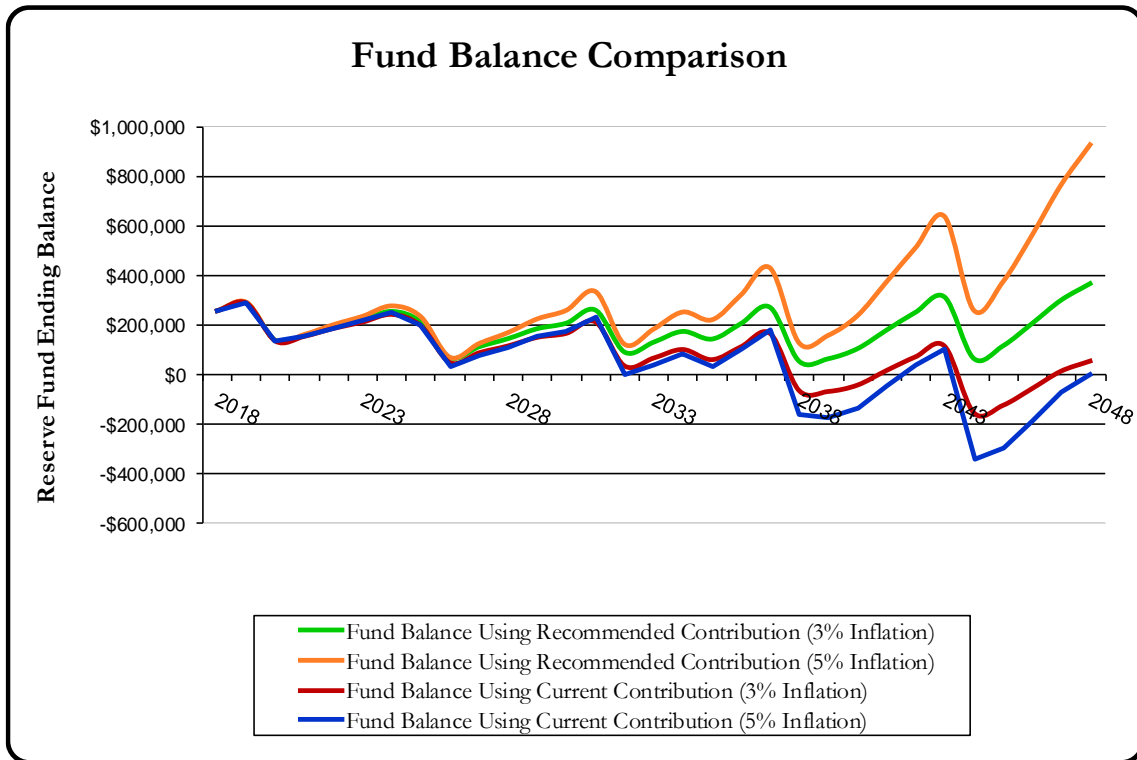
The following chart illustrates the ratio of expenses that will be incurred over the 30-year study period for each of the elements that represent a majority of the future repair or replacement expenses.

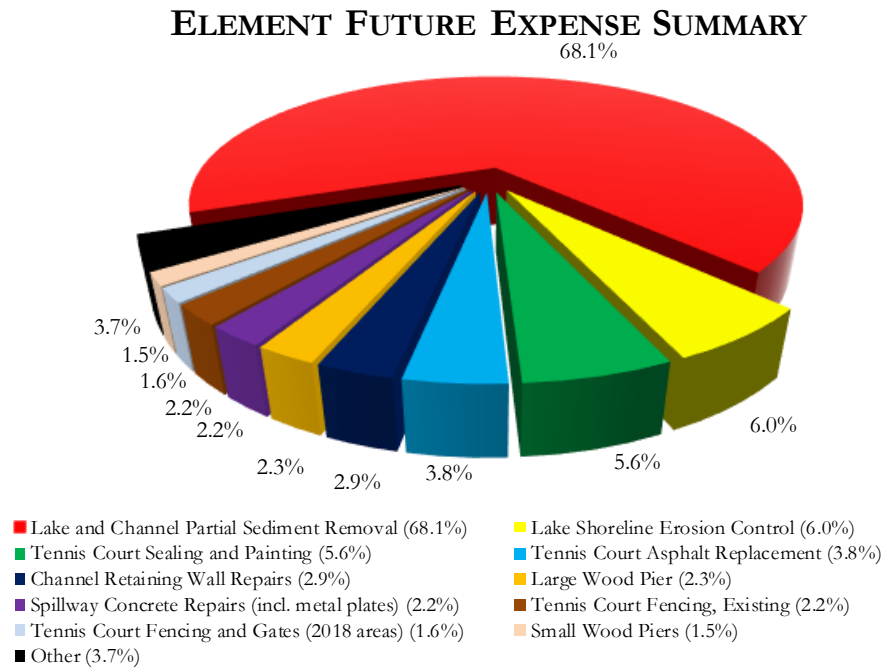
The annual contributions made to the reserve fund are a means to compensate for the difference between the ongoing deterioration of a property and its finances. Since elements deteriorate at varying rates and the finances of the property are typically changing on an annual basis, the need to maintain balance between the two is an ongoing process. Therefore, to maintain this balance, periodic updates to the Reserve Study are recommended approximately every three years. Annual updates may be warranted depending on the age of the property and the amount of repair or replacement activity.

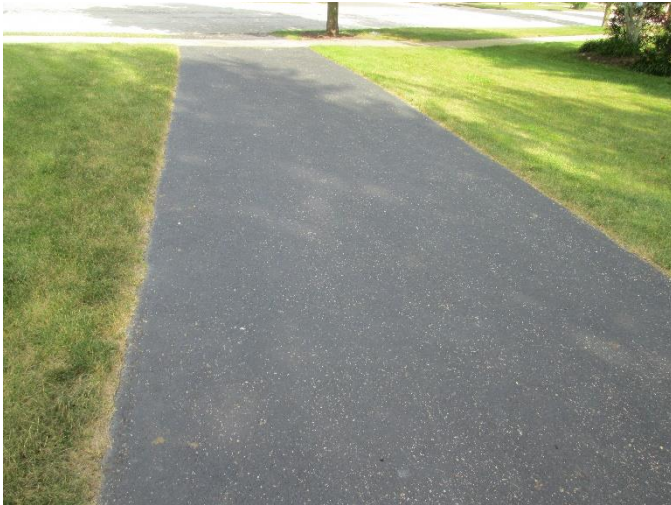
Asphalt pavement service drive near west tennis court

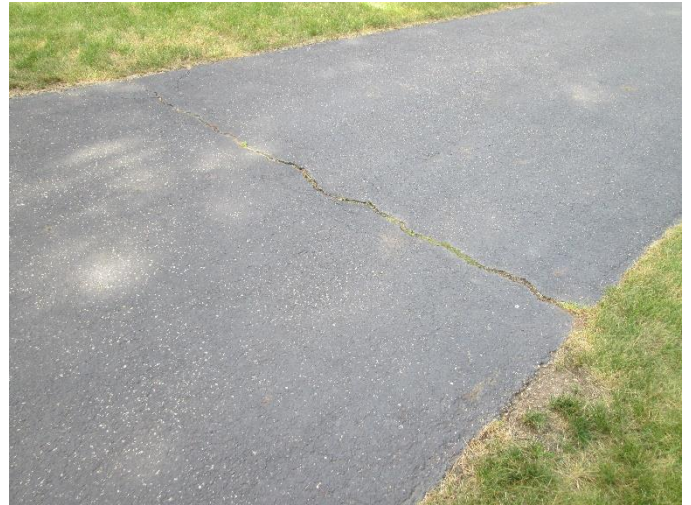
Pavement cracking and minor surface deterioration

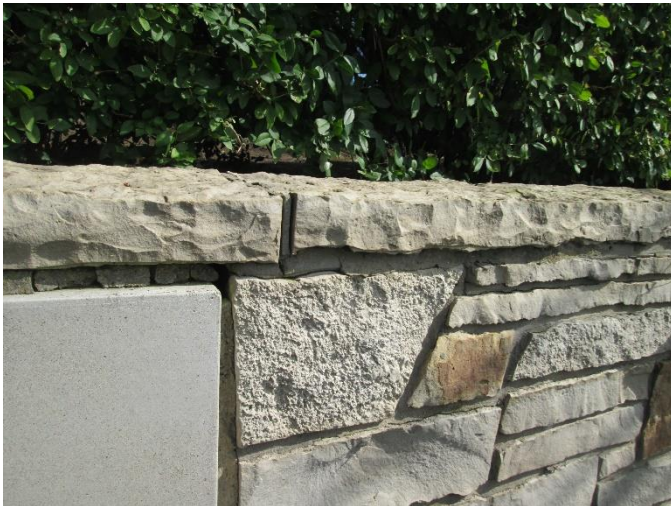
Mortar deterioration

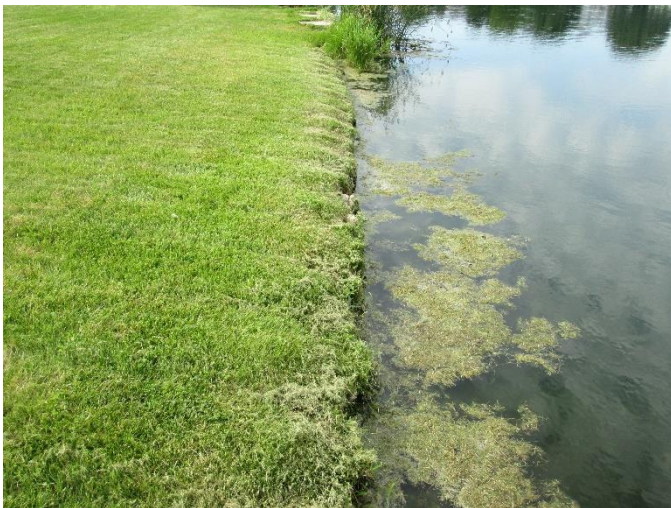
Limited portions of shorelines include landscaped turf grass up to water's edge. This condition may promote soil erosion. The location depicted in this photograph exhibits only minor erosion.

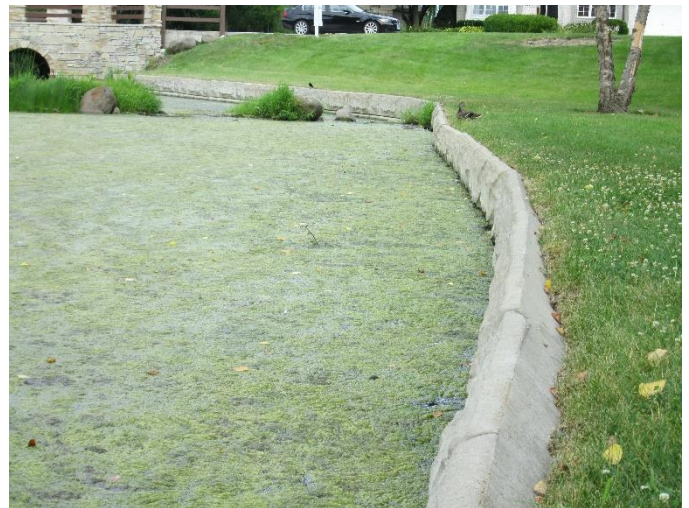
Channel lined with large concrete retaining wall blocks

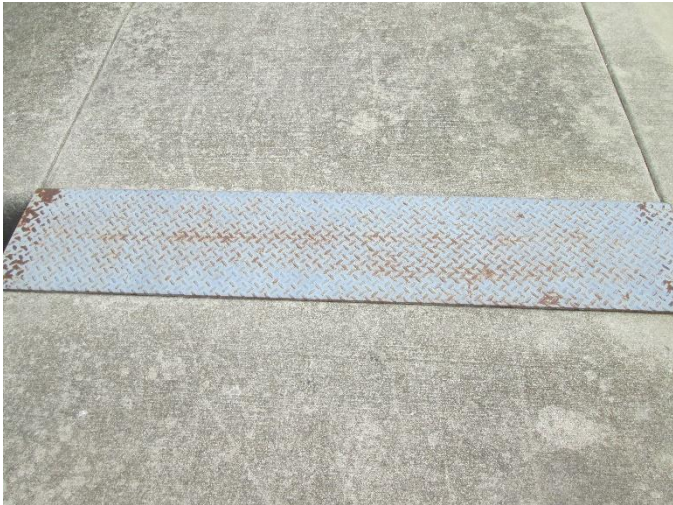
Surface rust on plate at spillway walking surface

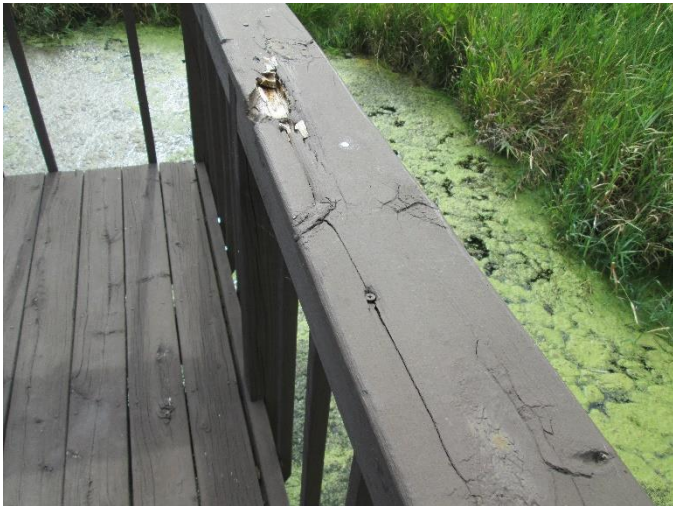
Deteriorated wood at large pier

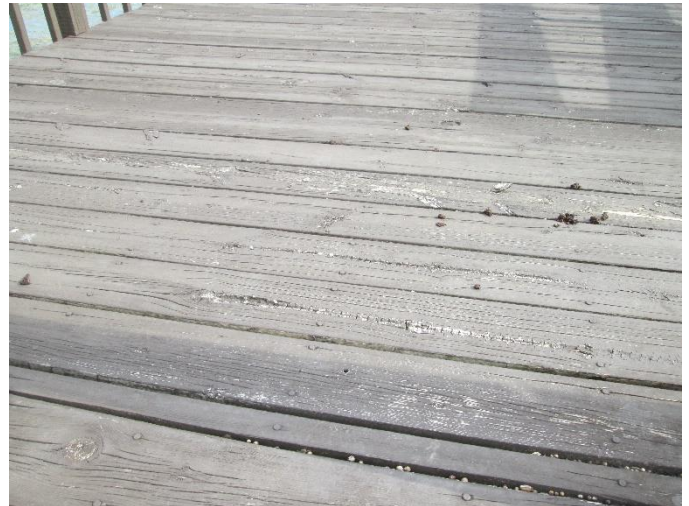
Deteriorated wood at large pier

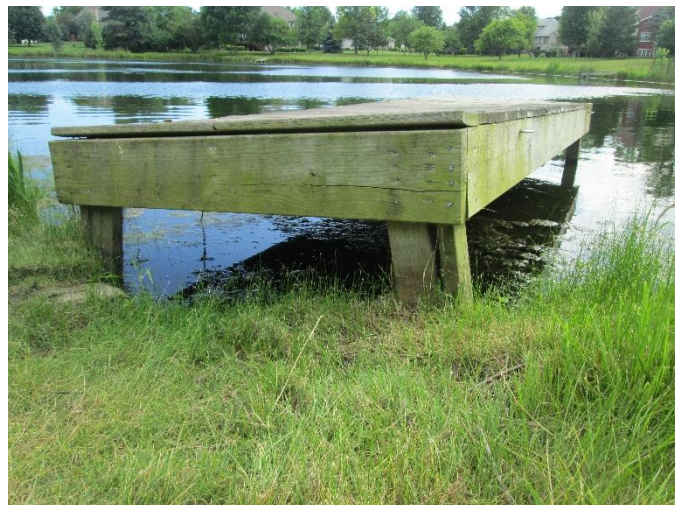
Settlement and deteriorated wood at small pier

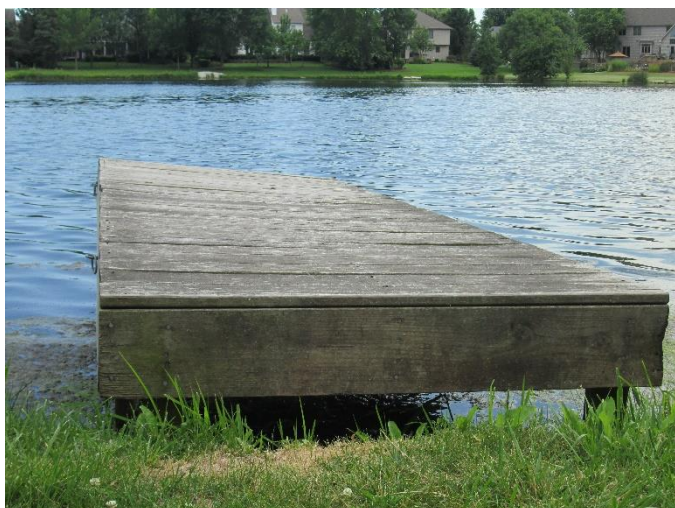
Settlement and deteriorated wood at small pier

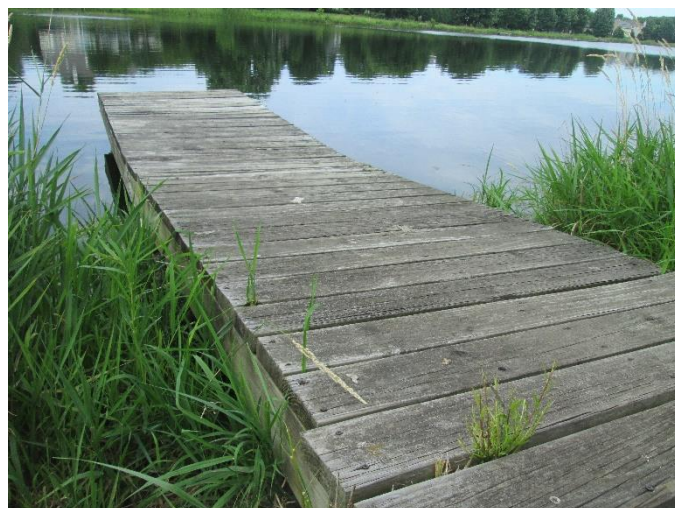
Settlement and deteriorated wood at small pier

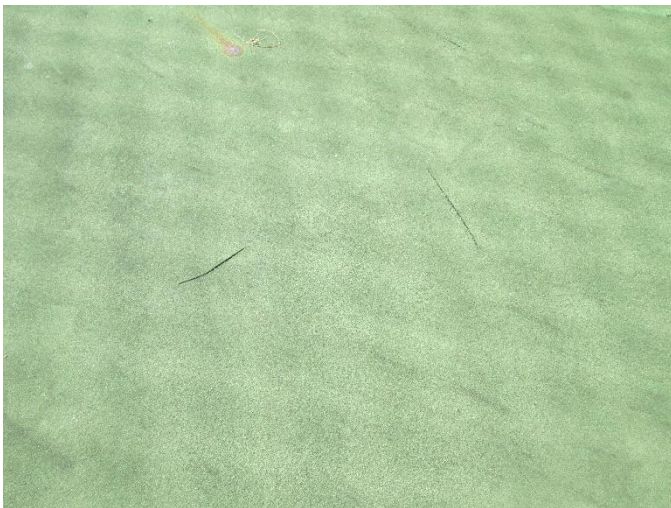
Minor surface damage

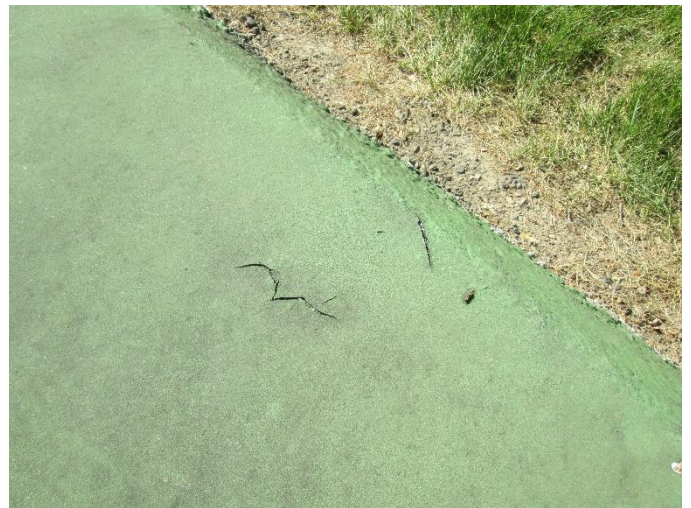
Minor surface damage

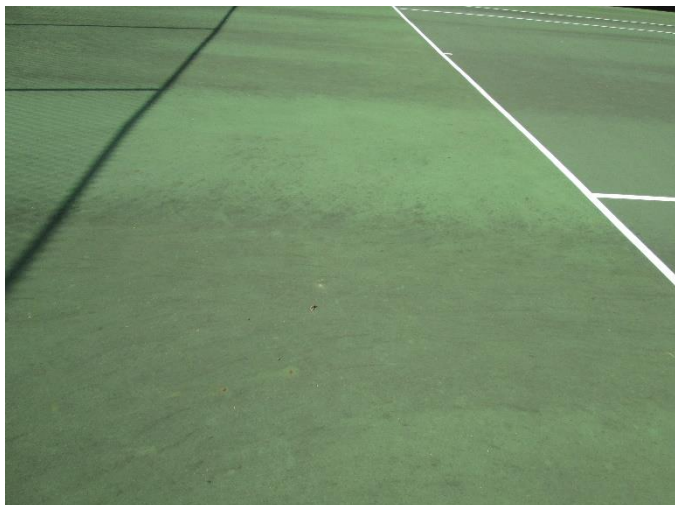
Color coat discoloration

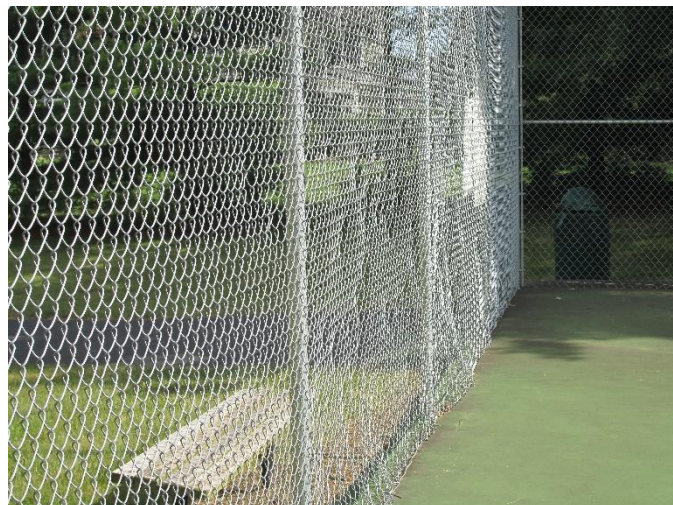
General wear noted at fencing

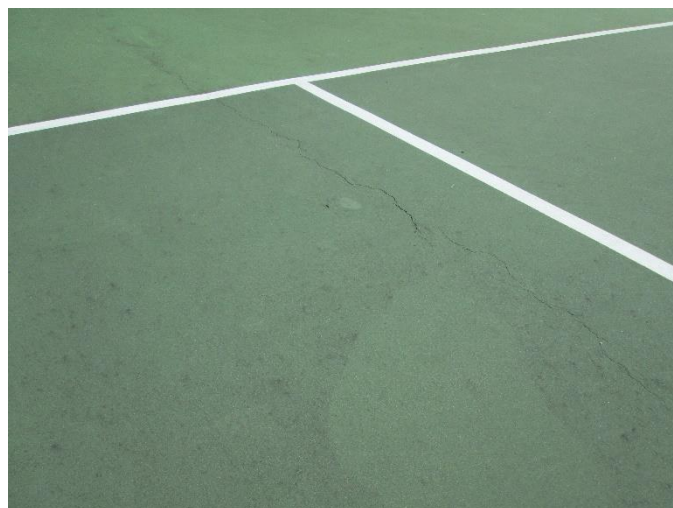
Color coat deterioration and surface cracking

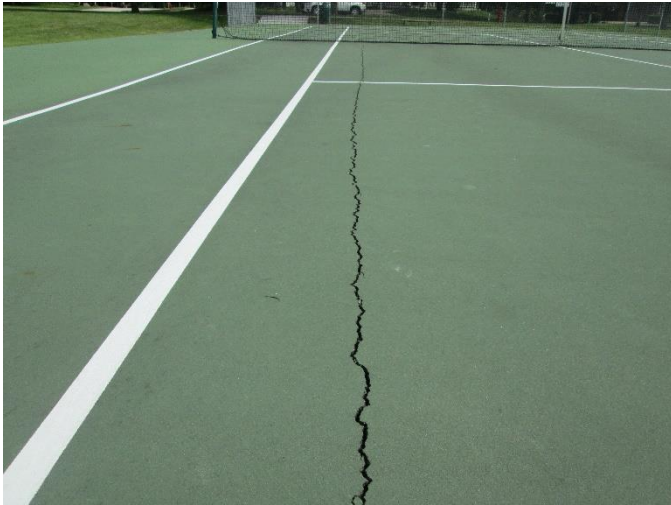
Significant surface cracking

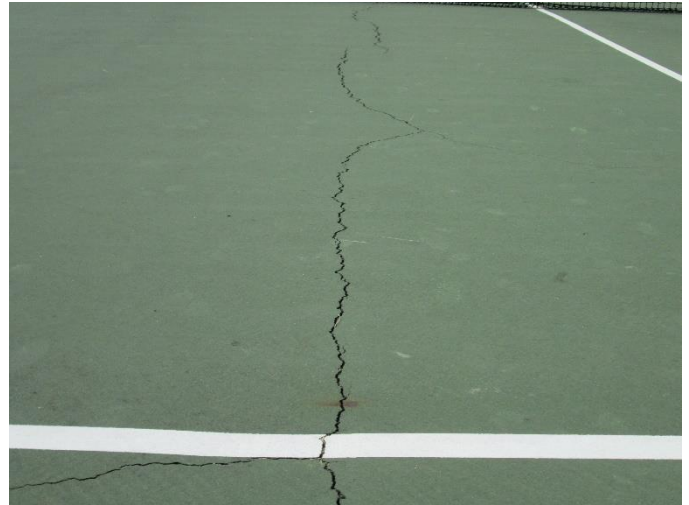
Significant surface cracking

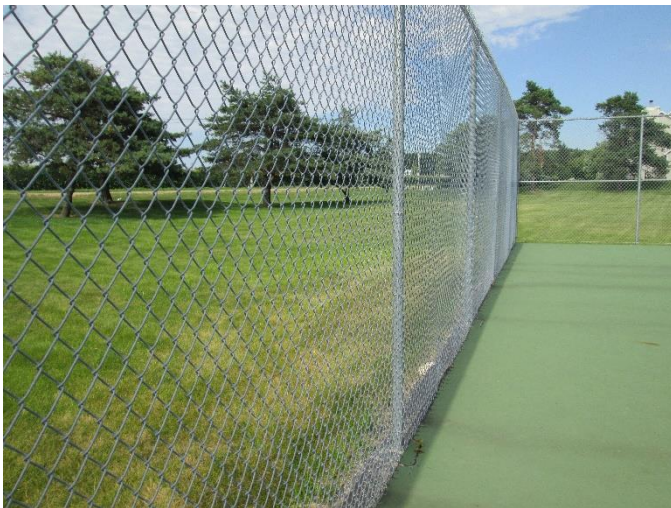
Minor general wear at fence

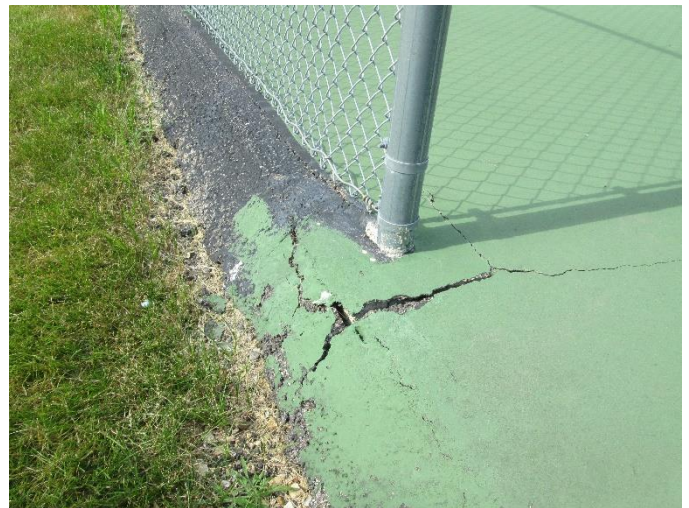
Minor heave at fencepost footing

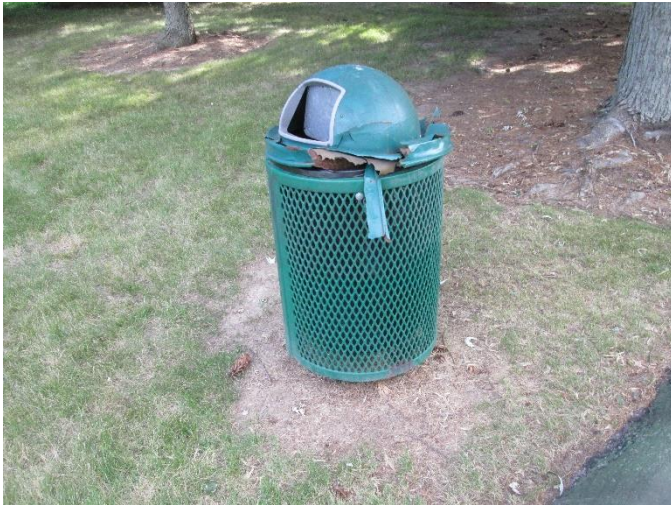
Badly damaged and deteriorated trash receptacle

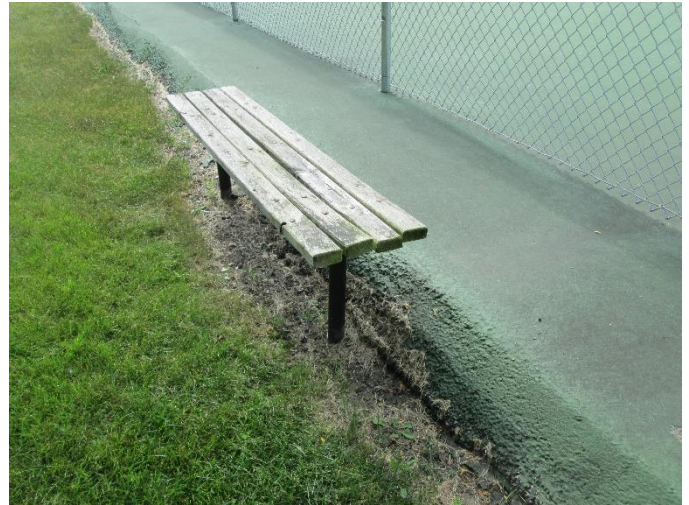
Weathered wood bench
