Pysht River Floodplain Habitat Inventory and Assessment

February 2, 2006

Final Report Submitted to:

Pacific Salmon Commission

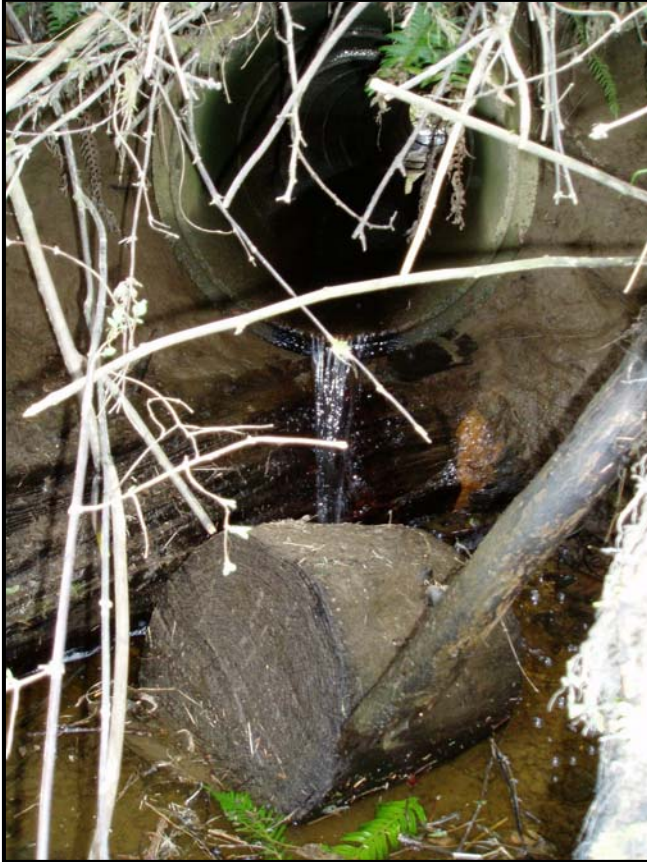
This tributary flows from a large wetland complex on the right bank of the Pysht River and enters the Pysht at RM 1.77 (Figure 19). A perched culvert forms a total barrier to fish at certain river and tidal stages (Figure 22). The culvert limits tidal exchange with tributary channel and wetland complex upstream. The partial culvert barrier limits fish access to 305 meters of low gradient, low energy stream channel, as well as two large fish bearing forested wetlands (total wetland area 2.1 acres). The upstream forested wetland has been recently logged and the lower forested wetland was logged 10-15 years ago. The SR 112 culvert upstream is 100% passable.

Figure 22. Perched culvert limiting fish access and tidal exchange in Section 9 Tributary (Farm Road crossing).

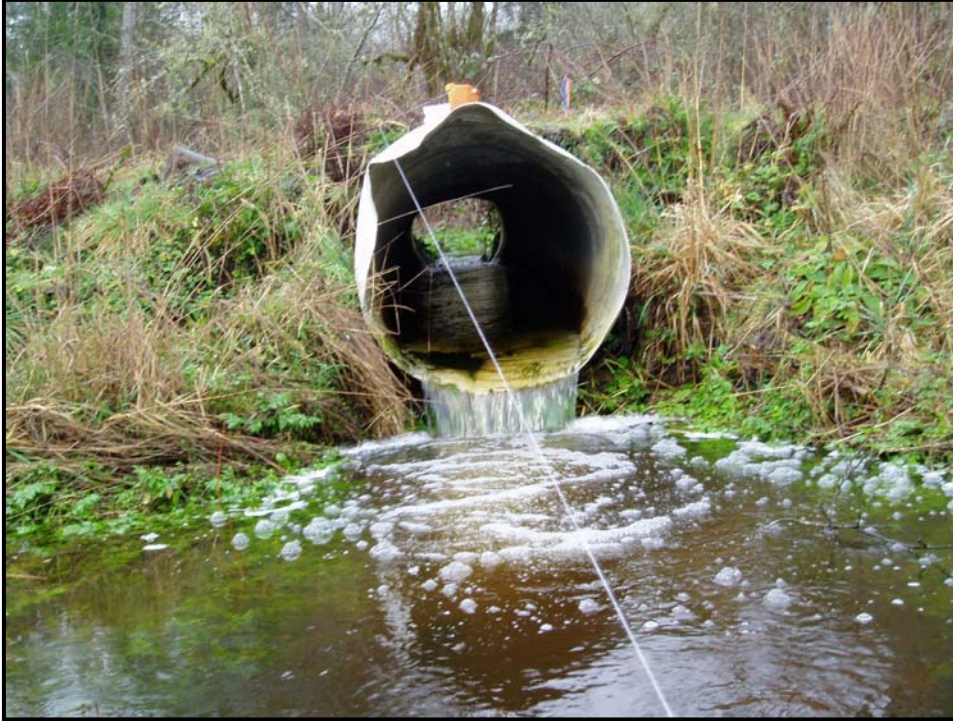
This tributary flows from a large wetland complex on the right bank of the Pysht River and enters the Pysht at RM 1.82. A perched culvert on the Farm Road forms a total barrier to fish at certain river and tidal stages. The culvert limits tidal exchange and fish access to 625 m of low gradient, over-wintering habitat, as well as 19.6 acres of fish-bearing forested wetland. Further upstream at the W3000 Road a partial culvert barrier limits access to the forested wetland complex (Figure 23). Cabin Creek Tributary 1 drains a large forested wetland between the W3000 Road and SR 112. Channel enhancement work was conducted in this habitat unit by M&R during the summer of 2003.

Figure 23. Perched culvert acting as a partial barrier to juvenile salmonids at the W3000 Road crossing.

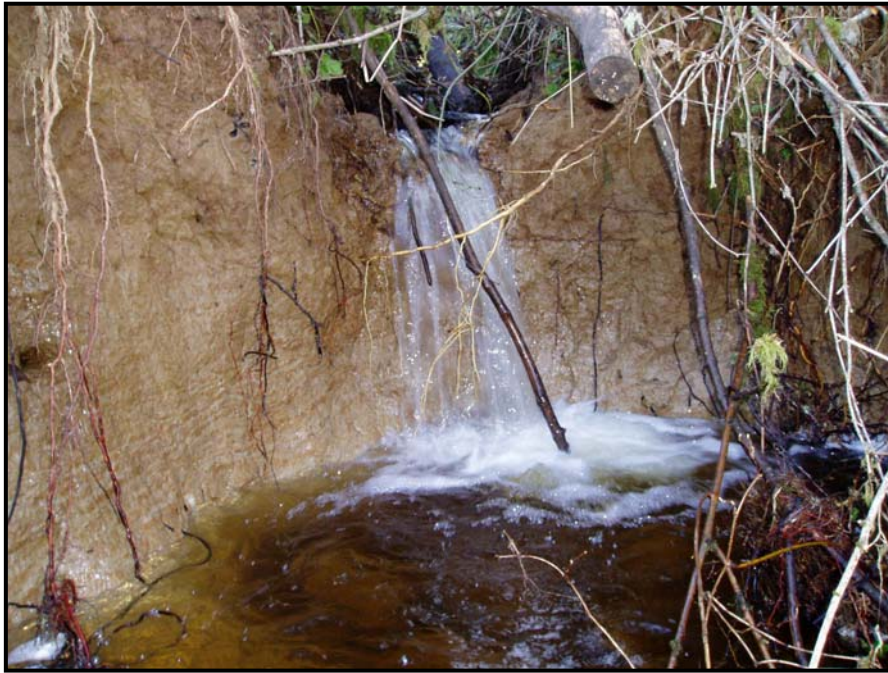
This left bank tributary drains a forested wetland and enters the Pysht on the left bank at RM 3.45 (Figure 24). The M&R 2100 road culvert is a partial barrier: culvert is rusted out, perched, and set at a steep slope. This partial barrier limits fish access to over 400 m of low gradient habitat, including a 3.4 acre wetland complex. Just downstream of the culvert there is a step/cascade that is approximately 1.2 m high (Figure 25; depending upon Pysht River stage). This step may have formed in response to mainstem channel incision.

Figure 25. Piling Creek step-pool feature downstream of 2100 Road.

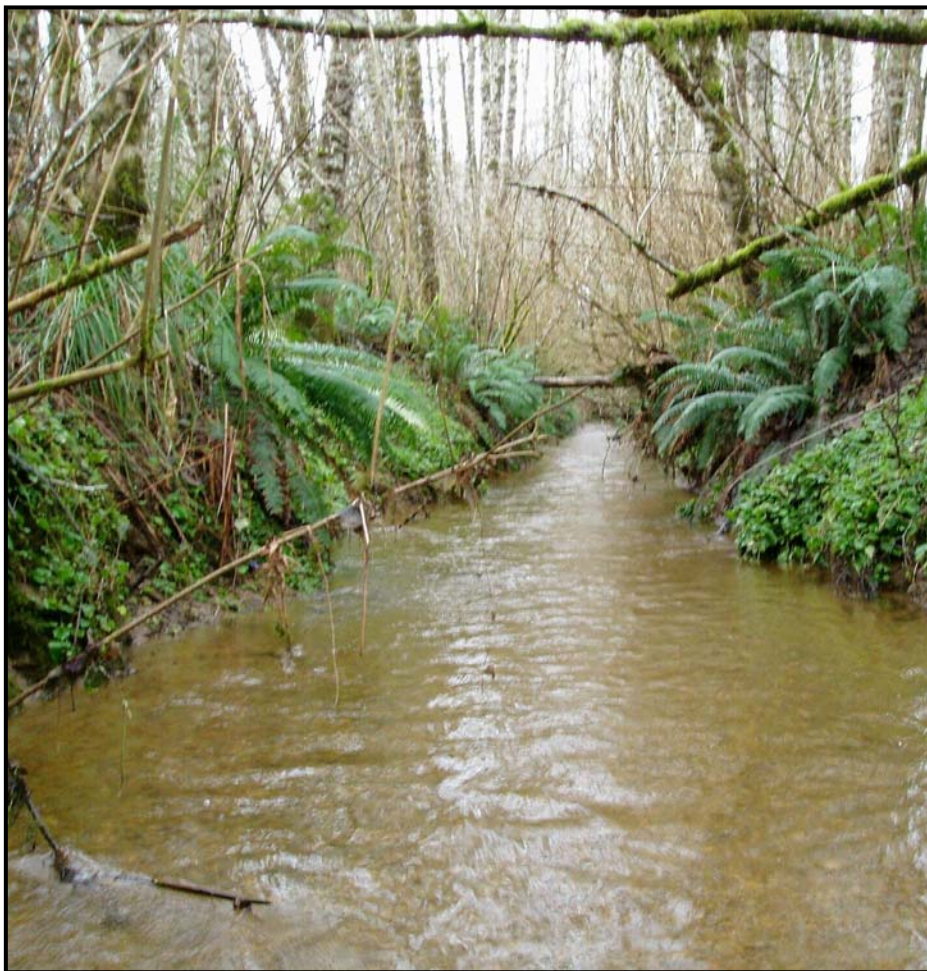
Figure 26. Typical channel conditions observed in lower Razz Creek where a lack of LWD and habitat structure prevails.

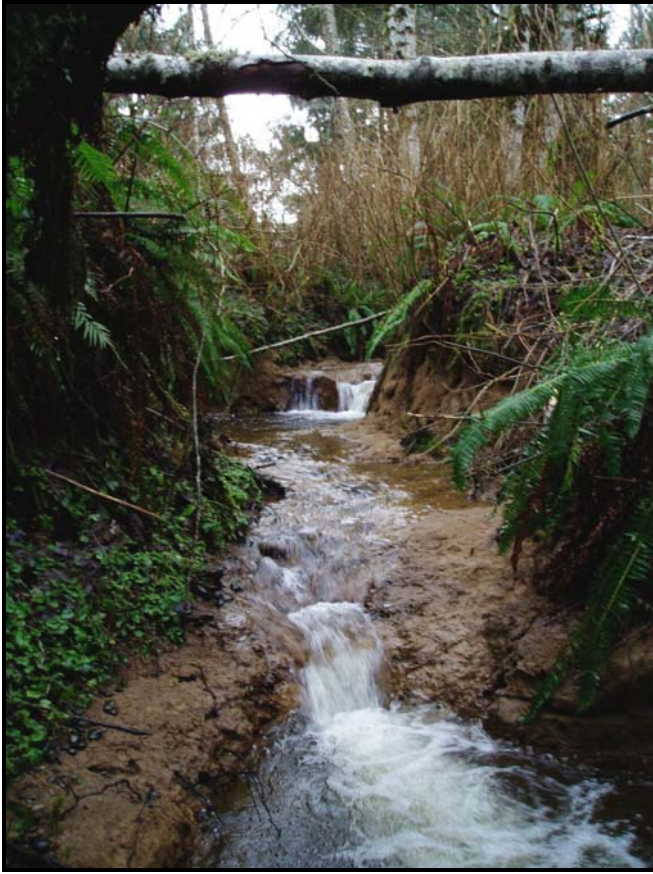
Figure 27. Razz Creek Tributary 1, looking upstream at cascades running through channelized reach.

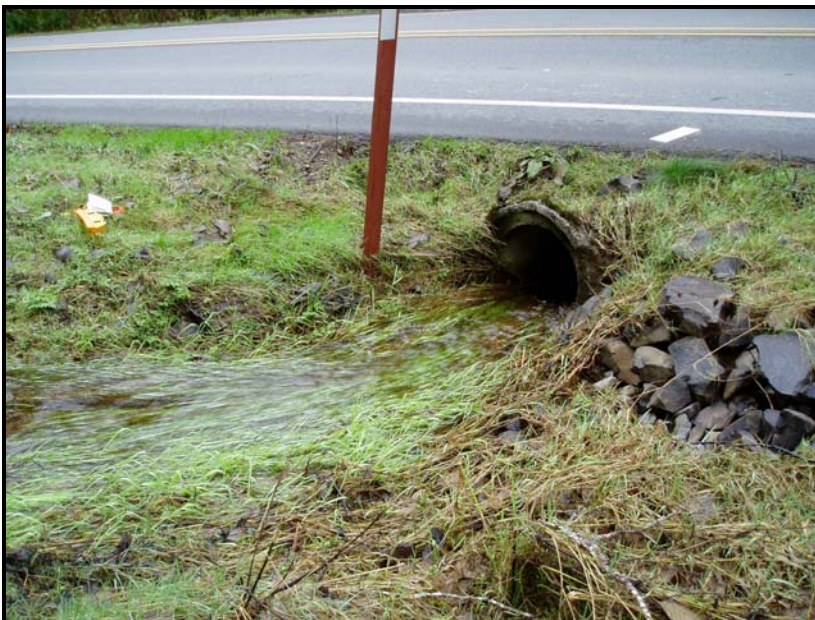
Figure 28. Razz Creek Tributary 1, looking downstream at SR 112 culvert where stream flows across highway during high flows.

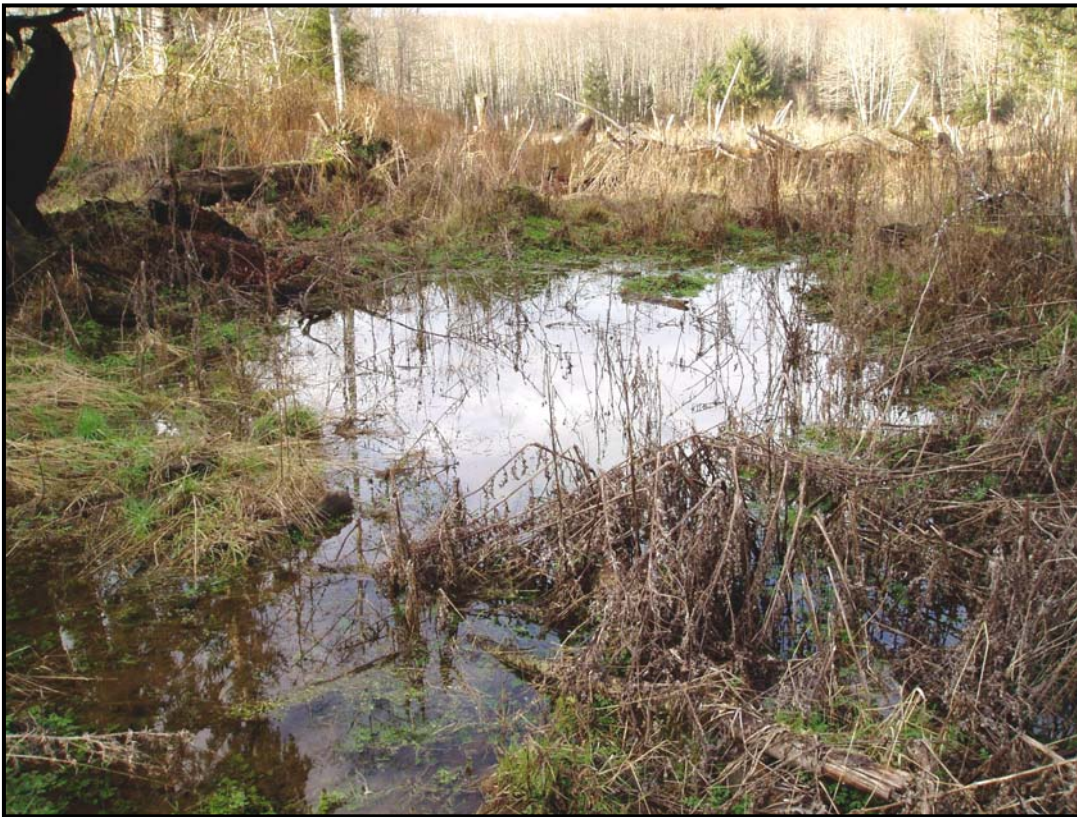
Figure 30. Example of high quality over-wintering habitat in Razz Creek Tributary 4_T3 upstream of Reefer Creek Road culvert.

This tributary enters Razz Creek upstream of SR 112 at RM 0.31 (Figure 24). This stream flows from a moderately confined hillslope across the Pysht River floodplain. The lower reach of this stream contains several small fish-bearing tributaries. A small RBT entering 36 meters upstream from Razz Creek (T4_T3) flows through recently logged, high quality forested wetland habitat. A culvert on Reefer Creek Road is set at 4-5% gradient is a partial barrier, and is likely to become a complete barrier in the near future as it continues to degrade. During field surveys 0.51 acres (length 276 m) of high quality/high fish use habitat was delineated upstream of the culvert (Figure 30).

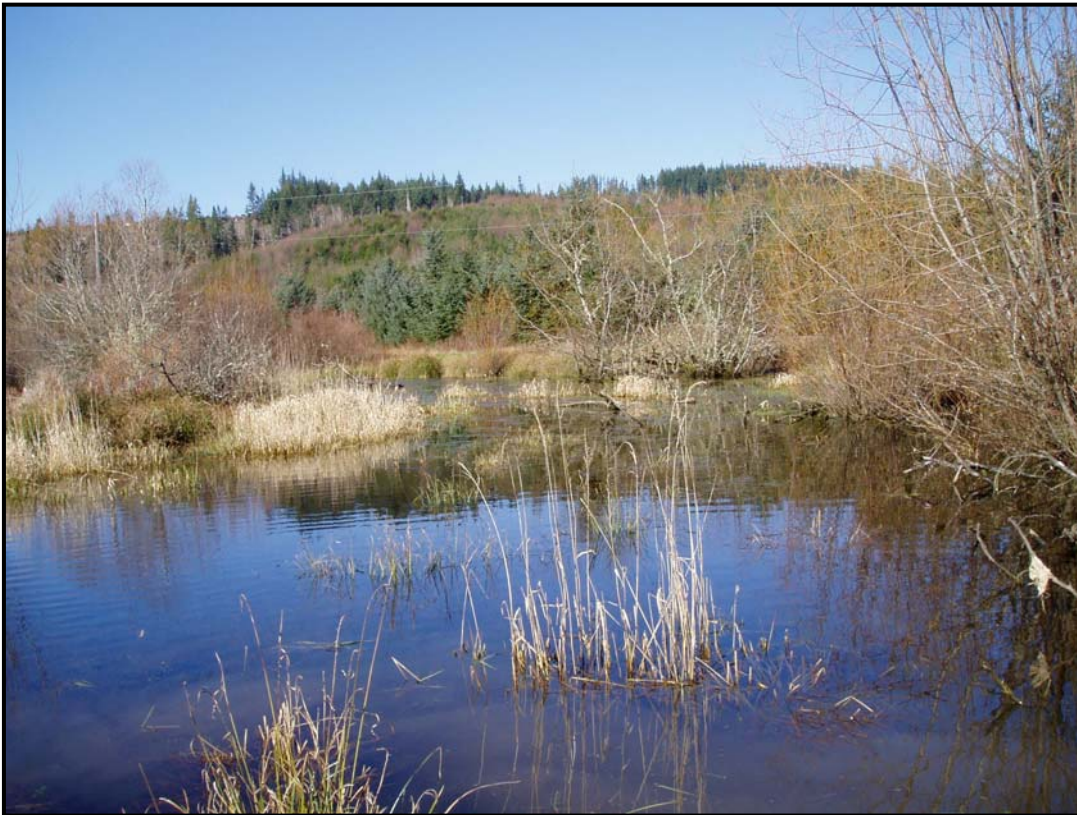
Figure 31. Example of some of the high quality open water habitat located in the 2100 Road Swamp complex.

This left bank tributary is almost entirely wetland and open water pond type habitat (except for the connection to the mainstem) and enters the Pysht River on the left bank at RM 4.11 (Figure 24). This is a large (7.9 acres) and potentially productive winter rearing habitat for fish (Figure 31). The main issues in this system are habitat connectivity and dewatering. During surveys on February 16, 2005 habitats in the 2100 Road swamp were hydrologically disconnected from one another and from the Pysht River. Channel incision along the mainstem of the Pysht River may be lowering the water table of wetland complex. Rerouting of Lost Creek may also play an important role in the hydrology of this wetland complex. Several juvenile coho were found dead in areas of the wetland where dewatering had occurred. Several juvenile coho were also found in isolated pockets of standing water.

This segment was segregated from Segment 2 because of the deep pond habitat that exists in this segment (see Figure 31). The total length of fish habitat was difficult to calculate because of the lack of understanding of what portion of the wetland floods during winter. During our surveys habitat extended at least 200 meters from Segment 2/3 break and occupied an area of 7.1 acres. However, this wetland extends several hundred meters beyond this point and is between 12 and 15 acres in size. It appears that Lost Creek may have historically fed this wetland complex but it now diverted down the 2100 Road ditch line and no longer has a connection to this habitat complex.

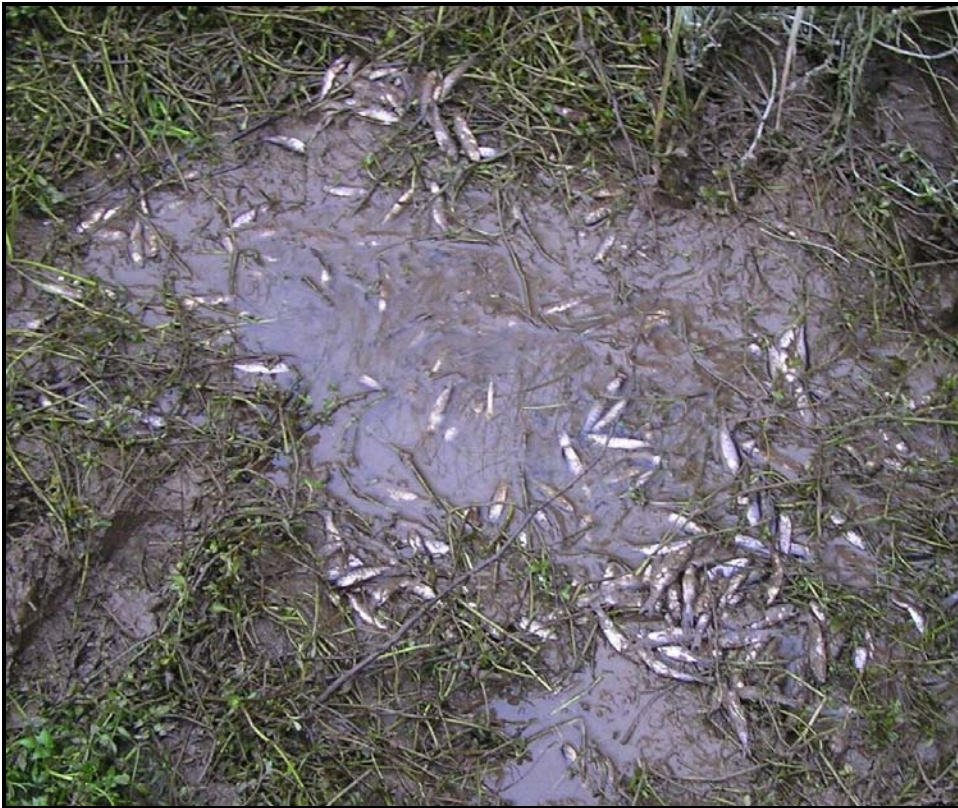
Figure 34. Dead coho which were trapped in Tributary 2 (source: D. Hamerquist).

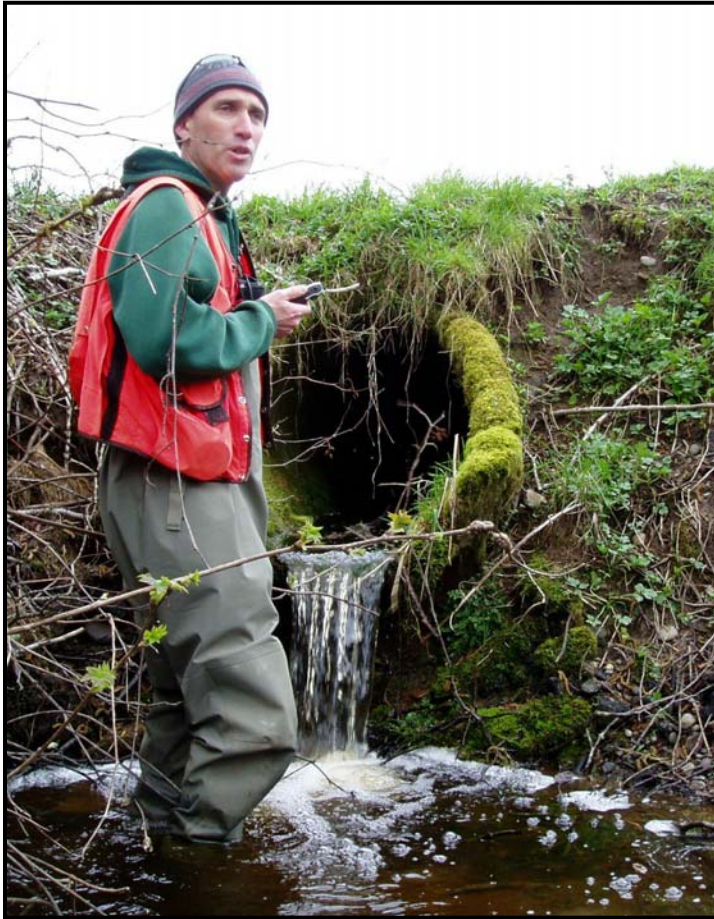
Figure 35. Michelena Creek perched SR 112 culvert.

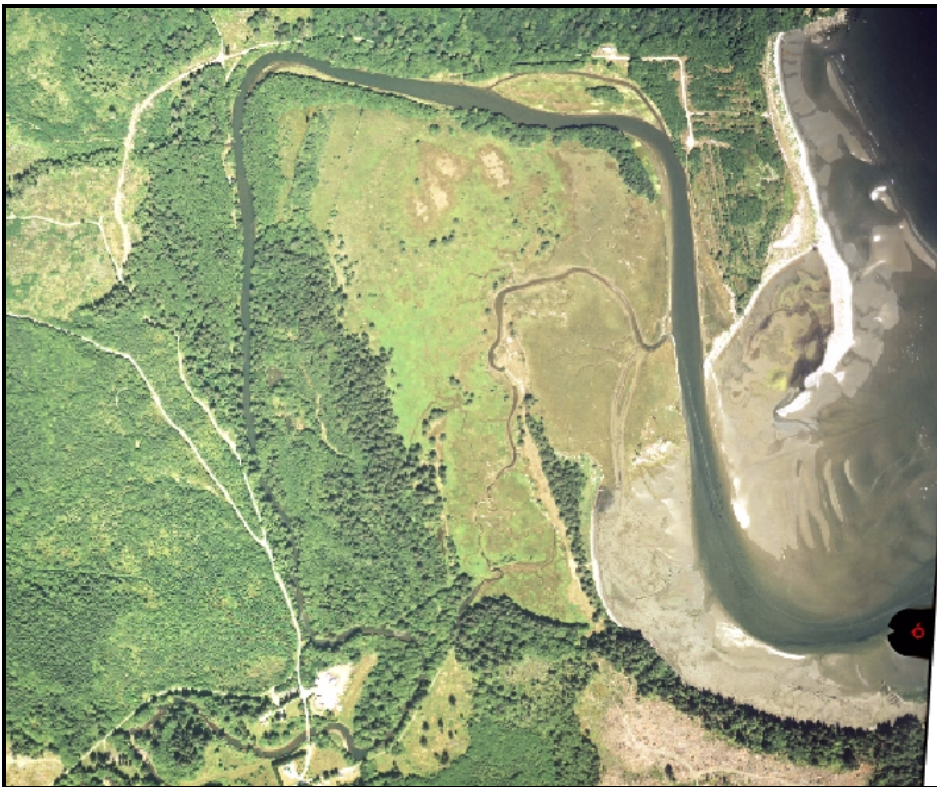
Figure 38. 2003 aerial photograph of Pysht River estuary.

As described earlier it was not possible to quantify the full extent of estuarine habitat alterations in the Pysht estuary. Aerial photos only extend back to 1951 for this area and therefore pre-development conditions in the estuary are relatively unknown. The lack of aerial photos prior to alterations of the estuary makes it difficult to understand the quantity of habitat alteration that has occurred. A comparison of the 1951 and 2003 aerial photos show some changes in the estuary but don't reveal drastic alterations that are assumed to have occurred in the late 1800s and early 1900s (Figure 37 and Figure 38). The most notable changes between 1951 and 2003 are changes in the shape and length of the spit and the narrowing and filling in of a section of the lower river.

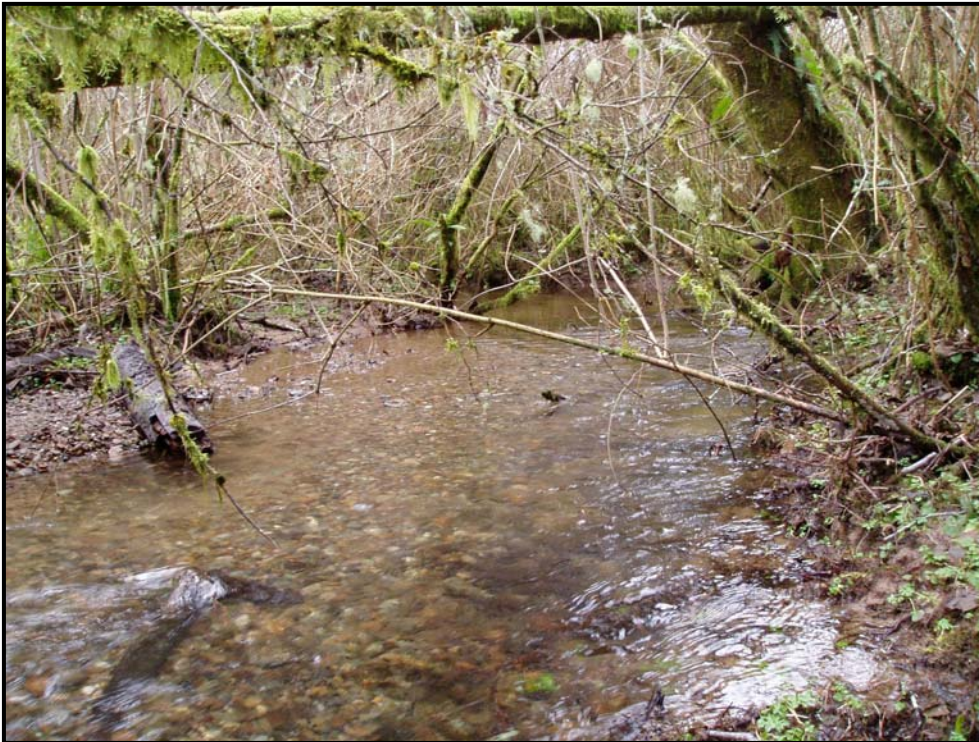
Figure 40. Indian Creek Segment 4, typical pool-riffle sequence, note the excellent quality of spawning gravels (765 m upstream of the Farm Road crossing).

This segment starts 650 meters upstream from the Farm Road crossing. This pool-riffle segment is 200 meters long, averages 5.1 m BFW, and has an average gradient of 1-2%. Segment 4 appeared to be the best overall salmon habitat in the system. There is extensive spawning habitat, nice pools, and very nice spawning riffles (Figure 40). This segment was absolutely loaded with juvenile salmonids. This segment had the highest juvenile rearing densities of any pool-riffle segment surveyed in the Pysht Watershed. There was no evidence of coho spawning but the survey was conducted at least a month after the spawning season.

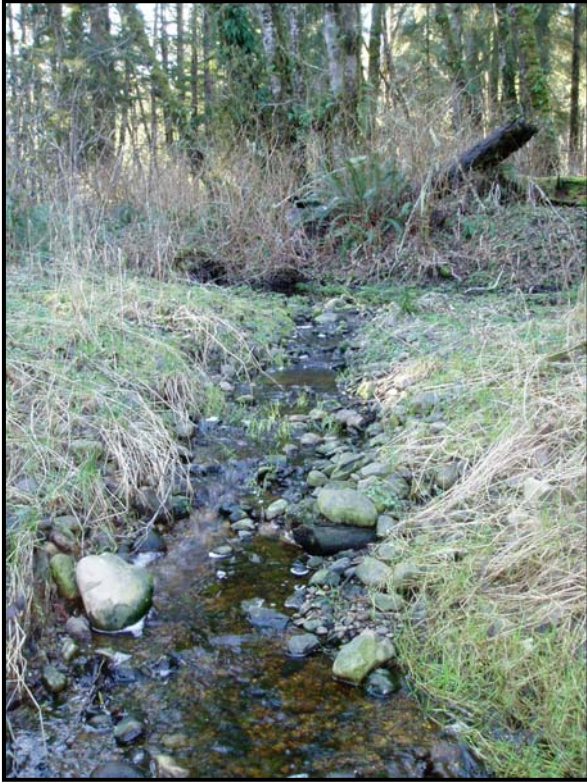
Figure 41. Spruce Creek segment 1 looking upstream at hardened road crossing (photo taken at the confluence with Pysht River).

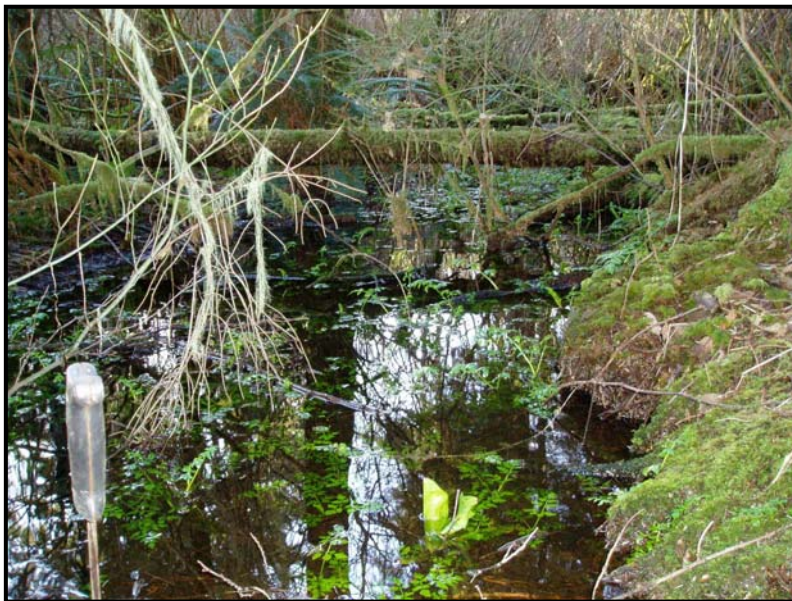
Figure 42. Typical pool environment within the Spruce Creek forested wetland complex, this pool was full of juvenile coho.

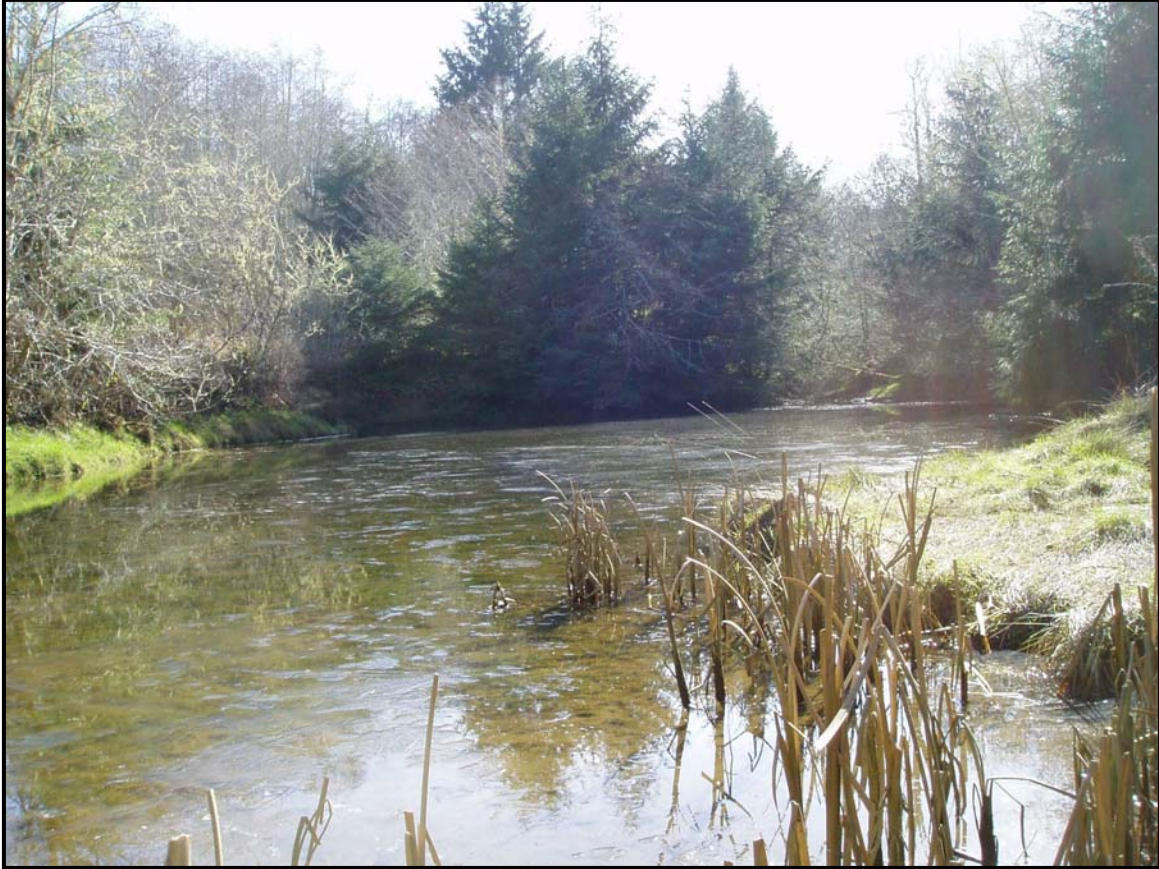
Figure 43. Pysht Ponds Segment 2 looking upstream at Pond 2.

Pysht Ponds Segment 2 contains the second largest (0.12 acres) of three ponds within this pond system. It is connected to the Pysht River through a connection to Segment 1, 106 m upstream from the Pysht River. The perimeter of the pond was surveyed, no tributaries were encountered. No fish were observed utilizing this pond. This habitat unit may play an important role for juvenile salmonid rearing during the winter and/or spring; as the conditions appear quite good (Figure 43).

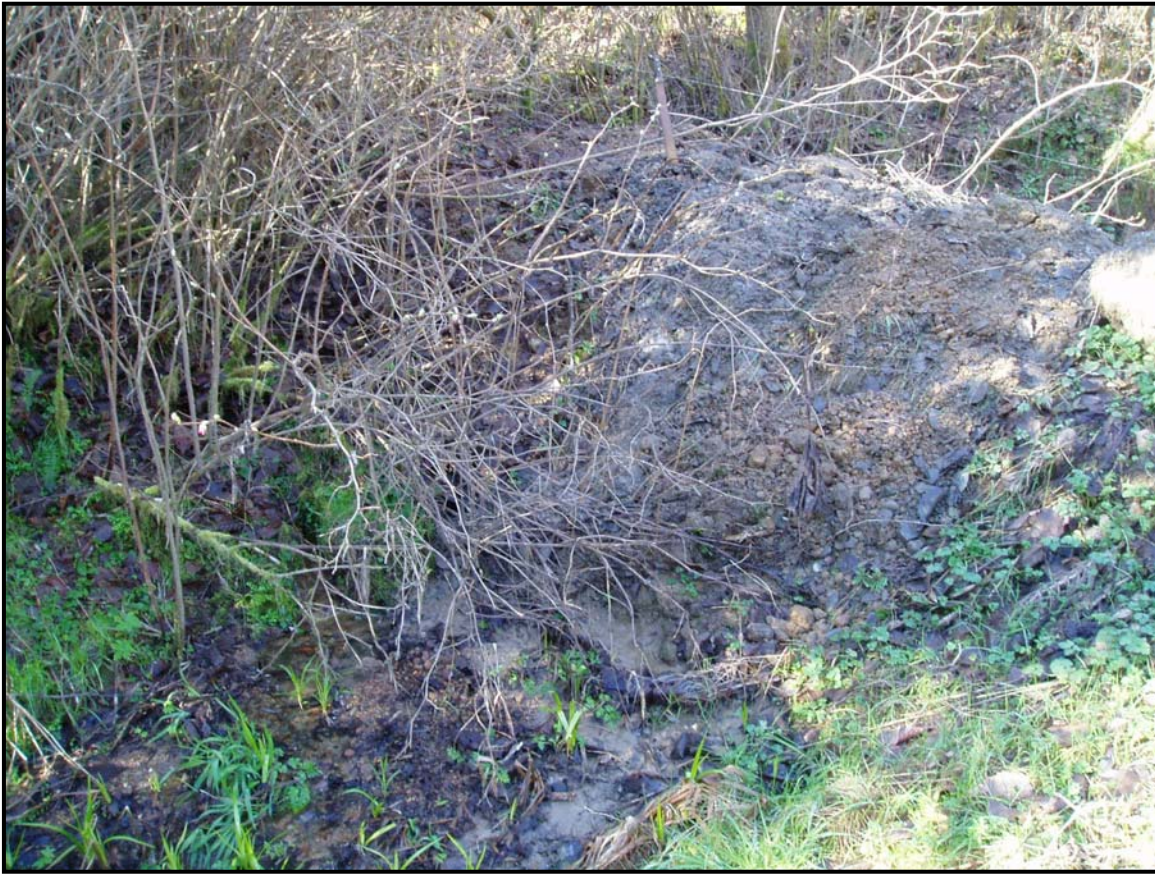
Figure 44. Ditch cleaning spoils blocking access to Ditch Creek Segment 3 (photo looking upstream).

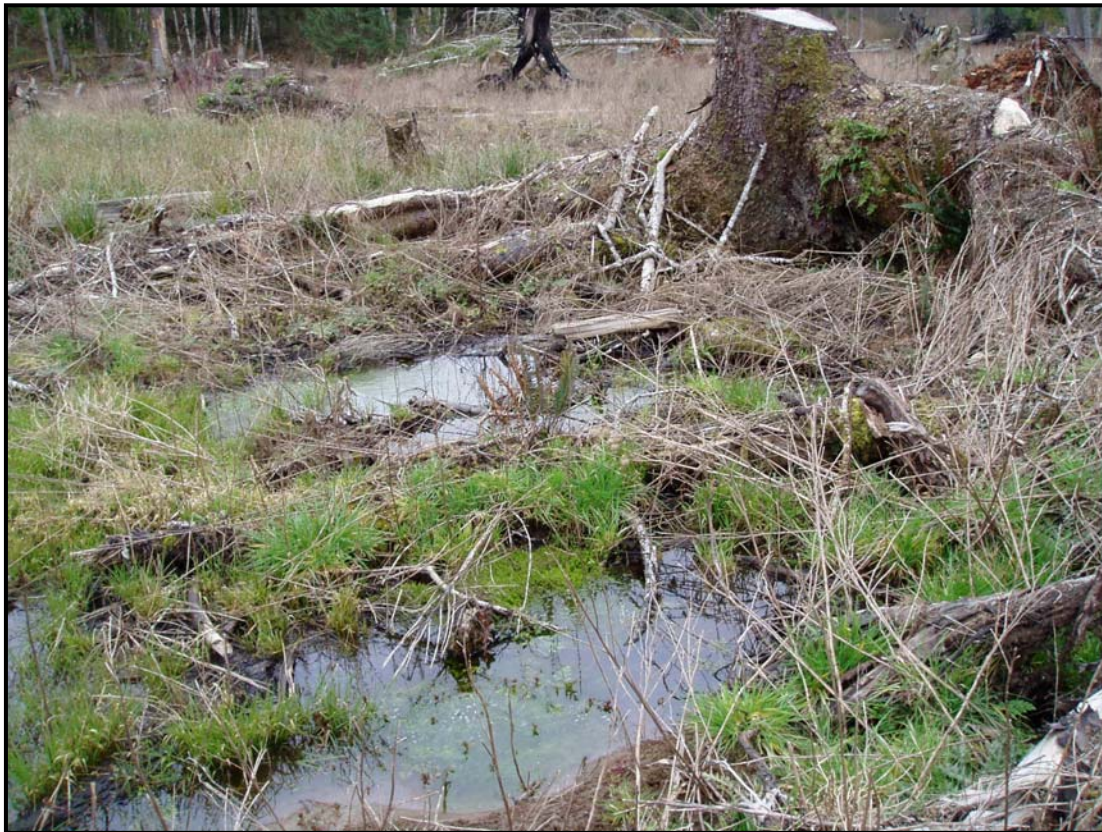
Figure 45. Example of typical habitat conditions in Section 9_Stream 1 Segment 2 (note juvenile coho observed in most pool habitat examined in clearcut).

Segment 2 is located upstream of the SR 112 culvert to end of the forested wetland complex. This forested wetland which has recently been clearcut. No riparian buffers were left and the habitat was logged. The habitat consists of multiple threaded, poorly defined channels (Figure 45). Several channels were followed but most were very short (<30 meters) and none of them leave the area which has been recently clearcut. Total habitat area was estimated (using aerial photos) to be 1 acre. Moderate fish use was observed throughout Segment 2.

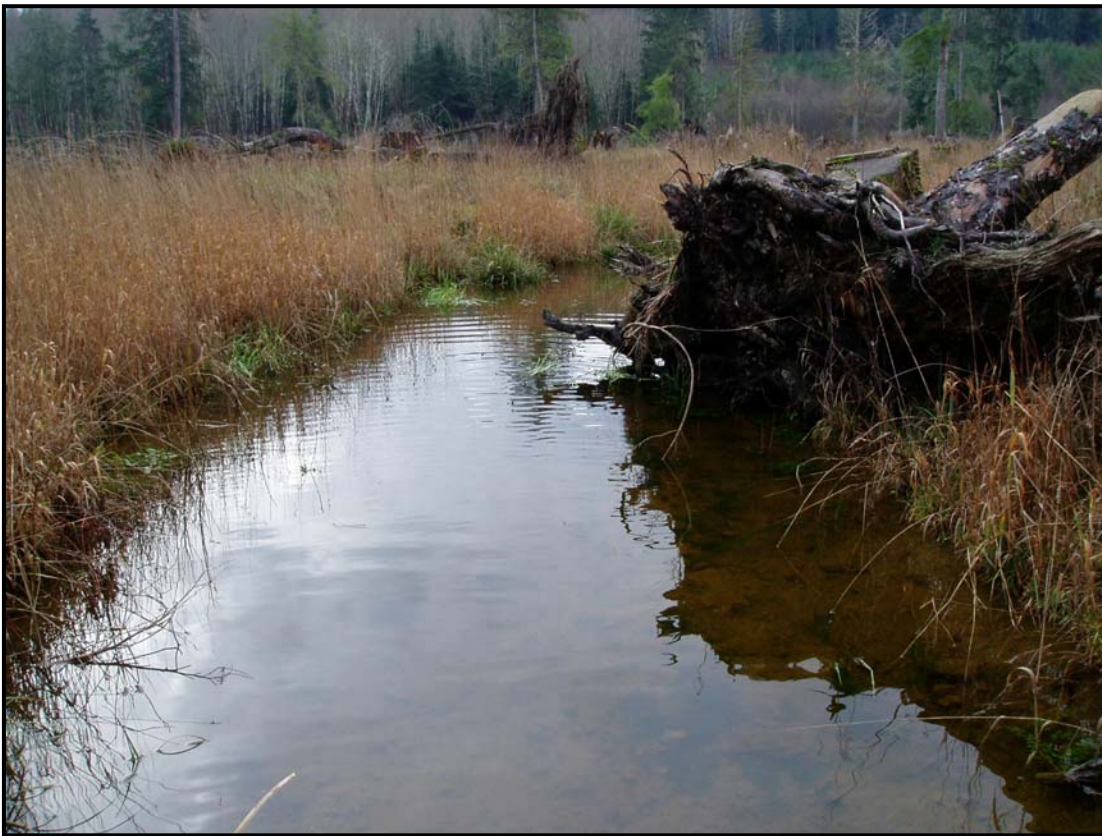
Figure 46. Typical channel/habitat conditions within Cabin Creek_T1 Segment 1 (photo looking upstream 62m upstream from confluence with Cabin Creek).

Segment 1 was historically a forested wetland complex. The channel was modified and channelized as part of a habitat enhancement project during the summer of 2003. Typical habitat/channel conditions are depicted in Figure 46. A recent clearcut is adjacent to the entire length of Segment 1, no riparian buffer was left. This entire segment appears to be a continuation of what was once a very large forested wetland complex which likely included all of Cabin Creek and Section 9_Stream 1. The total length of Segment 1 is 390 meters. This segment was classified as a regime channel. BFW and BFD averaged 3.7 and 0.33 meters respectively. The lower 43 meters of channel flow through the SR 112 ditch line. Segment 1 ends at the 3000W Road culvert. Several small tributaries, which are actually branches of the old wetland complex, were present throughout Segment 3. Juvenile coho were observed throughout this segment.

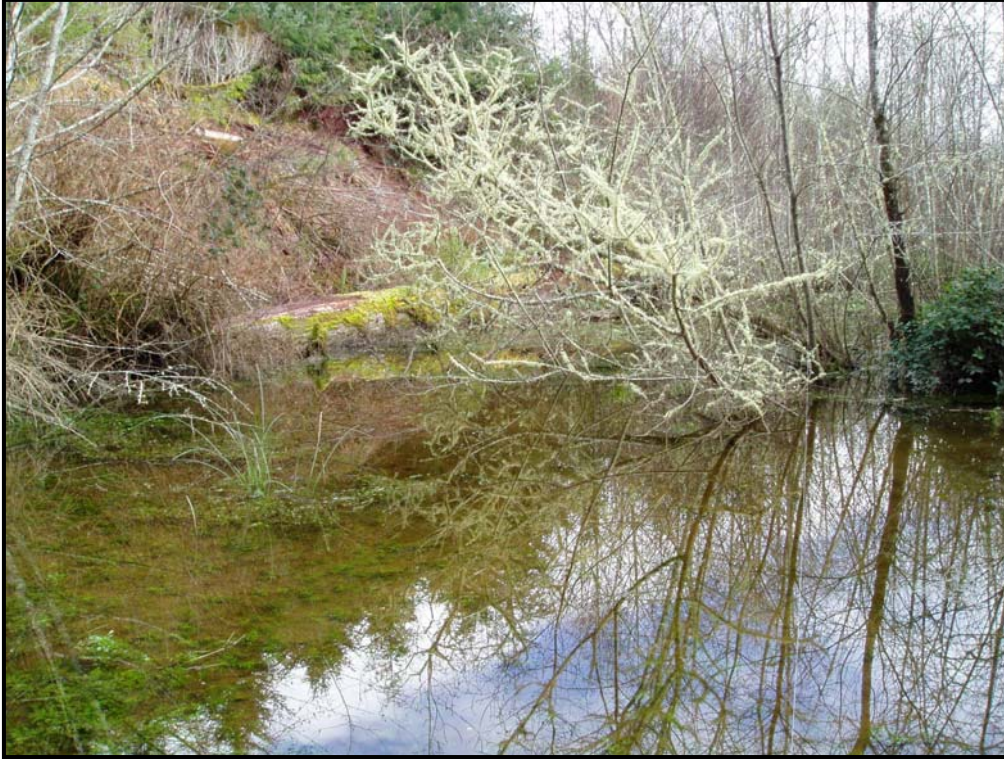
Figure 47. Looking downstream at pond, Rymer Creek Segment 2.

This segment is 127 meters long and contains a mix of forested wetland and open water wetland habitat. Most of the channel length within this segment is multi-thread or open water wetland. The lower 37 meters of channel was a multi-thread forested wetland channel system which transitions into a beautiful pond approximately 30 meters long (Figure 47). Dozens of large juvenile coho were observed in this pond system. The upstream end of the pond transitions back into a multi-thread forested wetland habitat unit. Numerous coho were observed throughout this segment. In areas where the stream maintained a single channel BFW and BFW averaged 1.4 and 0.28 meters respectively.

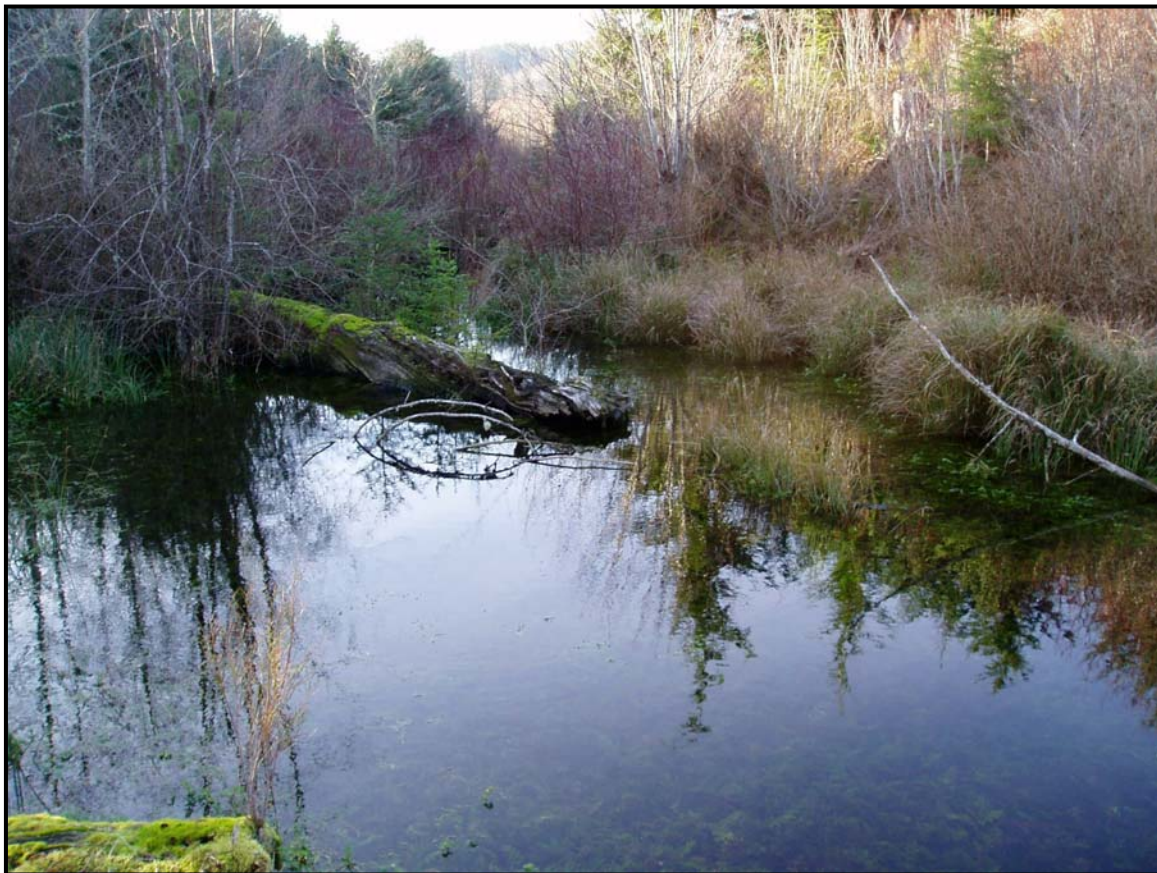
Figure 48. Example of small pond habitat unit in Piling Creek Segment 3, photo looking upstream 215 meters upstream from the 2100 Road.

The habitat type varies in this segment from forested wetland to open water wetland with small ponds. In total the wetland area was estimated to cover 3.4 acres. The field survey only extended 225 meters up Segment 3; the total length of this habitat unit was estimated to be 333 m (using field notes and aerial photos). In general this segment appears to have excellent habitat potential (Figure 48), but access appears to be the limiting factor affecting fish use.

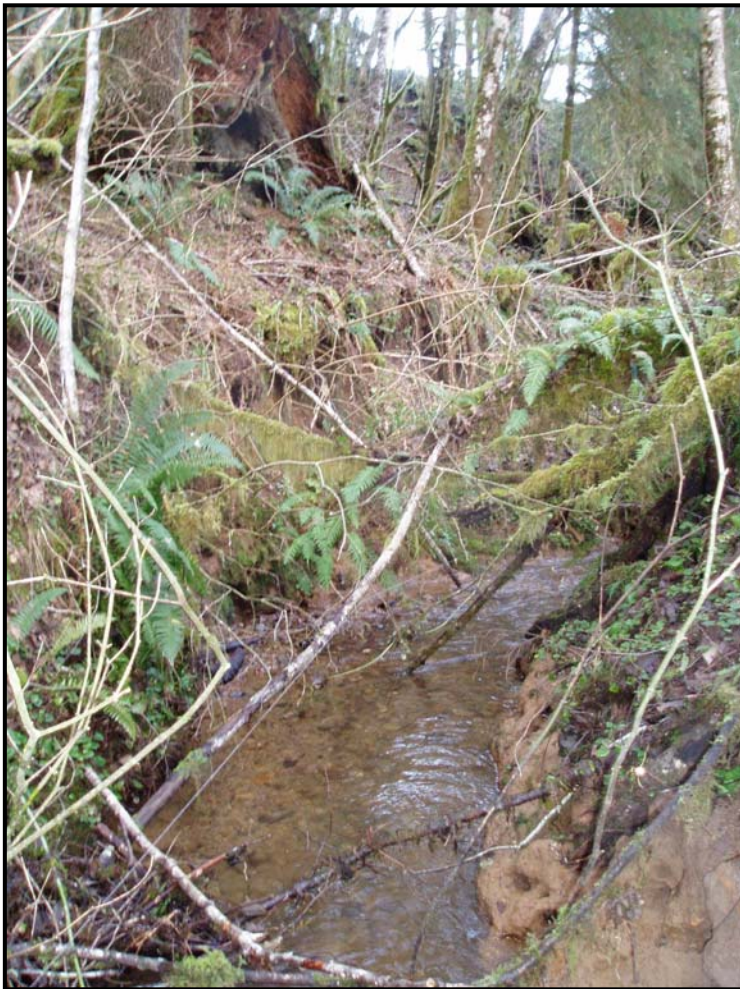
Figure 49. Razz Creek Segment 5, photo depicting channel incision in the upper half of Segment 5.

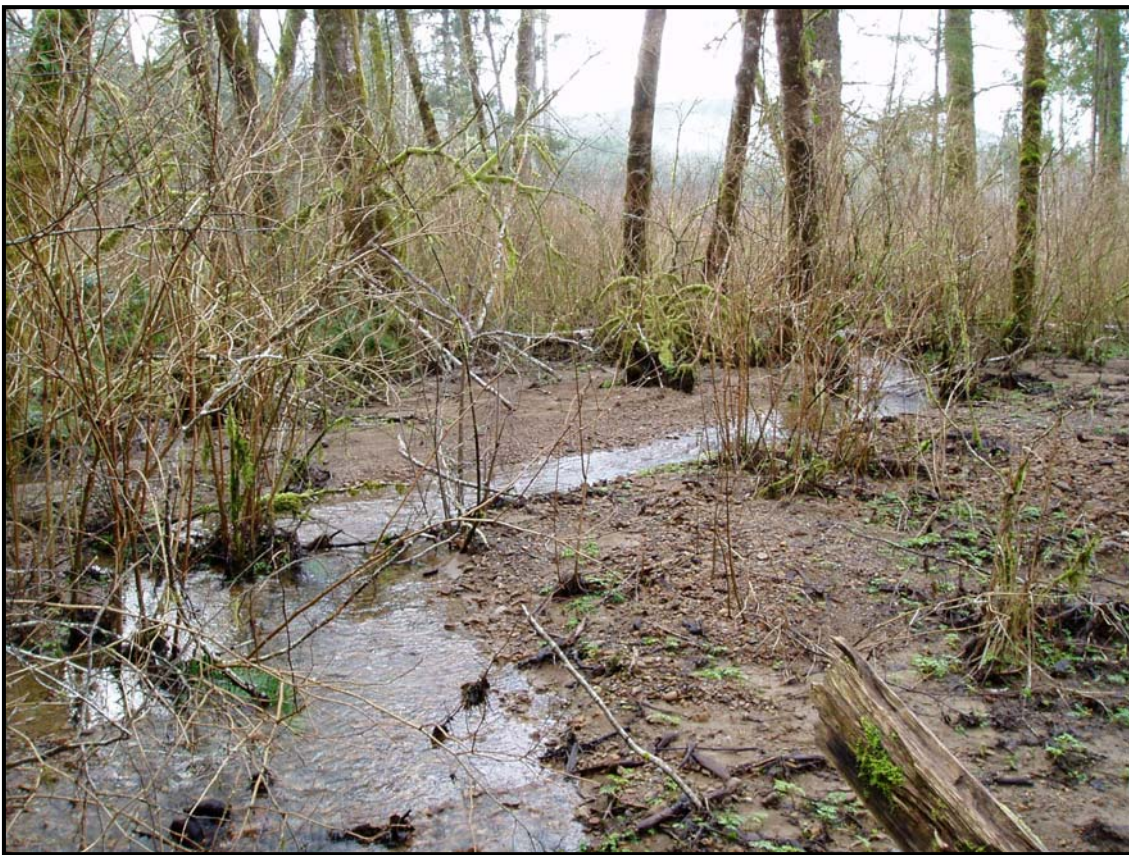
Figure 50. Sediment deposition associated with alluvial fan in the upper half of Razz Creek_T1 Segment 2.

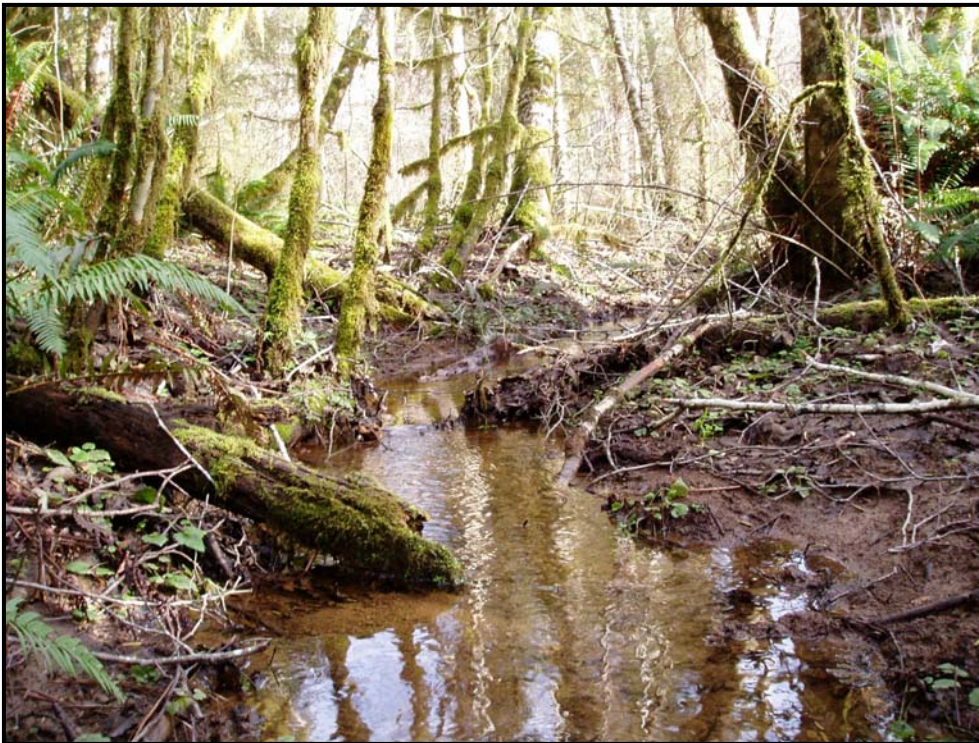
Figure 51. Typical channel conditions observed in Razz Creek_T3 Segment 1, photo looking upstream from photo point located 60 m upstream from Razz Creek.

Segment 1 is 135 meters long and is positioned between the mainstem of Razz Creek and SR 112. This segment is low gradient (<1%), mud bottomed, and low energy with fair habitat structure. Typical channel conditions are depicted in Figure 51. The channel segment was classified as a regime channel. BFW and BFD averaged 1.7 and 0.28 meters respectively. High densities of juvenile coho were observed throughout this channel segment. A small tributary enters 18 meters upstream from Razz Creek.

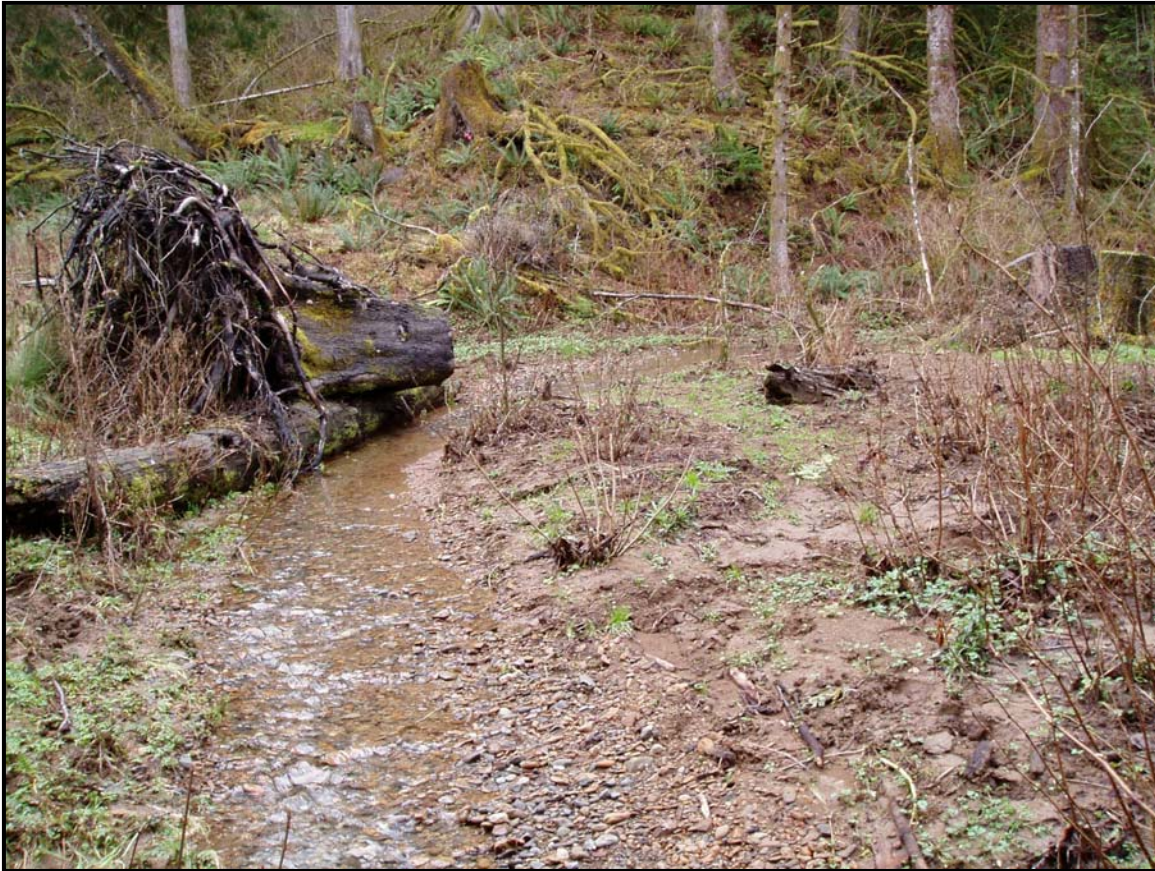
Figure 52. Alluvial fan in Segment 2 of Razz Creek_T4, photo looking upstream.

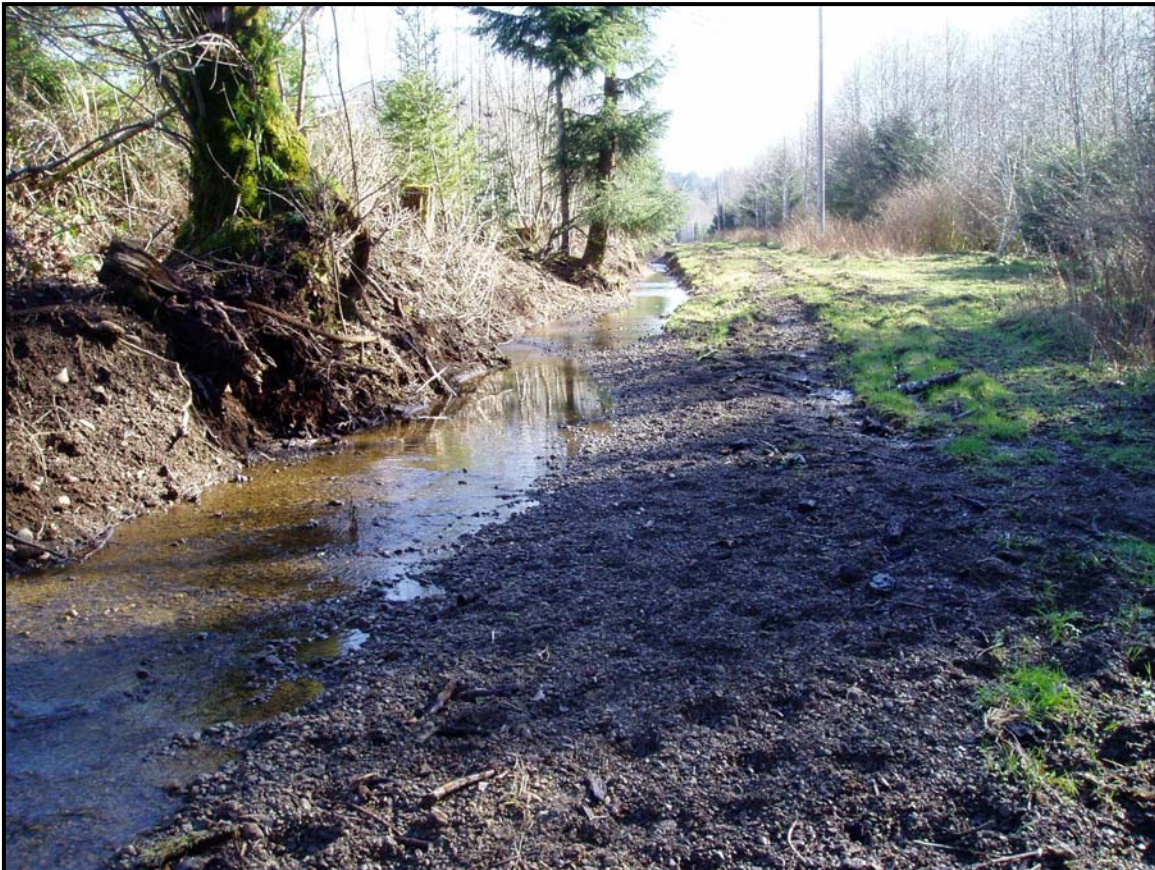
Figure 53. Lost Creek looking upstream at channel diverted by the 2100 Road ditch (noted that ditch is aggraded with sediment and stream was recently flowing across the road).
