Pysht River Floodplain Habitat Inventory and Assessment

February 2, 2006

Final Report Submitted to:

Pacific Salmon Commission

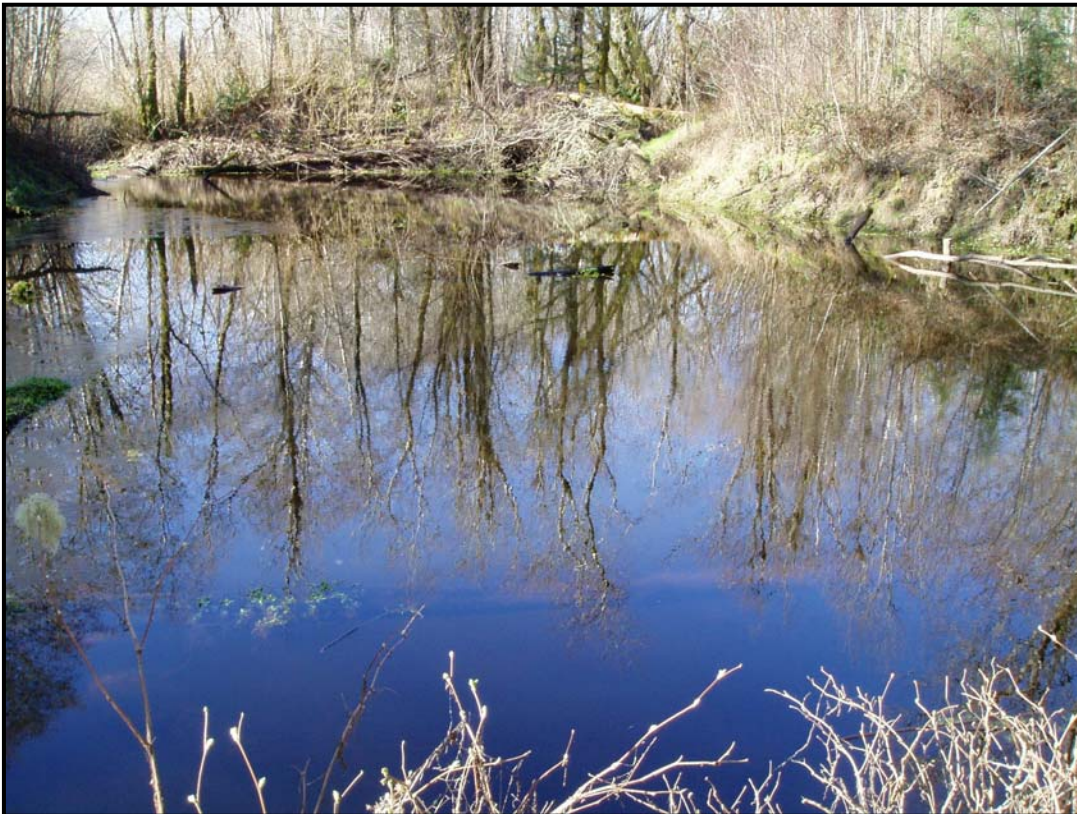
Figure 54. Lee Creek Segment 2, photo looking upstream at pond habitat.

This segment is 45 meter long and is classified as a pond. This pond was constructed in the 1990s by M&R. The pond is deep (>1 m) and appears to provide ideal pond habitat (Figure 54). The perimeter of the pond was surveyed along the left bank, no fish were observed. A smolt trap was operated during the spring of 2000 downstream of this pond and 3,742 coho smolts were captured leaving Segment 2 (Elwha Fisheries, Unpublished smolt trap data).

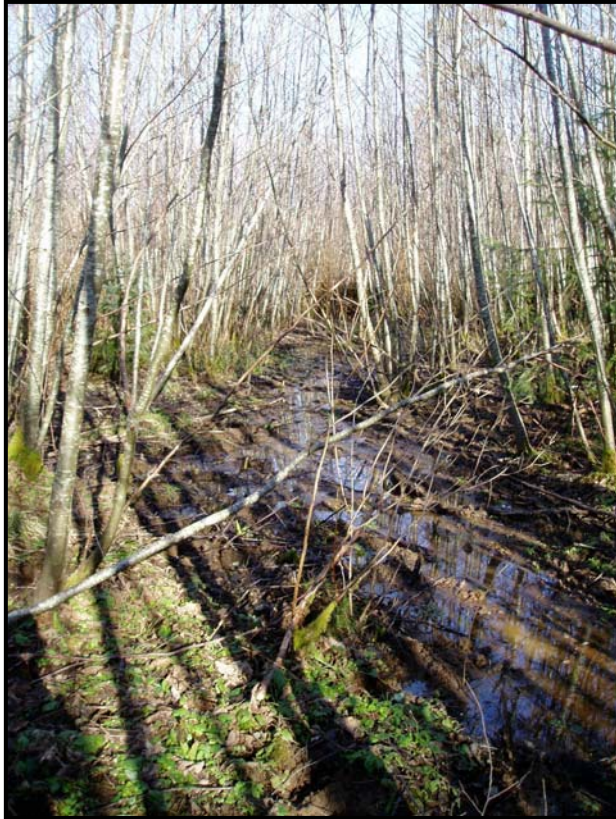
Figure 55. Lee Creek_T4 380 meters upstream from confluence with Lee Creek (note: fish habitat in this area appears to be little more than a muddy game trail).

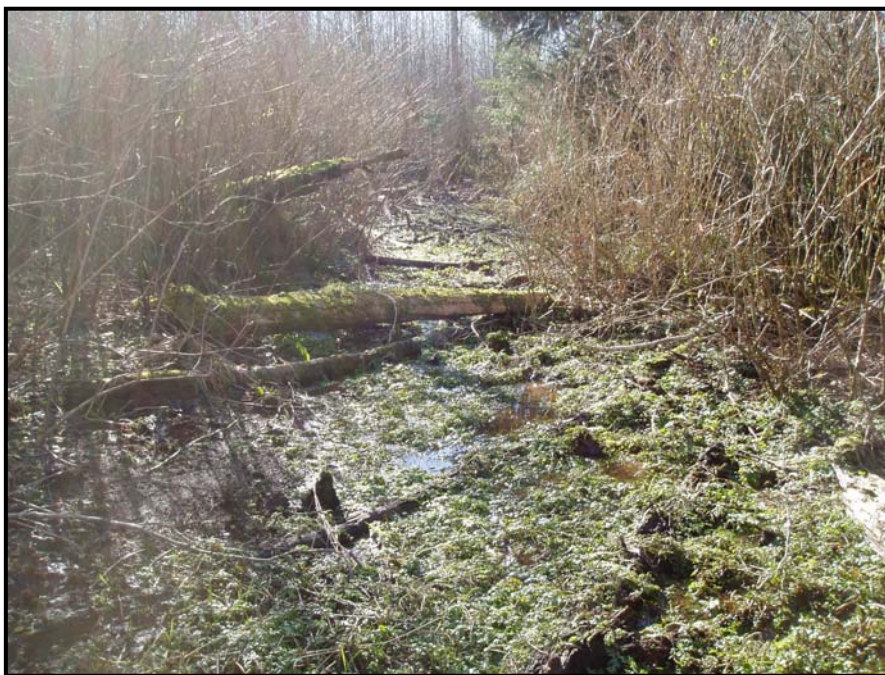
Figure 56. Lee Creek_T4 123 m upstream from Lee Creek, photo looking upstream at channel choked with aquatic vegetation.

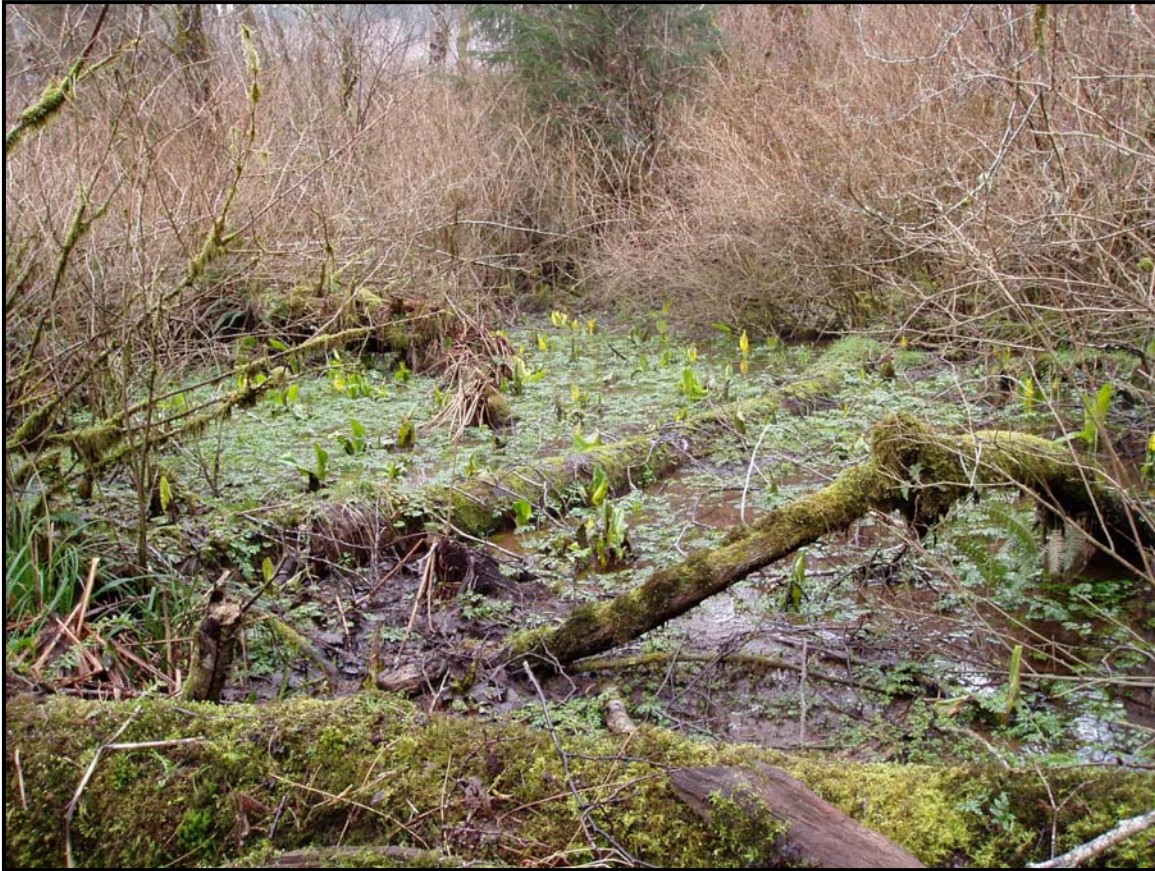
Figure 57. Example of high quality forested wetland habitat in Hamerquist Creek_T1.

stream appears to provide some excellent off-channel habitat for juvenile coho (Figure 57). Fish habitat extends to the end of survey. At this point the stream comes to within a few meters of Hamerquist Creek_LBDT1.

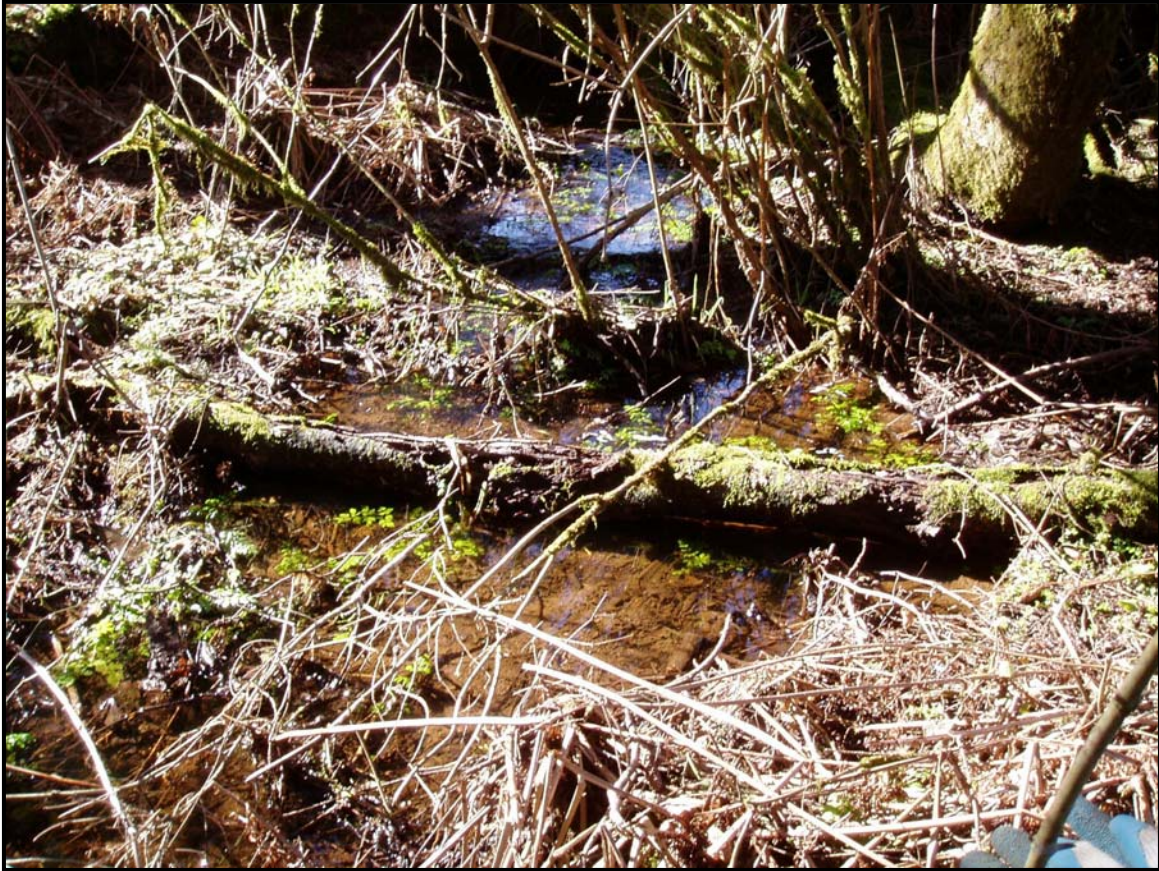
Figure 58. Example of high quality off-channel habitat in 4800 Road Creek Segment 1.

This is a short (77 m) forested wetland/regime habitat segment with an average gradient of ~1%. The segment extends for the confluence with the Pysht River to the upstream end of the SR 112 culvert. This segment contains excellent off-channel rearing habitat (Figure 58). During our survey were observed hundreds of juvenile coho within this segment. The SR 112 culvert is perched 0.11 meters and set at a 3-4% gradient; the culvert was classified as a 100% barrier to juvenile salmonids. The culvert outlet pool was examined on several occasions and each time 40-100 juvenile coho were present, further suggesting that the culvert is a barrier to juvenile coho migration.

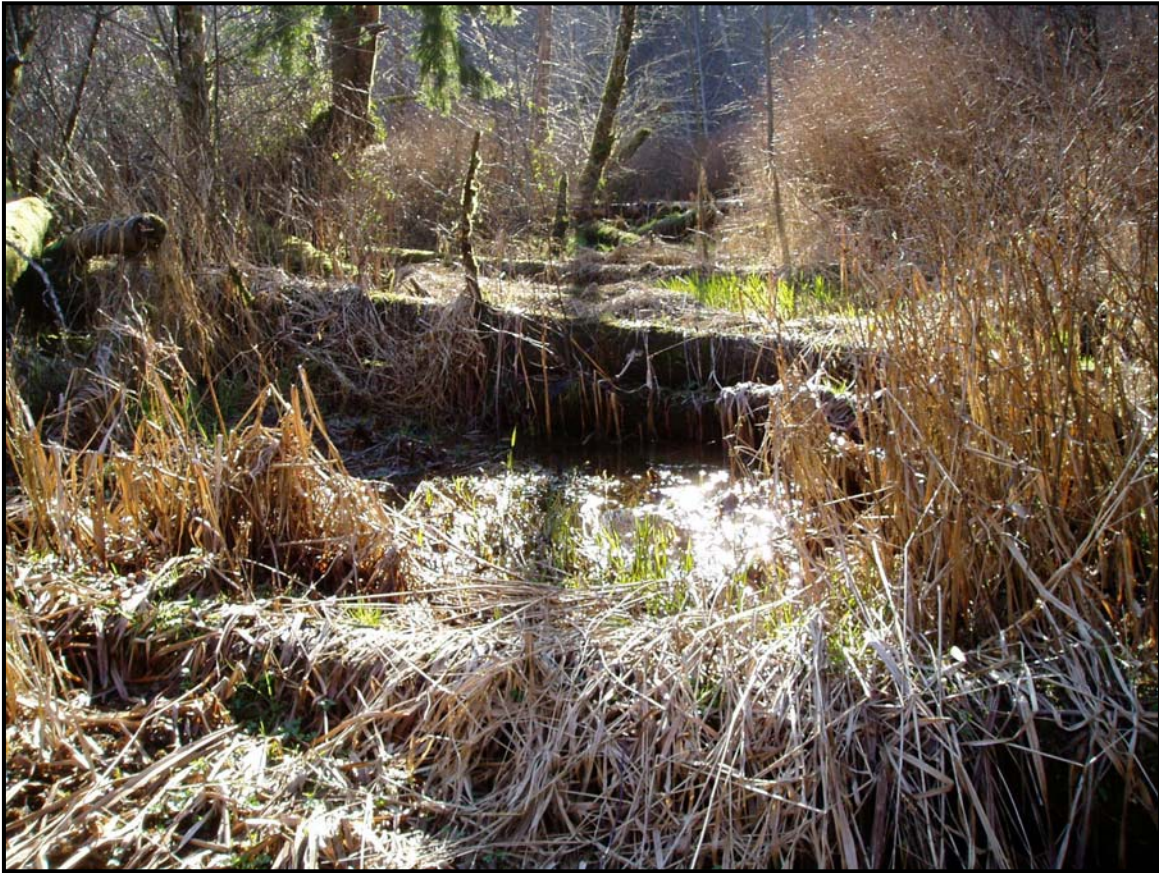
Figure 59. Wall Creek 1 looking upstream 44 meters from confluence with Pysht River, note extensive infestation of reed canary grass.

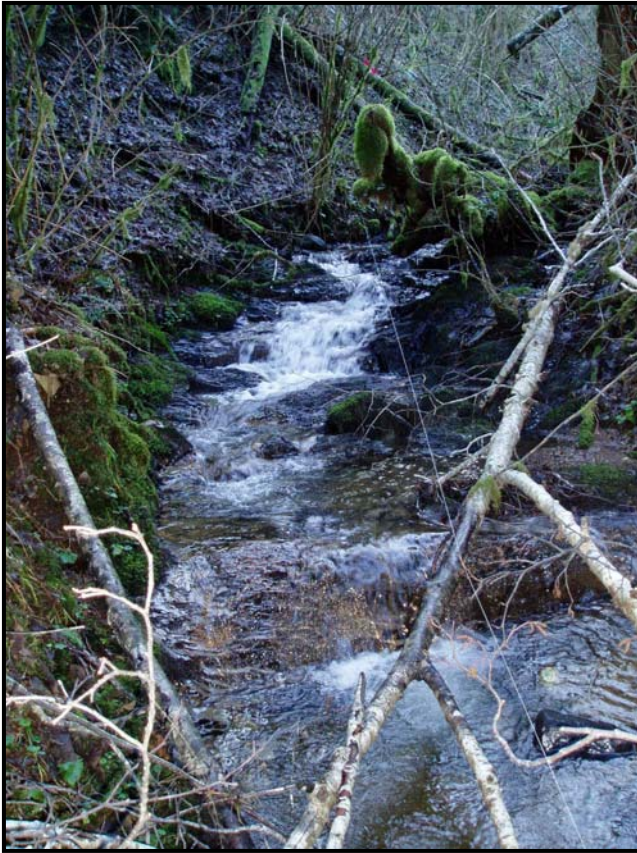
Figure 60. Burnt Creek 1 Segment 2, looking upstream at cascades.

This segment is 163 meters long and moderate to high gradient, ranging from 5-12%. This segment contains a mix of step-pool and cascade habitats. Two 64 m long culverts set at a 5% slope are located 26 meters upstream from the segment break. These culverts were classified as 99% barriers to adult salmonids and 100% barriers to juvenile salmonids. Upstream of the culverts stream gradient increases and averages 9-12% slope for 37 meters. This short, confined, bedrock cascade reach may pose migration difficulties to salmonids (Figure 60). At the end of this short cascade reach there is another culvert (801 Road) that poses fish passage problems.

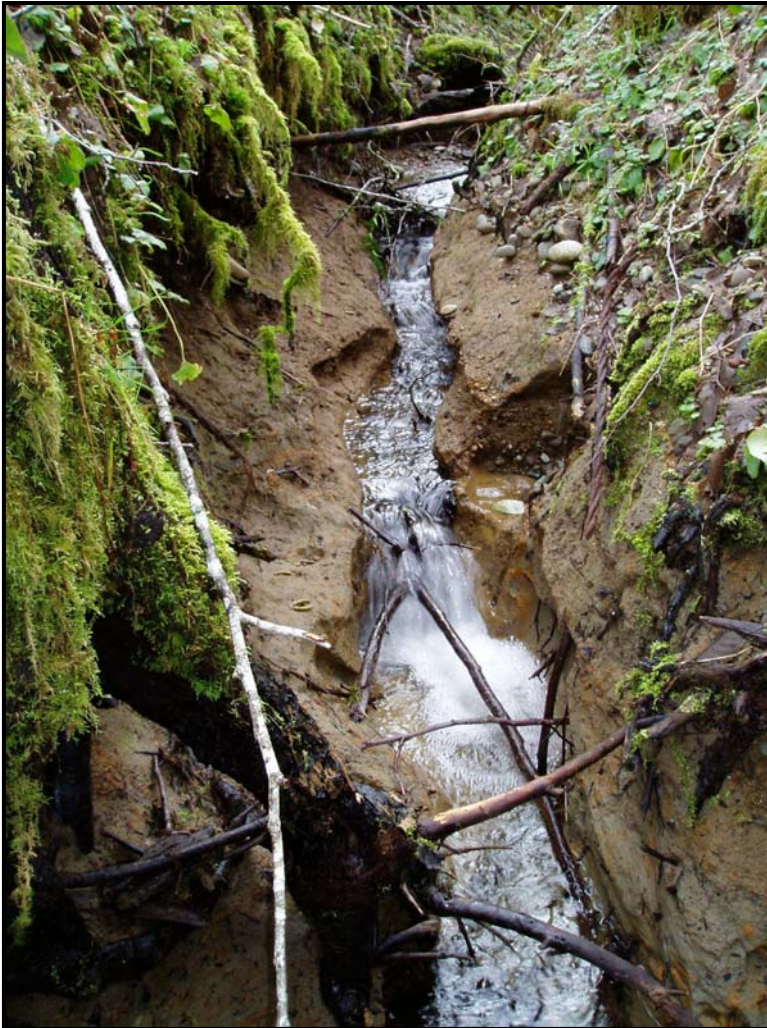
Figure 61. Active channel incision in Segment 1 of Burnt Creek Two.

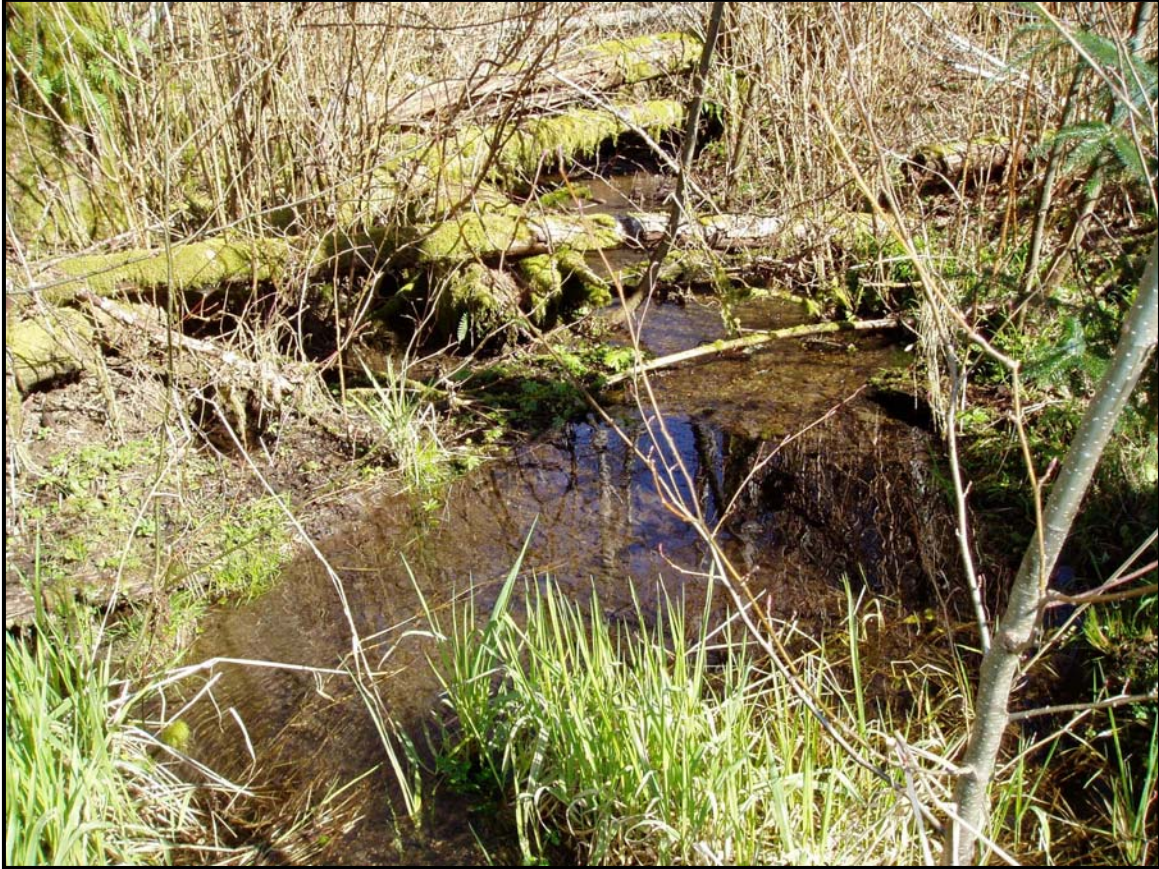
Figure 62. Example of the high quality habitat in Wall Creek 2, photo looking downstream 93 meters upstream from the Pysht River.

This stream system is a small wall-based off channel habitat which enters the Pysht River along the right bank at RM 11.02. Streamflow is sustained by a large side-hill spring. The total length of this habitat feature is 100 meters. Channel gradient averaged 1 to 2% slope. This spring-fed wall based system had exceptionally strong flow at the time of our survey. Several weeks without any significant rainfall had occurred prior to the survey but this channel had excellent flow and excellent water quality. High fish use by juvenile coho was observed throughout the entire length of this habitat feature. Figure 62 illustrates the high quality nature of this habitat unit.
