Uniform Mitigation Verification Inspection Form

Inspection Date: Oct 29, 2018		
Owner Information		
Owner Name: LONGWOOD COND ASSN INC		Contact Person: LONGWOOD COND ASSN INC
Address: 11811 AVENUE OF THE PGA BUILDING 5		Home Phone:
City: PALM BEACH GARDENS	Zip: 33418	Work Phone:
County: PALM BEACH		Cell Phone:
Insurance Company:		Policy #:
Year of Home: 1970	# of Stories: 3	Email:

Inspectors Initials MC Property Address 11811 AVENUE OF THE PGA BUILDING 5

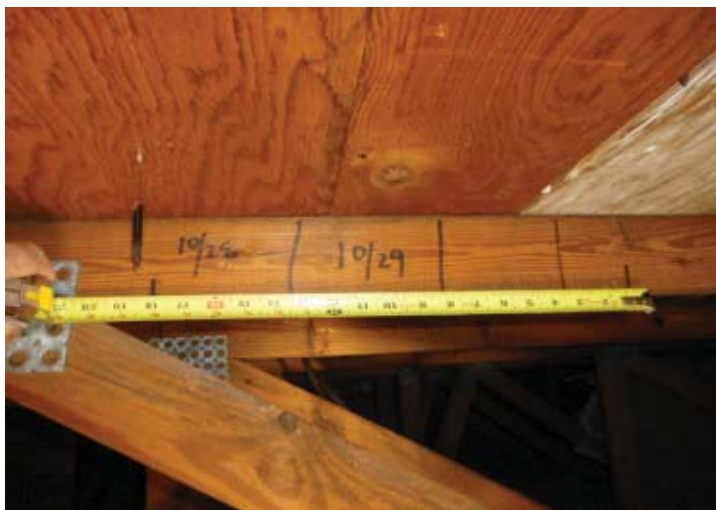
- ☒ C. Plywood/OSB roof sheathing with a minimum thickness of 7/16" inch attached to the roof truss/rafter (spaced a maximum of 24" inches o.c.) by 8d common nails spaced a maximum of 6" inches in the field. -OR- Dimensional lumber/Tongue & Groove decking with a minimum of 2 nails per board (or 1 nail per board if each board is equal to or less than 6 inches in width). -OR- Any system of screws, nails, adhesives, other deck fastening system or truss/rafter spacing that is shown to have an equivalent

or greater resistance than 8d common nails spaced a maximum of 6 inches in the field or has a mean uplift resistance of at least 182 psf.

#3 ROOF DECK ATTACHMENT
6" X 6" NAIL SPACING

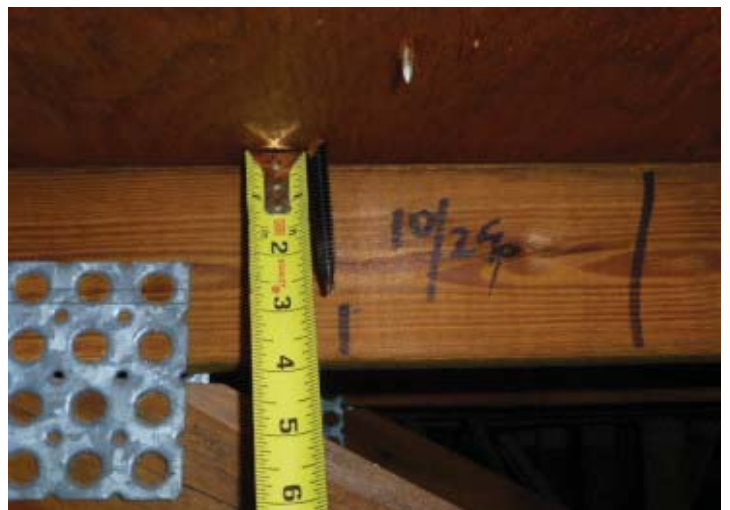
#3 ROOF DECK ATTACHMENT
8d NAILS

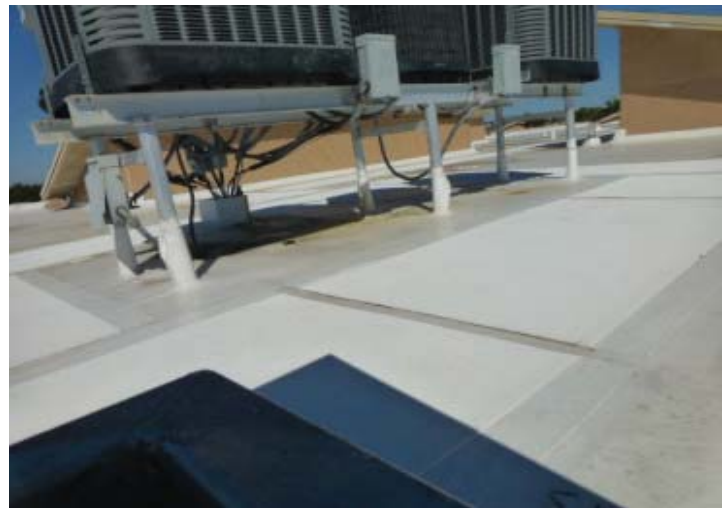
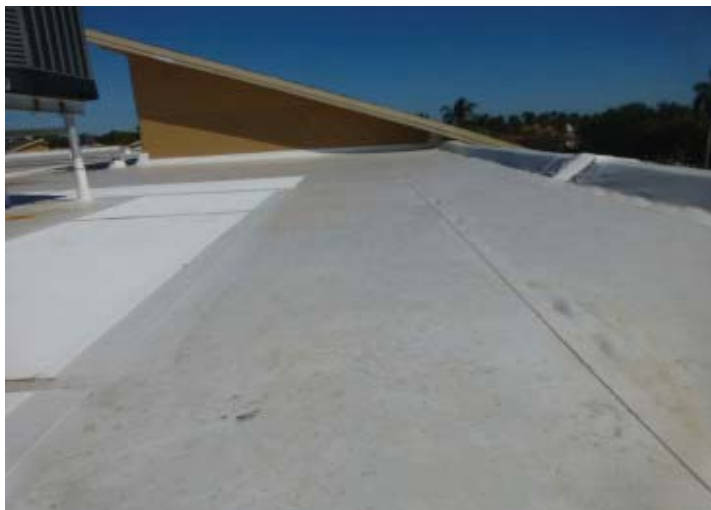
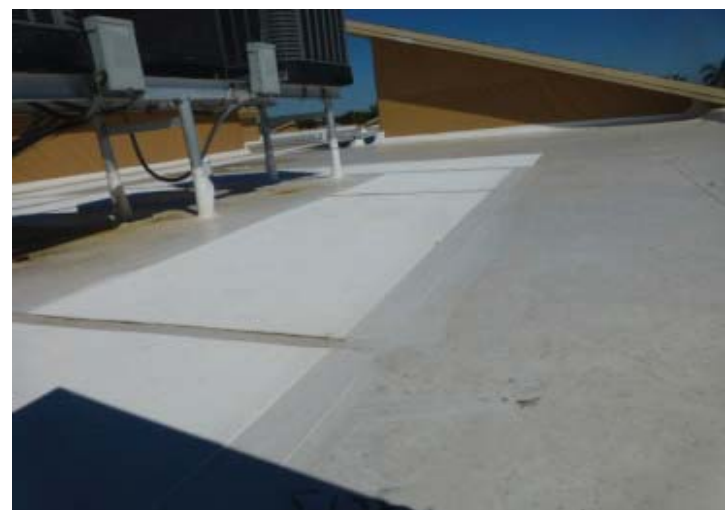
ROOF COVERING

2.1 Roof Covering Type:	Permit Application Date	FBC or MDC Product Approval #	Year of Original Installation or Replacement	No Information Provided for Compliance
<input type="checkbox"/> 1. Asphalt/Fiberglass Shingle	____/____/____	_____	_____	<input type="checkbox"/>
<input type="checkbox"/> 2. Concrete/Clay Tile	____/____/____	_____	_____	<input type="checkbox"/>
<input type="checkbox"/> 3. Metal	____/____/____	_____	_____	<input type="checkbox"/>
<input type="checkbox"/> 4. Built Up	____/____/____	_____	_____	<input type="checkbox"/>
<input checked="" type="checkbox"/> 5. Membrane	01/29/2018	_____	2018	<input type="checkbox"/> 18-01088422
<input type="checkbox"/> 6. Other _____	____/____/____	_____	_____	<input type="checkbox"/>

- ☒ A. All roof coverings listed above meet the FBC with a FBC or Miami-Dade Product Approval listing current at time of installation OR have a roofing permit application date on or after 3/1/02 OR the roof is original and built in 2004 or later.
