Battle Creek Alliance Defiance Canyon Raptor Rescue

Water and air temperatures recorded by Battle Creek Alliance in the Battle Creek watershed 2019, 2020, 2021

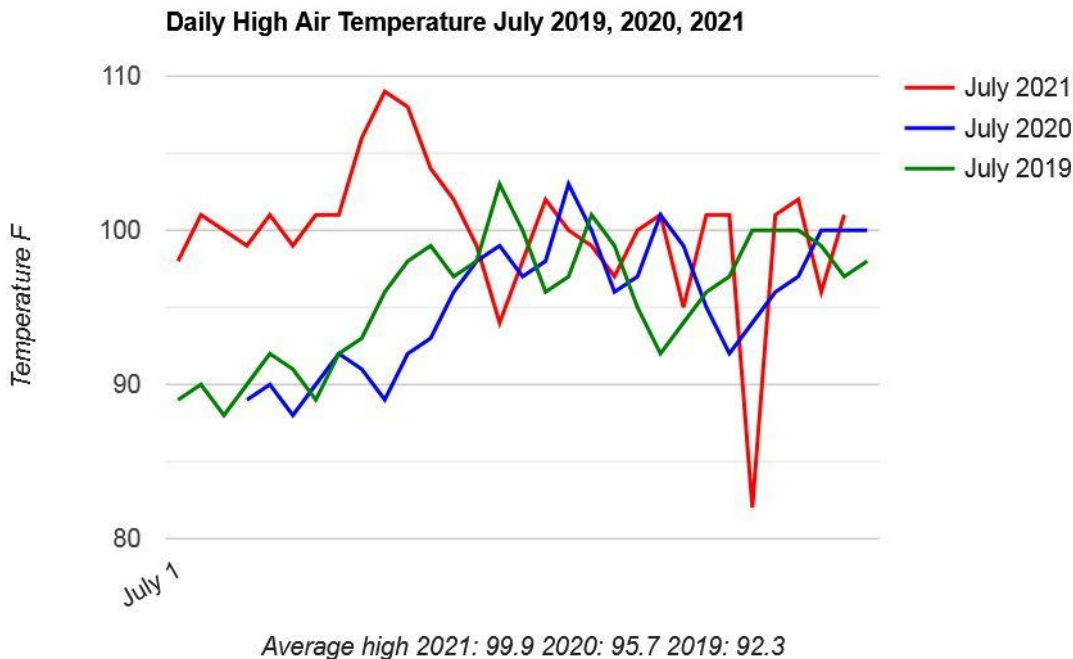
The following graph summarizes the daily high air temperatures in July 2019, 2020, and 2021.

Between 2019 and 2021 the average high temperature increased by 7.6 degrees.

We began recording the high and low air temperatures in Manton at 2200' elevation in 2019. This is to the west of the border of the industrial timberland and near our north fork Battle Creek water sampling site (NFB). The readings are taken by a digital thermometer installed in the shade on the northeast side of a building. The thermometer is calibrated to a NIST thermometer weekly.

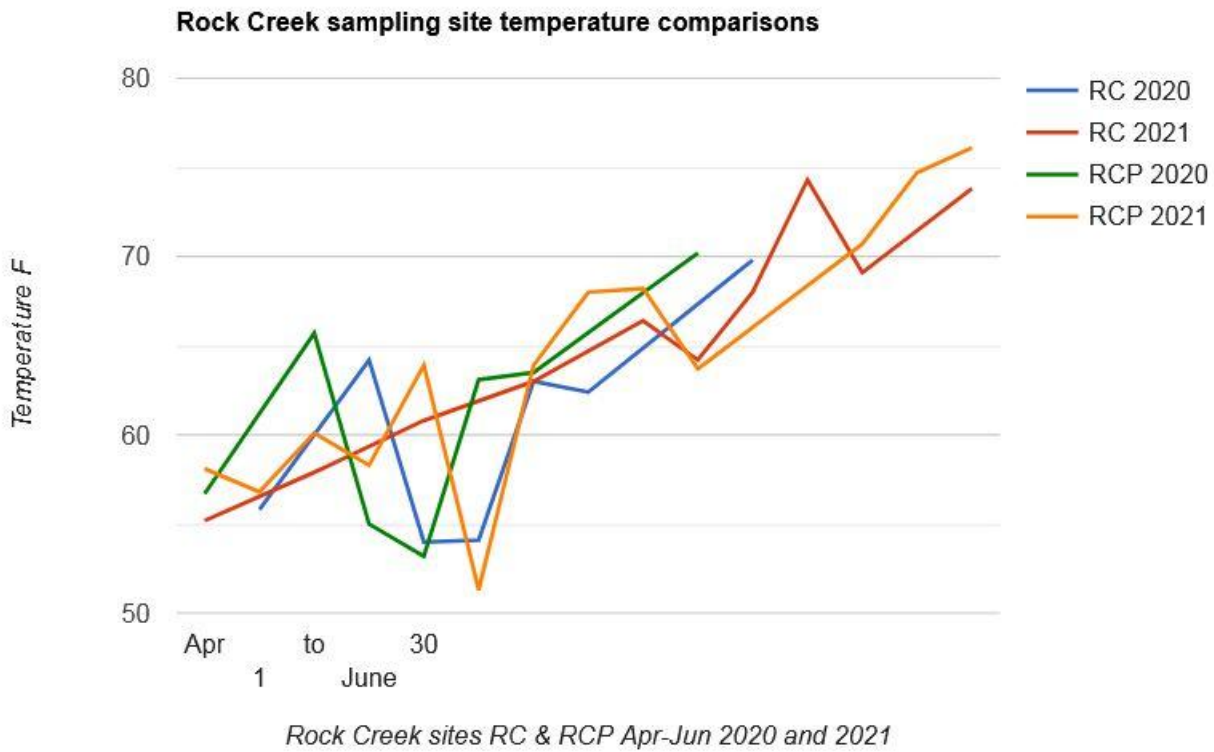
The next graph illustrates the water temperature changes at our water monitoring sites Rock Creek (RC) and Rock Creek Ponderosa (RCP) recorded between April 1st and June 30th in 2020 and 2021.

RC is higher upstream at 3090' elevation, RCP is downstream at 2590' elevation. The details of the equipment used, methodology, and the sites are in our Quality Assurance Project Plan (QAPP) document.

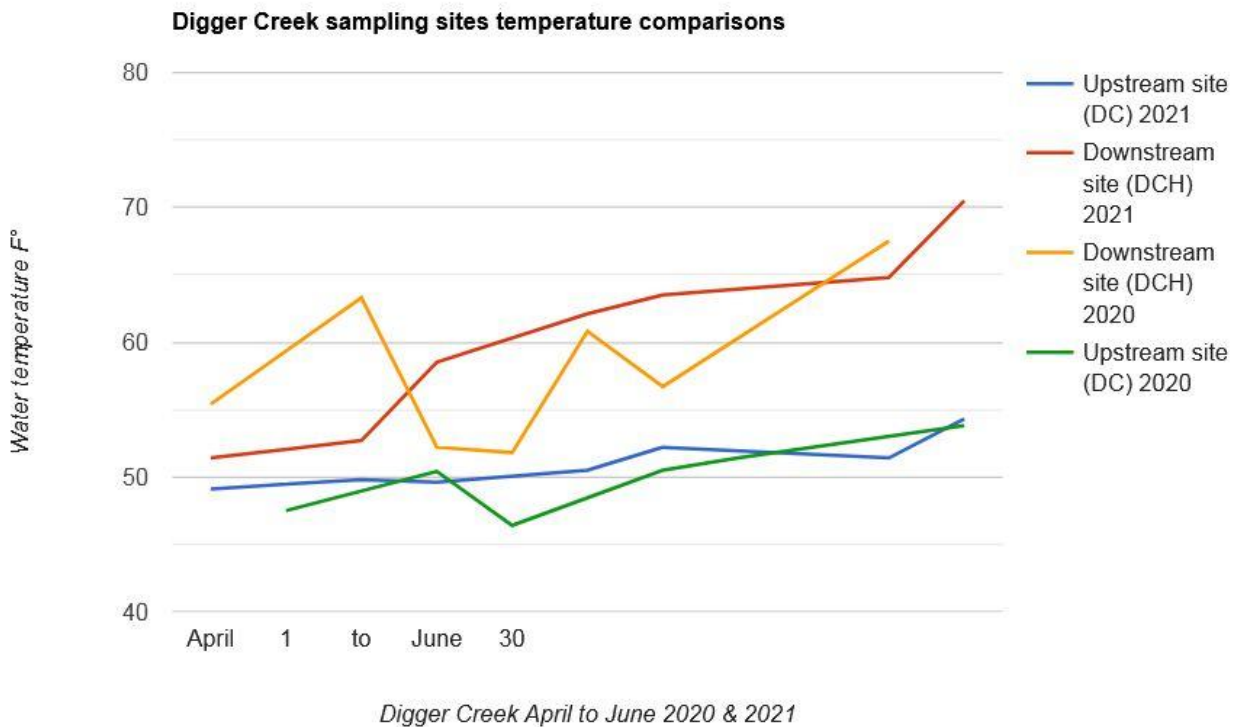
The next graph is of our Digger Creek sites, DC and DCH.

DC is the higher upstream site at 3440' elevation; DCH is downstream at 2580' elevation.
