SES Doc No : 611015-PL-RP-0010 Rev 0

SUBJECT: Long-term Composite Repair Study, Year 3 Burst Results

This letter report provides a summary of the burst testing that was performed for the Year 3 samples by Stress Engineering Services, Inc. (SES).

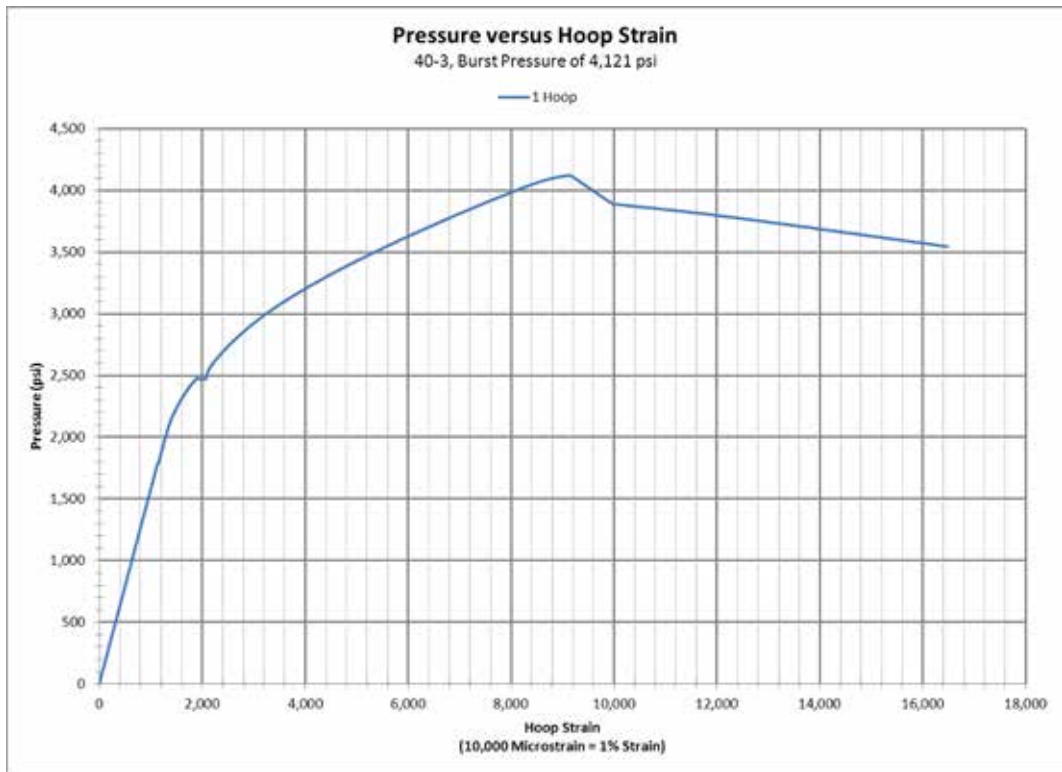
Figure 1 – Pressure vs. Hoop Strain, 40% Corrosion Sample

The test program is attached to this letter report and provides the specific activities completed in the burst test. The Year 3 samples were removed from the burial area at our Waller facility in December 2012. The three samples (40%, 60% and 75% wall loss) were then pressured to failure while pressure and strain were recorded. The burst pressures for the samples are listed in the table below.

Sample Number	Burst Pressure (psi)
40	4,121
60	4,135
75	4,046

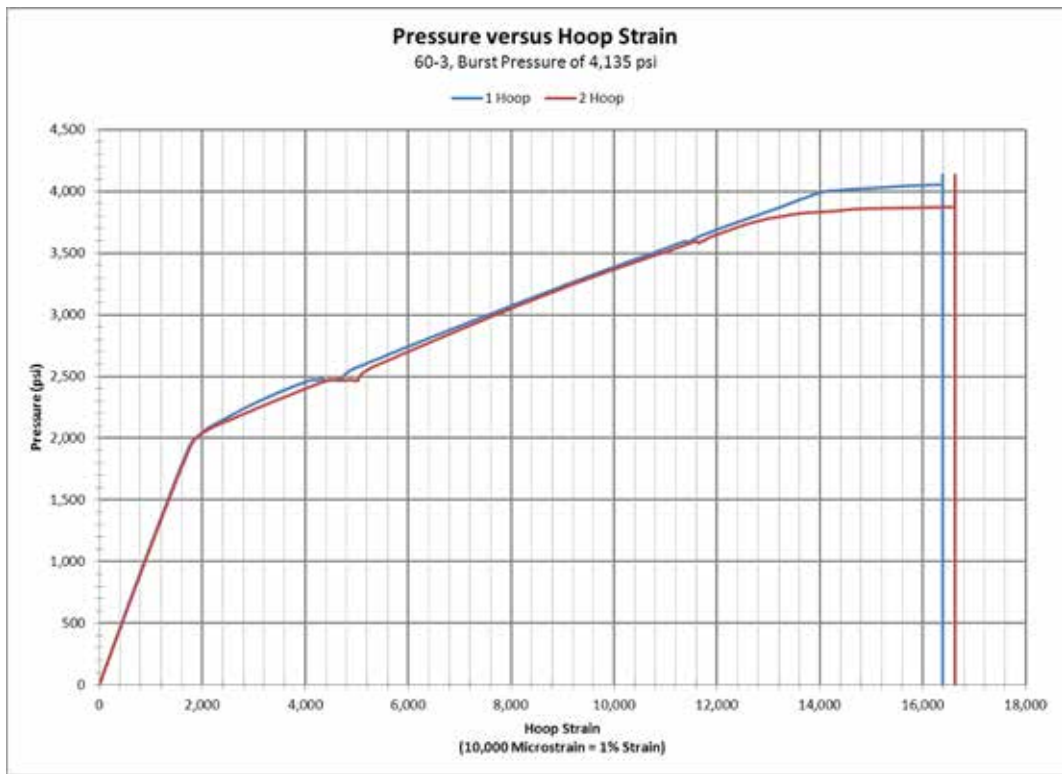
Figure 2 – Pressure vs. Hoop Strain, 60% Corrosion Sample

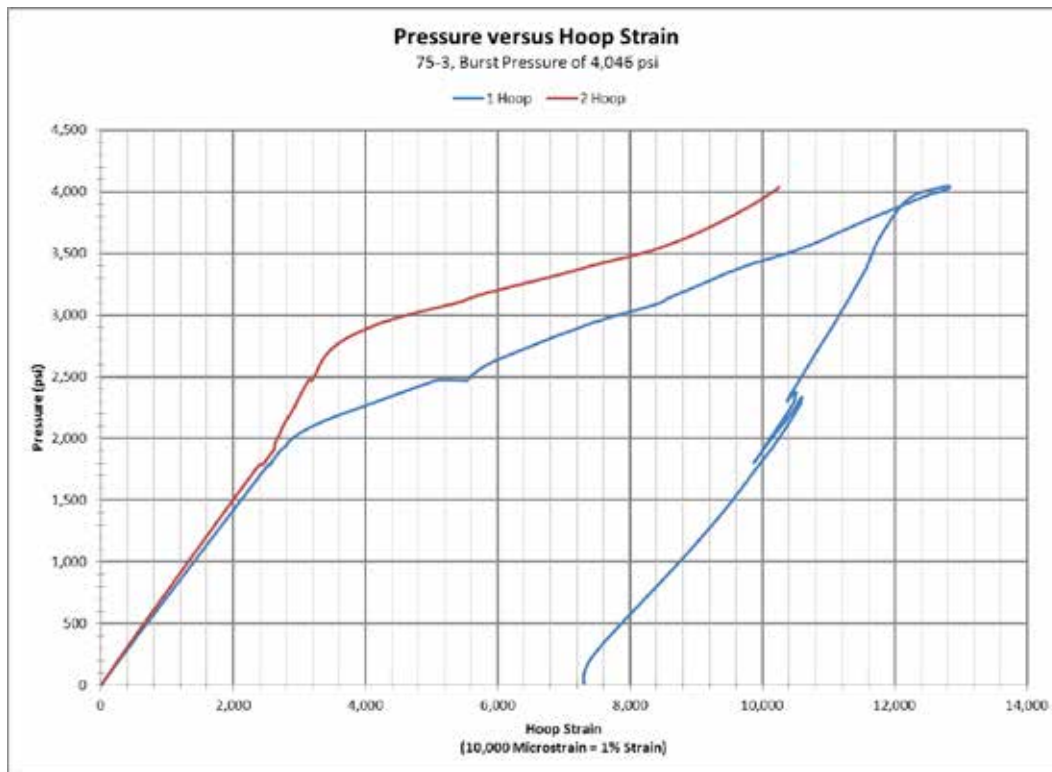
Figure 3 – Pressure vs. Hoop Strain, 75% Corrosion Sample

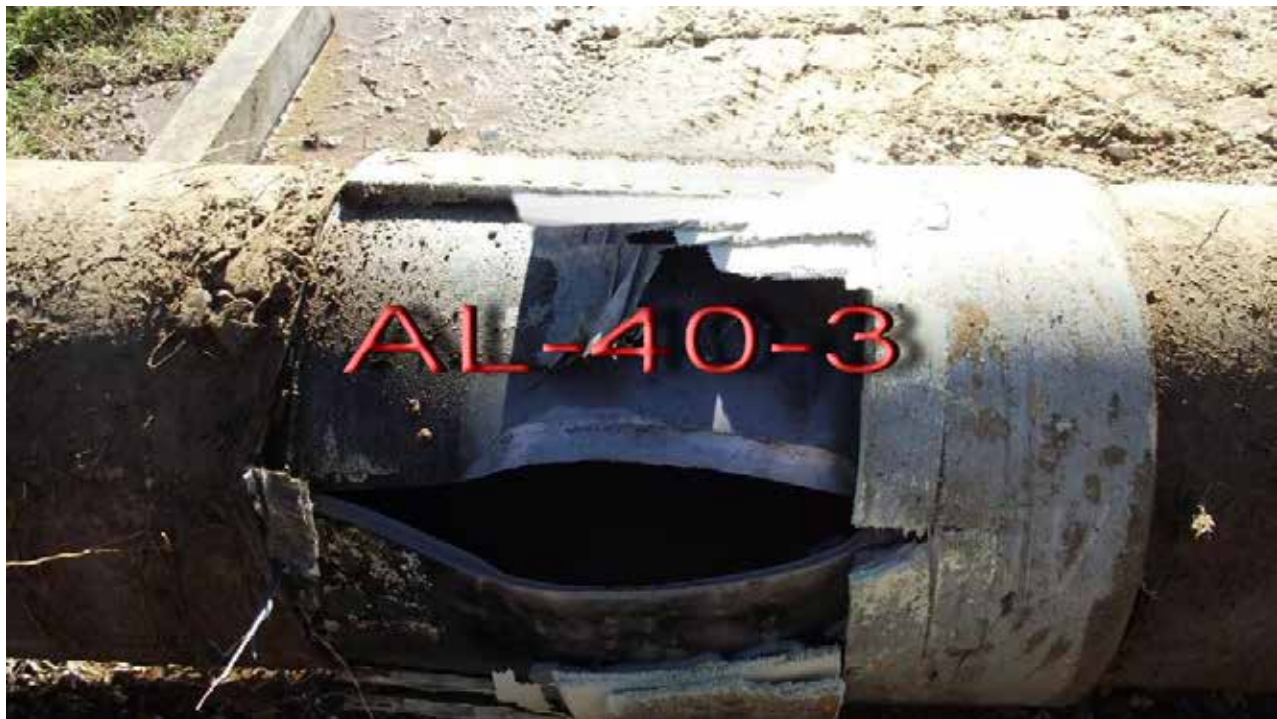
Figure 4 – Photograph of Failure Location, 40% Corrosion Sample

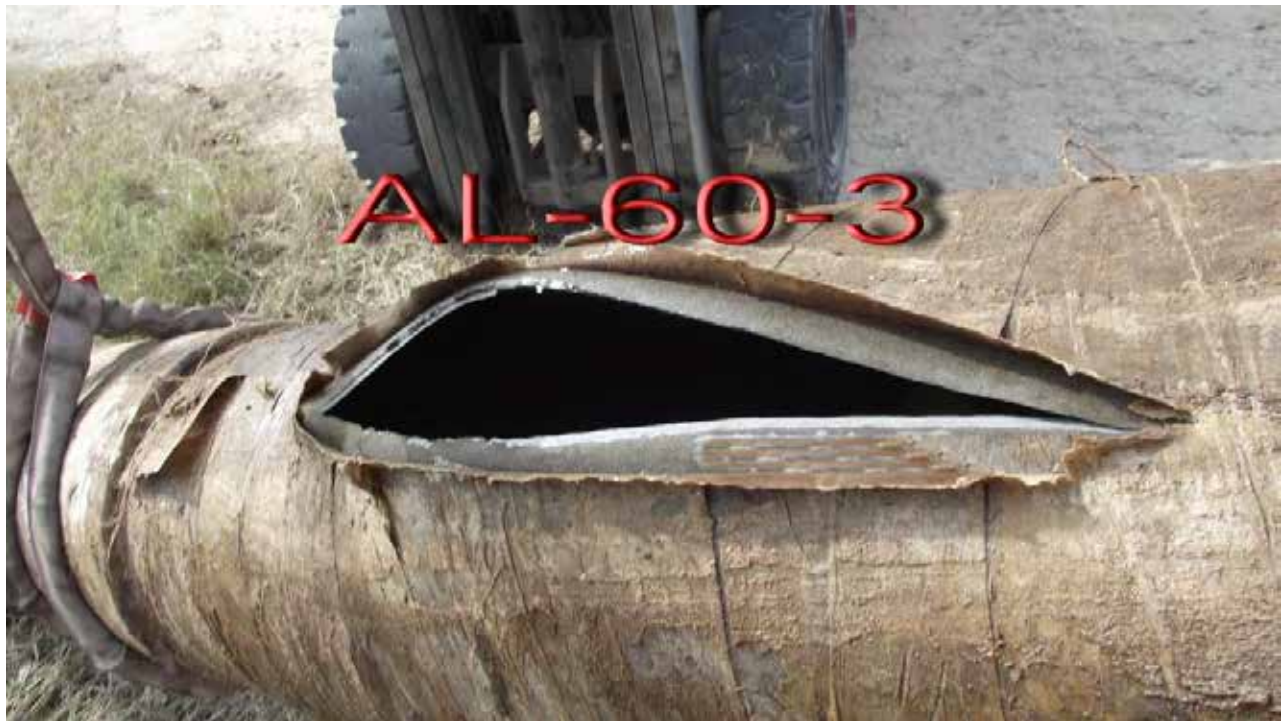
Figure 5 – Photograph of Failure Location, 60% Corrosion Sample

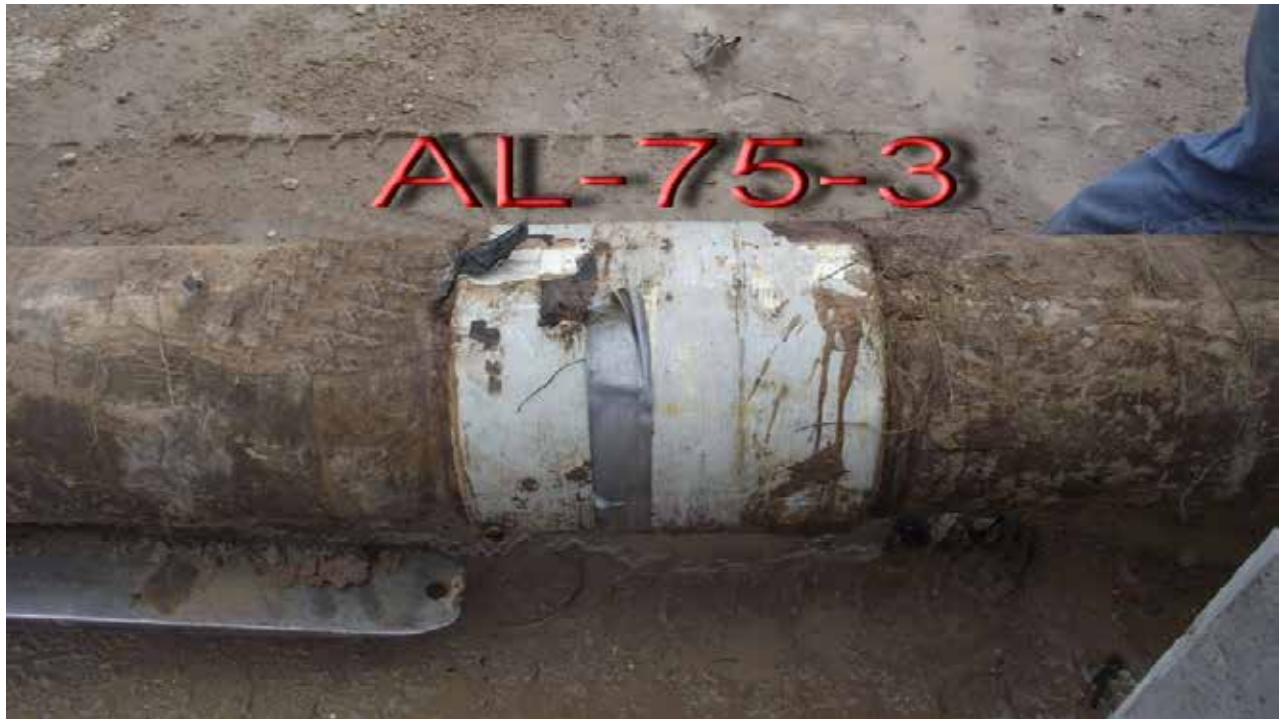
Figure 6 – Photograph of Failure Location, 75% Corrosion Sample

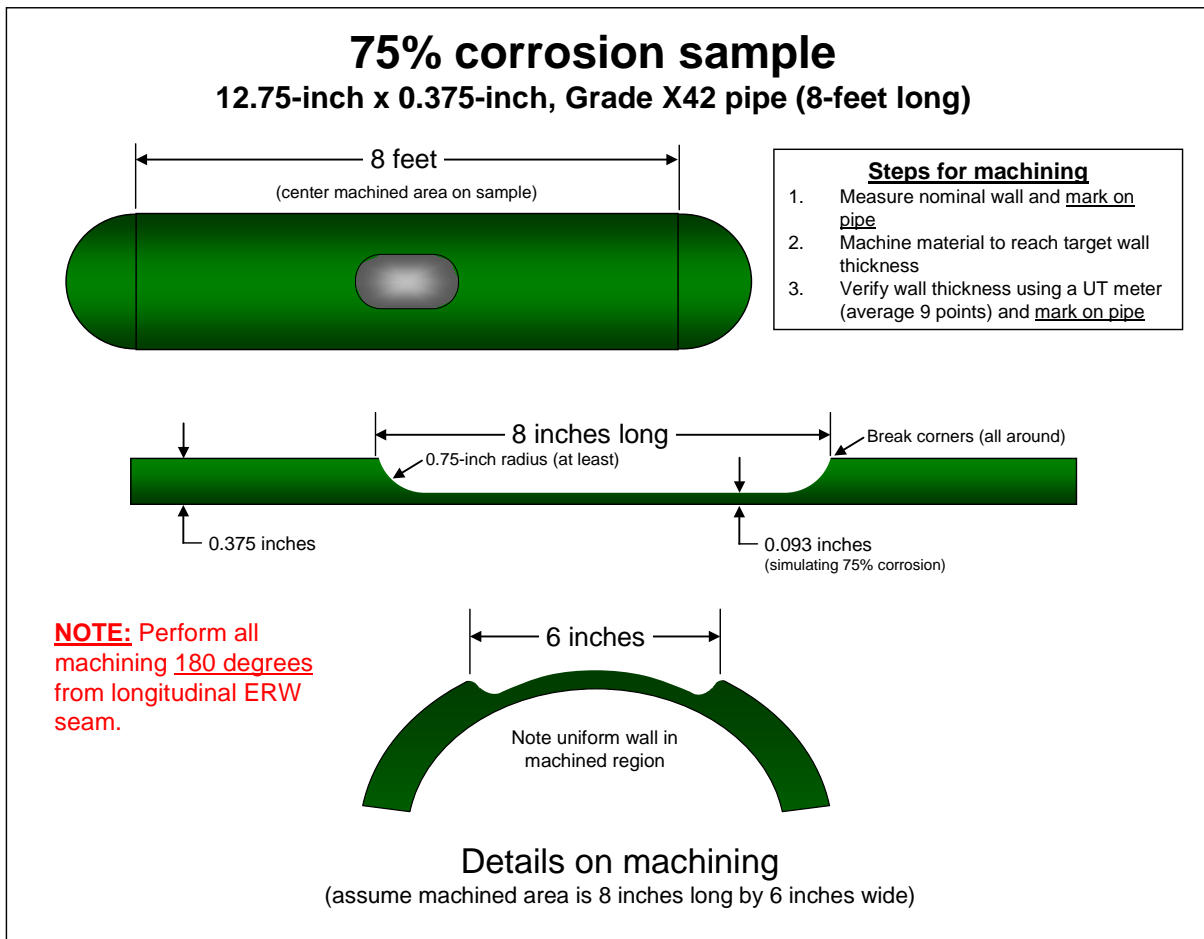
- Fabrication of 180 12.75-inch x 0.375-inch, Grade X42 8-ft long test samples with welded end caps (36 Year 0 burst tests and 144 buried samples).
- Sample preparation included simulated corrosion installed via machining with depths of 40%, 60%, and 75% of the pipe's nominal wall thickness (refer to Figure A for geometry of the machined regions).

Figure A - Sketch of simulated corrosion

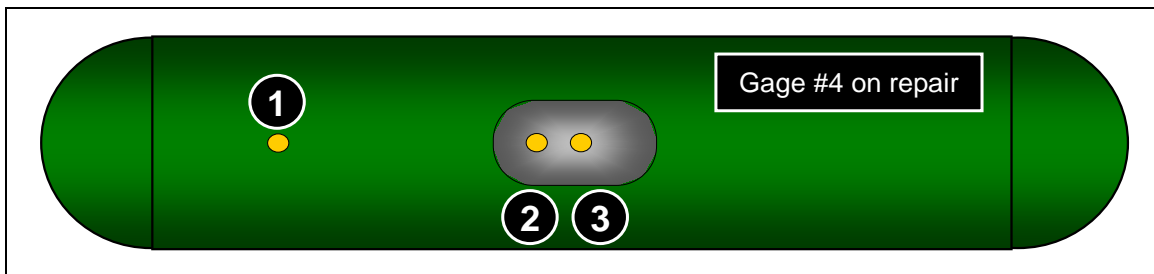
- During the testing period, strain gages will be used to monitor strain in the corroded steel beneath the composite repairs. Figure B and Figure C provide a schematic of the strain gage locations and a photograph of the machined region with strain gages, respectively.

Figure B- Diagram of strain gage locations

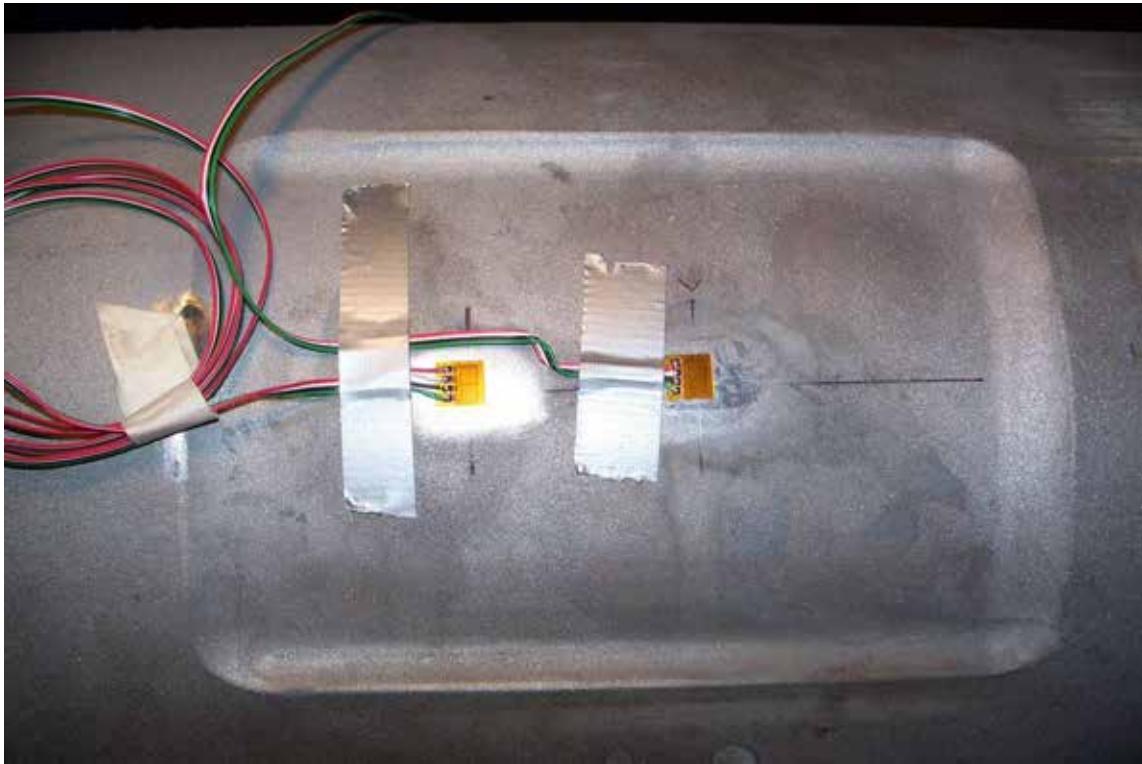
Figure C - Strain gages in simulated corrosion

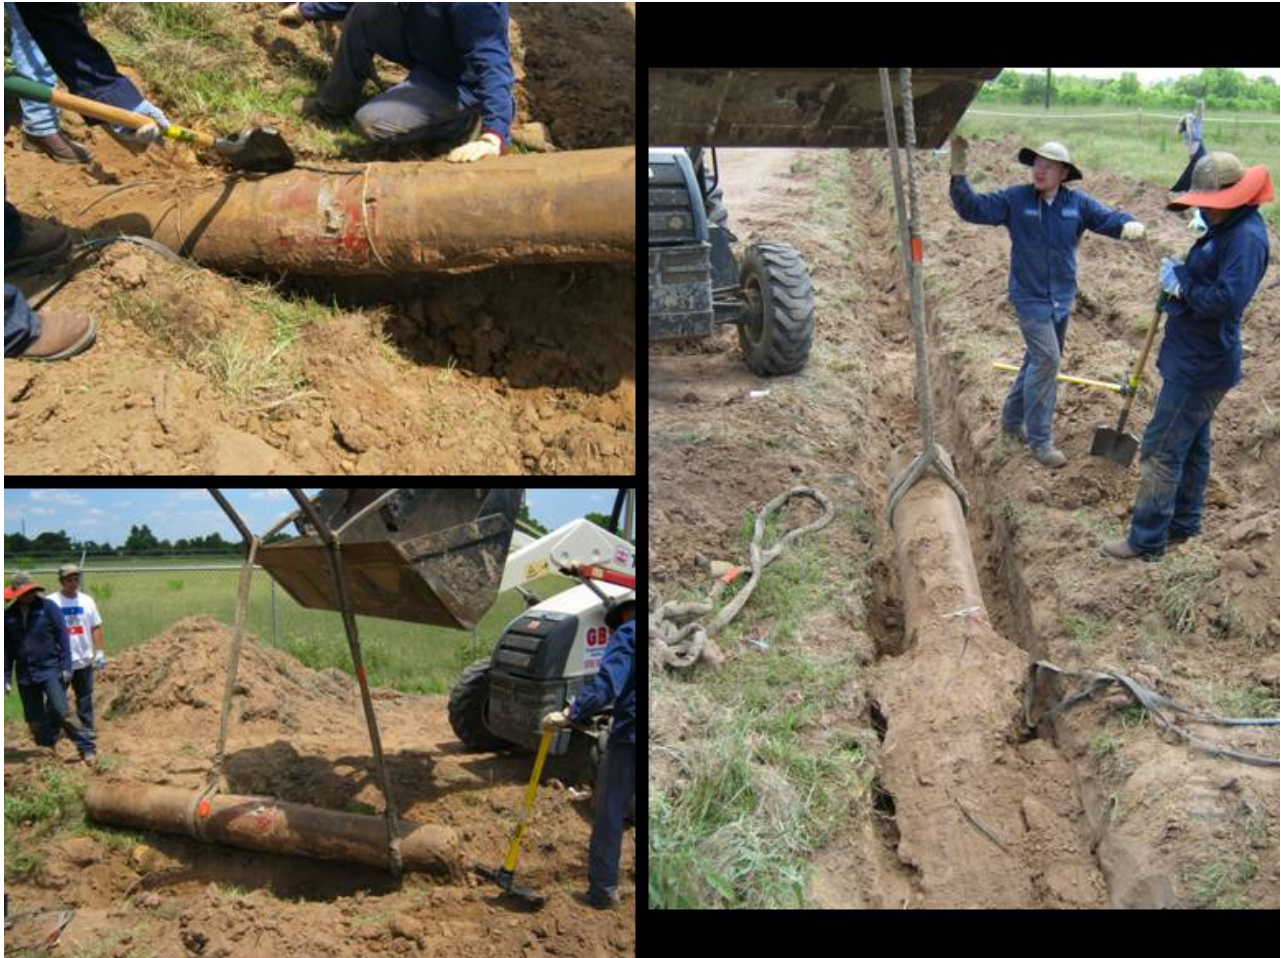
The 35 samples from the Year 3 group were unearthed prior to burst testing. Figure D provides photographs taken during the pipe removal activities. The same process was used for the samples removed for the Year 2 phase of work.

Figure D - Photographs from Year 1 sample removal
