Uniform Mitigation Verification Inspection Form

Inspection Date: Jan 9, 2015		
Owner Information		
Owner Name: LONGWOOD COND ASSN INC		Contact Person: LONGWOOD COND ASSN INC
Address: 11811 AVENUE OF THE PGA BUILDING 1		Home Phone: 561-371-3260
City: PALM BEACH GARDENS	Zip: 33418	Work Phone:
County: PALM BEACH		Cell Phone:
Insurance Company:		Policy #:
Year of Home: 1970	# of Stories: 2	Email:

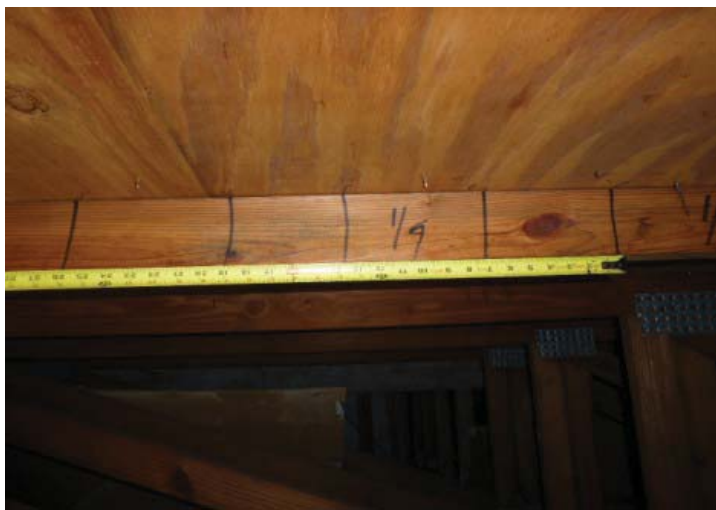
- ☒ C. Plywood/OSB roof sheathing with a minimum thickness of 7/16" inch attached to the roof truss/rafter (spaced a maximum of 24" inches o.c.) by 8d common nails spaced a maximum of 6" inches in the field. -OR- Dimensional lumber/Tongue & Groove decking with a minimum of 2 nails per board (or 1 nail per board if each board is equal to or less than 6 inches in width). -OR- Any system of screws, nails, adhesives, other deck fastening system or truss/rafter spacing that is shown to have an equivalent

#3 ROOF DECK ATTACHMENT
6" X 6" NAIL SPACING

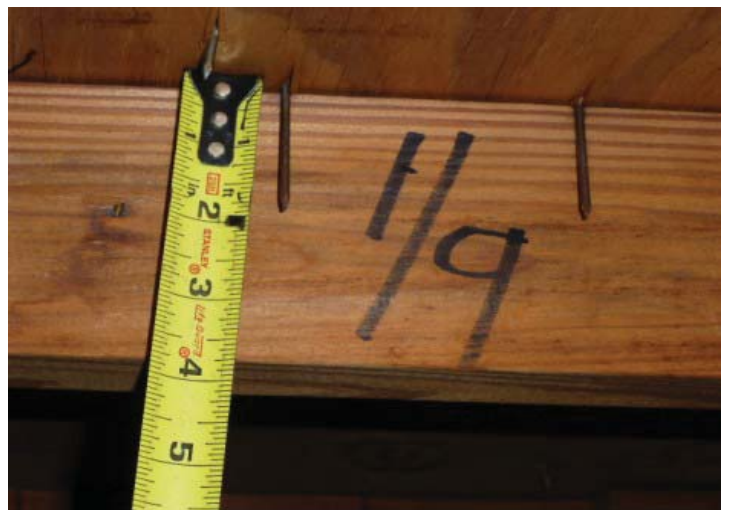
#3 ROOF DECK ATTACHMENT
8d NAILS

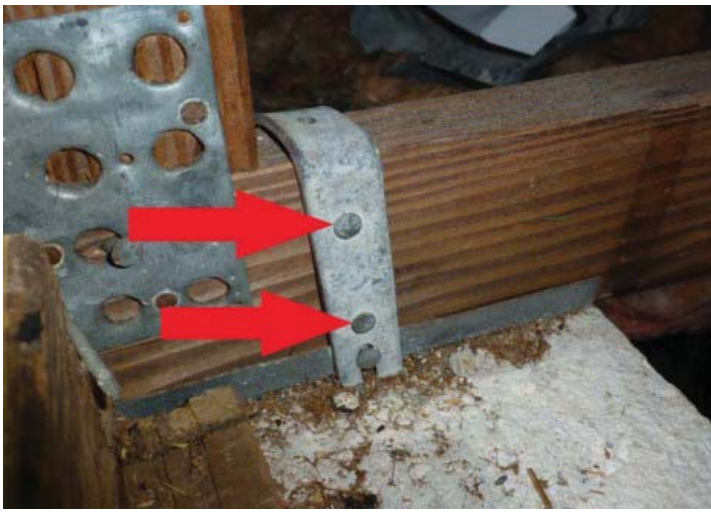
- ☒ C. Single Wraps
 - Metal connectors consisting of a single strap that wraps over the top of the truss/rafter and is secured with a minimum of 2 nails on the front side and a minimum of 1 nail on the opposing side.

**#4 ROOF TO WALL ATTACHMENT
FACE SIDE**

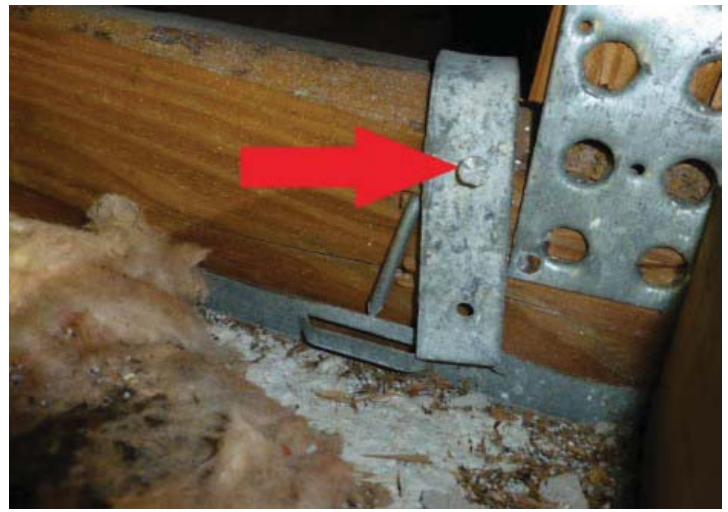
**#4 ROOF TO WALL ATTACHMENT
OPPOSITE SIDE**

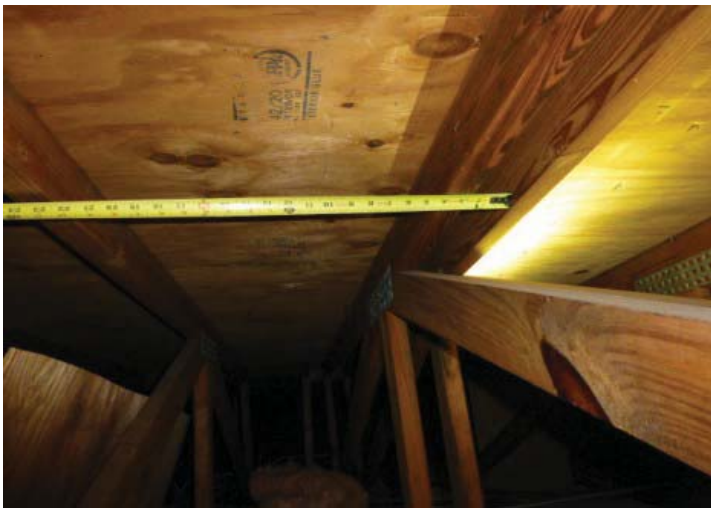
TRUSS/RAFTER SPACING

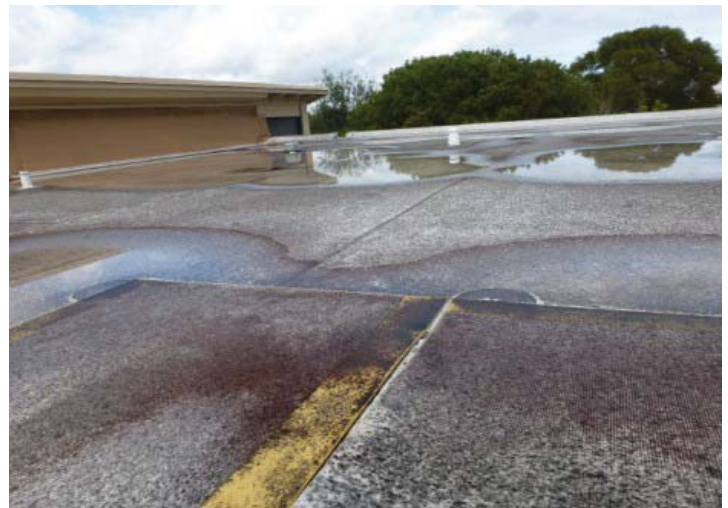
- ☐ C. One or more roof coverings do not meet the requirements of Answer "A" or "B".
- ☒ D. No roof coverings meet the requirements of Answer "A" or "B".

ROOF COVERING

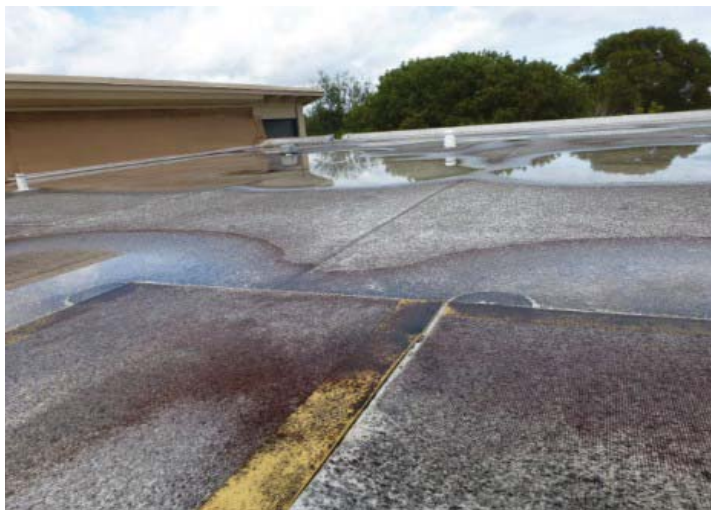
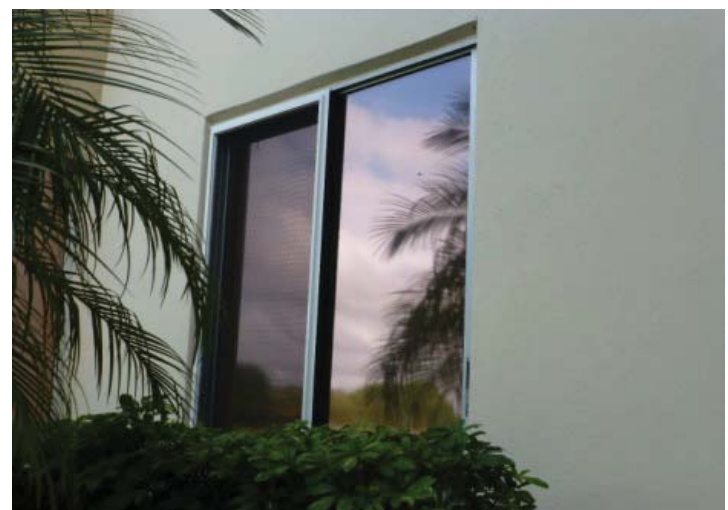
N	Opening Protection products that appear to be A or B but are not verified						
	Other protective coverings that cannot be identified as A, B, or C						
X	No Windborne Debris Protection	X				X

WINDOWS ARE NOT PROTECTED
