Sample Report
Rob Rehm Indianapolis Home Inspector
IN

Inspector: Rob Rehm #HI00500115

SECTION I. KEY FINDINGS

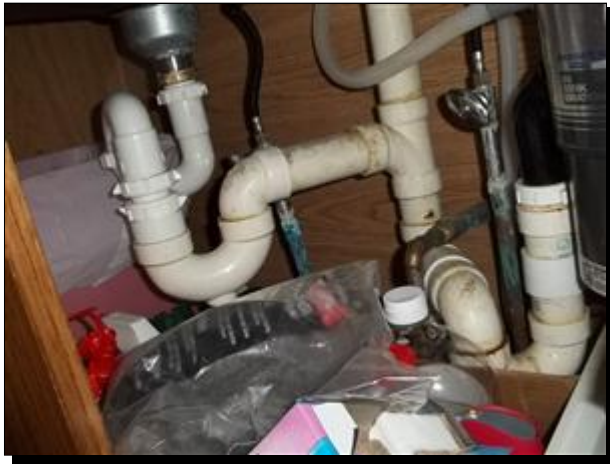
♦ The kitchen sink drain is double trapped. This does not meet today's standard building practices and can contribute to poor drainage. This does not appear to be a concern at the time of inspection but should be monitored..(Picture 1)

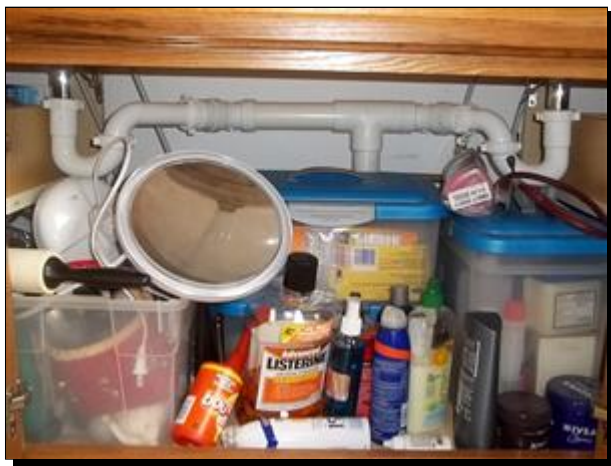
♦ The master bath sink drain is double trapped. This does not meet todays standard building practices and can contribute to poor drainage. This does not appear to be a concern at the time of inspection but should be monitored..(Picture 1)

- 14. The master bath sink drain is double trapped. This does not meet today's standard building practices and can contribute to poor drainage. This does not appear to be a concern at the time of inspection but should be monitored..(Picture 1)
- 15. The hot and cold water at the Jack and Jill bath room sink faucet are installed in reverse. Repair as needed.(Picture 2)

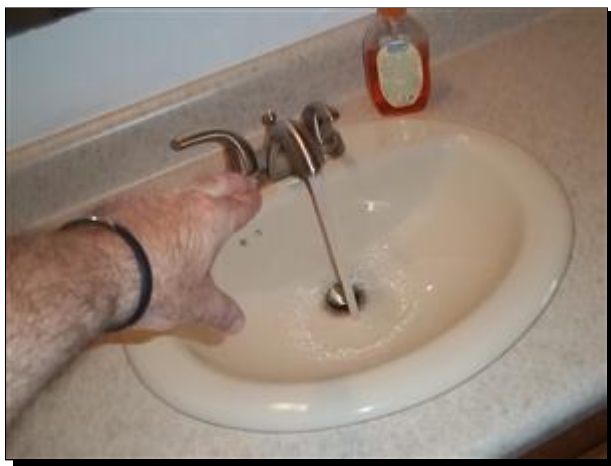
♦ The hot and cold water at the Jack and Jill bath room sink faucet are installed in reverse. Repair as needed.(Picture 2)

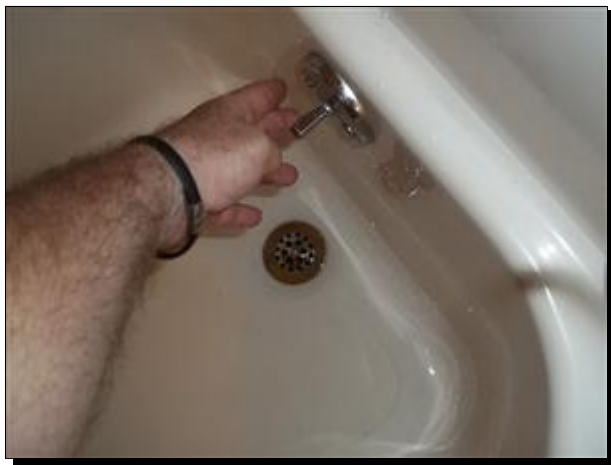
♦ The stopper drain hardware at the Jack and Jill bath tub does not work and will need repair.(Picture 1)

- 16. The stopper drain hardware at the Jack and Jill bath tub does not work and will need repair.(Picture 1)

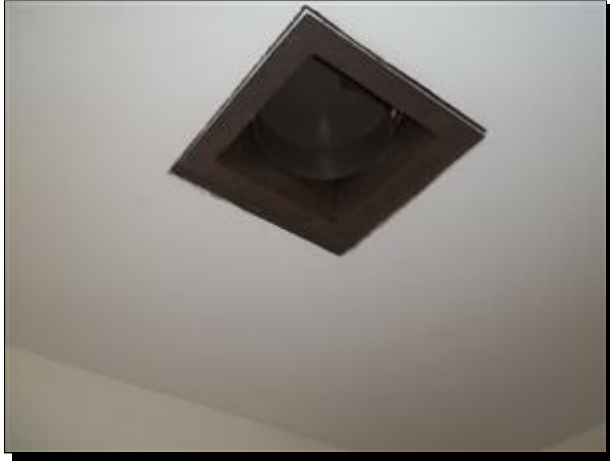
♦ The exhaust vent fan at the full bathroom is not installed at time of inspection. Install as needed.(Picture 1)

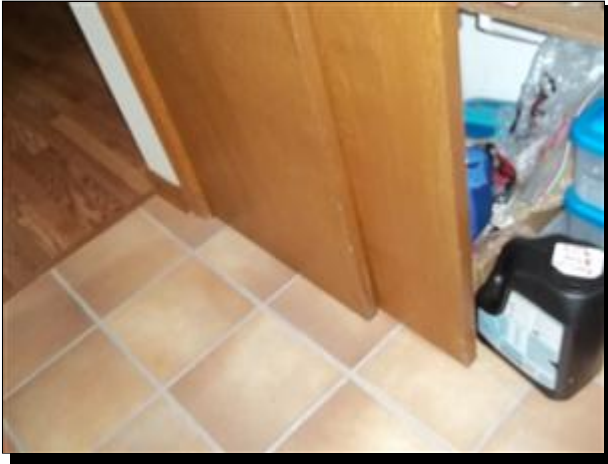
♦ Suggest adding floor guides at by pass sliding closet doors where missing.(Picture 1)

- 17. Suggest adding floor guides at by pass sliding closet doors where missing.(Picture 1)
- 18. The closet door at the rear corner guest bedroom will not latch when closed. Adjust door as needed.(Picture 2)

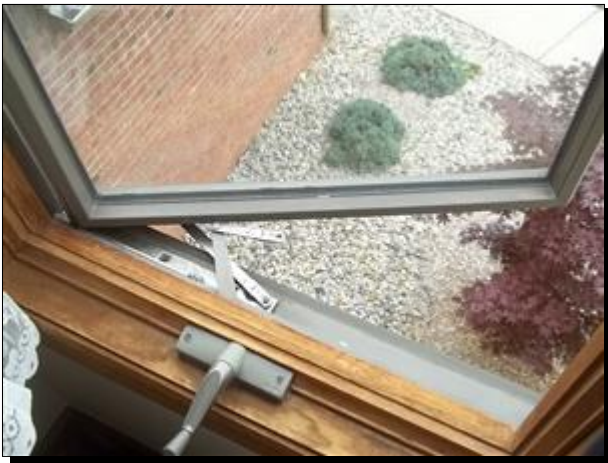
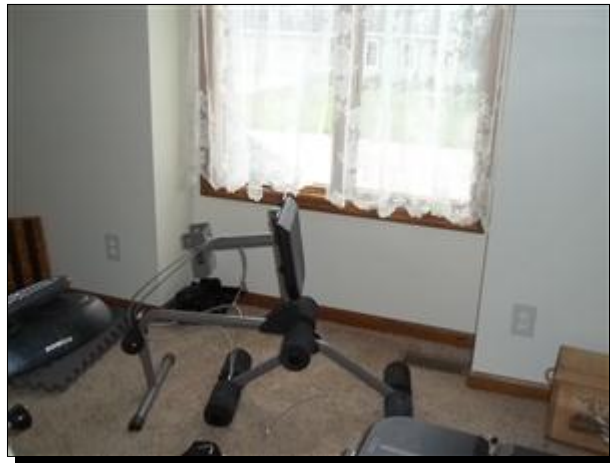
- ✘ ◆ The left side window at the front guest bedroom or exercise room has disconnected hardware and will not open or close. Repair window hardware as needed.(Picture 1)

- ❌ 2. The left side window at the front guest bedroom or exercise room has disconnected hardware and will not open or close. Repair window hardware as needed.(Picture 1)

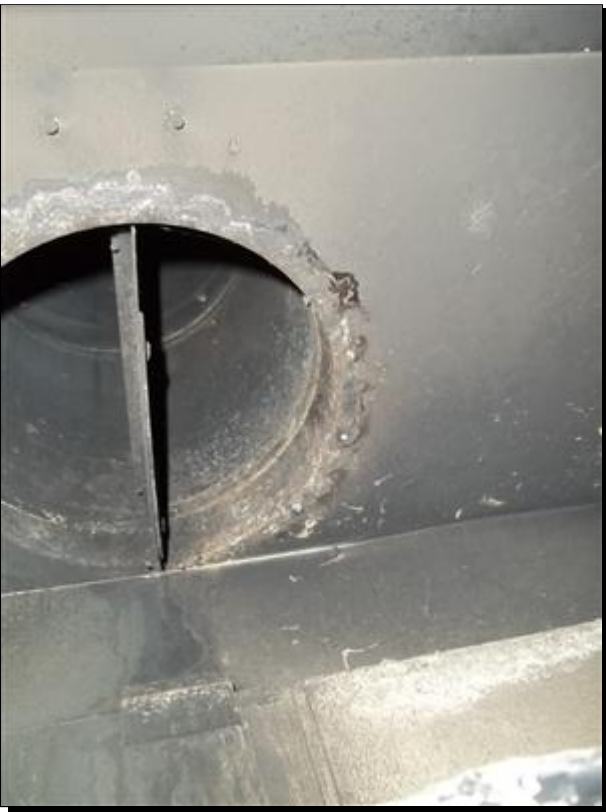
♦ The gas fireplace damper is missing a safety clamp, which provides continuous air draft. Consider installing a damper clamp for safety reasons.(Picture 1)

- 20. The gas fireplace damper is missing a safety clamp, which provides continuous air draft. Consider installing a damper clamp for safety reasons.(Picture 1)

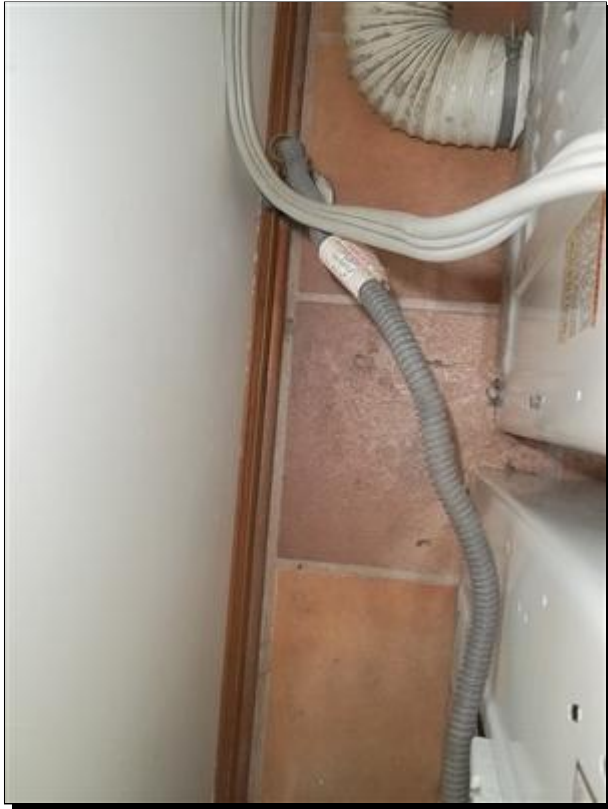
- ♦ The gas supply pipe at the laundry room for the dryer is not capped off, The pipe should be capped for safety reasons.(Picture 1)

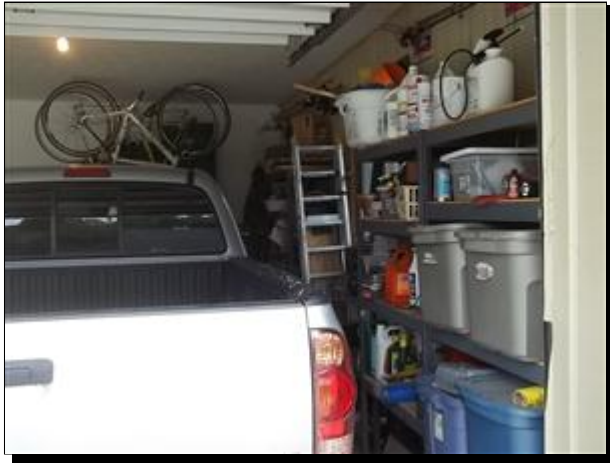
- ◆ Interior garage inspection is limited due to stored items.(Picture 1)

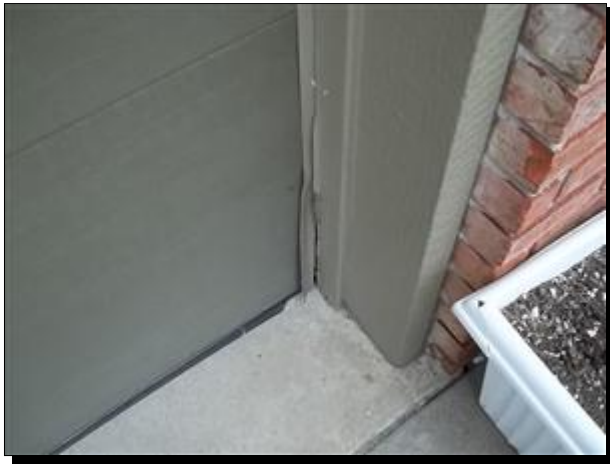
- ◆ Some of the weather stripping at the garage over head door is torn. Repair/replace as needed.(Picture 1)

- 21. Some of the weather stripping at the garage over head door is torn. Repair/replace as needed.(Picture 1)
- 22. The garage over head door does not seal completely at its bottom weather seal when closed. Repair/replace seal as needed.(Picture 2)

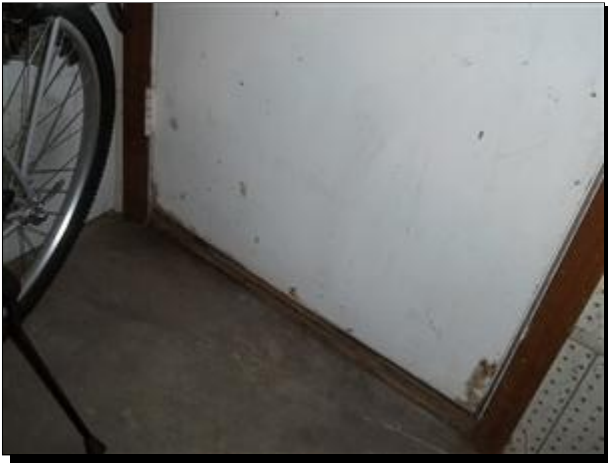
- ♦ The bottom door sweep at the exterior garage service door is missing or damaged and should be replaced.(Picture 1)

- ❌ 4. The bottom door sweep at the exterior garage service door is missing or damaged and should be replaced.(Picture 1)

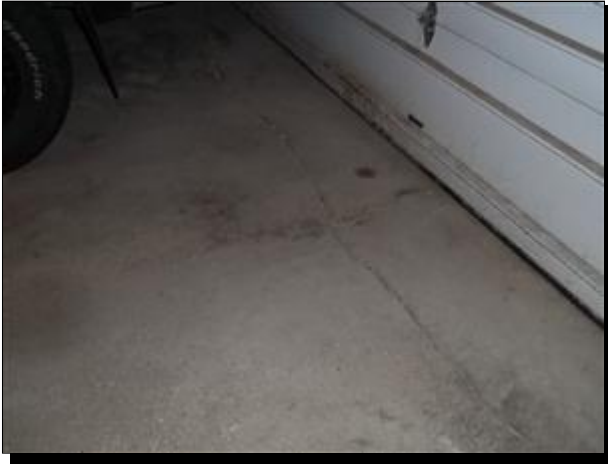
- ♦ The concrete floor slab has common shrinkage cracks but no settlement, and should remain serviceable. Monitor for changes.(Picture 1)

- 23. The concrete floor slab has common shrinkage cracks but no settlement, and should remain serviceable. Monitor for changes.(Picture 1)

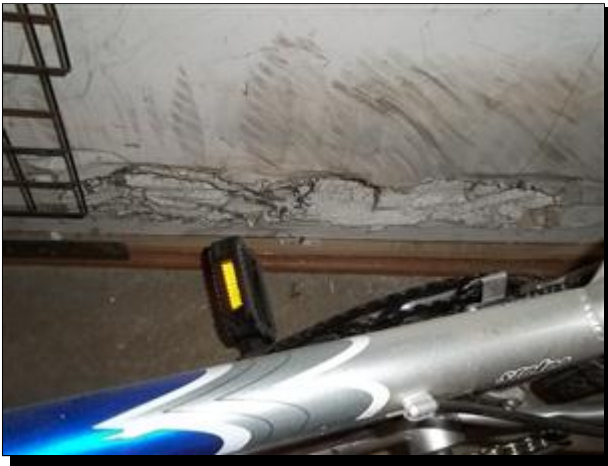
♦ Drywall damage is noted at the rear garage wall. Patch drywall as needed.(Picture 1)

- 24. Drywall damage is noted at the rear garage wall. Patch drywall as needed.(Picture 1)

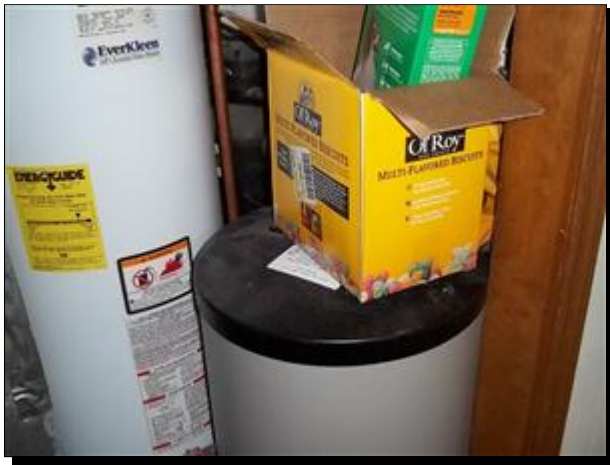
- ◆ Water softener is outside the scope of the home inspection and is not inspected. Water lab testing is required to determine if the softener is performing its intended function properly. (Picture 1)

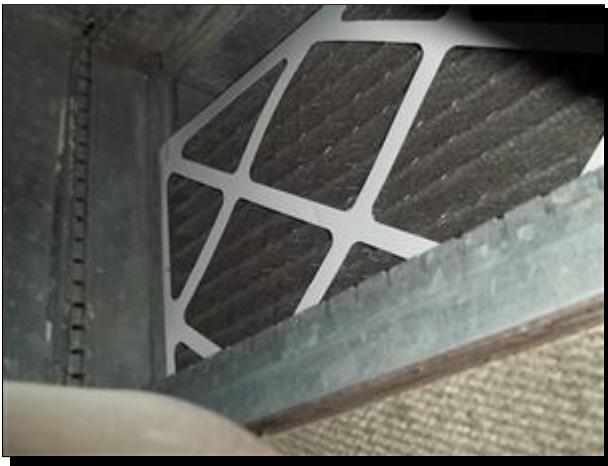
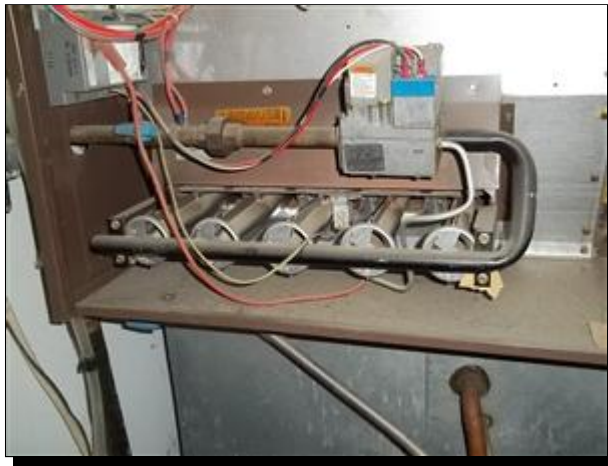
- ❌ ♦ The heating system short cycled when test operated. This can indicate a defect in the fan limit or some other problem. Have it checked professionally and repaired as necessary. The heating unit and filter and also dirty and the unit should be cleaned as needed.(Picture 1)(Picture 2)

- ❌ 6. The heating system short cycled when test operated. This can indicate a defect in the fan limit or some other problem. Have it checked professionally and repaired as necessary. The heating unit and filter and also dirty and the unit should be cleaned as needed.(Picture 1)(Picture 2)

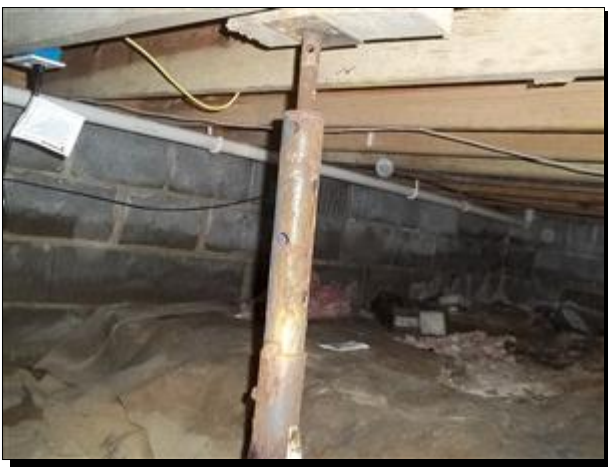
- ◆ Additional bracing has been adding at floor framing in crawl space. Monitor for changes in floors.(Picture 1)

- 28. Additional bracing has been added at floor framing in crawl space. Monitor for changes in floors.(Picture 1)
- 29. There is evidence of past water leaks under the bathrooms when viewed in the crawl space. These do not appear to be active leaks at time of inspection but should be monitored.(Picture 2)(Picture 3)
- 30. Flexible tubing not designed for heating has been added to the duct work which appears to be for the half bathroom. Suggest installing proper insulated heat run.(Picture 4)
- 31. There is some suspected mold staining at framing in the crawl space. Have cleaned or removed as needed. be advised we do not know the type of mold or if any related health concerns. Further lab test could be performed if desired.(Picture 5)(Picture 6)

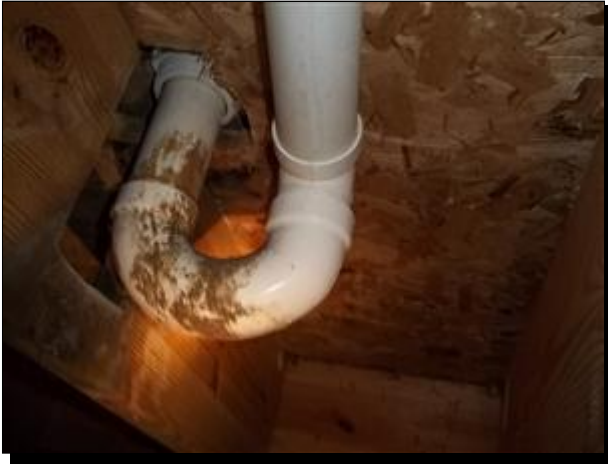
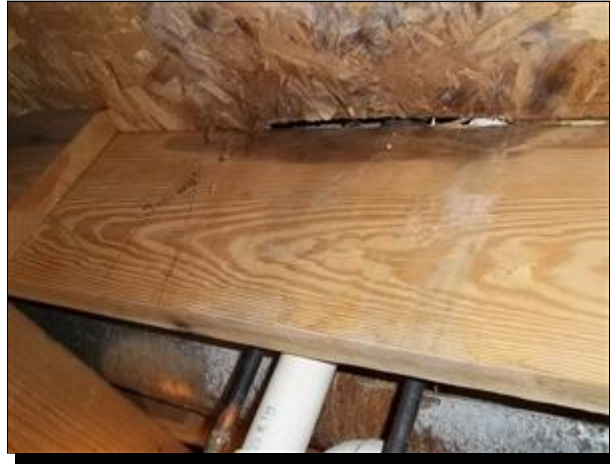
- ◆ There is evidence of past water leaks under the bathrooms when viewed in the crawlspace. These do not appear to be active leaks at time of inspection but should be monitored.(Picture 2)(Picture 3)

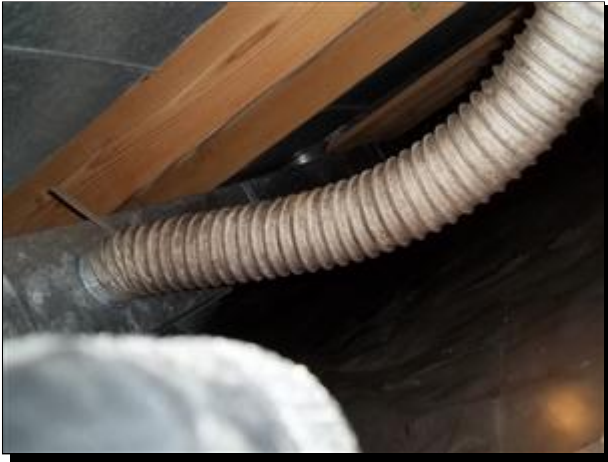
- ◆ Flexible tubing not designed for heating has been added to the duct work which appears to be for the half bathroom. Suggest installing proper insulated heat run.(Picture 4)

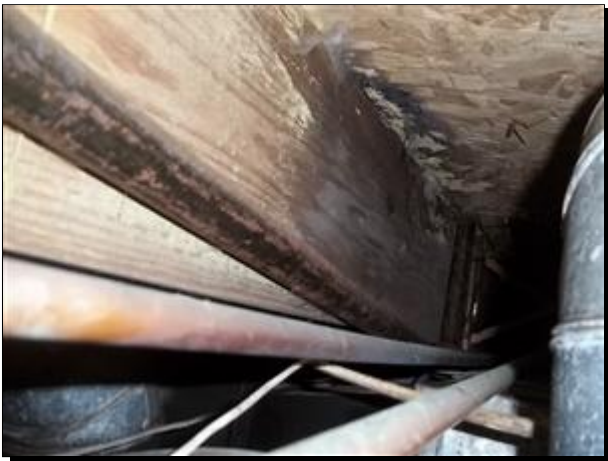
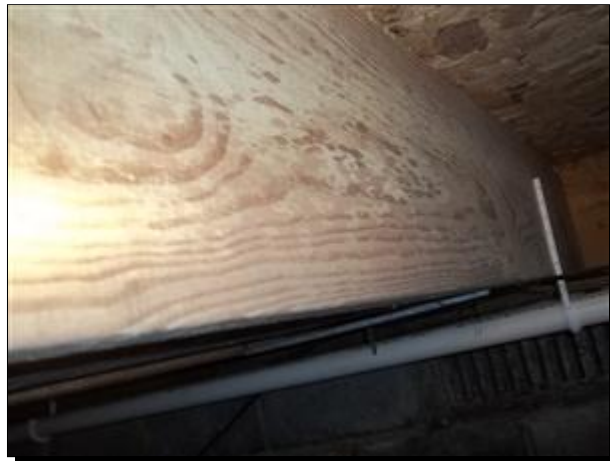
- ◆ There is some suspected mold staining at framing in the crawlspace. Have cleaned or removed as needed. be advised we do not know the type of mold or if any related health concerns. Further lab test could be performed if desired.(Picture 5)(Picture 6)

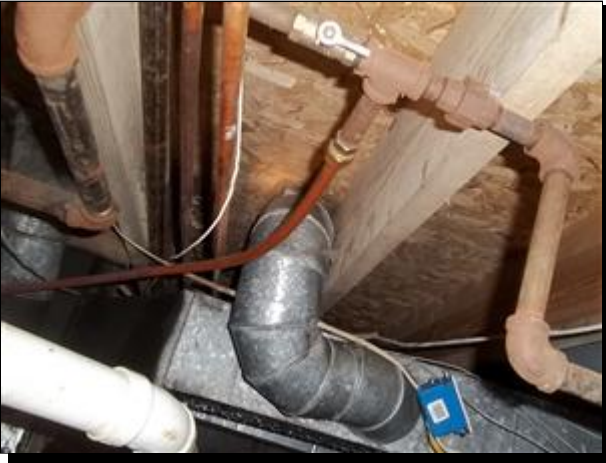
- ❌ ♦ There is improper use of copper tubing at gas pipe in the crawl space where there is also a slight gas odor. Have evaluated and install proper piping and repair leakage as needed.,(Picture 7)

- ❌ 7. There is improper use of copper tubing at gas pipe in the crawl space where there is also a slight gas odor. Have evaluated and install proper piping and repair leakage as needed.,(Picture 7)
- ❌ 8. There is water in the crawl space at time of inspection. Improve as possible with grading and other drainage adjustments. Definitive repair might entail drain tile run to the sump pump.(Picture 8)

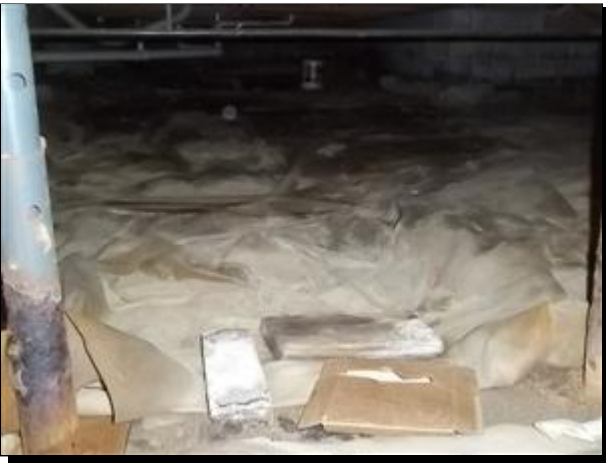
- ❌ ♦ There is water in the crawl space at time of inspection. Improve as possible with grading and other drainage adjustments. Definitive repair might entail drain tile run to the sump pump.(Picture 8)

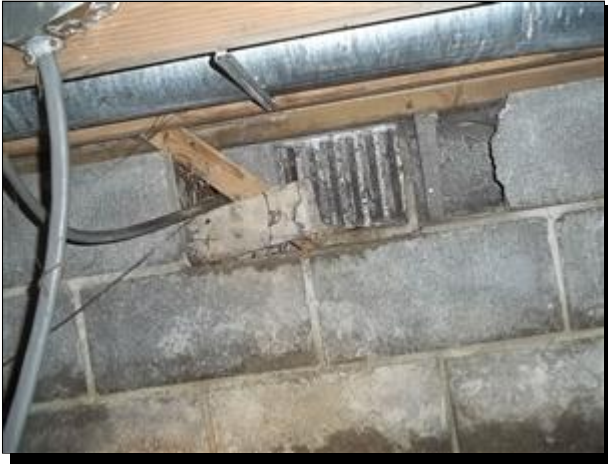
- ⏏ ♦ Make sure all foundation vents are open and are not obstructed for proper ventilation in the crawl space.(Picture 1)

- 32. Make sure all foundation vents are open and are not obstructed for proper ventilation in the crawl space.(Picture 1)

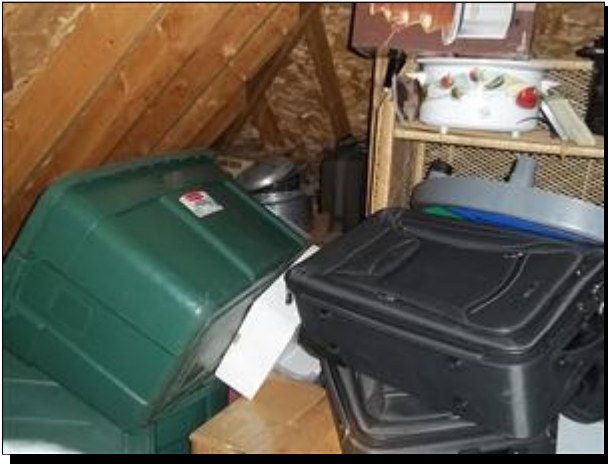
- ◆ Garage attic inspection is limited due to stored items.(Picture 2)

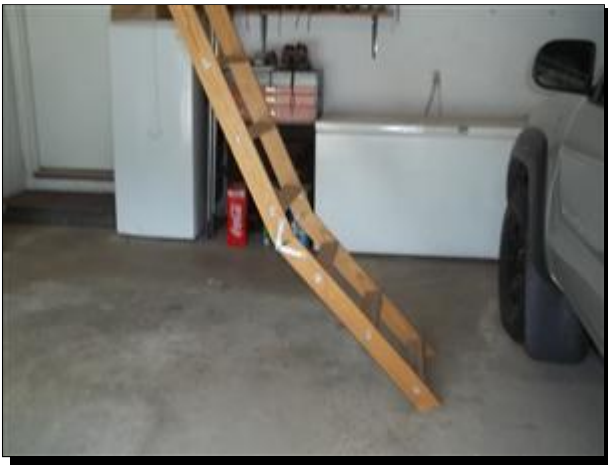
- ❌ ◆ Attic pull down stairs are loose. Repair/replace for safety.(Picture 1)

- ❌ 9. Attic pull down stairs are loose. Repair/replace for safety.(Picture 1)

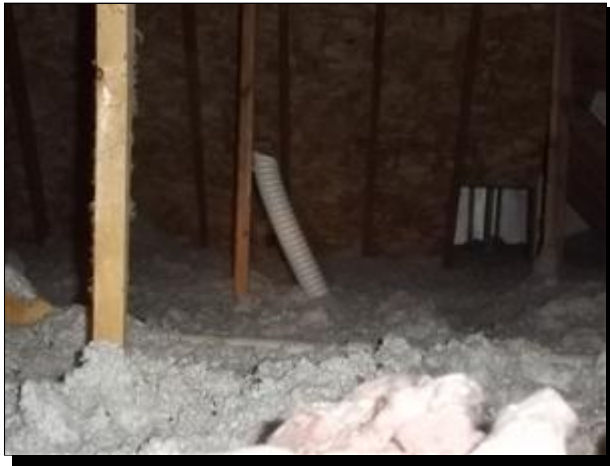
- ⚠️ ◆ The bathroom vent duct(s) discharge(s) into the attic, which is common for this age of construction. Excessive attic moisture can result in fungal growth or mildew. We recommend having a qualified technician update the vents to discharge to the exterior.(Picture 1)

- 34. The bathroom vent duct(s) discharge(s) into the attic, which is common for this age of construction. Excessive attic moisture can result in fungal growth or mildew. We recommend having a qualified technician update the vents to discharge to the exterior.(Picture 1)

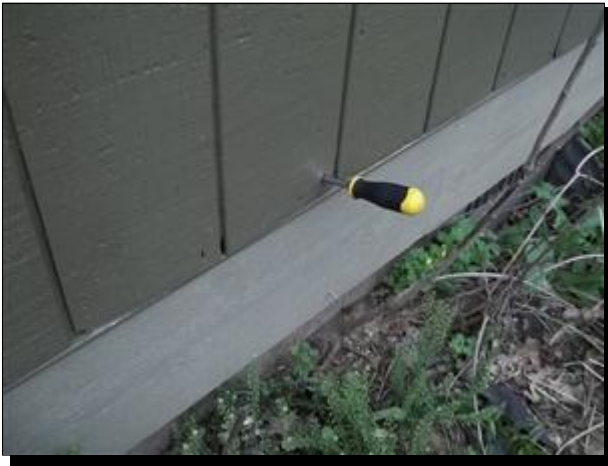
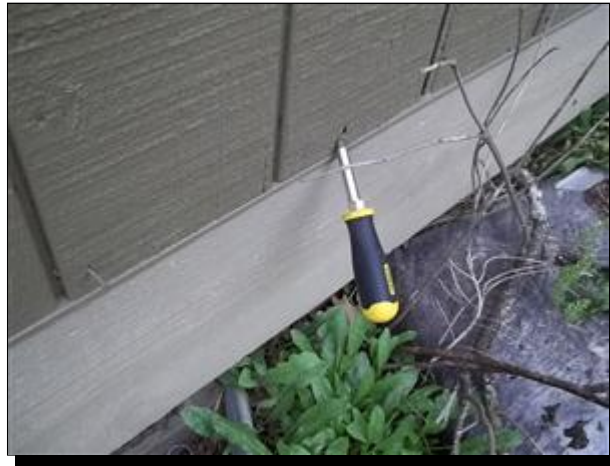
- ✘ ♦ Some of the wood siding has moisture damage or wood rot at the bottom at the exterior side wall of the home. Moisture damage siding should be replaced where needed.(Picture 1)(Picture 2)

- ❌ 10. Some of the wood siding has moisture damage or wood rot at the bottom at the exterior side wall of the home. Moisture damage siding should be replaced where needed.(Picture 1)(Picture 2)

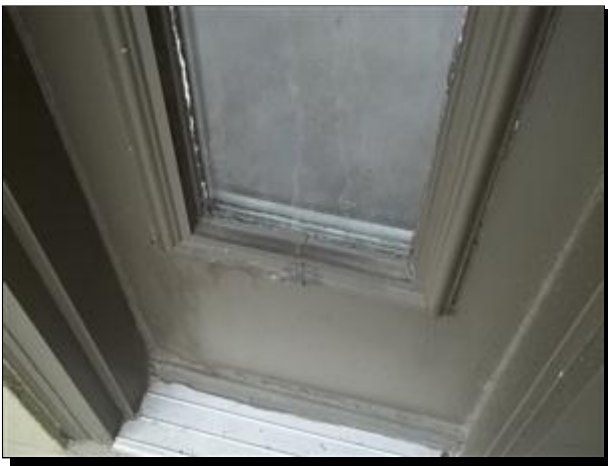
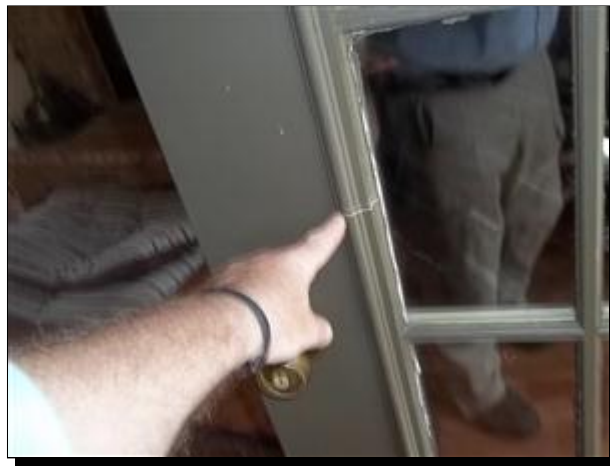
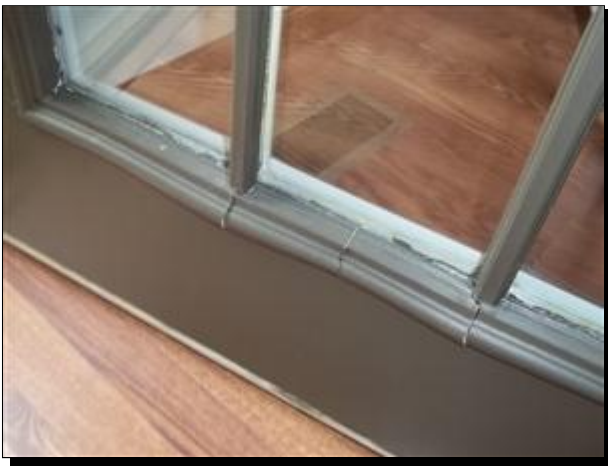
- ❌ ♦ The plastic trim pieces at all entry door glass panes are cracked. these should be replaced to prevent possible water seepage and damage.(Picture 1)(Picture 2)(Picture 3)

- ❌ 11. The plastic trim pieces at all entry door glass panes are cracked. these should be replaced to prevent possible water seepage and damage.(Picture 1)(Picture 2)(Picture 3)

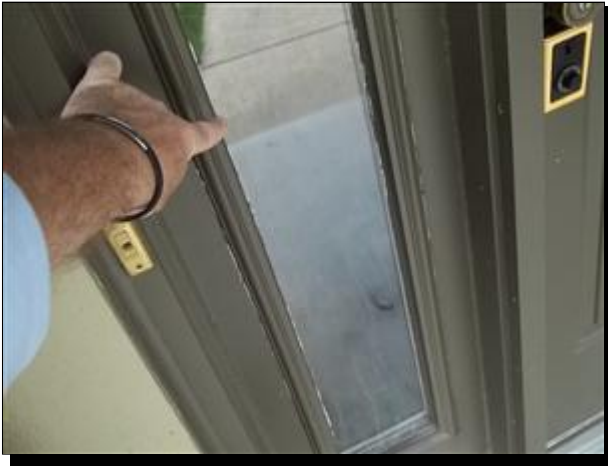
- ✘ ◆ The glass at the front entry door shows signs of a broken thermal seal. Condensation and/or cloudiness visible in the noted window, indicates a broken thermal seal. Glass replacement is necessary to restore original efficiency and cosmetic condition.(Picture 1)

- ❌ 12. The glass at the front entry door shows signs of a broken thermal seal. Condensation and/or cloudiness visible in the noted window, indicates a broken thermal seal. Glass replacement is necessary to restore original efficiency and cosmetic condition.(Picture 1)

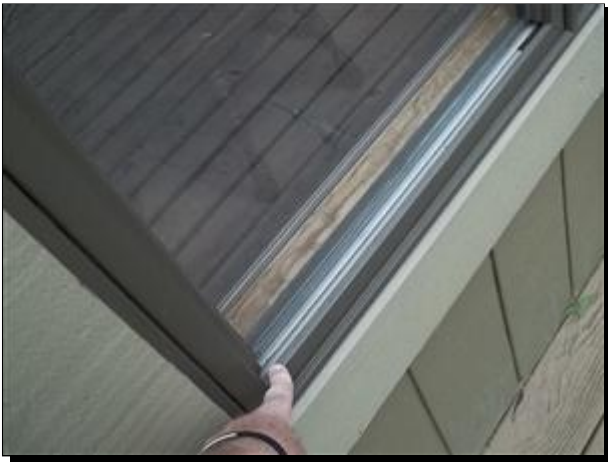
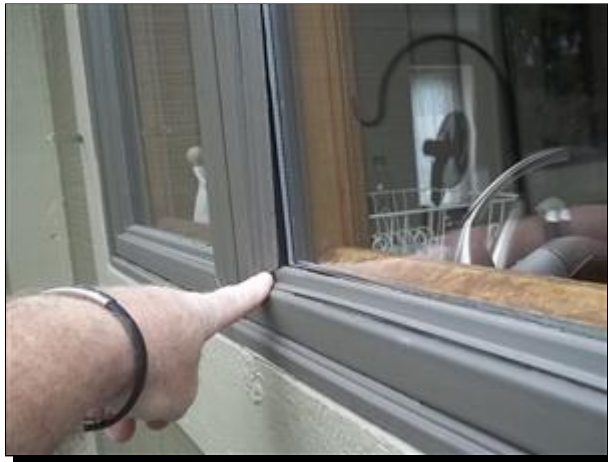
- ☒ ◆ Plastic trim pieces at the glass exterior of kitchen windows are missing or loose and should be repaired/replaced to prevent water intrusion.(Picture 2)(Picture 3)

- 35. Plastic trim pieces at the glass exterior of kitchen windows are missing or loose and should be repaired/replaced to prevent water intrusion.(Picture 2)(Picture 3)
- 36. Not all screens are installed at windows at time of inspection. Make sure screens are accounted for and in good condition.

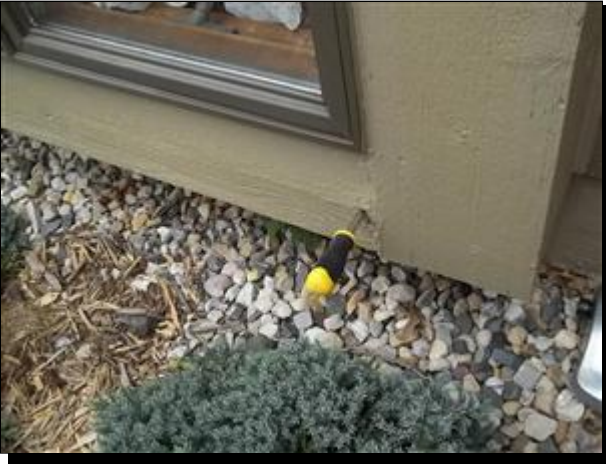
- ☒ ◆ Wood trim boards at the front dining room window have some moisture damage or minor rot. Repair/replace wood trim as needed.(Picture 1)

- 37. Wood trim boards at the front dining room window have some moisture damage or minor rot. Repair/replace wood trim as needed.(Picture 1)

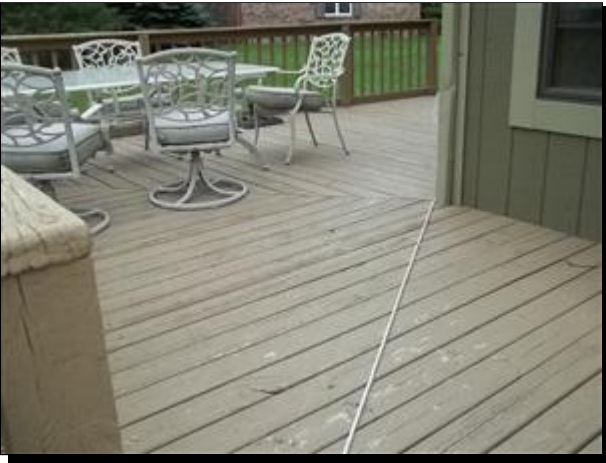
♦ The deck is ready to cleaned and treated. (Picture 1)

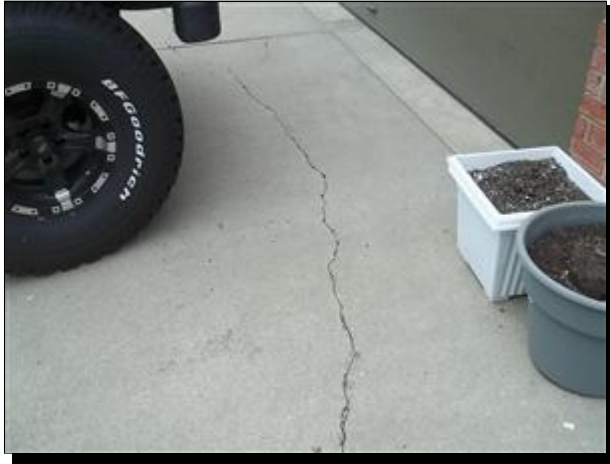
♦ The concrete drive is adequately drained and serviceable with minimal cracking, settlement, and surface spalling. Periodic sealing of any joints and cracks is worthwhile maintenance.(Picture 1)

- 39. The concrete drive is adequately drained and serviceable with minimal cracking, settlement, and surface spalling. Periodic sealing of any joints and cracks is worthwhile maintenance.(Picture 1)

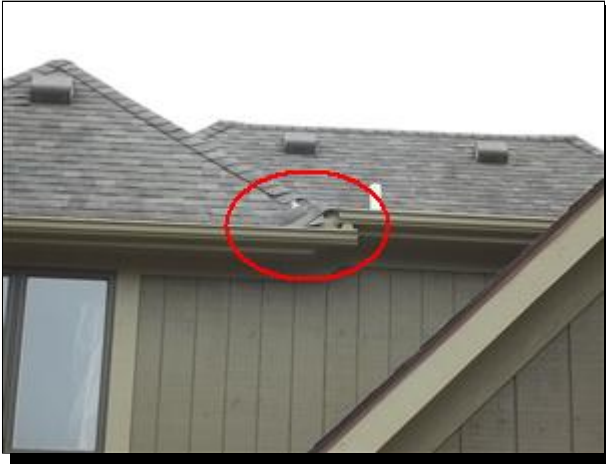
♦ There is a marginally installed or improperly installed shingle at the rear upper roof at the gutter. Suggest this be repaired and installed properly to prevent possible leaks.(Picture 1)

40. There is a marginally installed or improperly installed shingle at the rear upper roof at the gutter. Suggest this be repaired and installed properly to prevent possible leaks.(Picture 1)
