PIKE RIVER CORRIDOR

MOUNT PLEASANT, WI

MAINTENANCE PLAN

June 25, 2015

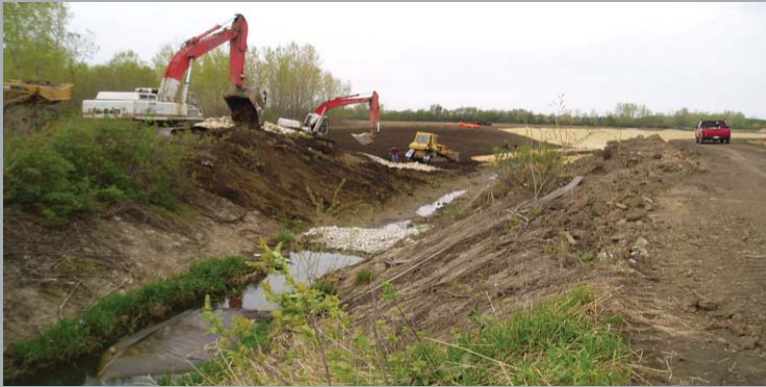
Widening of riparian floodplain at the south end of Phase 1.

Phase 1 involved the restoration of a 2.4 km corridor north from Hwy 20 to Old Spring Street. Construction began in Fall of 2002 and was completed in Spring 2003 at a total cost of \$1.3 million. Additional wetland plantings were done in the Summer of 2003. The project included the creation of a large wetland complex with 0.5 km of new meandering stream channel at the downstream end. In other areas to the north, the channel was widened and the banks flattened to a 4:1 slope. The excavation was designed to increase the capacity of the river to contain the 100-year event within the restored channel and surround wetlands. The channel modifications were structured to reduce flood flow shear stresses and address problematic bank erosion. Erosion mat was placed on all slopes of 4:1 or steeper. All disturbed areas were seeded with native prairie, mesic prairie or wetland seeds. Land was purchased surrounding the channel to include area for planting a prairie buffer of varying widths and land for a paved recreational trail.

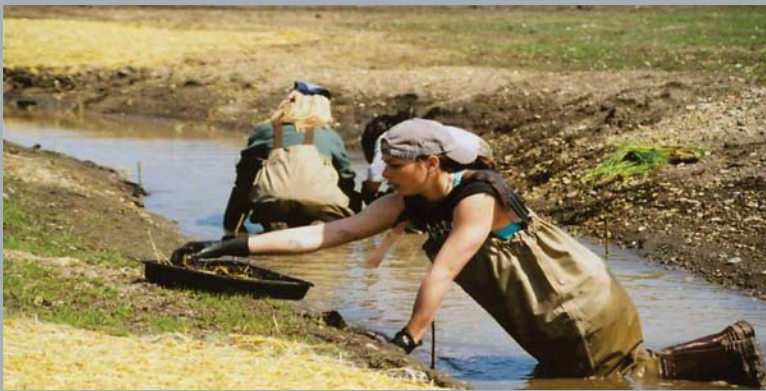
Planting shrubs and grasses along the stream banks of the new channel in Phase 1.

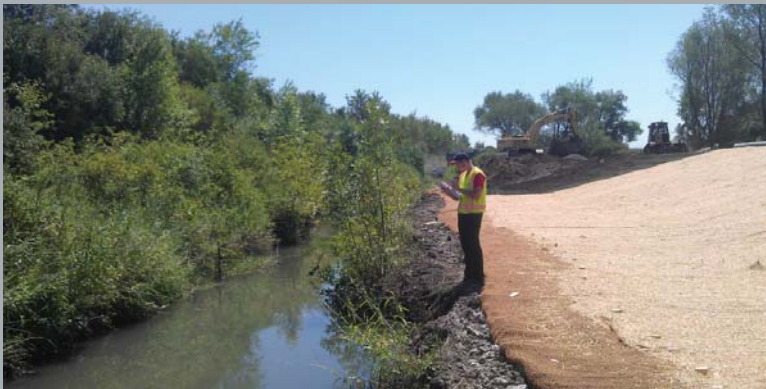
Riparian floodplain widening in Phase 6.

Phase 6 stretches approximately 0.9 km downstream of Highway 11. The upstream half was constructed in 2011 and was constrained by industrial development on both sides of the channel, and required the removal of a portion of a parking lot located on the eastern bank. In this portion, the channel bench was widened and floodway banks laid back to a flatter slope relative to the incised channel. Stone riffles, deep pools, single- and double-wing deflectors, and scattered boulder arrangements were placed in this section to improve heterogeneity of the habitats. The downstream half of Phase 6 was completed in 2012. This section was not constrained by development along the channel and allowed for greater flexibility in channel and floodplain design,

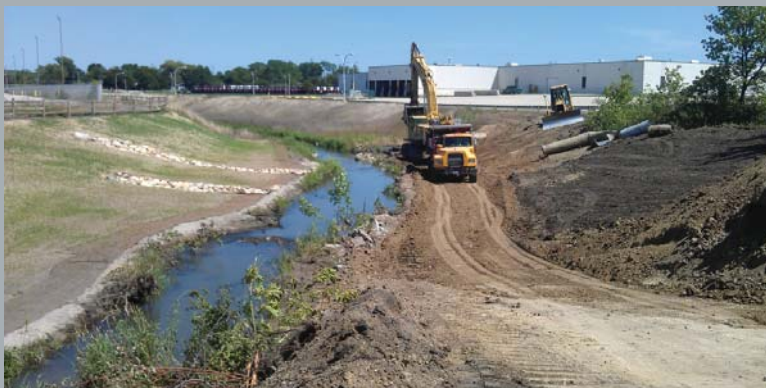
Floodplain widening and prairie planting in Phase 6

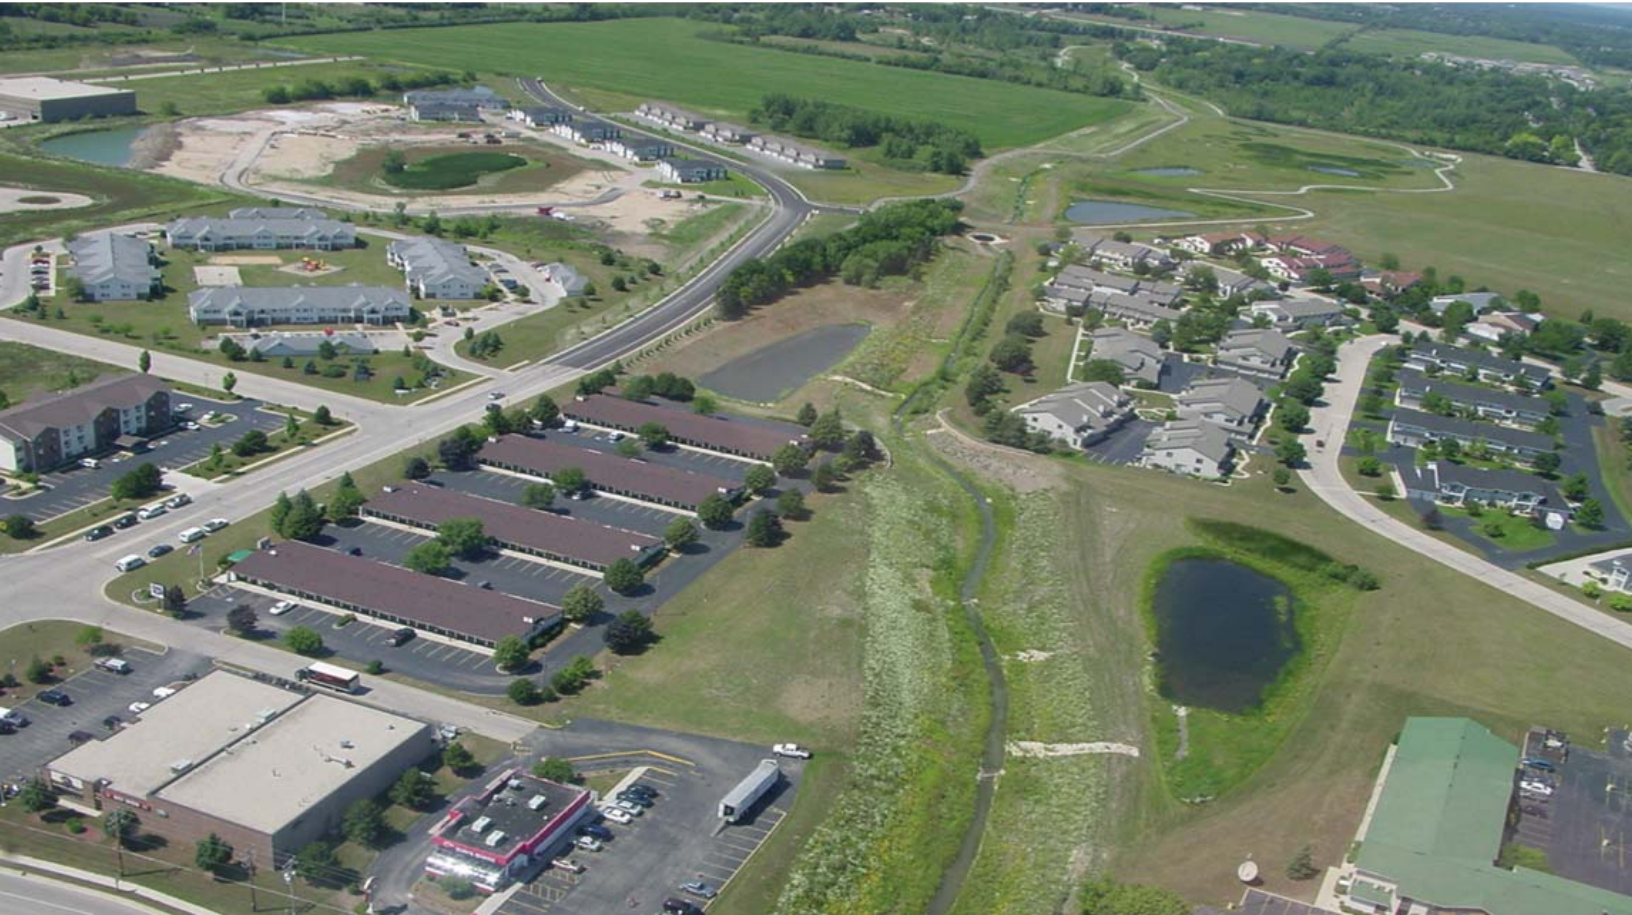
Photo of Phase 1 looking north from Highway 20. July 27, 2005
