**CASE STUDY
ANALYSIS OF PROCESS FAN FAILURE
AND BEARING HOUSING/SHAFT DESIGN**

Abstract: An Air Movement and Control Association (AMCA) Arrangement 8 fan handling hot process gas experienced several bearing failures and ultimately a catastrophic failure requiring shutdown of the plant's production. The investigation found that the 1st critical of the fan rotor was too close to the operating speed resulting in excessive bearing loads and short bearing life. Rotor dynamic modeling was used to evaluate a new shaft design. A new shaft and one-piece bearing housing were designed, fabricated and installed, successfully moving the critical speed several hundred RPM above running speed. The new design also provided improved maintainability over commercially available designs, as well as lowering vibration and significantly improving reliability. This article discusses the analysis process, rotor modeling, bearing housing design process, vibration data comparison before and after the new shaft and bearing housing were installed.

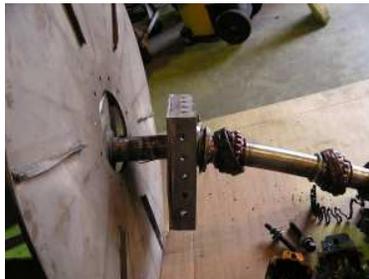
Figure 4. Fan Shaft and Wheel in Shop After Failure.

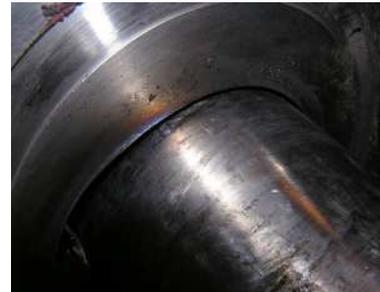
Figure 5. Mechanical Seal Housing.

One of the first images taken of the fan shortly after the failure is shown in **Figure 3**. Both bearing housings (cast iron) fractured. The fan shaft had a significant permanent deformation (bend) in the area of the mechanical seal, see **Figure 4**. The shaft at the mechanical seal area, see **Figure 5**, showed heavy rub part way around the circumference of the shaft.

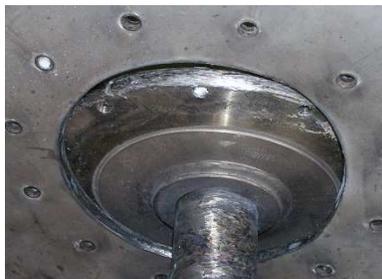
Figure 6. Fan Shaft and Fan Hub. Shaft Heavy Rub Against Fan Wheel.

Heaviest rubbing had occurred near the bottom of the seal housing. The shaft also exhibited heavy rubbing by the fan wheel, see **Figure 6**, after all of the wheel hub bolts failed, see **Figure 7**. The shaft rub locations and the bend in the shaft suggested a significant thermal bow in the shaft may have developed due to rubbing at the seal.

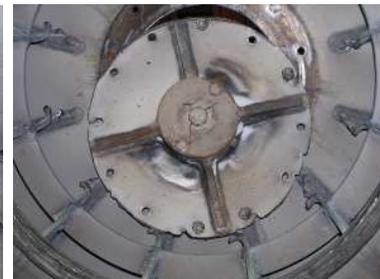
Figure 7. All Fan Wheel Hubs Failed.

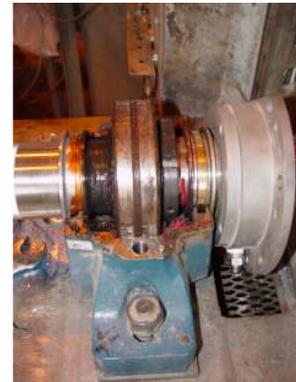
Figure 10. Fan End Bearing Nov 6, 2006.

The wheel end bearing was an FAG 22218 ESK C4 with a steel double cage. The grease was very dark indicating contamination, as shown in **Figure 10**. The bearing outer race and housing bore exhibited severe fretting corrosion. The bearing cage at the wheel end exhibited axial wear from the rollers rubbing. The cage bore exhibited rubbing on the inner race. The inner race had guide grooves machined for the seals.

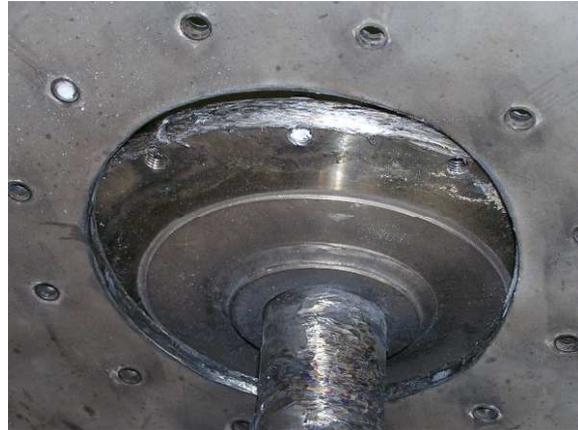
Figure 30. Nov 6, 2006 Failure, All Fan Hub Bolts Failed.

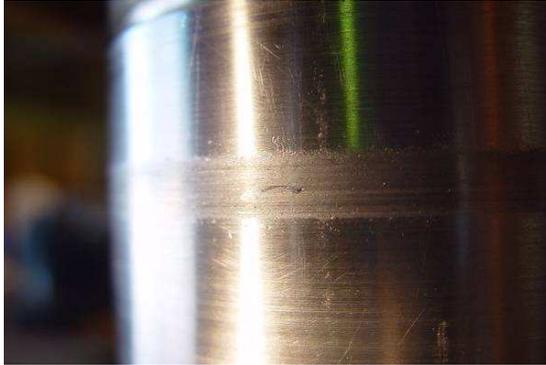
shaft bearing fits, **Figures 31, 32** show scoring damage to the journals by the balancing machine rollers. Scoring of the shaft journals is always a concern when using rollers in a balance machine to support the shaft. To minimize scoring some actions that can be taken are as follows:

Figure 31. Journal Showing Balance Machine Roller Damage to Bearing Fit (Coupling End). Metal Shaving Embedded in Journal.

- The balance machine pedestals and rollers should be aligned perpendicular to the shaft centerline. Misalignment of the rollers to the shaft can reduce the roller/shaft contact area and increases the stress level. Misalignment can also cause the rollers to generate an axial thrust increasing scoring damage.
- Lubricating oil should be applied to the shaft and rollers at regular intervals to maintain an oil film.
- Felt wipers in good condition should be installed. The felt should contact the rollers to clean the rollers and minimize metal particles being carried between the rollers and the shaft.

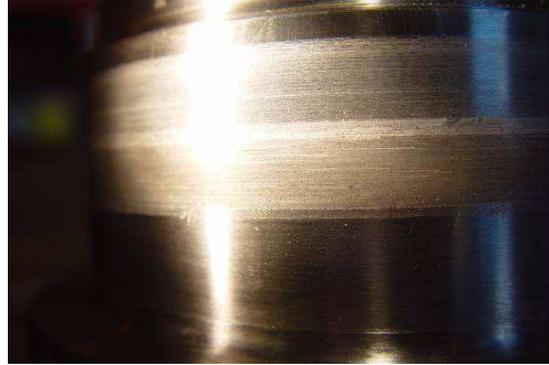
Figure 32. Journal Showing Balance Machine Roller Damage to Bearing Fit, Wheel End. This Roller Track Appeared Wider or the Shaft Shifted Axially During Balancing Operation Generating Two Tracks.

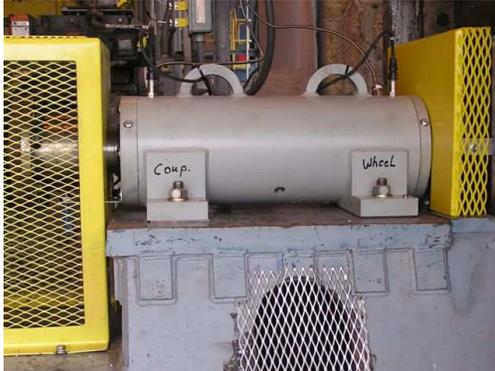
Installation of New Bearing Housing and Shaft: The specially designed bearing housing and rotor were installed in Sept 2007. Images of the beefed up bearing support plate, access panel in the fan housing (added to permit in-place balancing and inspection of the wheel), and the bearing housing and shaft are shown in **Figures 34-37**.

Figure 34. Photos of Newly Installed One Piece Bearing Housing.

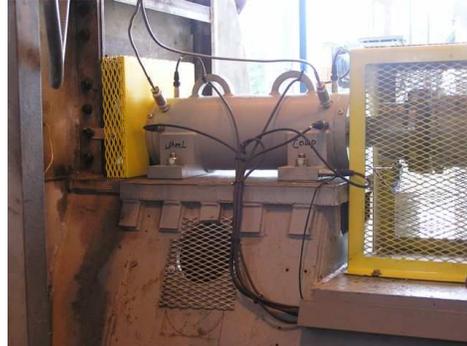
Figure 35. Photo of Newly Installed One Piece Bearing Housing With Accelerometers and Temperature Sensors Installed.

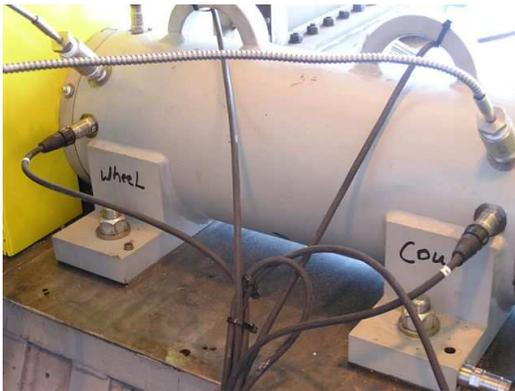
Figure 36. Close Up Photo of Newly Installed One Piece Bearing Housing With Accelerometers and Temperature Sensors Installed.

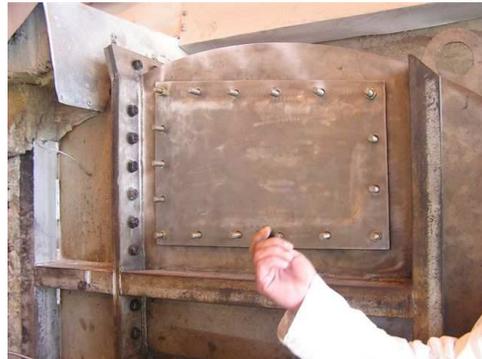
Figure 37. Photo of Modified Fan Housing to Install Access Panel for In-Place Balancing & Inspection.
