9709 Artesia Boulevard, Suite 101
Bellflower, CA 90706
(562) 804-0443
(800) 439-1978
ned@houseinspector.com

Inspection No. : Sample Report
Inspection Date : Sample Report
Address : Sample Report

This is a single-family dwelling, one story structure built on a flat lot. Estimated age is approximately 72 to 76 years old. Weather at the time of inspection was sunny.

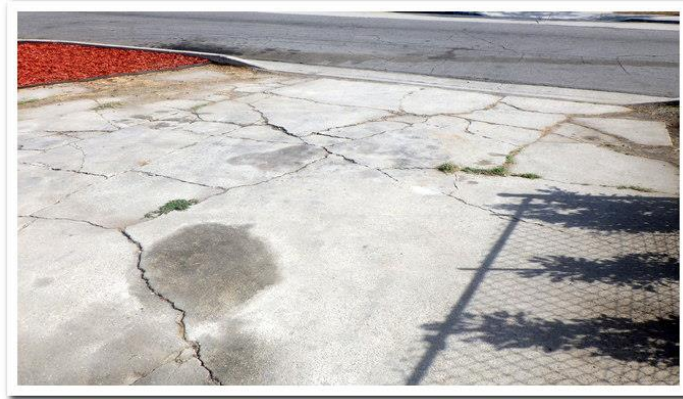
101 Driveway:

Concrete. **Expansive cracks and sunken areas noted are a possible trip hazard. This is a safety concern. We advise repair/replacement as needed to ensure safety.**

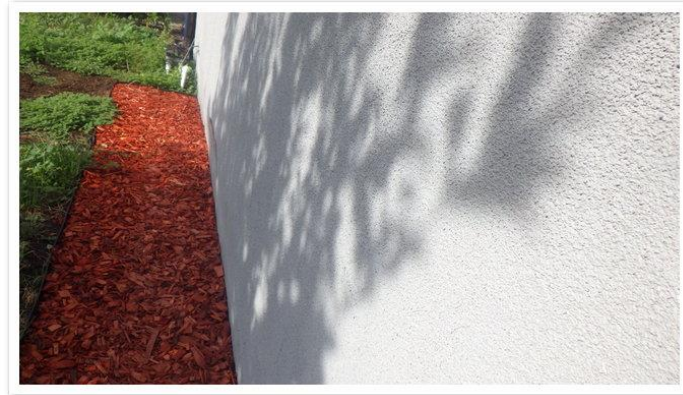
104 Siding:

Stucco. **Cracks noted at front.**

Bow noted in left wall; suggest consulting with specialist for further review prior to close of escrow.

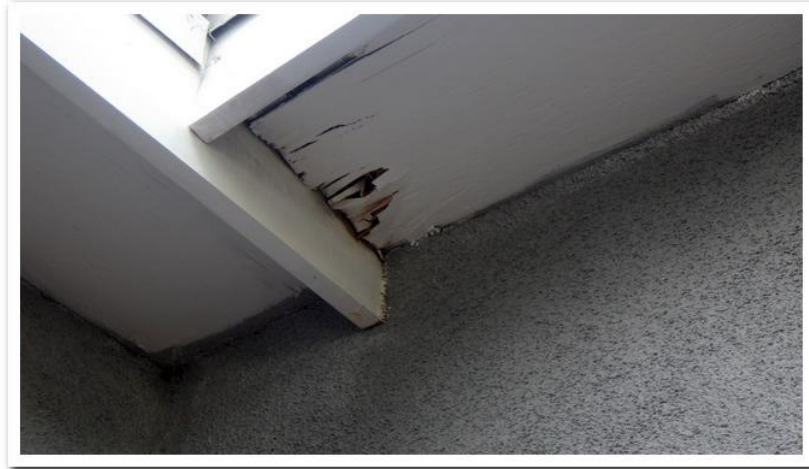
105 Trim: Wood. **Deteriorated wood noted at front.**

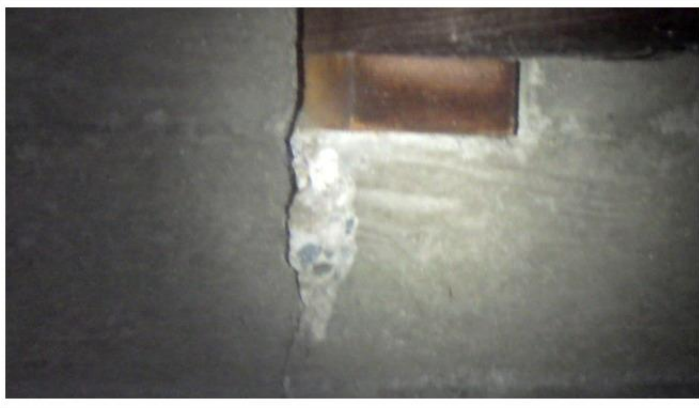
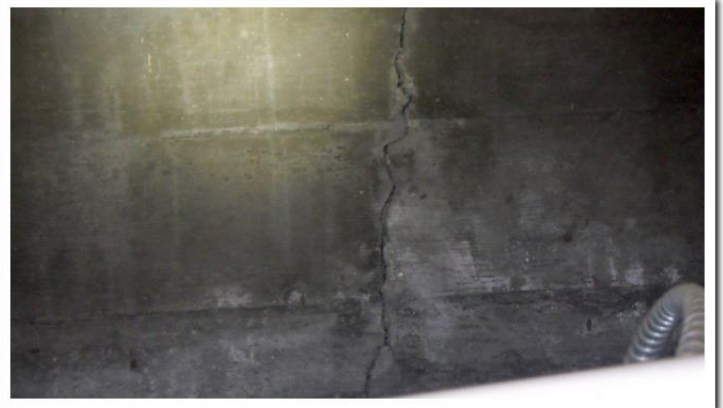
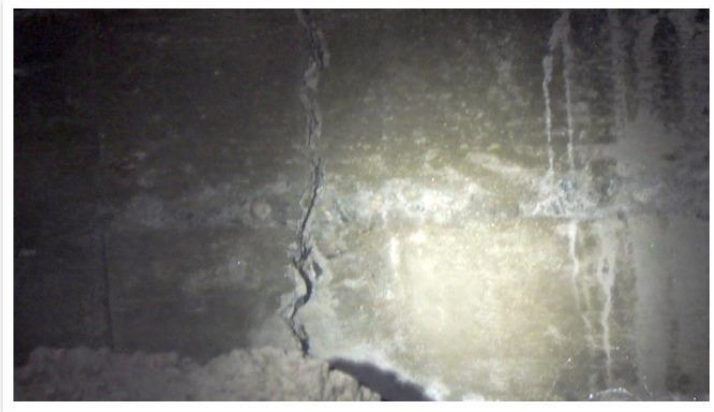
115 Foundation:

Raised foundation/pier and post construction.

Expansive cracks noted at a few areas; suggest consulting with specialist for further review prior to close of escrow.

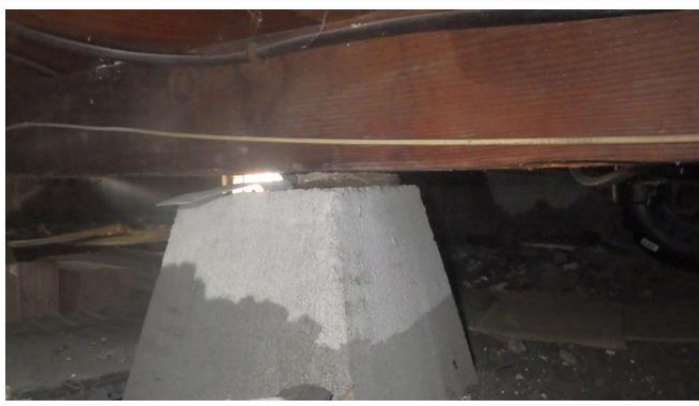
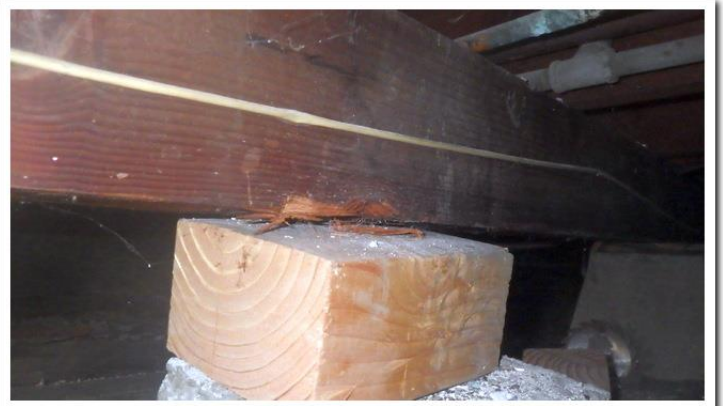
Some pier and posts noted are not installed properly; suggest consulting with specialist for further review prior to close of escrow.

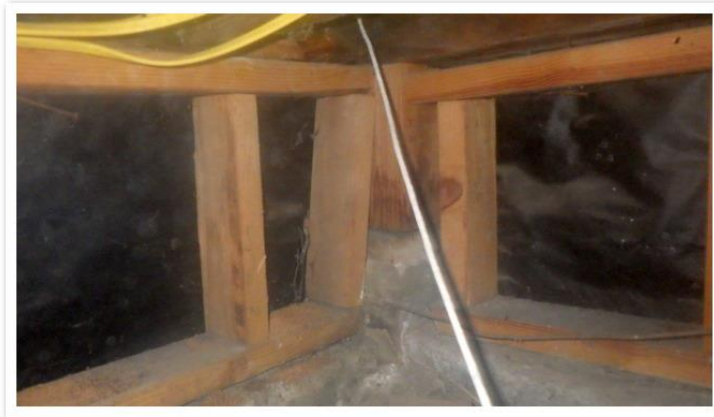
115c Cripple Walls: **Yes, rear wall noted behind master bedroom is not braced.**

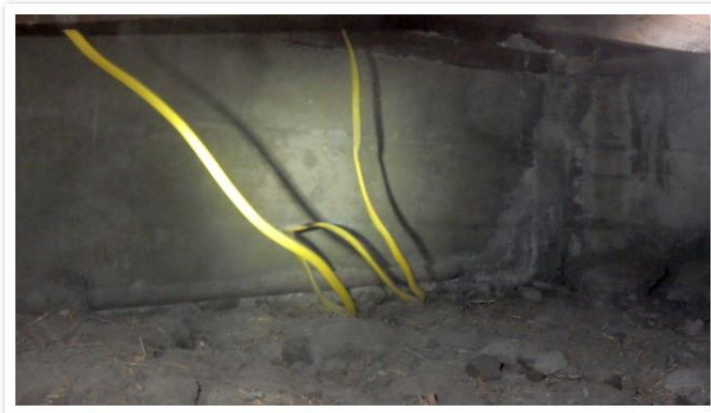
116a Sub-Floor Comments: **Romex noted is on ground under house; suggest elevating as a safety upgrade.**

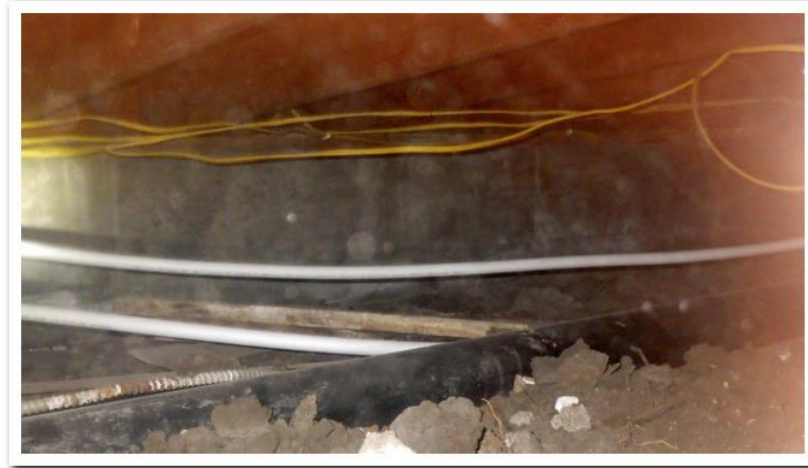
116a Sub-Floor Comments

Cont'd: **Aquapex plumbing pipe noted on ground under house; suggest elevating as a safety upgrade.**

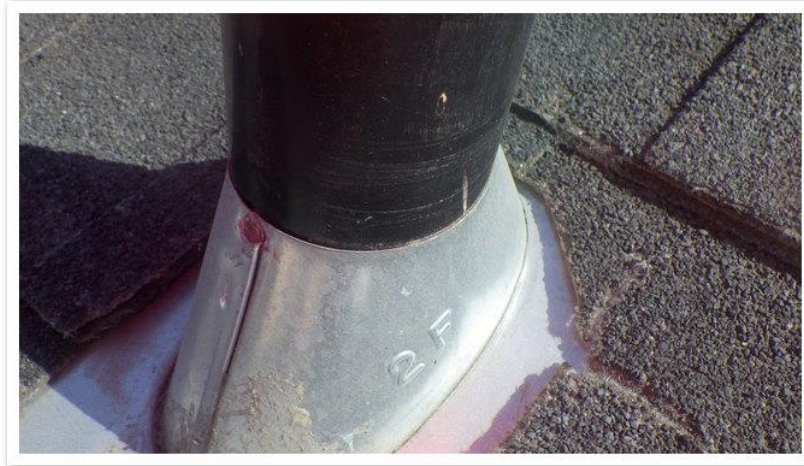
127 Roof Comments: Roof shows normal wear for its age and type; appears to be in serviceable condition.
We advise resealing all through roof vents and projections as part of routine maintenance.

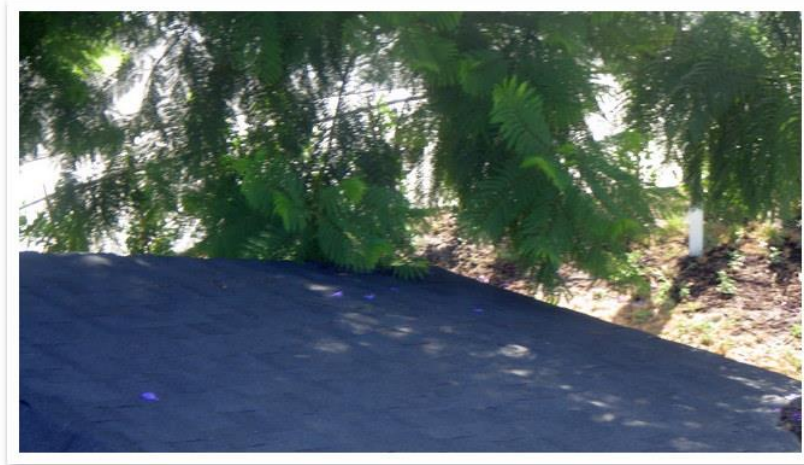
We advise trimming all trees and vegetation away from roof at left side to prevent damage and premature deterioration of roofing materials.

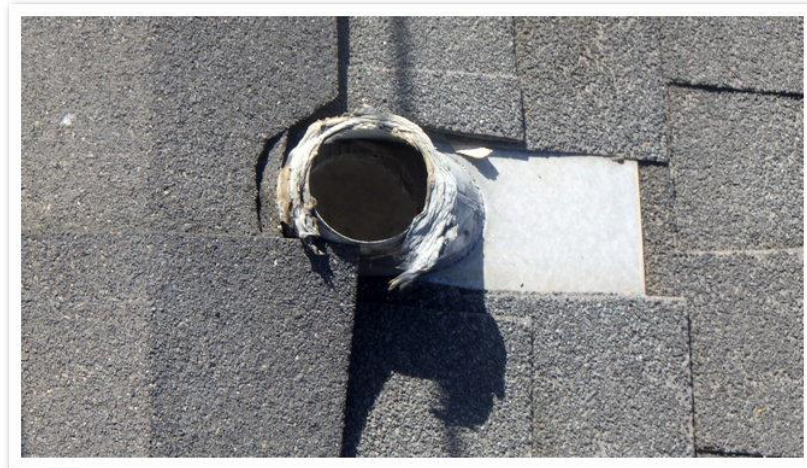
Missing cap noted at flashing; we advise making necessary corrections.

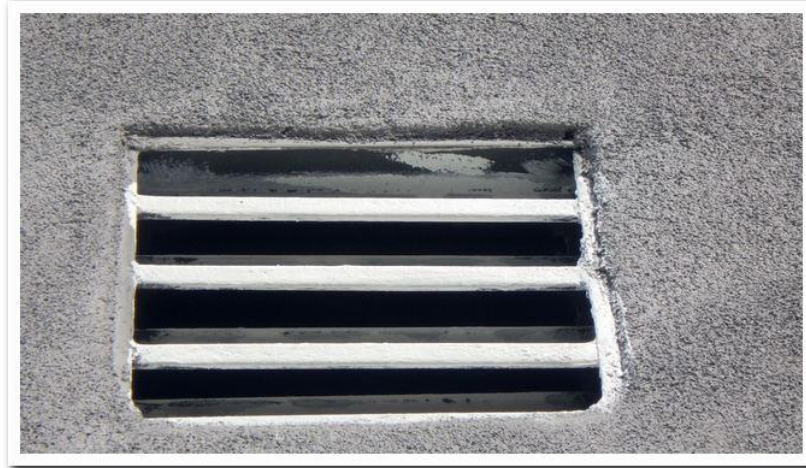
141 Ventilation: Appears to be adequate. **Missing gable screen noted at left side.**

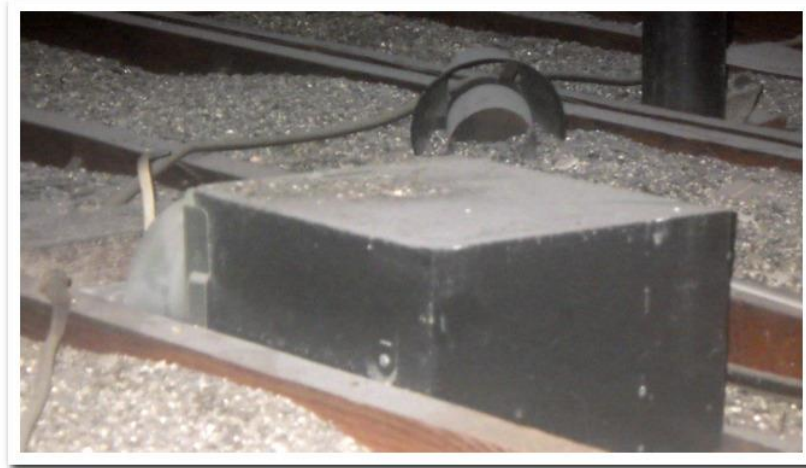
142 Attic Comments: **Hall exhaust fan noted is improperly vented. Recommend extending the fan's exhaust to the exterior of the property to prevent damage/deterioration from moisture/condensation.**

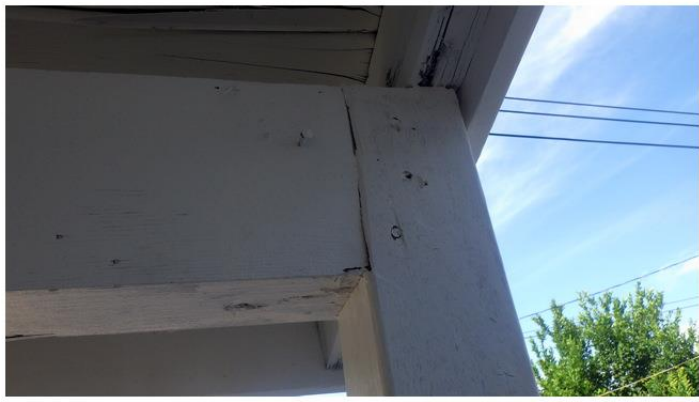
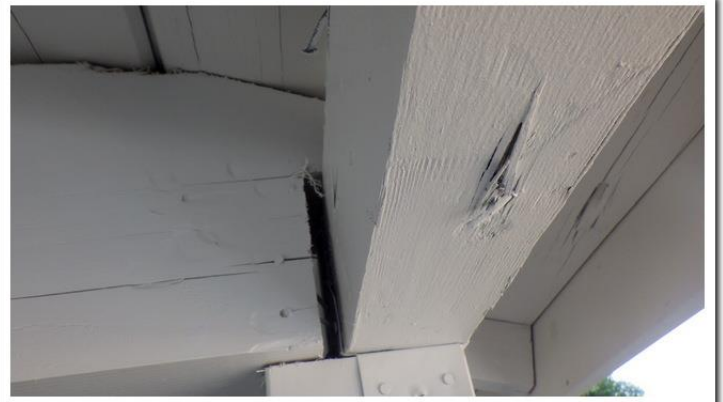
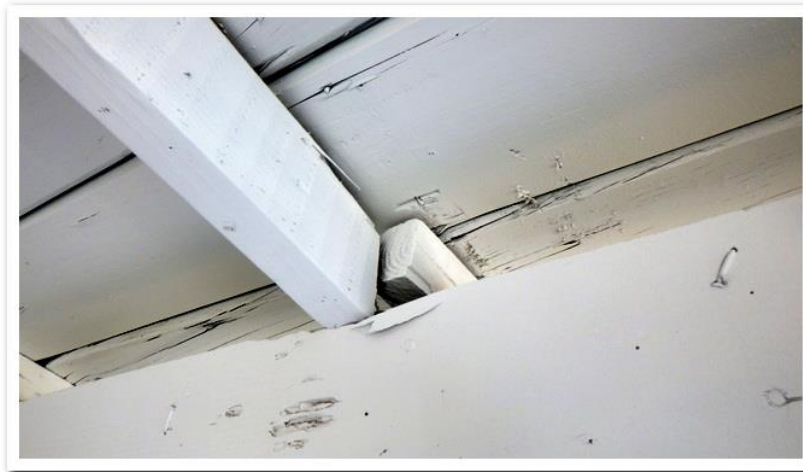
201 Cover: Wood. **Unable to determine if cover is installed properly; suggest consulting with specialist for further review prior to close of escrow.**

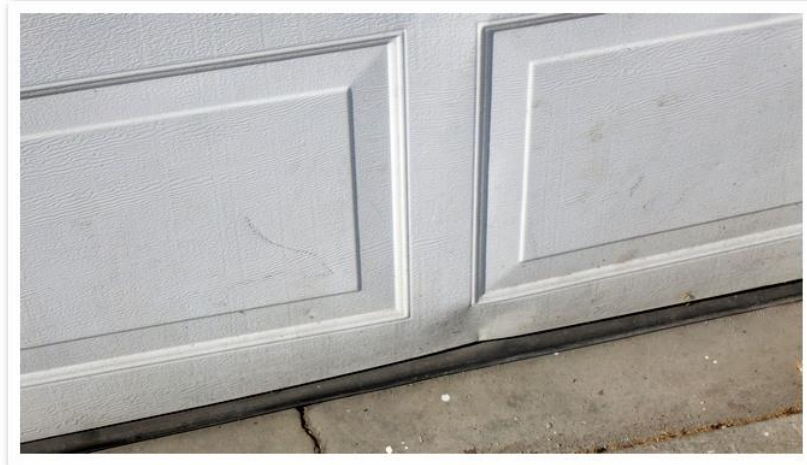
- 301 Exterior: Serviceable; stucco.
- 302 Roof: Please see roof comments.
- 303 Slab: Concrete. **Expansive cracks and lifted concrete noted at various areas; suggest consulting with specialist for further review prior to close of escrow.**
- 304 Overhead Door: Metal. **Overhead garage door noted is difficult to open and close. Loose metal noted at base; suggest securing. Overhead garage door noted is dented at various areas; suggest consulting with specialist for further review prior to close of escrow.**

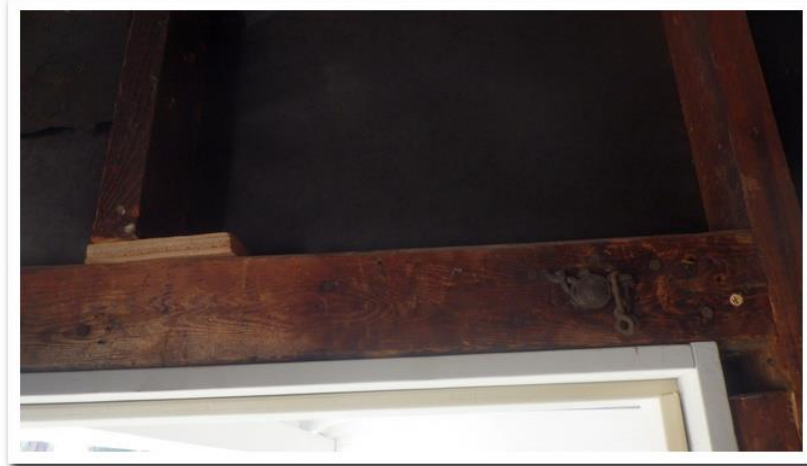
- 305 Garage Door Hardware: **Unable to test; please see number 304.**
- 306 Door Opener: Non-Applicable.
- 307 Windows: Non-Applicable.
- 308 Access Door: **Improper header beam noted above access door; suggest consulting with specialist for further review prior to close of escrow.**

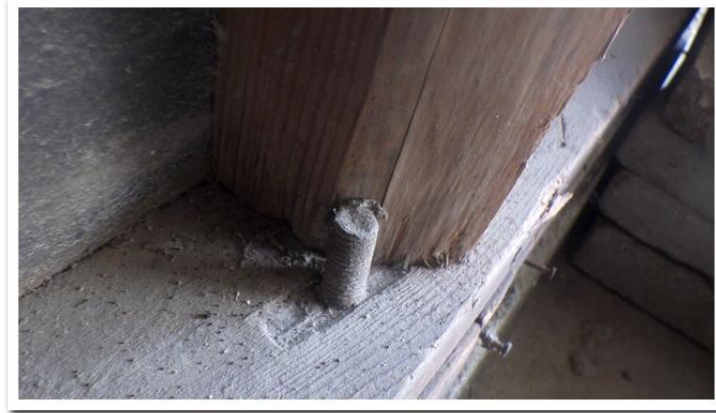
- 309 Fire Door: Non-Applicable.
- 310 Fire Wall: Non-Applicable.
- 311 Vent Screens: Non-Applicable.
- 312 Walls: **Missing nuts noted at several bolts; we advise making necessary corrections.**

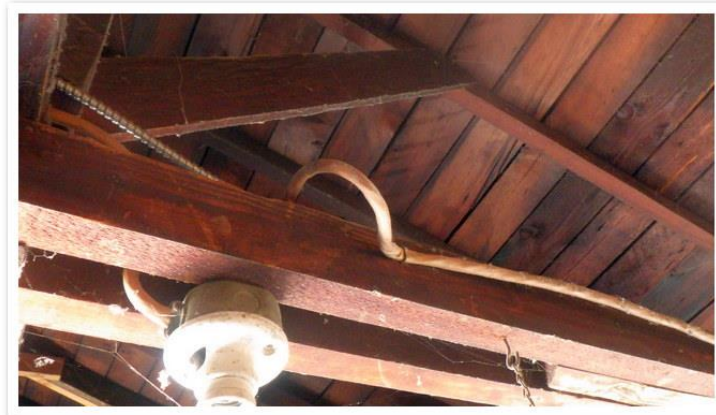
- 313 Ceiling: **Ceiling noted has been repaired at various areas; unable to determine effectiveness of these repairs.**
- 314 Electrical: **There is no ground fault interrupter noted in this area which may not have been standard at the time of construction. However, today's standards require ground fault interrupters at all areas within five feet of running water and external outlets. We suggest installing a ground fault interrupter in this area as a safety upgrade.**
Two (2) inoperable outlets noted by toilet
Exposed romex wiring noted at various areas. This may be a safety concern if used where it could be subject to physical damage. Client may wish to encase as a safety upgrade.

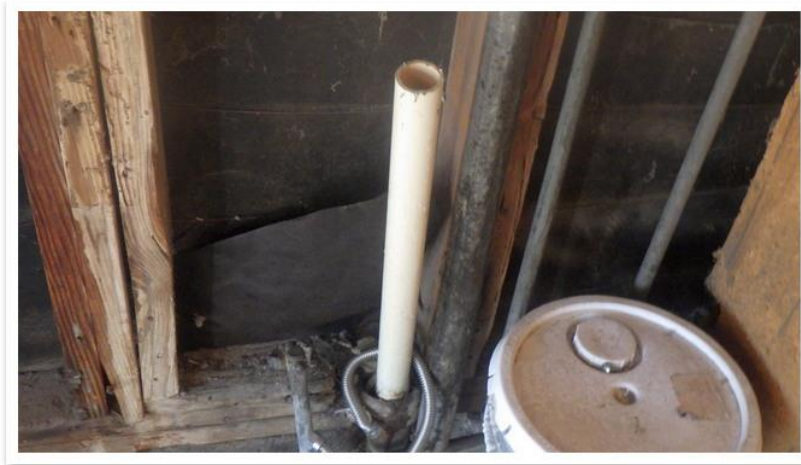
- 315 Laundry Tub: Non-Applicable.
- 316 Washer H/Up: **No vent pipe noted for drain; suggest consulting with specialist for further review prior to close of escrow.**
Washer hook-up noted is not installed properly; suggest consulting with specialist for further review prior to close of escrow.

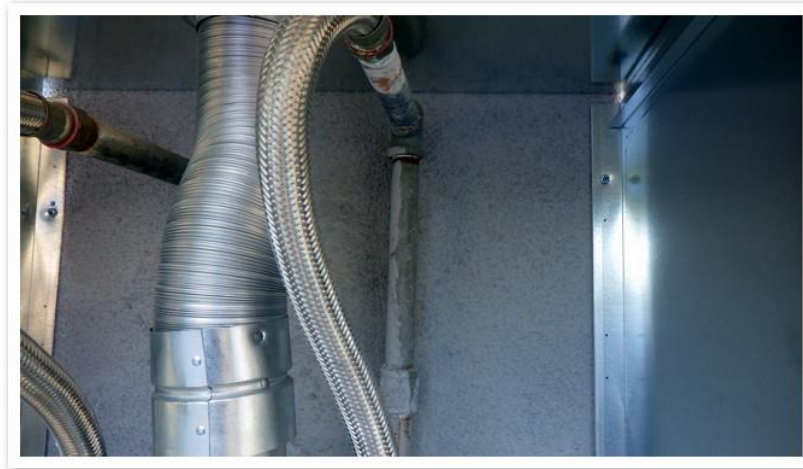
407 Water Heater #1:

Approximately 28 gallons, gas water heater located in closet behind garage. Temperature and pressure relief valve installed as a safety feature. Two earthquake straps are installed as a safety measure.

Water heater noted is not equipped with a required cold water shut-off; suggest consulting with specialist for further review prior to close of escrow.

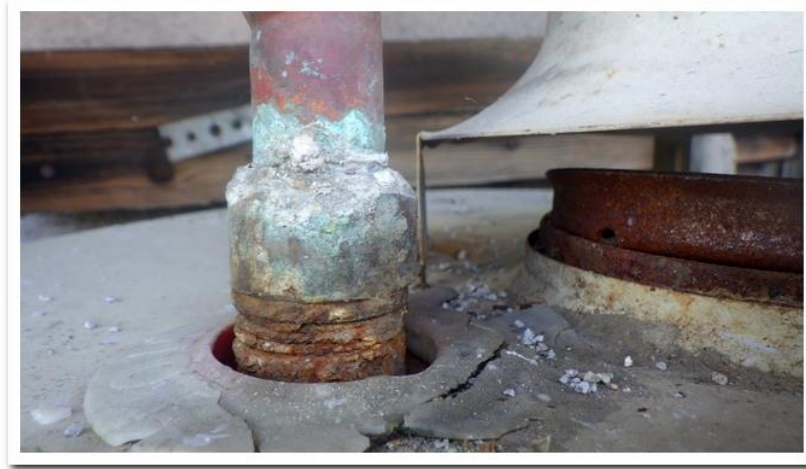
Corrosion noted on plumbing; no evidence of leakage at time of inspection.

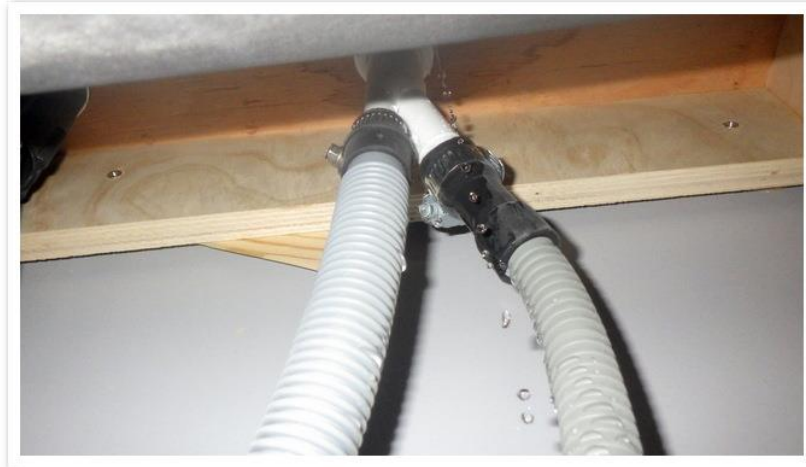
511 Traps/Drains/Supplies: **Leak noted under sink under air gap; please see number 513.**

513 Dishwasher: Samsung. **The air gap overflow port leaks water. This indicates a possible obstruction in the line. Clean out of these drains is advised.**
