## Root Canal Therapy for Multiple Broken Teeth in a 5-year-old German Shepherd Dog

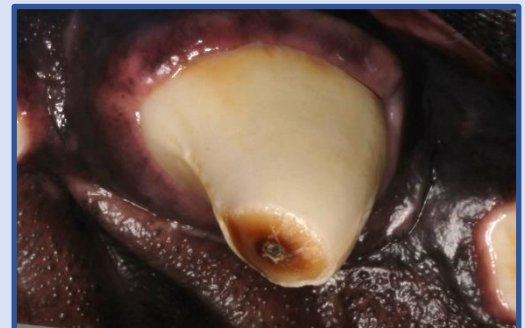
Figure 2 -broken upper right canine tooth with pulp chamber exposure

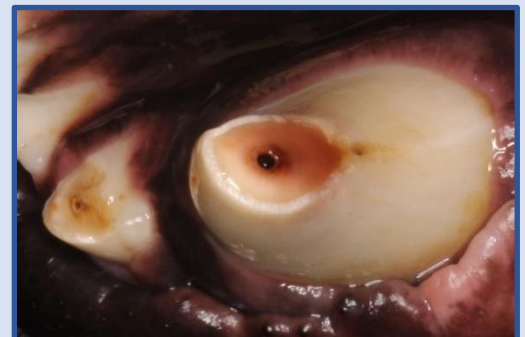
Figure 3 – Broken lower left 3<sup>rd</sup> incisor and canine teeth with pulp chamber exposure

**Figure 10** – After photo of finished root canal procedures on lower left 3<sup>rd</sup> incisor and canine teeth. Compare to figure 3

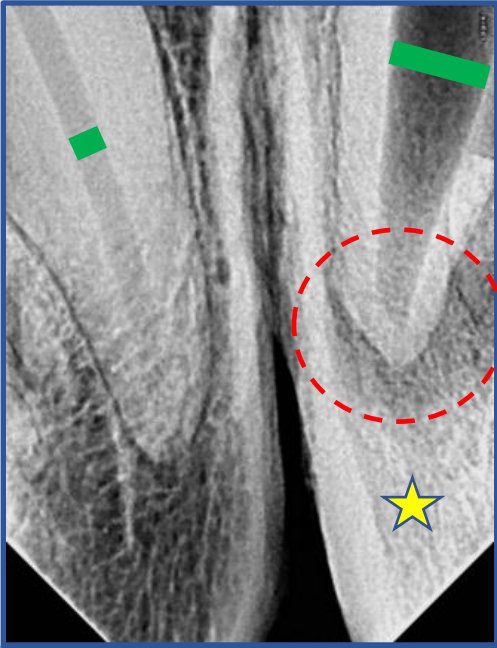
filling of the root canal and final restoration. In this case, the canine teeth appear to have been broken at a young age based on the wide diameter of the root canals on dental radiographs. Figure 4 is a dental radiograph that shows the most apical portion of the lower canine teeth with an obvious discrepancy in root canal diameters. The wider canal is the non-vital tooth that stopped maturing when the pulp died. This tooth will not be as sturdy as the opposite tooth that has thicker walls, but with successful root canal therapy, it can remain in the mouth and continue to function.

The process of root canal therapy requires access to the root canal including the apex of the tooth which is the very end of the root. On dental radiographs lesions of endodontic origin can be identified where bone density is decreased by inflammation (Figure 4). The goal of therapy is to remove the necrotic pulp tissue and diseased dentin, disinfect, rinse and dry the canal system, seal the canal (Figure 7), obturate (fill) the canal (Figure 8), place intermediate and final restorations (Figures 9 & 10). Dental radiographs are taken during the procedure and upon completion to assess each step. Most of the time, oral antibiotics are given to resolve infection that could remain around the tooth root in the bone. “Yasko” was prescribed clindamycin twice daily for 4 weeks. Carprofen and tramadol were prescribed for 3-5 days for pain control.

**Figure 4** – Dental radiograph showing canal diameter disparity (green lines). The tooth on the right is the lower left canine tooth. There is an obvious periapical lucency (dashed lines) surrounded by more dense bone (star)

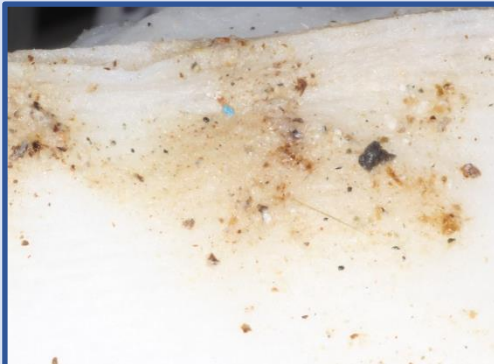
In this case, “Yasko” has a job to do that would require he have his canine teeth intact. We performed root canal therapy which was very challenging due to the long duration the canal was open allowing hair, sand, pieces of chew toys and other debris to fester inside the wide canal (Figure 5). Once a fracture occurs that exposes the pulp chamber, the pulp tissue swells which can keep the canal free of infection for a short time. If it is not treated with vital pulp therapy in a timely fashion, it will become contaminated and eventually shrink and die. In this case, the pulp underwent liquefactive necrosis which is a process where the blood rich pulp tissue rots. Successful root canal therapy is essential for the teeth to be salvaged.

**Figure 5** – Debris from root canal (hair, sand, pieces of chew toy and more)

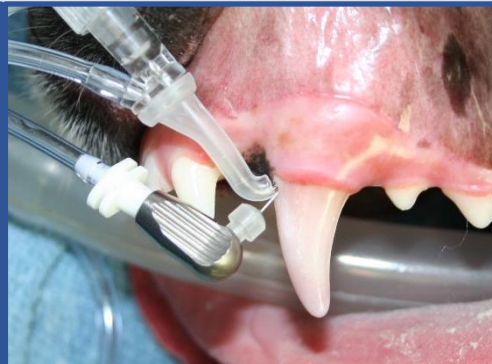
**Figure 6** – EndoVac (Kerr Endo) being used on a different patient to disinfect and rinse canal

In cases like this, where there are huge canals, it is not possible to physically file debris. The endodontic files cannot hit all walls of the canal (Figure 7). We rely on chemical disinfection with full strength bleach for extended time periods in combination with use of an EndoVac endodontic vacuum system (Figure 6). This vacuum stirs the contents of the canal and allows more dilution of contaminants with reduced risk of extrusion of bleach into the surrounding tissues, which would be disastrous. Less severe cases will have 15-30 minutes of contact time with dilute bleach, however in this case there was at least 60 minutes of contact time with full-strength bleach with frequent replacement and flushing with sterile saline. Areas of concern in this case are some voids which are created by calcification in the apex of the canal or reduced ability to file. It is my hope that chemical disinfection and sealing will be sufficient for clinical success.

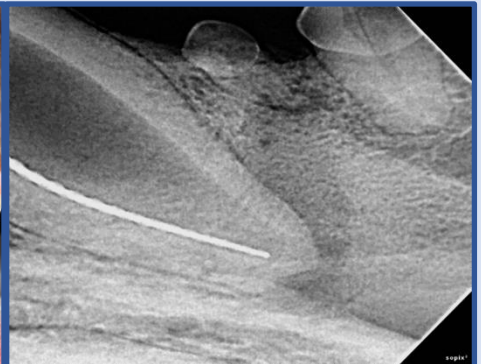
**Figure 7** – Endodontic file in canal illustrating size difference

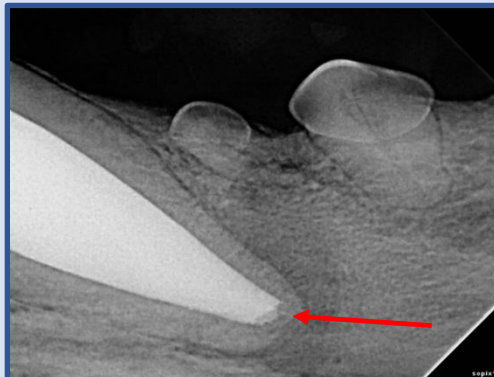
**Figure 8** – Canal filled with sealer and gutta percha to isolate the tooth from the body. Minor canal defect of uncertain significance (red arrow)

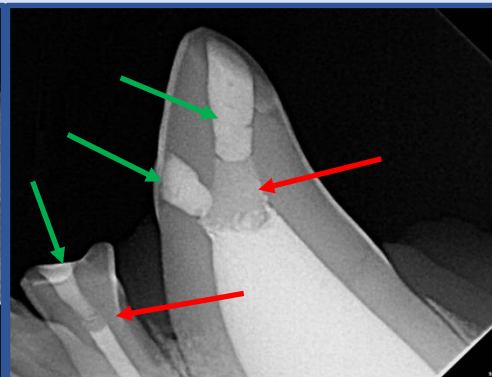
**Figure 9** – Intermediate (red arrow) and final restorations (green arrows)
