PROPERTY INSPECTION REPORT

40646 Carriage Ct , Palmdale , CA 93551

Date of Inspection: 8/31/2022 Time: 4:00 PM

Age of Home: Built in 2004 Size: 3147 sq ft

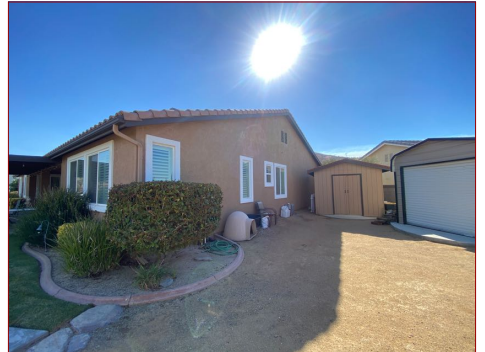
2. DRIVEWAY

2.1. The Inspector observed no deficiencies the driveway condition at the time of the inspection.

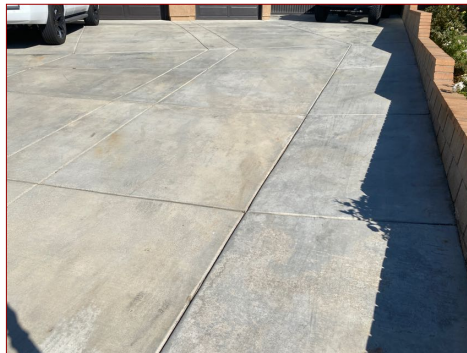
3. CARPORT

• The Inspector observed no deficiencies in the carport cover condition at the time of the inspection.

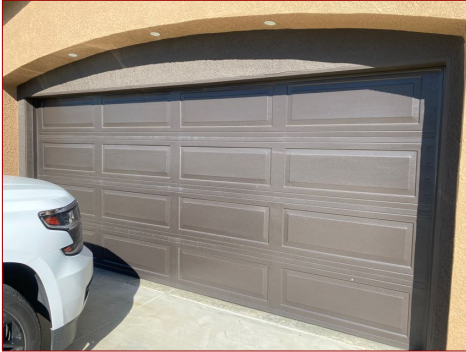
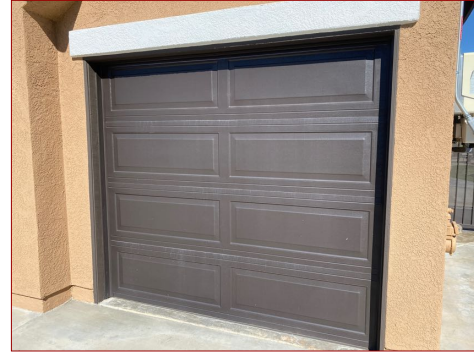
6.1. At the time of the inspection, the Inspector observed no deficiencies in the condition of the overhead vehicle doors.

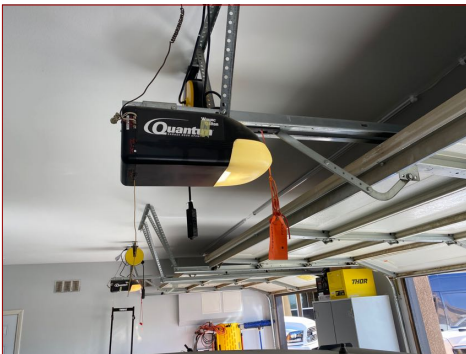
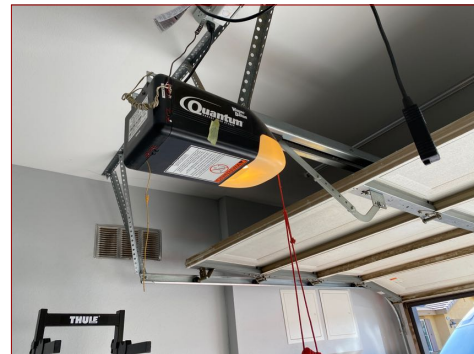
7.1. Two overhead garage doors were equipped with automatic door openers.

7.2. Both automatic garage door openers responded to the controls at the time of the inspection.

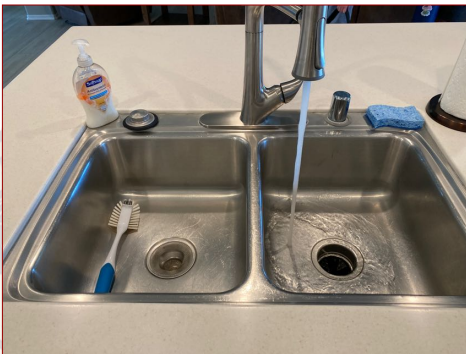
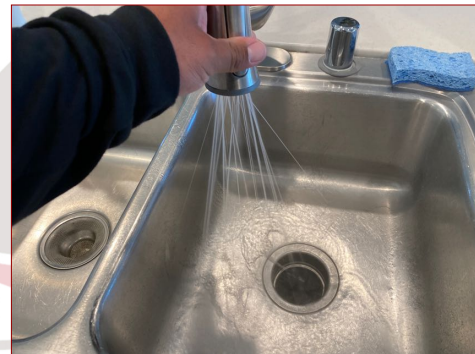
- 3.1. Sink Condition: At the time of the inspection, the Inspector observed no deficiencies in the condition and operation of the kitchen sink.
- 3.2. The kitchen sink had functional flow and functional drainage at the time of the inspection.
- 3.3. Faucet: The kitchen sink faucet appeared to be in serviceable condition at the time of the inspection.
- 3.4. Wand: The kitchen sink wand appeared to be in serviceable condition at the time of the inspection.

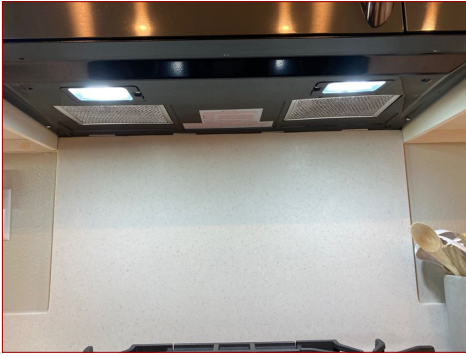
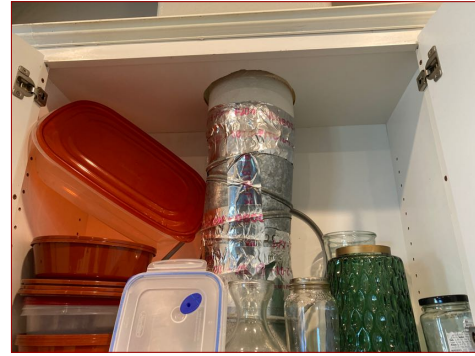
8.2. At the time of the inspection, the Inspector observed no deficiencies in the condition and operation of the range hood exhaust fan and lights.

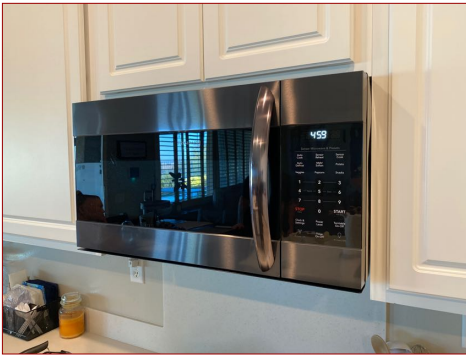
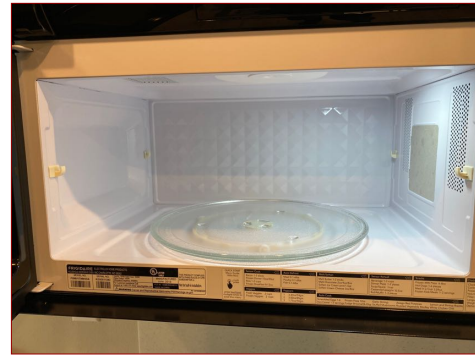
9.1. At the time of the inspection, the Inspector observed no deficiencies in the condition and operation of the built-in microwave oven. Built-in microwave ovens are tested using normal operating controls. Unit was tested and appeared to be serviceable at time of inspection. Leak and/or efficiency testing is beyond the scope of this inspection. If concerned, you should seek further evaluation by qualified technician prior to closing.

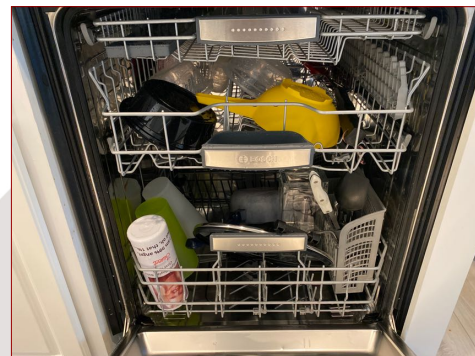
10.1. At the time of the inspection, the Inspector observed no deficiencies in the condition and operation of the dishwasher. It was operated through a cycle.

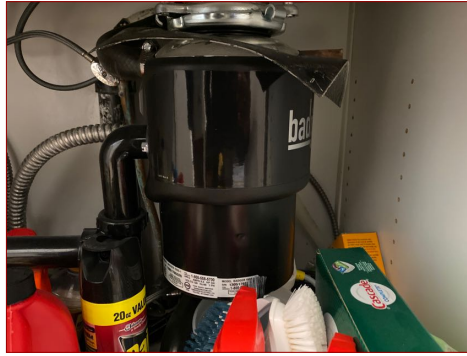
11.1. At the time of the inspection, the Inspector observed no deficiencies in the condition and operation of the garbage disposal.

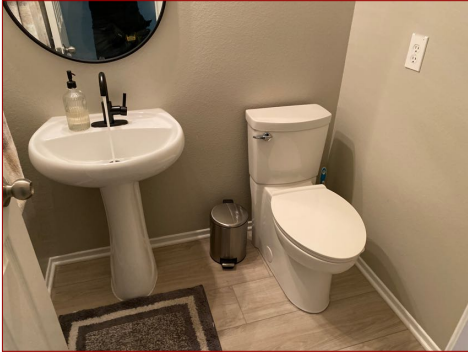
- Bathroom 1
- This bathroom contained a pedestal sink and a toilet.
- Bathroom 2
- This bathroom contained two sinks in a cabinet, a toilet and a tub with a shower.
- Bathroom 3
- This bathroom contained two sinks in a cabinet, a toilet, a tub and a shower.

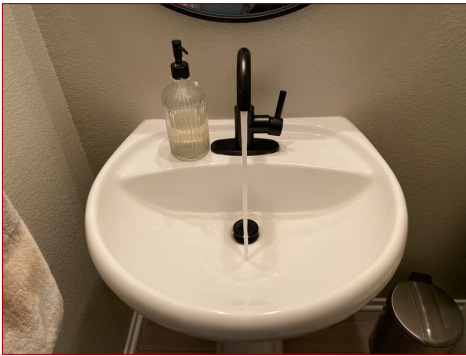
Bathroom 1

- 3.1. Sink Condition: At the time of the inspection, the Inspector observed no deficiencies in the condition of the bathroom sinks.
- 3.2. The bathroom sinks had functional flow and functional drainage at the time of the inspection.
- 3.3. Faucet: The bathroom sink faucets appeared to be in serviceable condition at the time of the inspection.

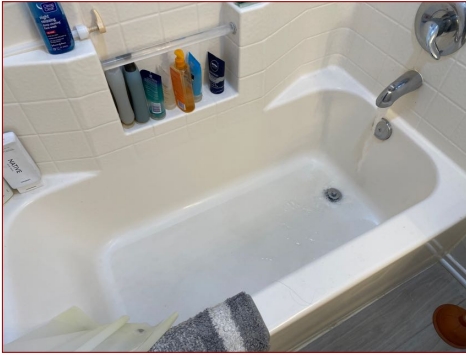
Bathroom 2

8.1. Bathtub Condition: At the time of the inspection, the Inspector observed no deficiencies in the condition of bathtub components.

8.3. Faucet: The bathroom bathtub faucets appeared to be in serviceable condition at the time of the inspection.

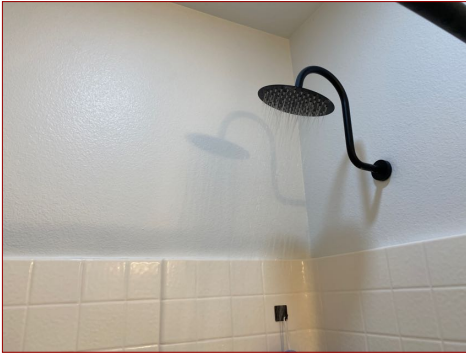
Bathroom 2

9.1. Shower Condition: The shower in the bathrooms appeared to be in serviceable condition at the time of the inspection. Inspection of the shower typically includes:

9.2. The showers had functional flow and functional drainage at the time of the inspection.

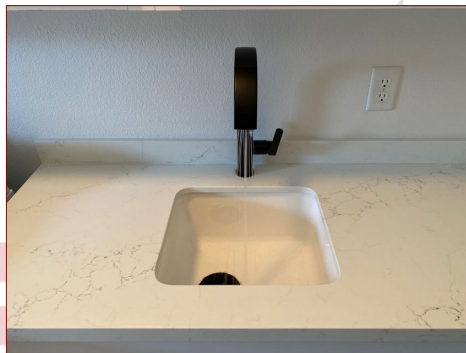
- At the time of the inspection, the Inspector observed no deficiencies in the condition and operation of the laundry room sink.
- The laundry room sink had functional flow and functional drainage at the time of the inspection.
- The faucet of the sink in the laundry room appeared to be in serviceable condition at the time of the inspection.

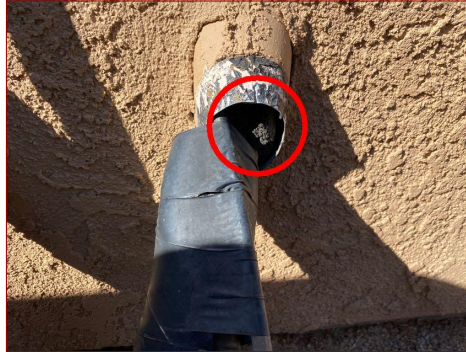
9.1. [CR]The hole in the exterior wall-covering cut to allow penetration of air-conditioning lines should be sealed with an appropriate sealant to prevent moisture and insect entry.

Gap observed

Page 30 Item: 9	AC Refrigerant Lines	9.1. [CR]The hole in the exterior wall-covering cut to allow penetration of air-conditioning lines should be sealed with an appropriate sealant to prevent moisture and insect entry.

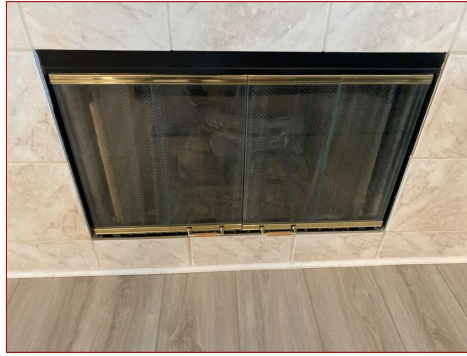
12.1. The home contained a gas-burning fireplace located in the family room. Full inspection of gas-burning fireplaces lies beyond the scope of the General Home Inspection. For a full inspection to more accurately determine the condition of the fireplace and to ensure that safe conditions exist, the Inspector recommends that you have the fireplace inspected by an inspector certified by the Chimney Safety Institute of America (CSIA).

Find a CSIA-certified inspector near you at <http://www.csia.org/search>

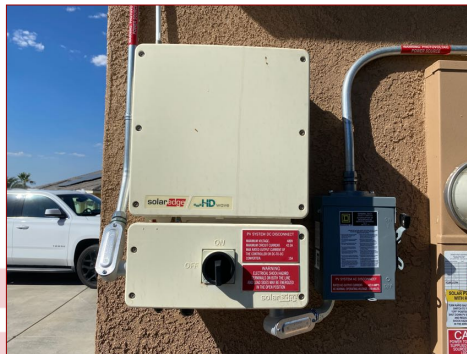
This system requires a specialist inspection, and not all electrical contractors will be qualified. The Inspector strongly recommends that you have the PV system inspected. These systems commonly produce enough electricity to cause serious or fatal injury. You should have good instruction on the operation and maintenance requirements of this system.

- An adequate inspection of the PV system lies beyond the scope of the General Home Inspection and the expertise of the Inspector. These systems commonly produce enough electricity to cause serious or fatal injury. It is important that you have the system inspected by a qualified contractor to ensure that it is in safe operating condition. Not all electrical contractors will be qualified.

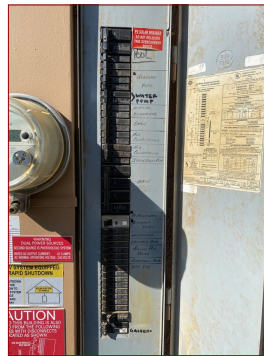
- Panel interior and exterior condition
- Panel amperage rating
- Main disconnect amperage rating and condition
- Main conductor amperage ratings
- Branch conductor types, amperage rating and condition
- Wiring visible materials, types, condition and connections
- Circuit breaker types, amperage ratings and condition
- Label information present
- Service and equipment grounding
- Bonding of service equipment

5.3. Panel Interior: The interior of the service panel was dirty and needed cleaning. This condition may affect the ability of electrical components within the service panel to function as they were designed. The Inspector recommends that the service panel be cleaned by a qualified electrical contractor.

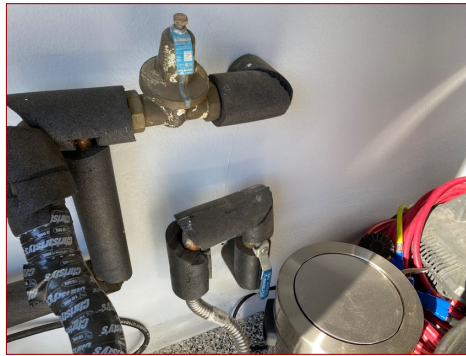
3.1. Main Water supply Shut-off Location: The main water supply shut-off was located at the garage of the home

3.2. Main Water Shut-off Condition: At the time of the inspection, the Inspector observed no deficiencies in the condition of the main water supply shut-off valve. It was not operated but was visually inspected.

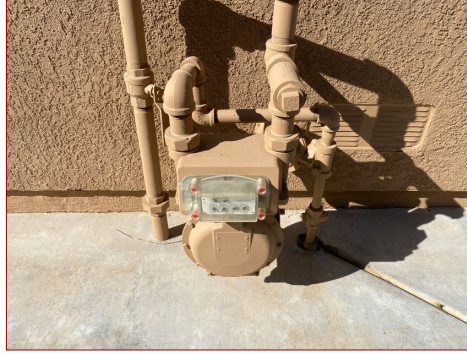
16.1. Gas Shut-off Location: The main gas shut-off was located at the gas meter located at the right side of the home.

16.2. Gas Shut-off Condition: The gas shut-off appeared to be in serviceable condition at the time of the inspection. Shut-offs were not operated, but were visually inspected.

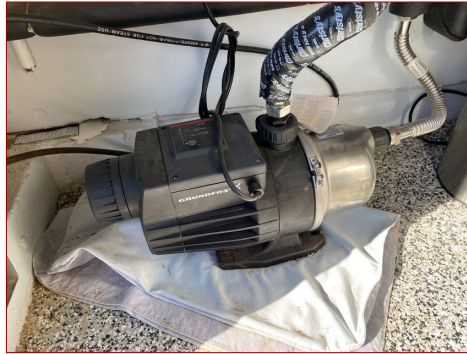
- At the time of the inspection, the booster pump was in operable working condition.

Booster pump

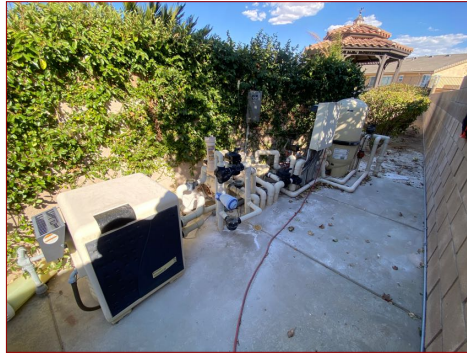
1.1. The photo shows the pool equipment for the pool.

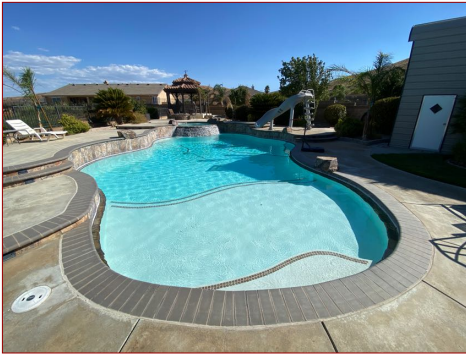
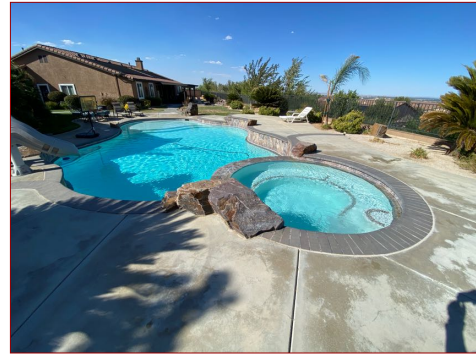
2.1. The pool appeared to be filled to capacity at the time of the inspection.

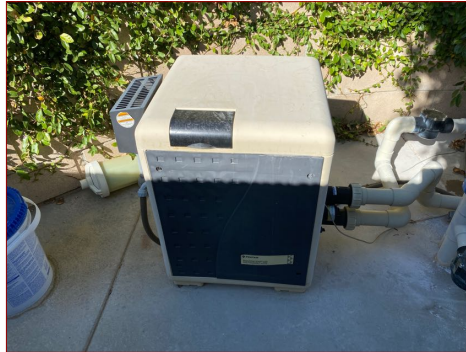
- 7.1. At the time of the inspection, the Inspector observed no deficiencies in the condition of the pool heating system.

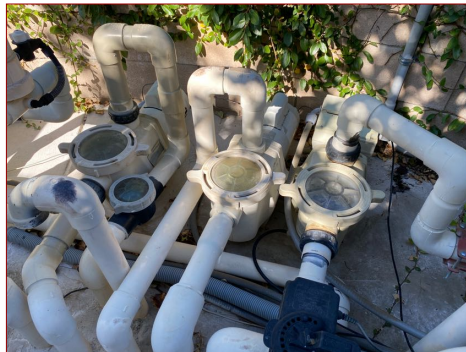
- 8.1. At the time of the inspection, the Inspector observed no deficiencies in the condition and operation of the swimming pool pump.

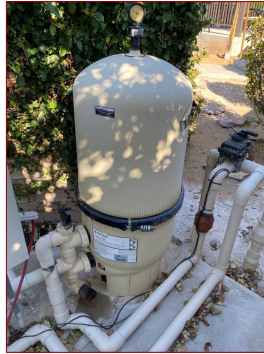
- 9.1. At the time of the inspection, the Inspector observed no deficiencies in the condition and operation of the pool filtration system.

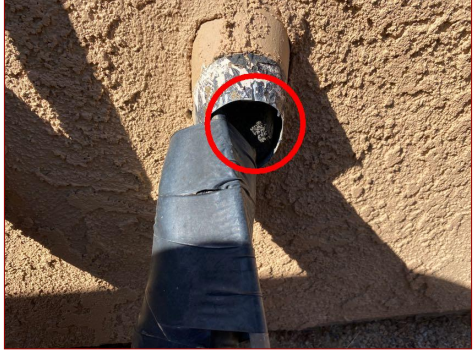
<p>Gap observed</p>
