Overhangs - Cantilevered Floor

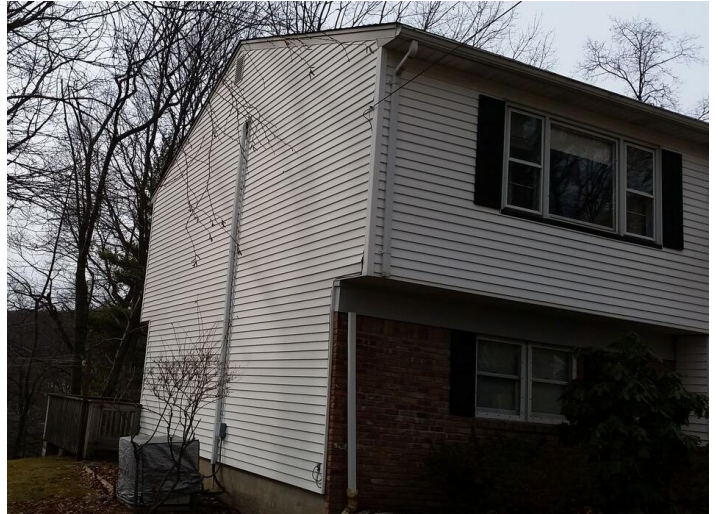
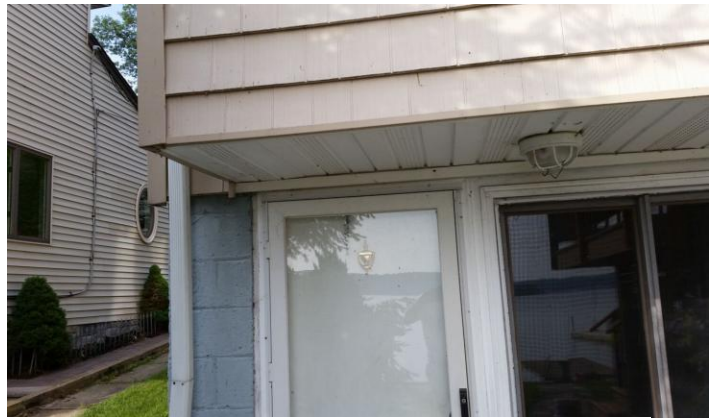
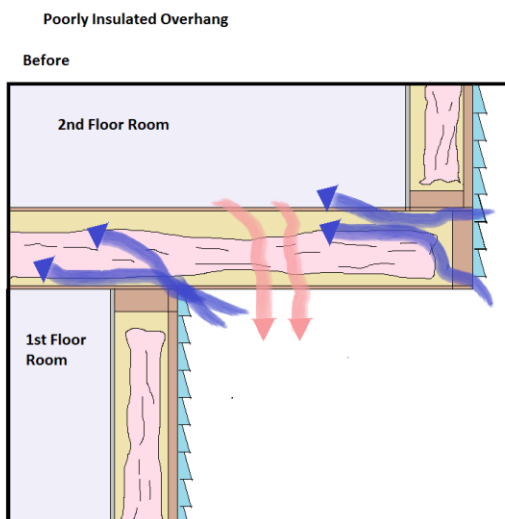
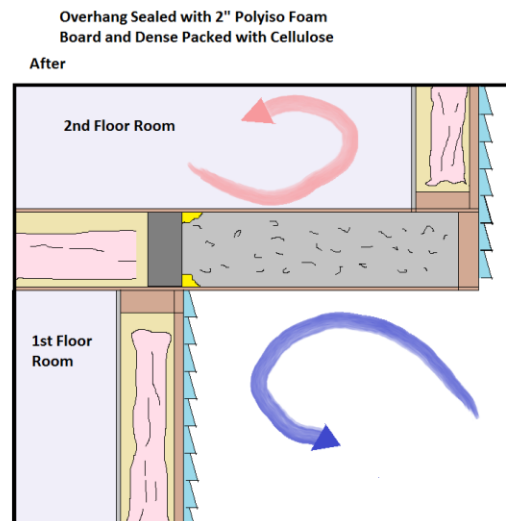
A big source of draftiness for floors that extend beyond the floor below them is caused by the overhang. This area is usually very poorly insulated with fiberglass and in some cases completely un insulated. Fiberglass is only truly effective when it completely fills a cavity and this is especially true for floors that are exposed to the exterior. Air can flow around the fiberglass because there is usually space above and below the fiberglass batting. This leaves floors that have overhangs very cold in the winter. It also allows air to leak in which causes the floor of the room above and the ceiling of the room below uncomfortable.

The way to fix this issue is to block off and seal the overhangs with 2" polyiso foam board and then dense pack the entire overhang area with cellulose insulation. This will properly insulate the overhang area stopping the flow of air thus resulting in more comfortable rooms.
