# Investigation on erosion-corrosion behaviour of gate valve used in main water distribution line of Oman

Elansezhian Rasu, Salim Abdullah Khamis Al Senaidi

Caledonian College of Engineering, Department of Mechanical & Industrial Engineering,  
Seeb, Muscat, Sultanate of Oman.

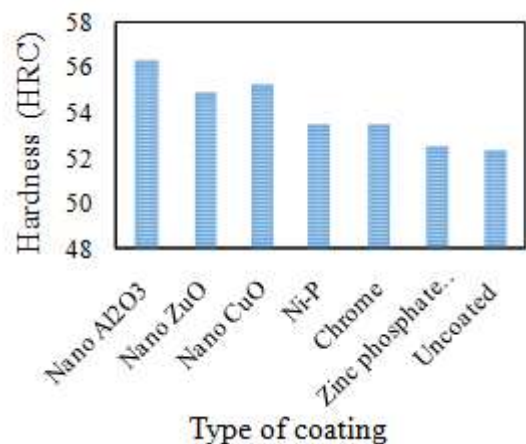
Figure 2. Hardness for samples

The Rockwell hardness values of different coatings are listed below and shown in Figure 2.
