PROPERTY INSPECTION REPORT

Concerning: 101Main St. North Texas

By: Temple Dale Busbice

5/6/2018

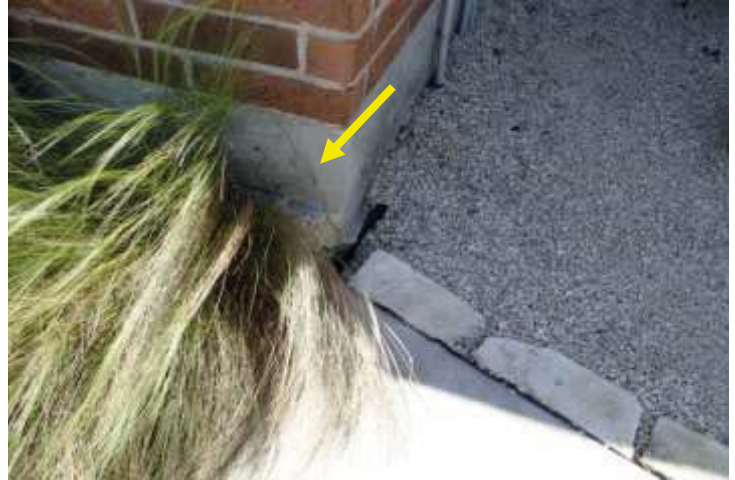
- The foundation appears to be providing adequate support for the structure at the time of this inspection. I did not observe any apparent evidence that would indicate the presence of adverse performance, or significant deficiencies in the foundation.
- Corner pop(s) were noted. Corner pops are cracks in the concrete within 3 feet of a corner. These are not considered structural, but should be repaired with hydraulic concrete.

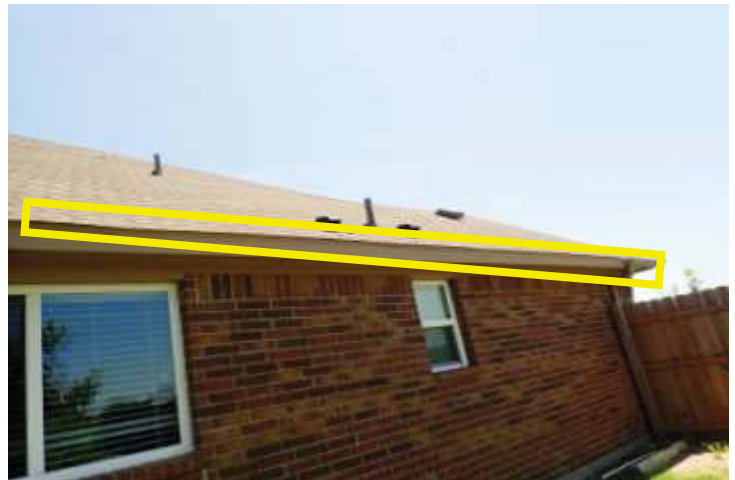
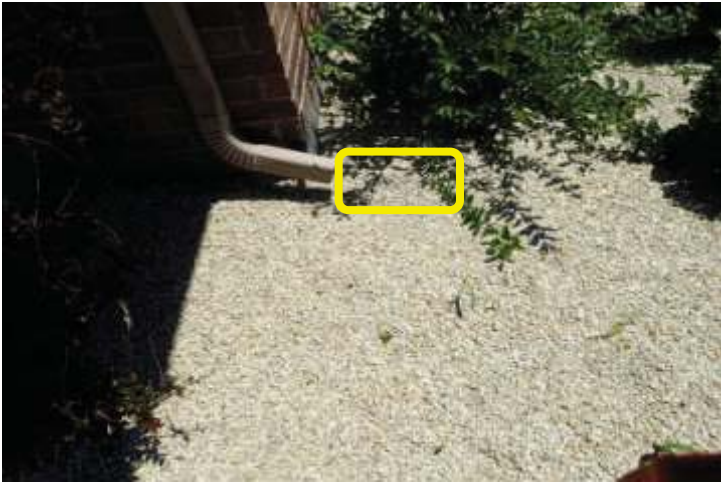
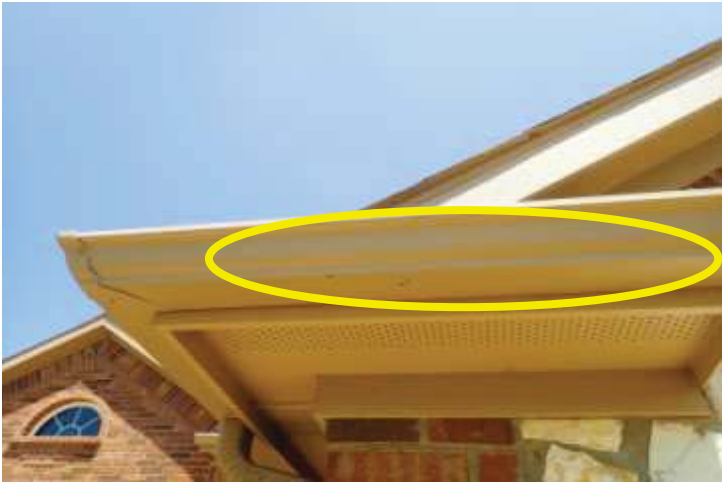
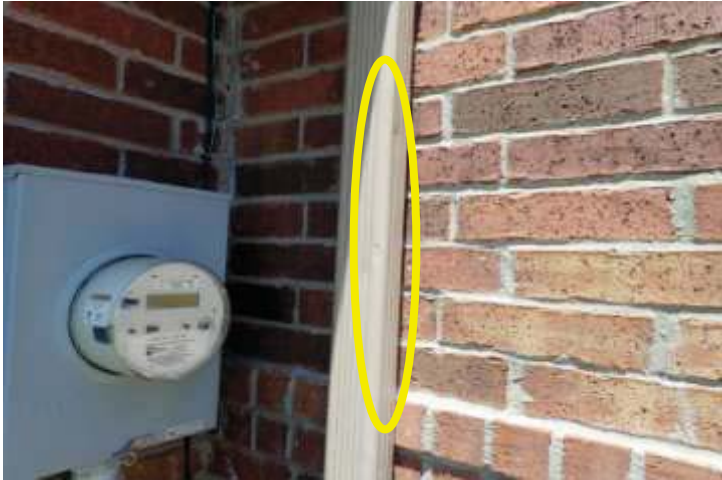
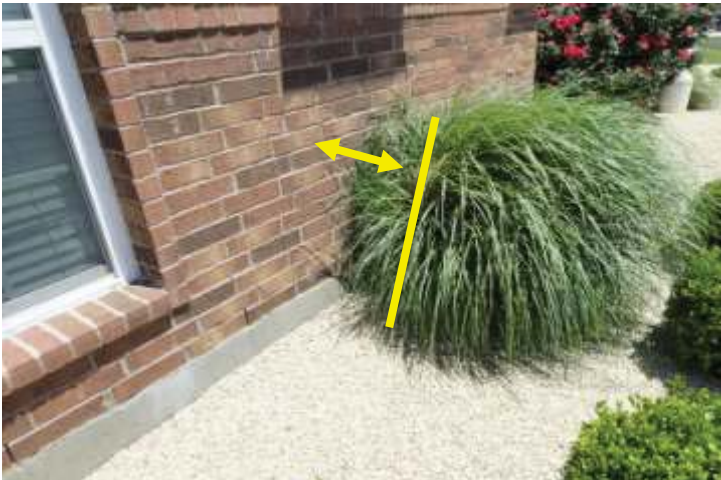
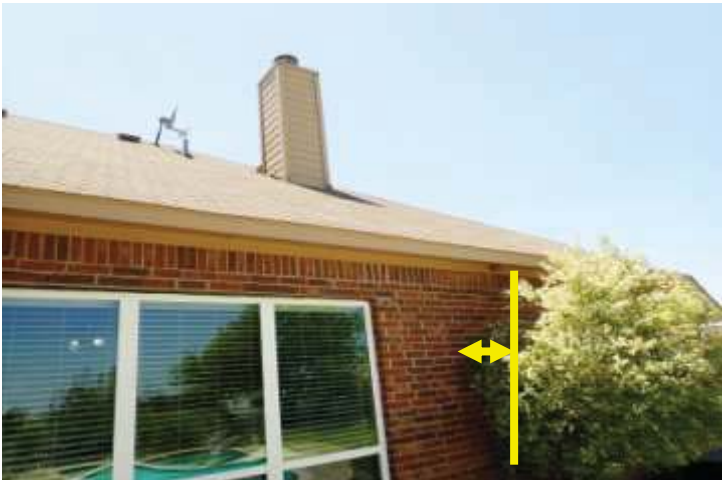
Drainage Condition: Marginal - Current building practices recommend a 6 inch drop within 10 feet to move water away from foundation.

- Negative grade noted at north side of structure.
- Recommend adding gutters around entire structure with 5 foot extensions to move water away from foundation.
- All downspouts should be equipped with splash blocks to prevent erosion.
- Gutters appear to have signs of hail damage.
- Shrubs/Trees/Foliage should be trimmed at least 1 foot from structure.

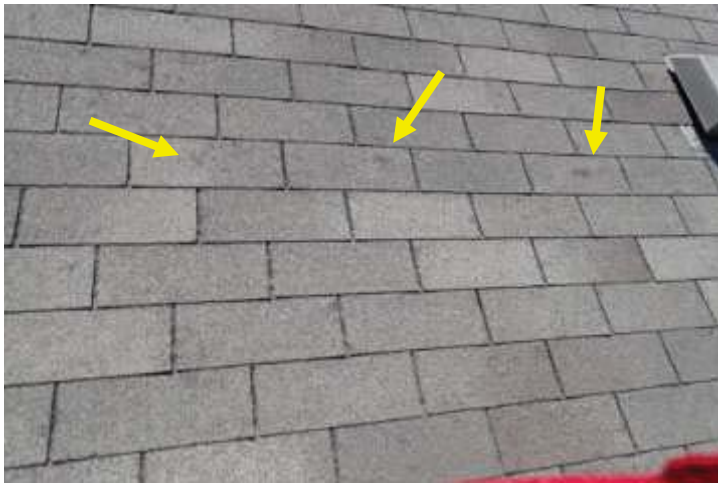
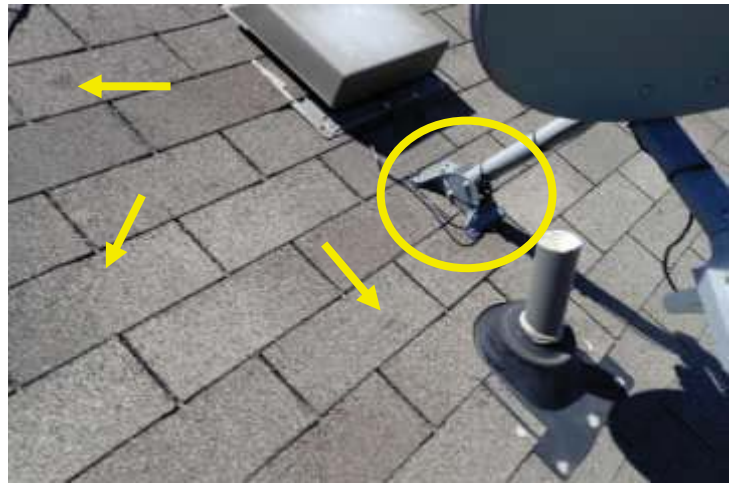
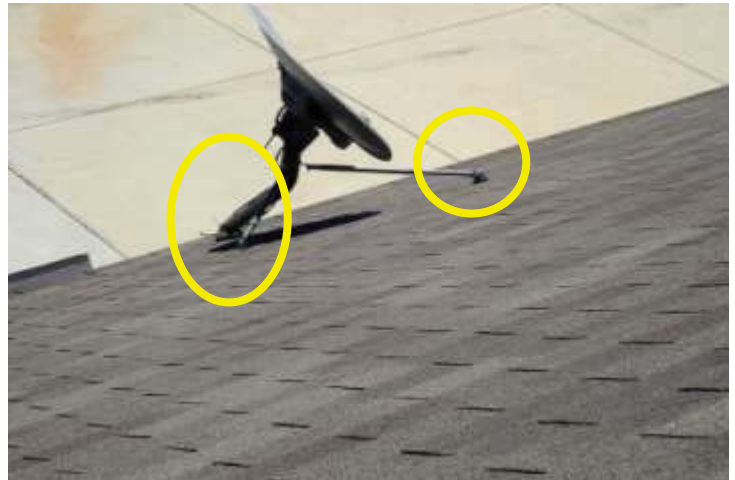
- Significant hail damage is noted. I recommend a Certified Roofing Company evaluate and make any repairs or replacement necessary.
- I recommend satellite dishes be removed and install with soffit brackets instead of penetrating shingles.

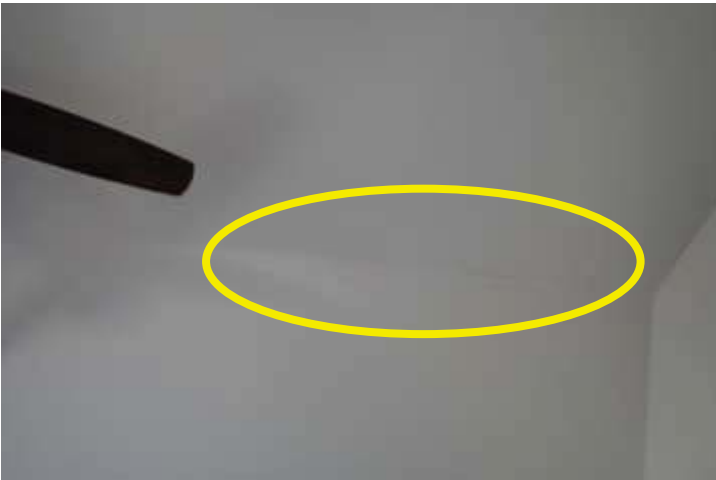
- Unknown staining on master bedroom ceiling. I recommend asking seller for clarification.

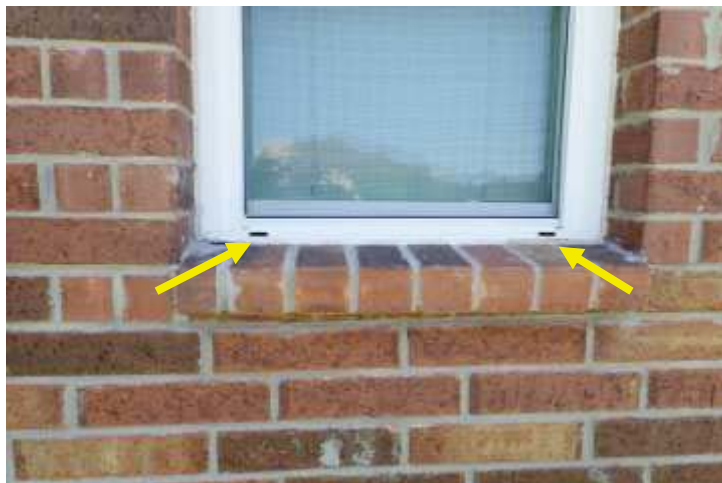
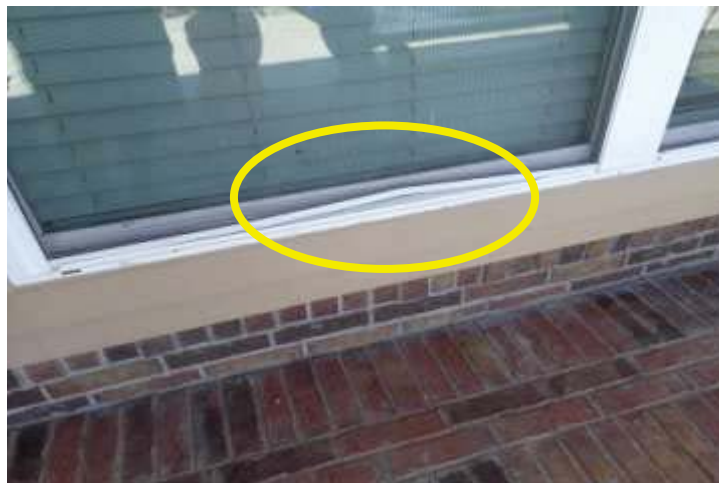
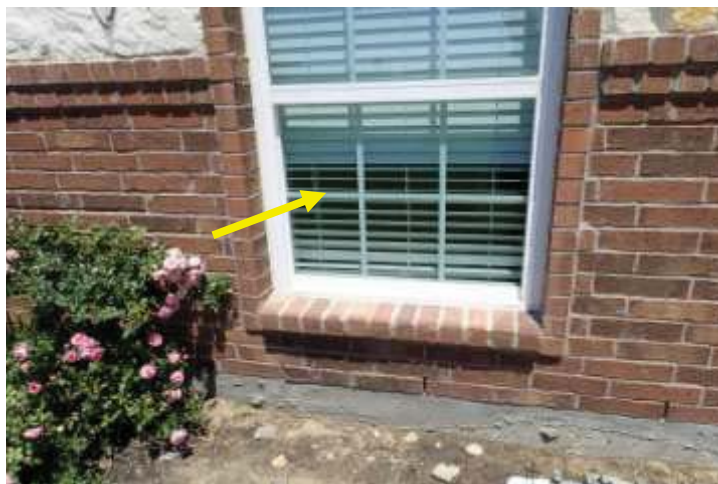
- Window vent caps are missing. – **West side.**
- Window screens damaged or missing.

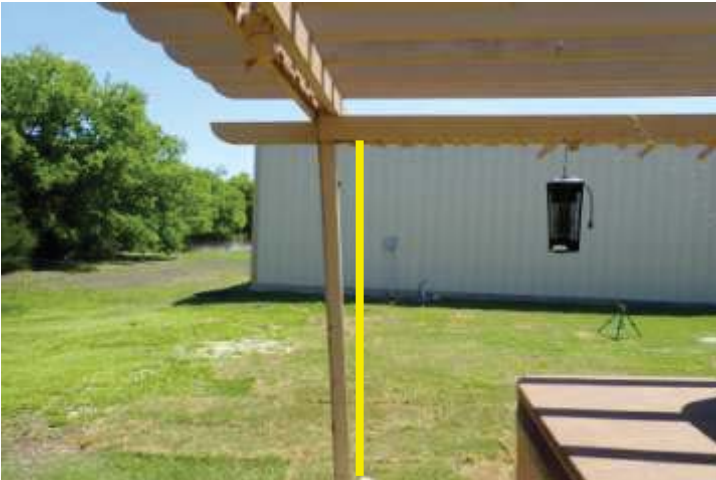
- Cupola over hot tub is leaning and built incorrectly. I recommend having this rebuilt and tearing down existing.

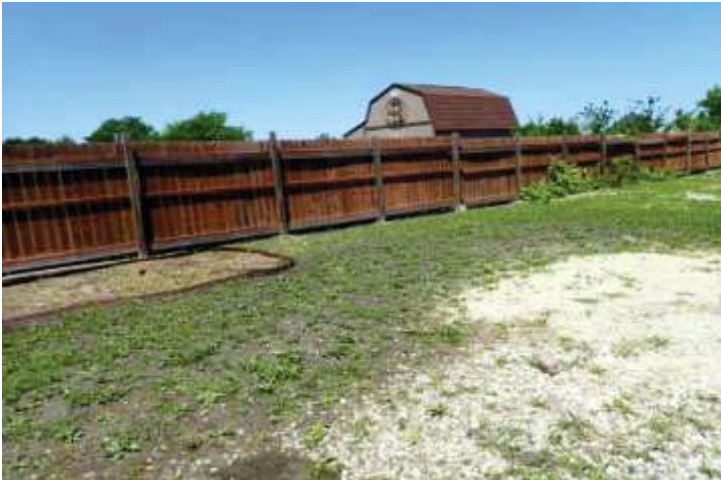
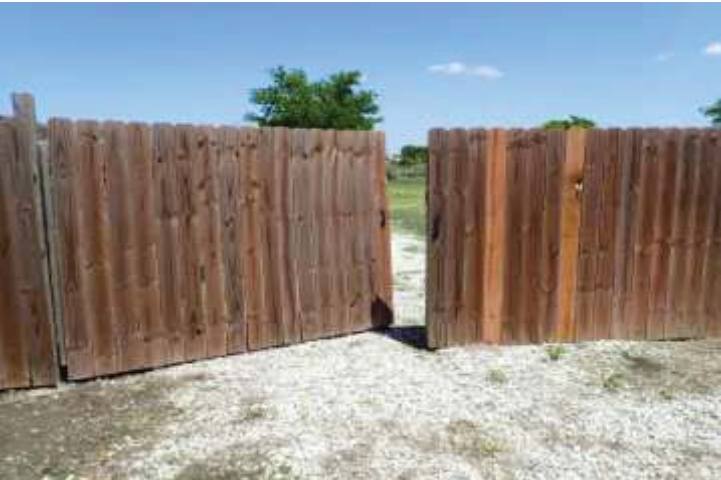
- Posts are loose and water damaged.

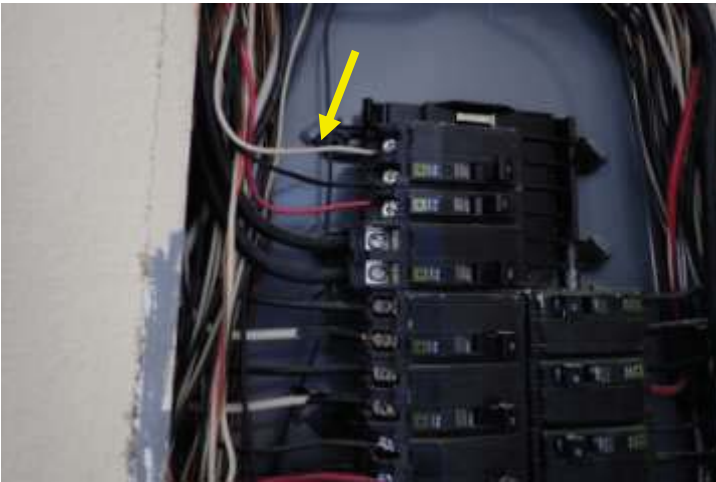
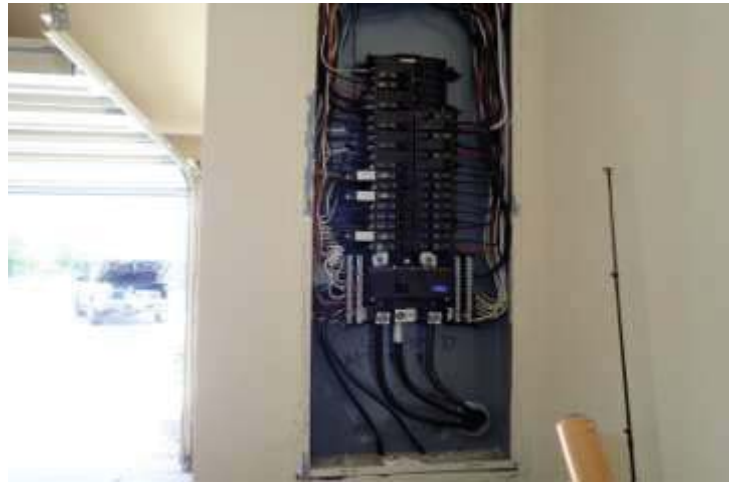
- White color coded wires are designated for neutrals. In this panel they are used for power and should be identified in the panel to distinguish their use.
- Shop breaker is not labeled.

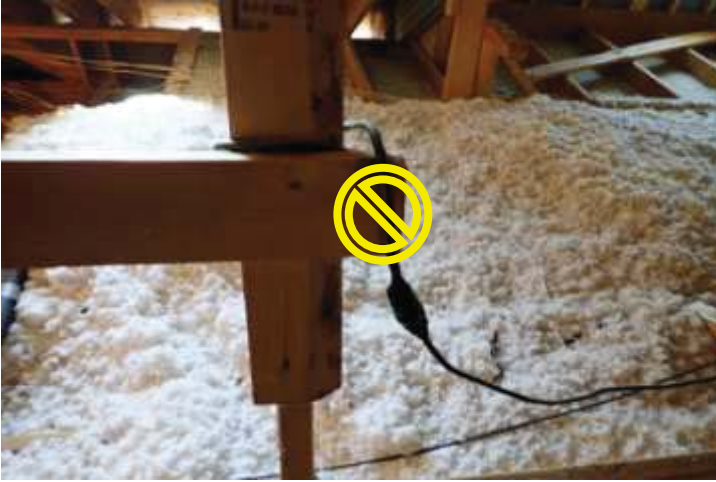
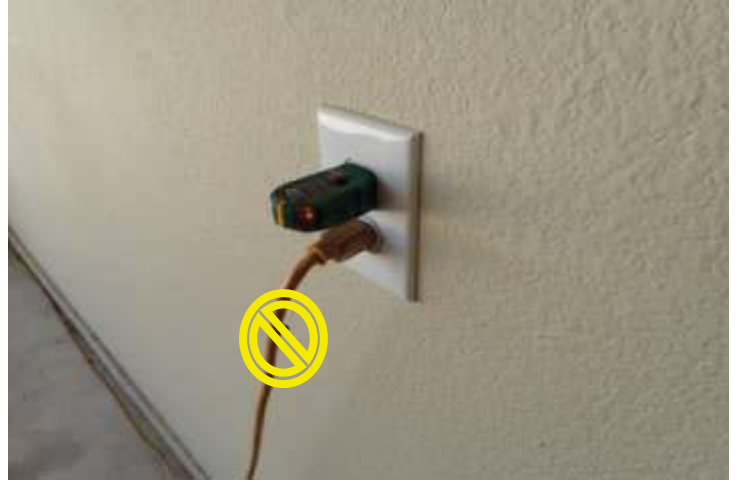
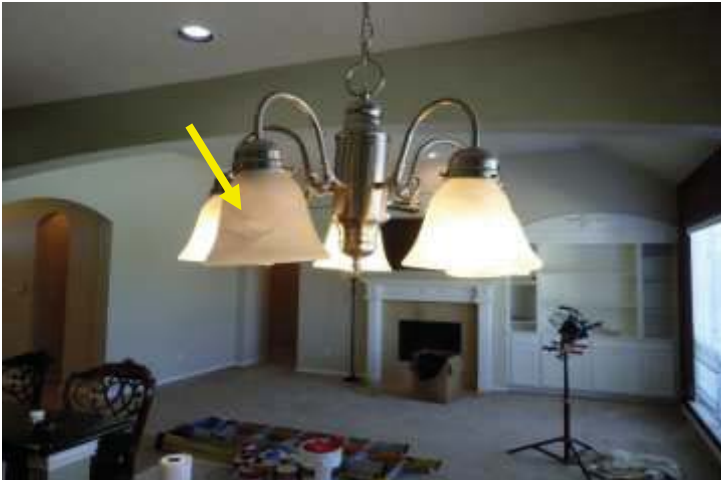
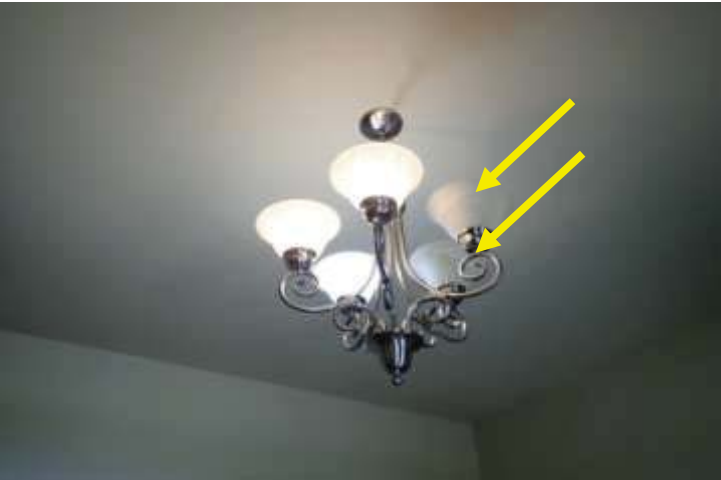
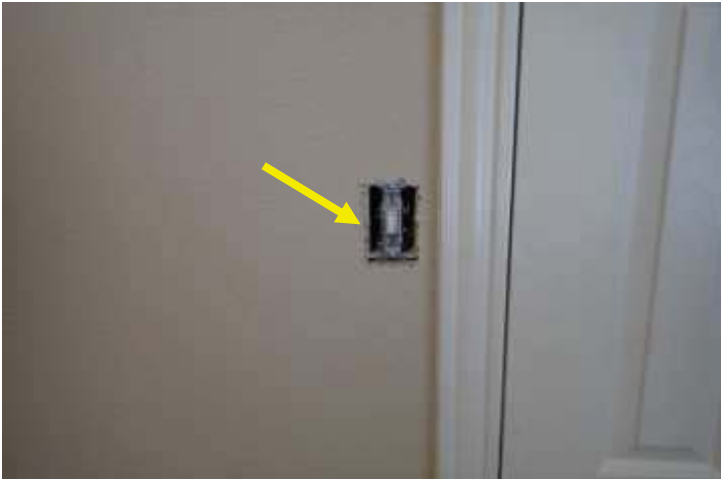
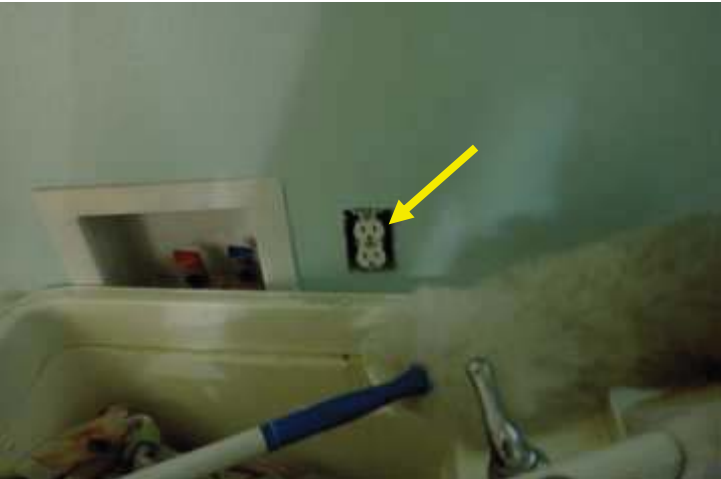
- Garage does not have GFCI's in all locations.

- Extension cords used in attic and low voltage lighting in garage are not allowed for permanent power. (Safety Hazard)
- Several bulbs/lights did not function.
- Multiple covers were missing from switches or receptacles.

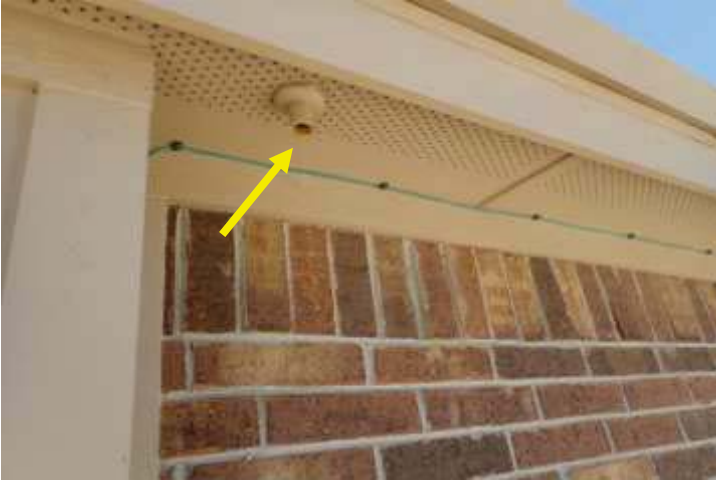
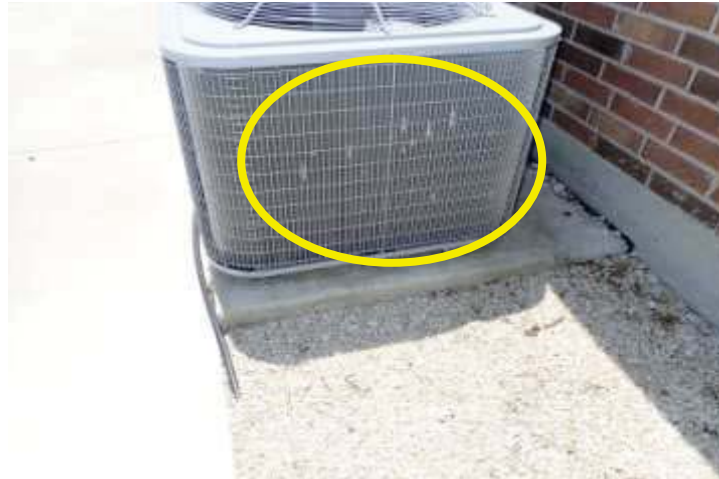
- Secondary drain is leaking water. Secondary condensate pan has rust. I recommend a Licensed HVAC technician replace pan and ensure primary pan and drain are clear.
- Condenser coil has hail damaged.

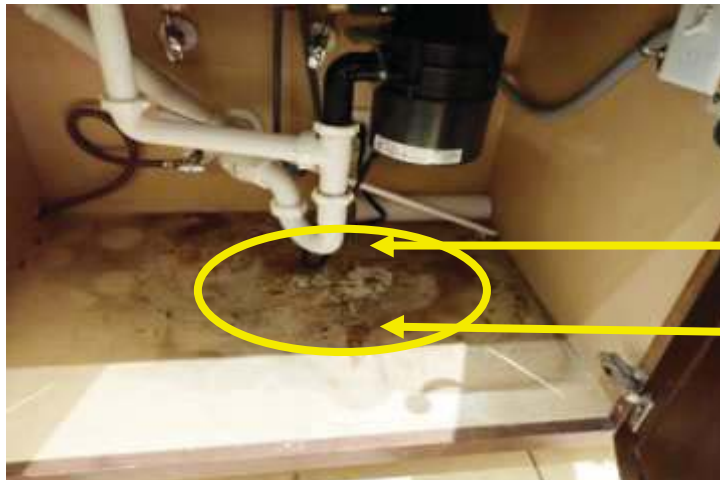
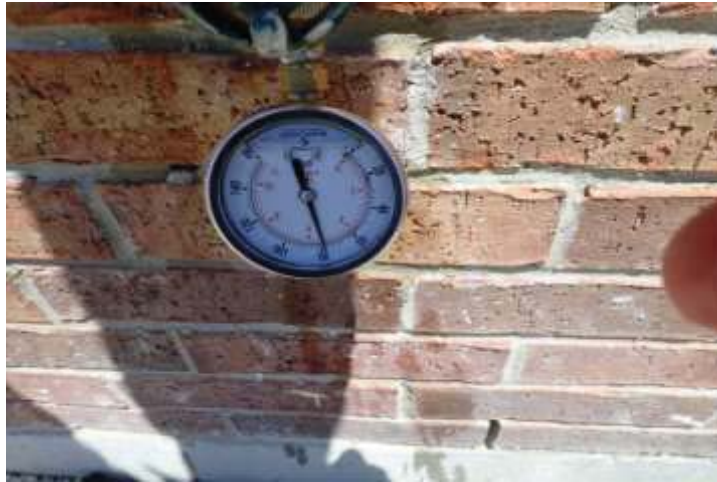
- Leakage around sink(s).
 - Kitchen
 - Hall bath right sink.
- Kitchen cabinet under sink is water damaged.

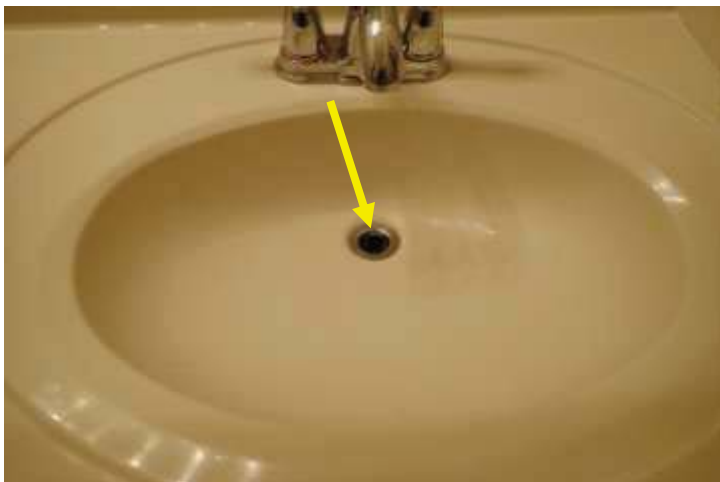
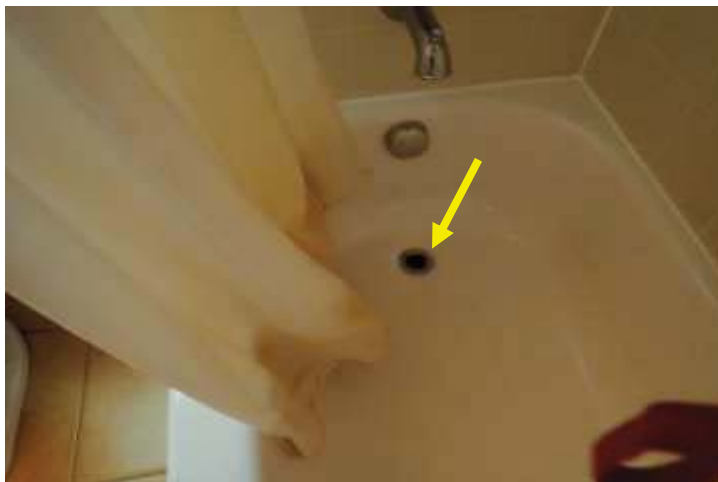
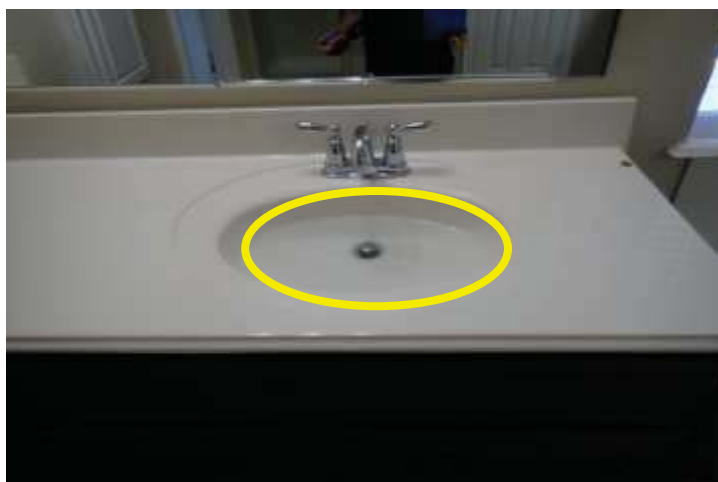
- Bathroom sink drain stop is missing or inoperable.
- Tub drain stop is missing or inoperable.
- Bathroom sink drains slowly.

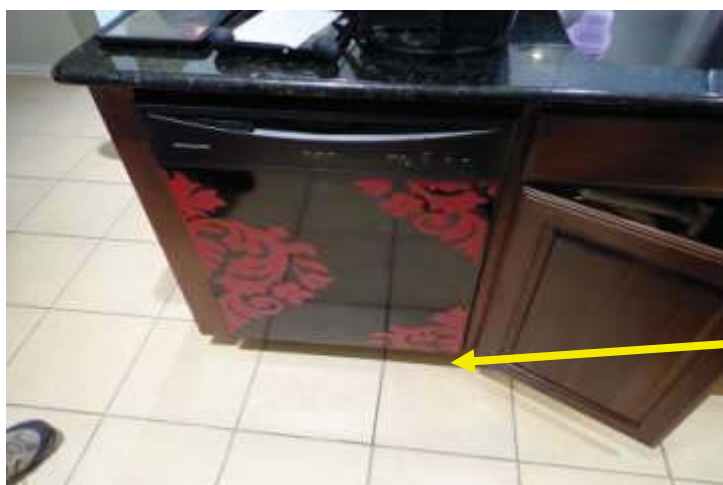
- Unit is leaking.

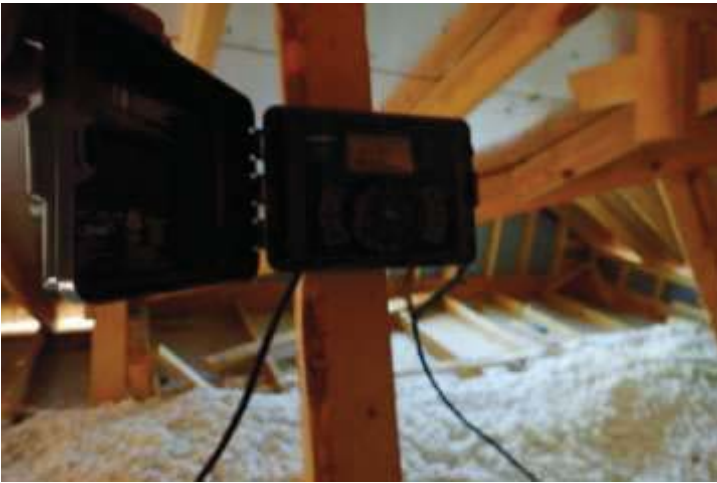
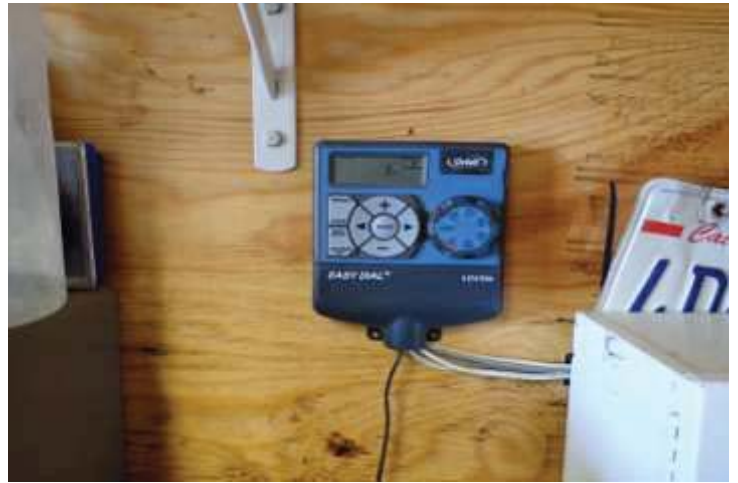
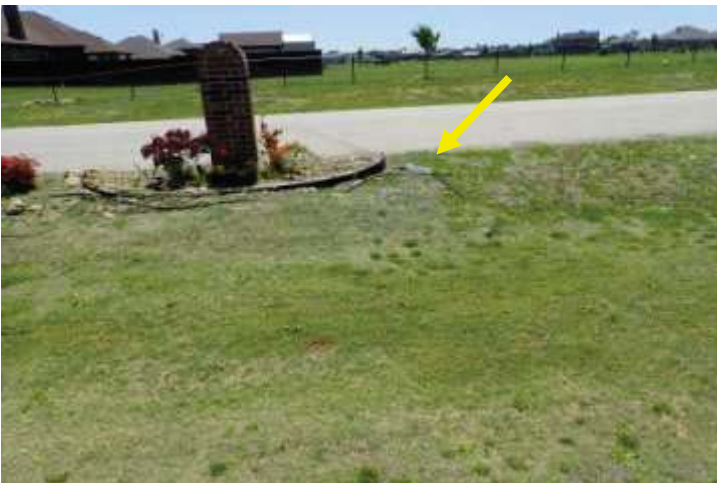
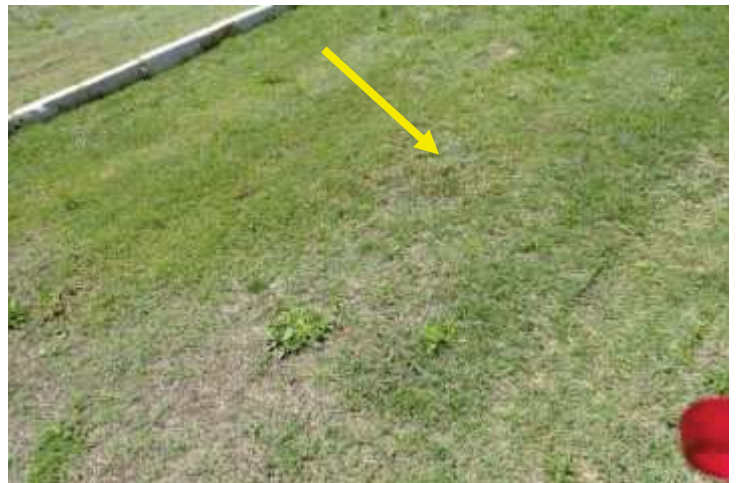
- Sprinkler system has 2 controllers. There are multiple broken heads, cut lines and damaged wiring. Backflow valve is designed for underground installation. If above ground is desired it should be protected from freezing with an insulation bag. Controller should be moved from attic to a more accessible location. I recommend a Certified Sprinkler Company evaluate and repair as required.

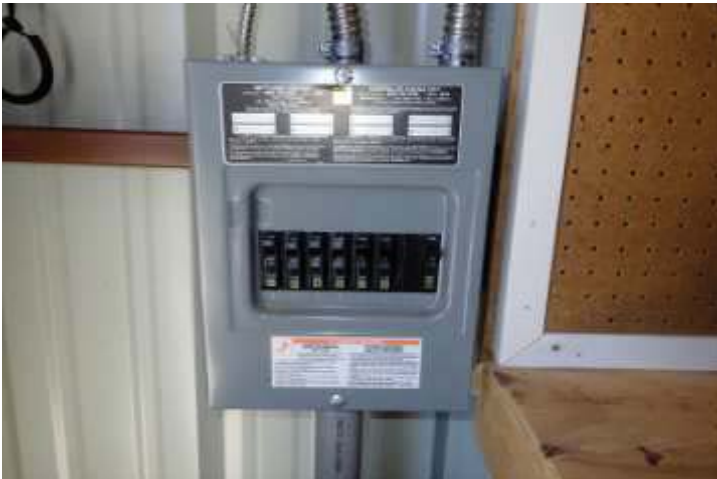
- Receptacles in building are not GFCI protected.
- Door is damaged and does not operate correctly. A qualified door company should evaluate and repair as required.
- Door opener is installed incorrectly. A qualified door company should evaluate and repair as required.
- Door lock should be removed or disabled with opener.
- Minor dents in siding.
- West grading is not 6 inch drop within 10 feet.
- Window unit tested OK.
