# YOUR INSPECTION REPORT

123 Indigo Ct.  
Lakewood, CO 80226

Tuesday, September 17, 2013

Report No. 1100, v.2

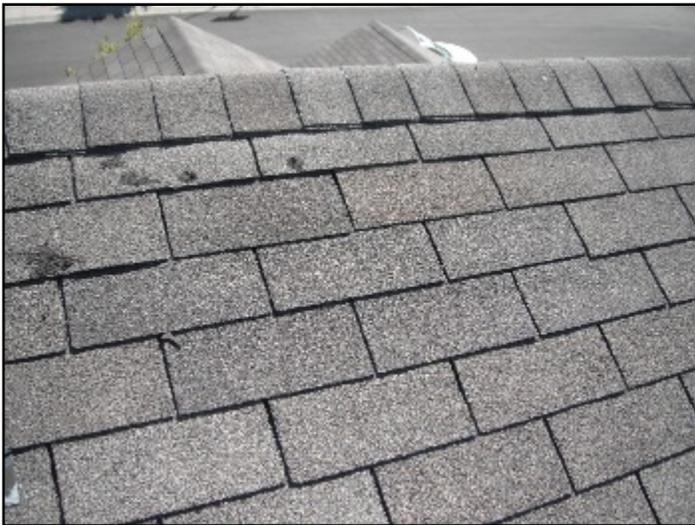
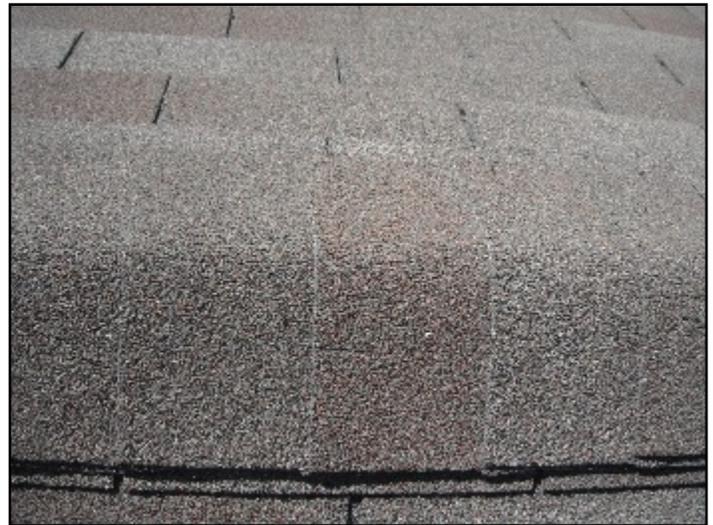
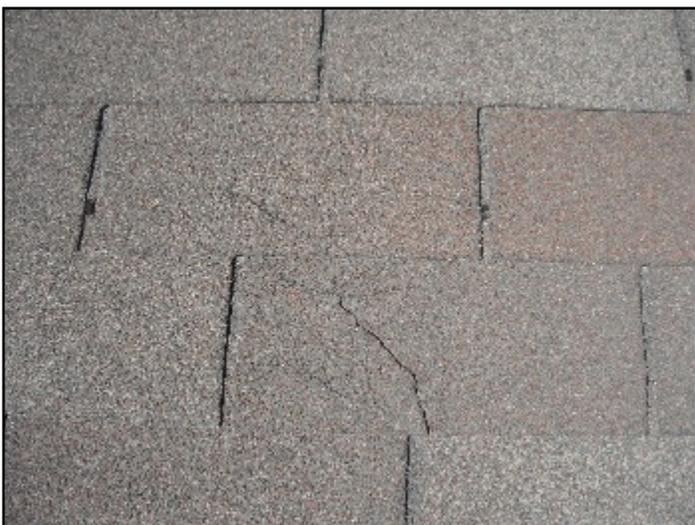
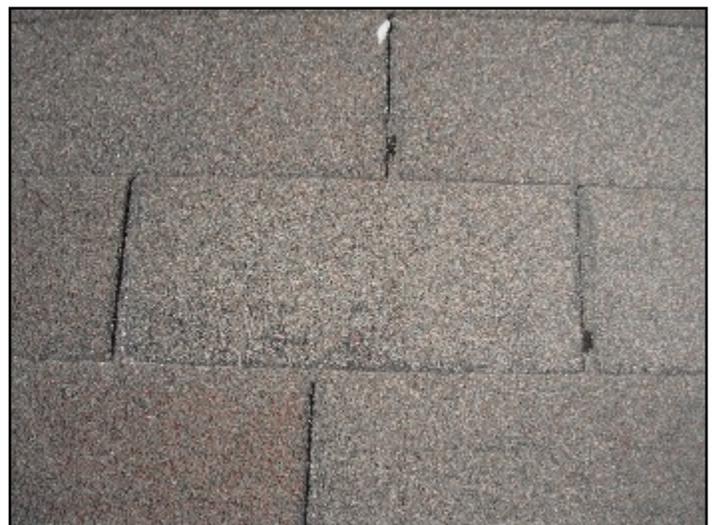
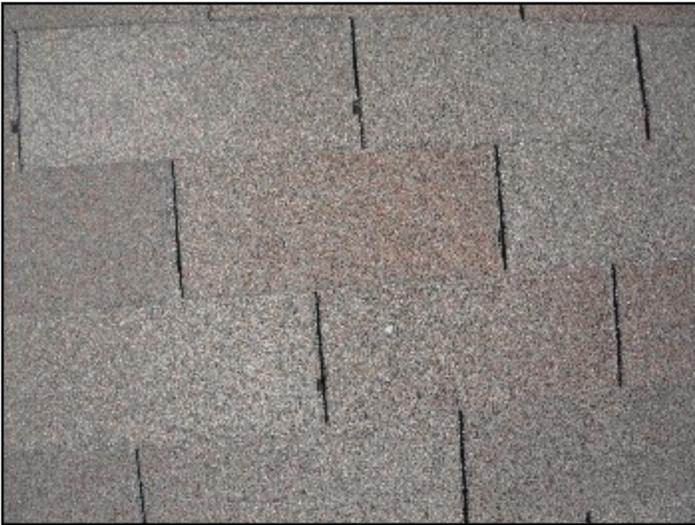
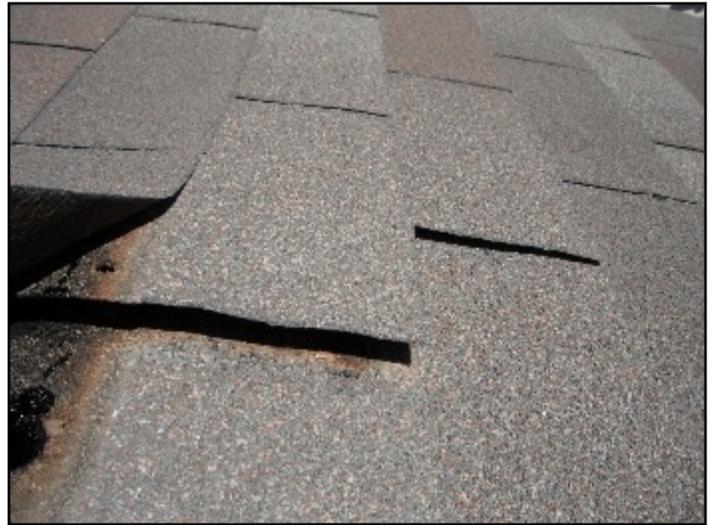
**Condition:** • Cracks, deterioration, minor pitting and multiple loose shingles observed. Prior repairs and exposed nail heads noted. Shingles are at their design life. Recommend tear-off and replacement of shingles due to age and condition by licensed roofing contractor.

**1. Condition:** • Cracks, deterioration, minor pitting and multiple loose shingles observed. Prior repairs and exposed nail heads noted. Shingles are at their design life. Recommend tear-off and replacement of shingles due to age and condition by licensed roofing contractor.

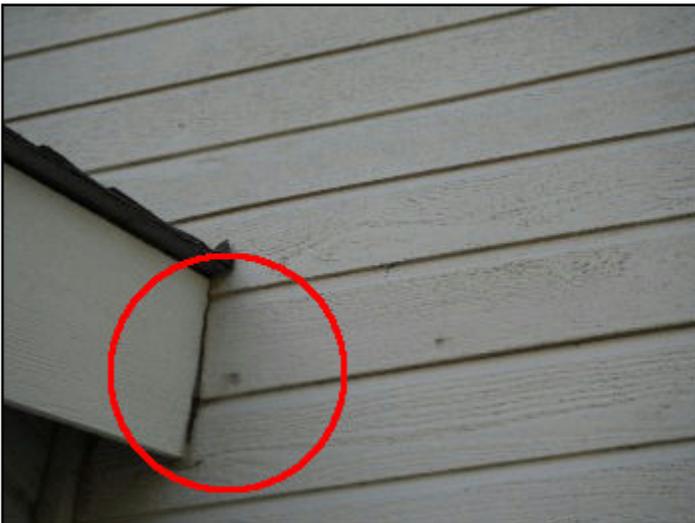
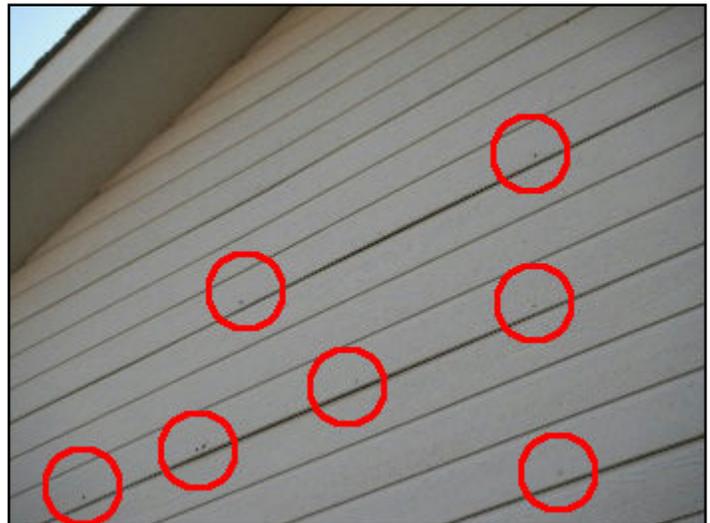
**Condition:** • The composite wood siding and trim were in poor condition. Paint is peeling and deteriorated. Areas of water damage, wood rot and warped siding observed. Multiple countersunk nails noted. Missing/cracked caulking allowing water intrusion. Missing paint and significant deterioration observed on trim and fascia. Loose fascia on west elevation. Recommend further evaluation, repairs and repainting by qualified contractor.

**4. Condition:** • The composite wood siding and trim were in poor condition. Paint is peeling and deteriorated. Areas of water damage, wood rot and warped siding observed. Multiple countersunk nails noted. Missing/cracked caulking allowing water intrusion. Missing paint and significant deterioration observed on trim and fascia. Loose fascia on west elevation. Recommend further evaluation, repairs and repainting by qualified contractor.

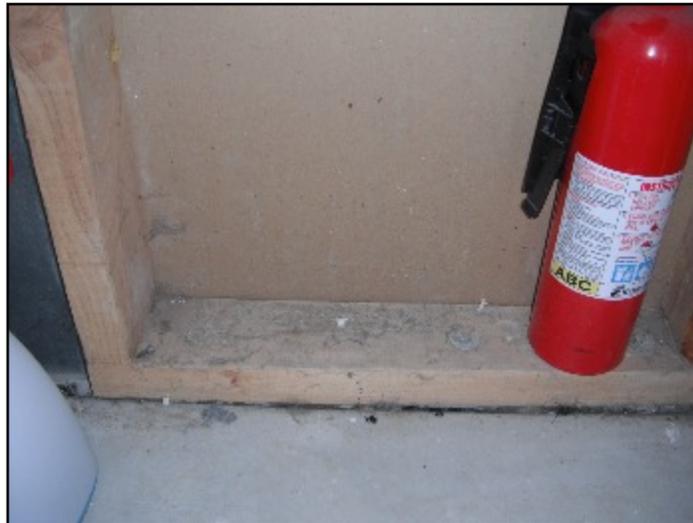
**Condition:** • Note: Basement walls are not floated which can cause stress/movement to the structure of the property. No significant movement or deflection of the slab was observed, although observation was limited due to stored material and floor coverings. Recommend further evaluation by qualified contractor and monitor condition.

**21. Condition:** • Note: Basement walls are not floated which can cause stress/movement to the structure of the property. No significant movement or deflection of the slab was observed, although observation was limited due to stored material and floor coverings. Recommend further evaluation by qualified contractor and monitor condition.

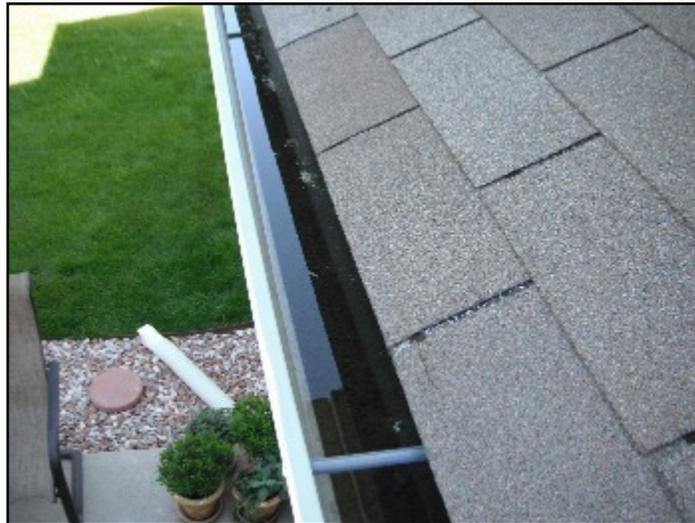
Note: Standing water observed in north gutter above patio. Recommend repairs for proper drainage by qualified contractor.

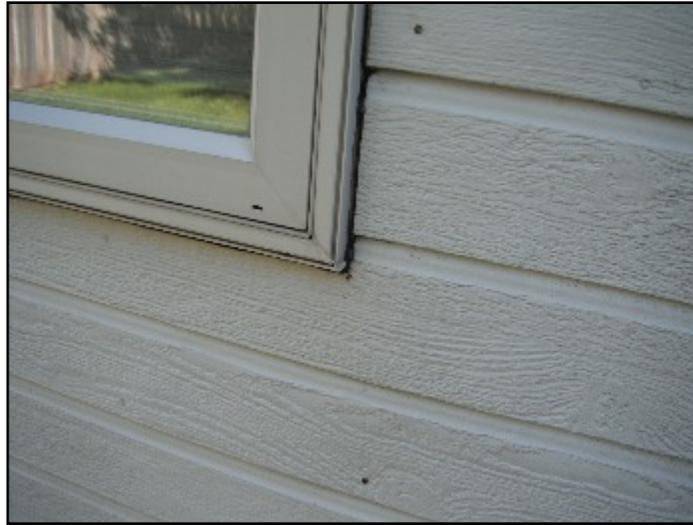
**6. Condition:** • Majority of windows appeared to be operating properly at time of inspection, general deterioration consistent with age observed. Keep all interior and exterior sills/seams caulked as part of routine maintenance.

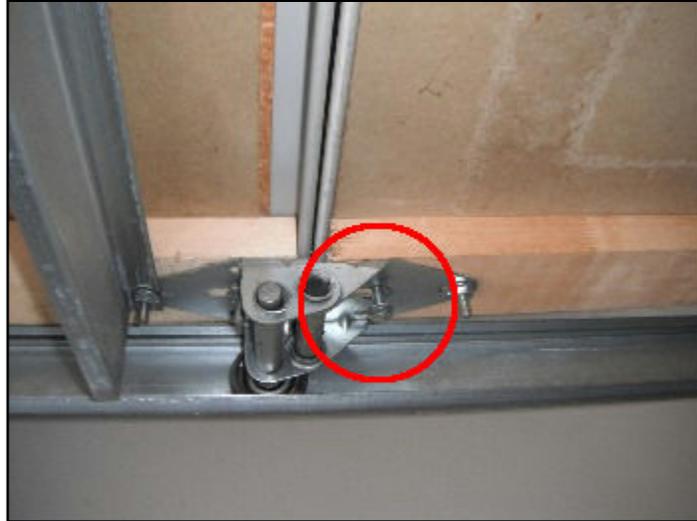
**18. Condition:** • Loose hardware observed on overhead garage door, recommend repairs by qualified person.

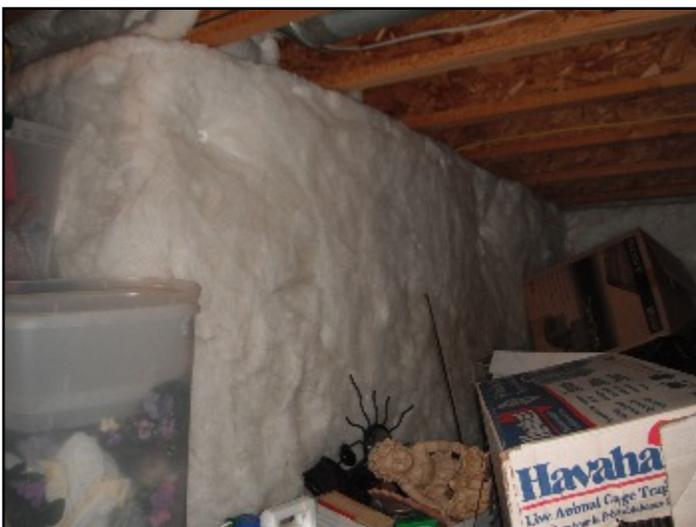
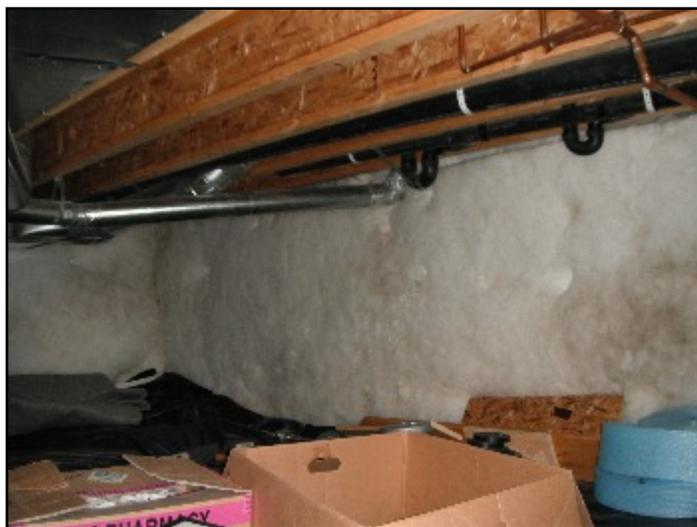
**19. Condition:** • Limited observation of foundation walls due to insulation and stored material. The foundation walls appeared to be plumb and stable; no significant settlement or cracks were observed or detected.

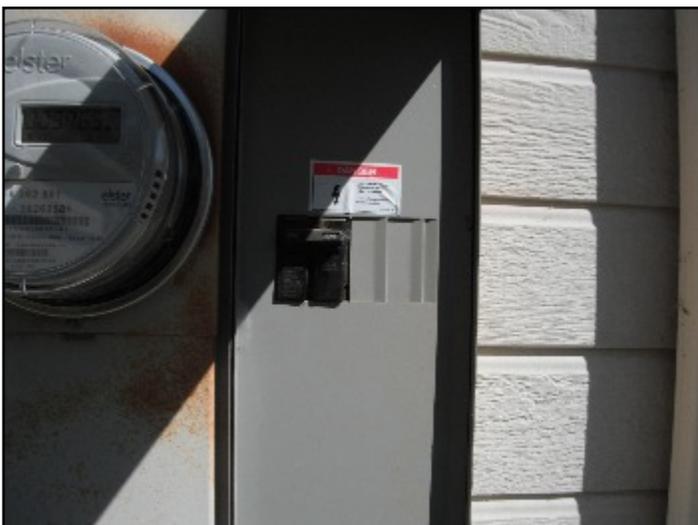
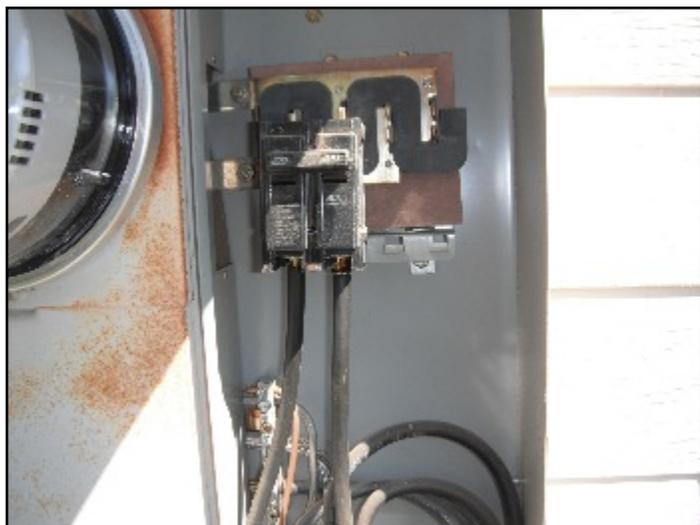
Note: Main disconnect is located on the west exterior wall

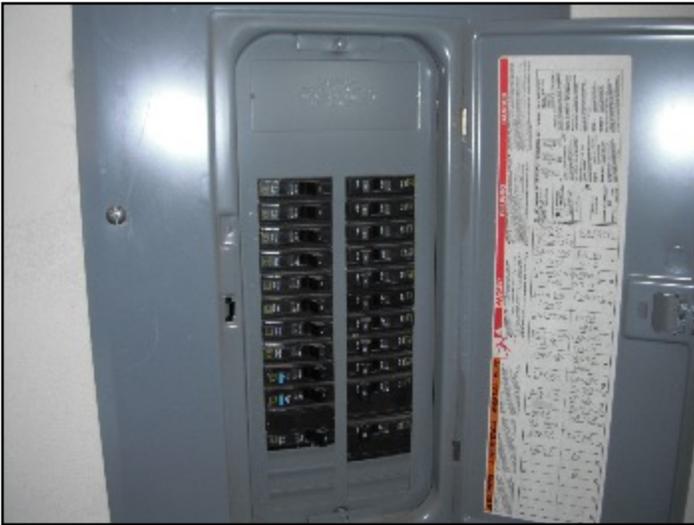
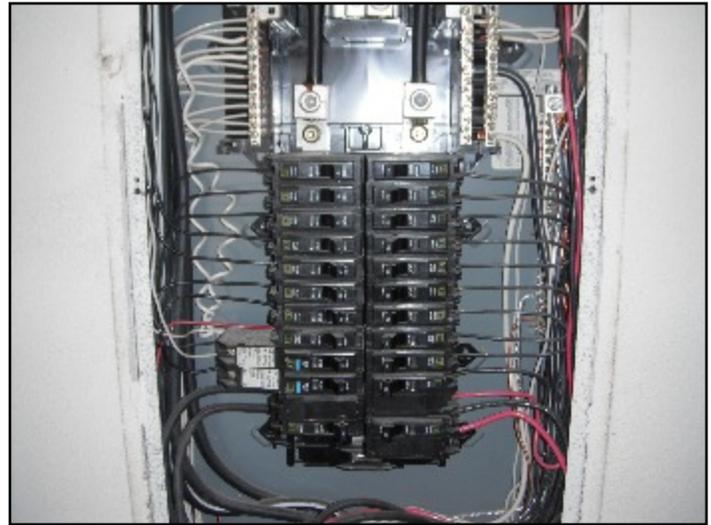
**23. Condition:** • The main service panel was wired properly with copper branch wiring; no deficiencies were detected.

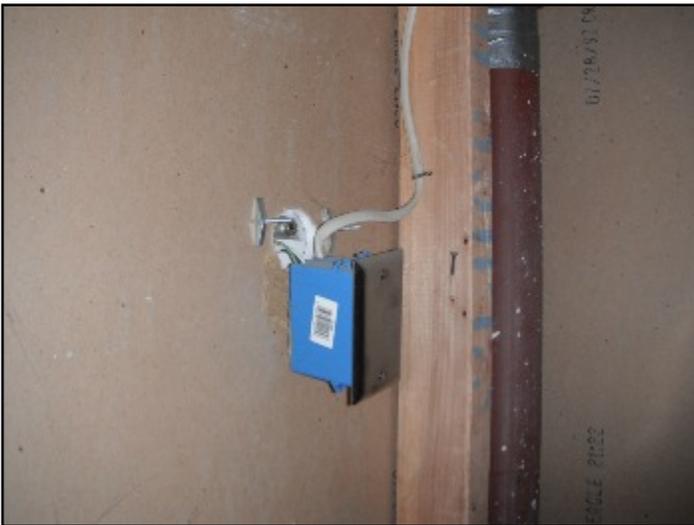
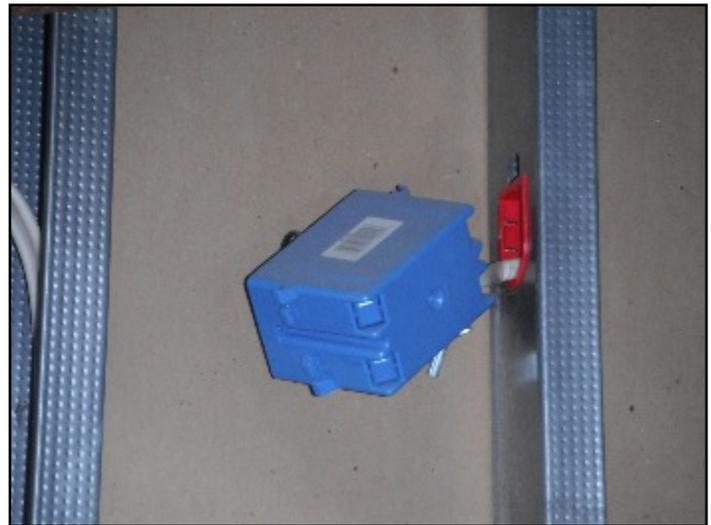
**24. Condition:** • Multiple loose and improperly installed junction boxes observed in the basement mechanical room. Recommend further evaluation and repairs by licensed electrician.

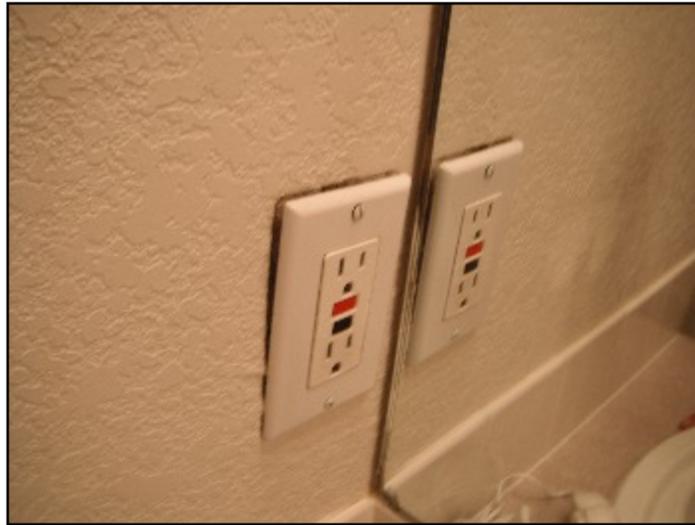
**25. Condition:** • Upstairs hallway bathroom GFCI wall outlet is loose and damaged. Recommend replacement by licensed electrician.

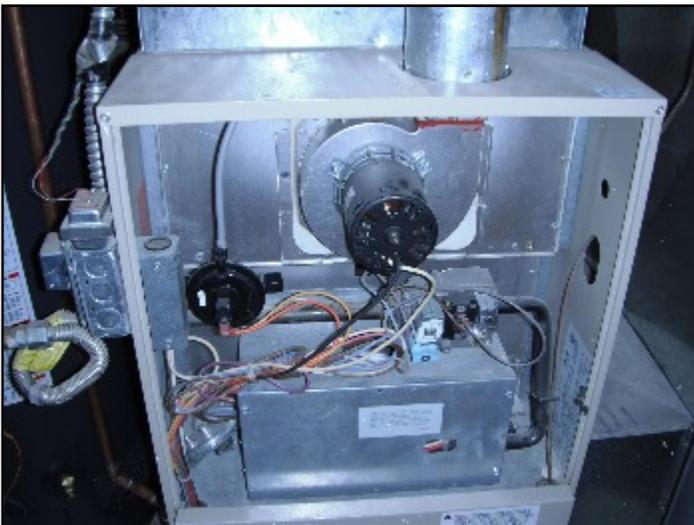
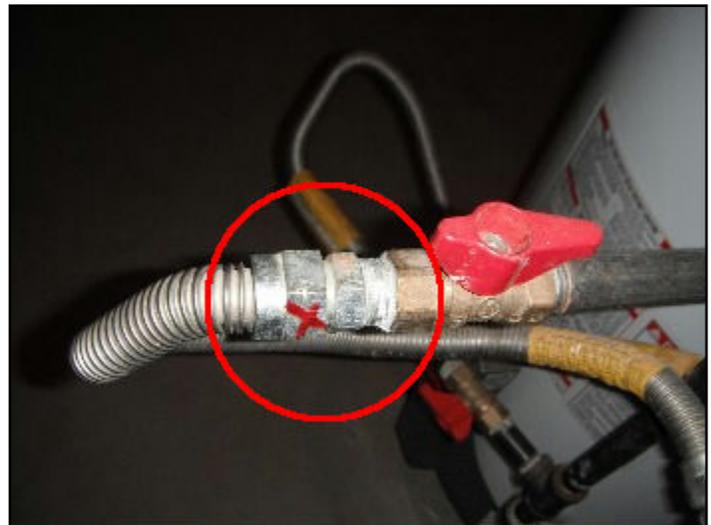
**28. Condition:** • Although the furnace was operating properly with no carbon monoxide detected, the furnace is at its design life. Minor gas leak detected at flexible gas line connection to shut-off valve. Recommend repairs and/or replacement of unit due to age by a qualified HVAC technician.

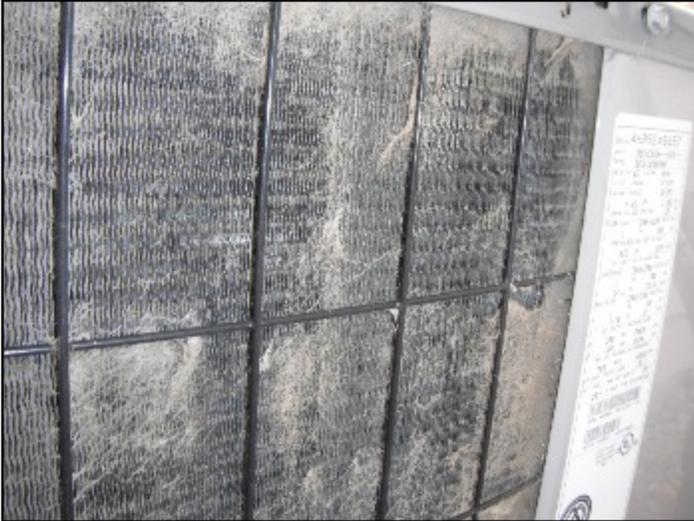
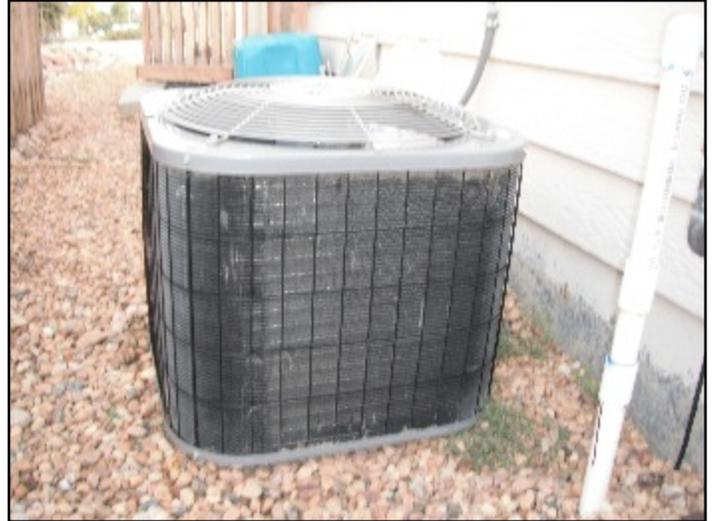
**30. Condition:** • The temperature differential was 22 degrees at the unit which is within industry standards for normal operation. Recommend routine cleaning and maintenance by a qualified HVAC technician.

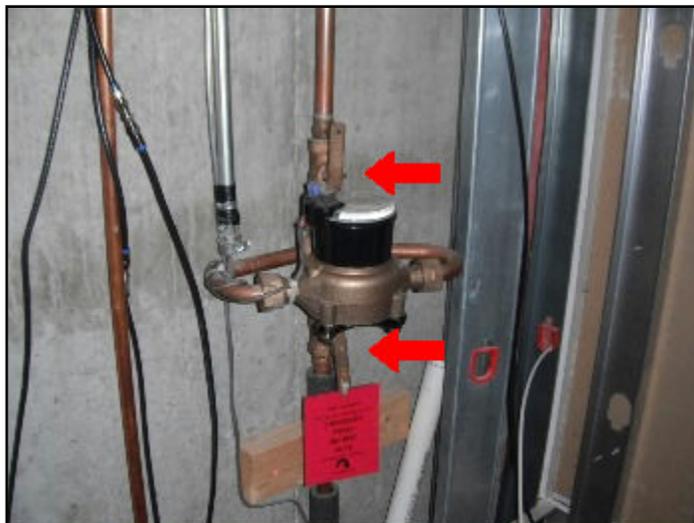
**Main water shut off valve at the:** • Basement utility room

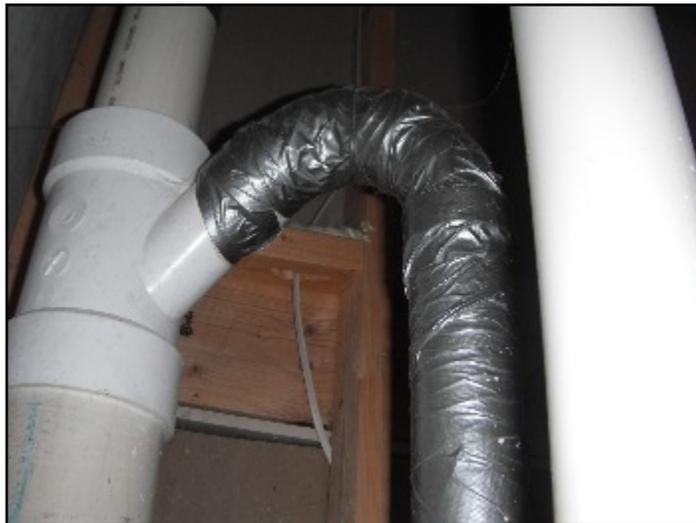
**34. Condition:** • Ejector pump was operating properly at time of inspection. Duct tape noted on drain pipe. No leaks present at time of inspection. Recommend further evaluation by qualified plumber and monitor condition.

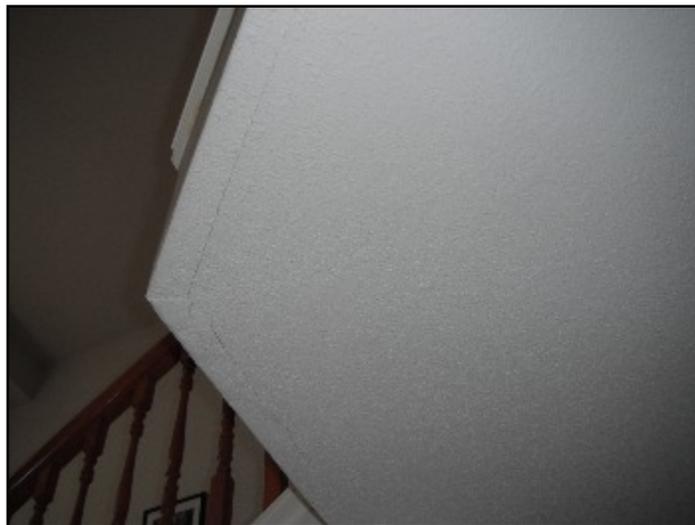
**36. Condition:** • Minor/typical ceiling cracks observed, monitor condition.

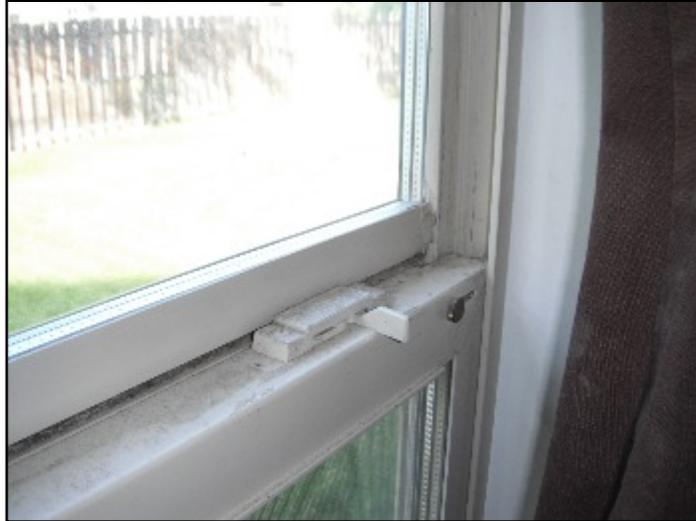
**37. Condition:** • Master bedroom north windows(2) balances were out. Recommend repairs by qualified contractor.

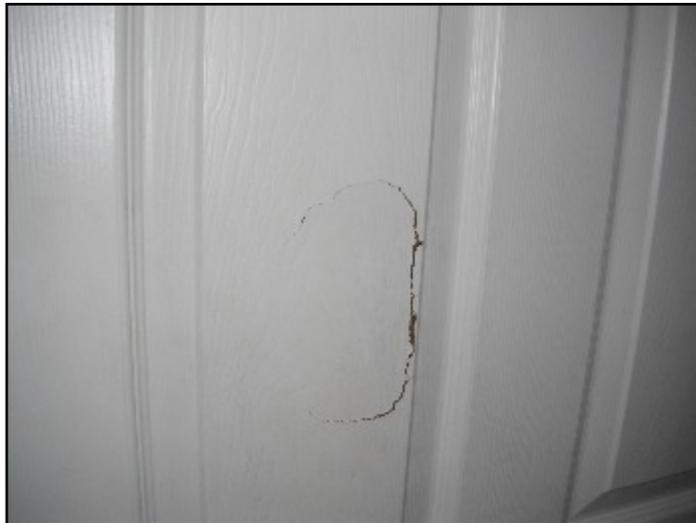
**38. Condition:** • Damage observed to master bedroom and basement doors. Recommend replacement by qualified person.

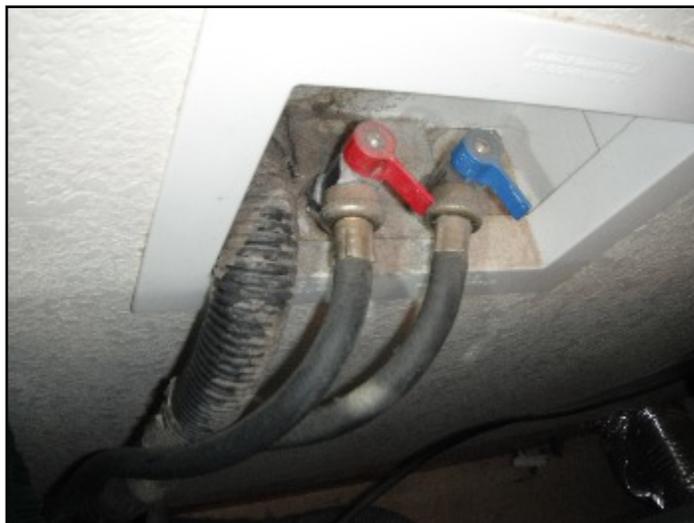
45. **Condition:** • No leaks were observed in supply lines at time of inspection. Note: Operation/draining of washing machine is not inspected during home inspection. Recommend replacing rubber supply hoses with braided stainless steel hoses.

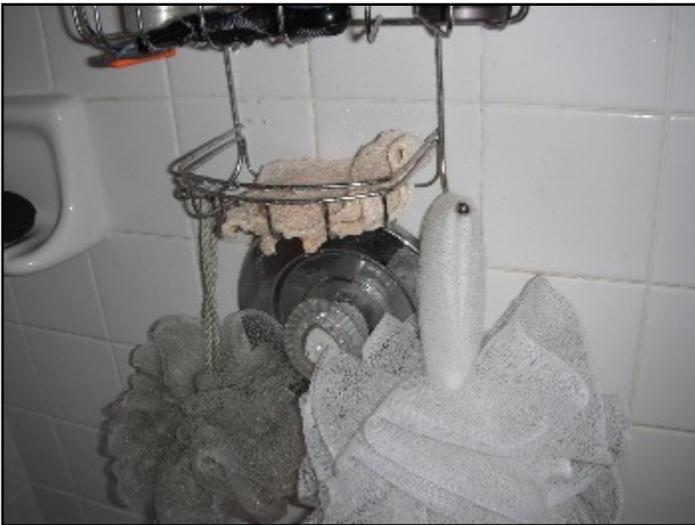
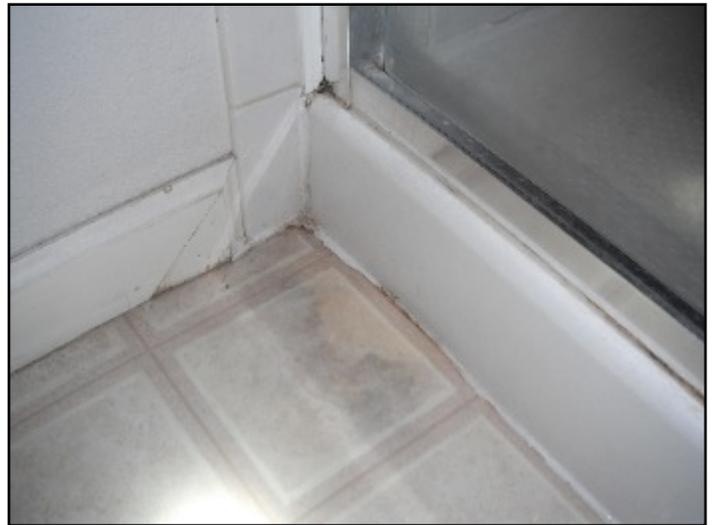
**47.** • Master bathroom shower valve is improperly installed. Nail pop noted on bathroom ceiling. Recommend repairs by qualified person. Maintain caulking around tub/shower and sink areas to prevent water intrusion.

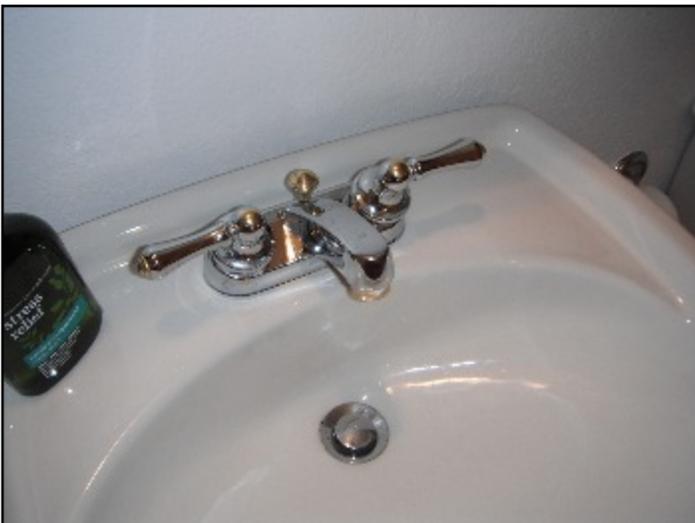
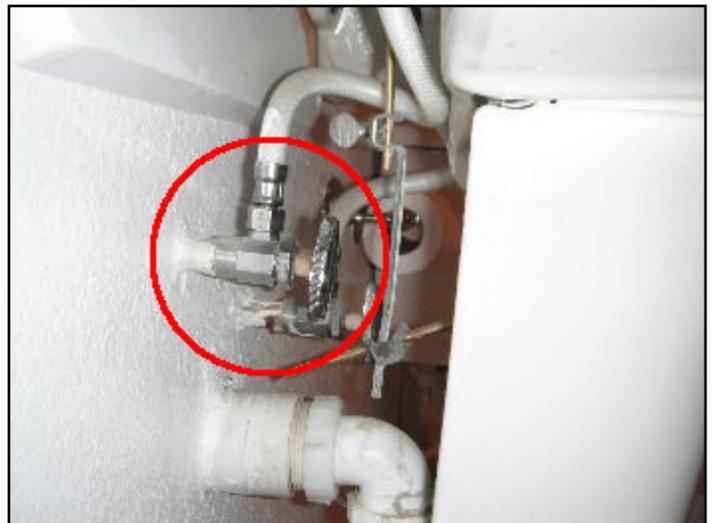
**48.** • Basement sink hot shut-off valve is not fully opening. Sink drain is slow. Multiple lights bulbs are burnt out in fixtures. Recommend further evaluation and repairs by qualified contractor.

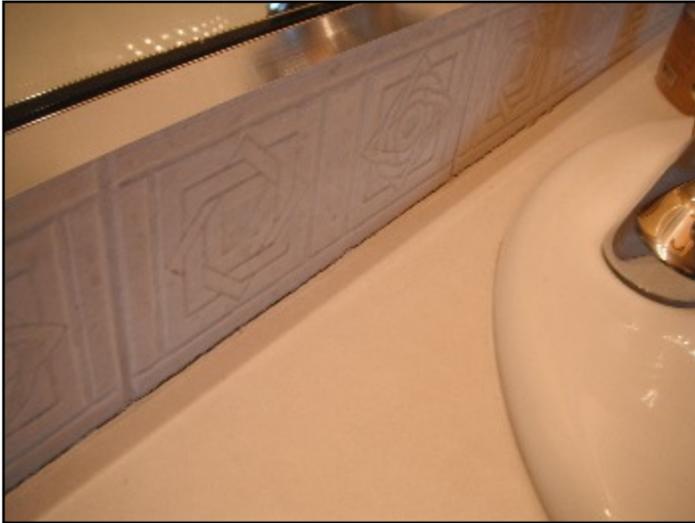
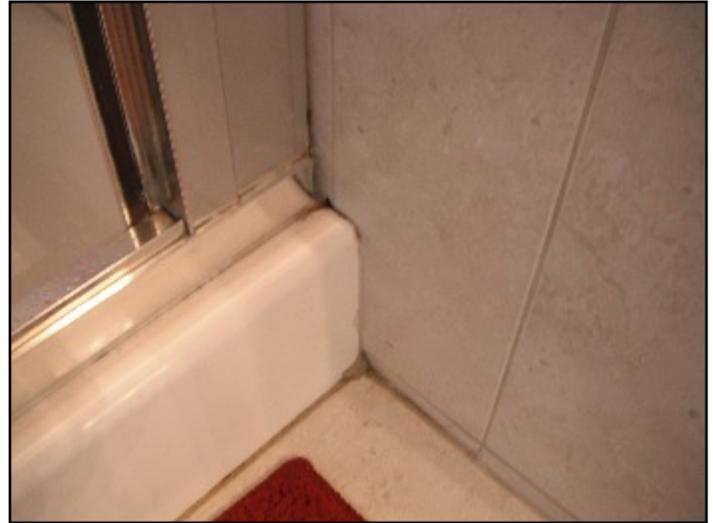
49. • All fixtures in the upstairs and hallway 1/2 bathrooms were inspected and operating properly with no leaks observed. Maintain caulking around tub/shower and sink areas to prevent water intrusion. Note: No heat source present in upstairs bathroom.

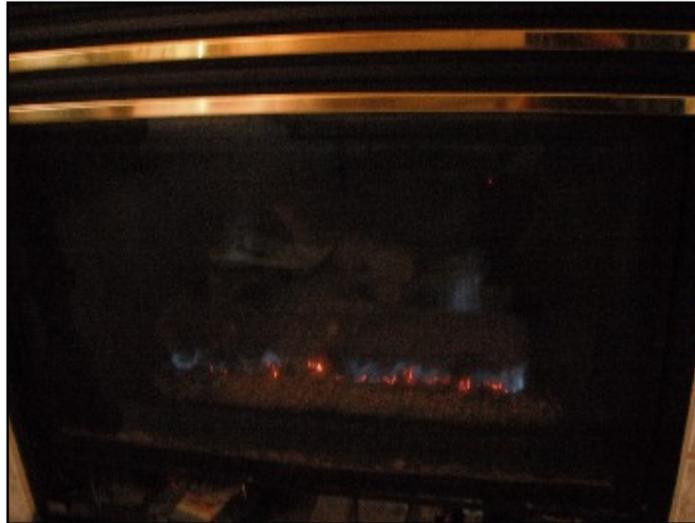
50. • The fireplace was operating properly, no gas leaks detected.
