# Uniform Mitigation Verification Inspection Form

| Inspection Date: <b>Jan 9, 2015</b> | | |
| Owner Name: <b>LONGWOOD COND ASSN INC</b> | | Contact Person: <b>LONGWOOD COND ASSN INC</b> |
| Address: <b>11811 AVENUE OF THE PGA BUILDING 3</b> | | Home Phone: <b>561-371-3260</b> |

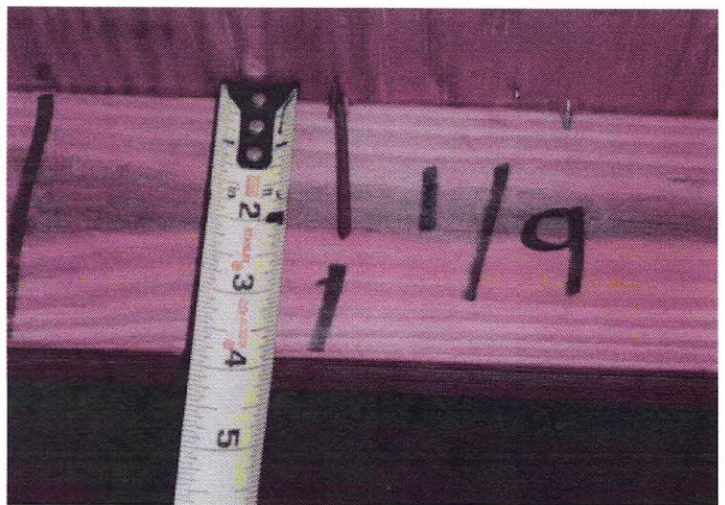
**#3 ROOF DECK ATTACHMENT**

- ☒ C. Plywood/OSB roof sheathing with a minimum thickness of 7/16" inch attached to the roof truss/rafter (spaced a maximum of 24" inches o.c.) by 8d common nails spaced a maximum of 6" inches in the field. -OR- Dimensional lumber/Tongue & Groove decking with a minimum of 2 nails per board (or 1 nail per board if each board is equal to or less than 6 inches in width). -OR- Any system of screws, nails, adhesives, other deck fastening system or truss/rafter spacing that is shown to have an equivalent

8d NAILS

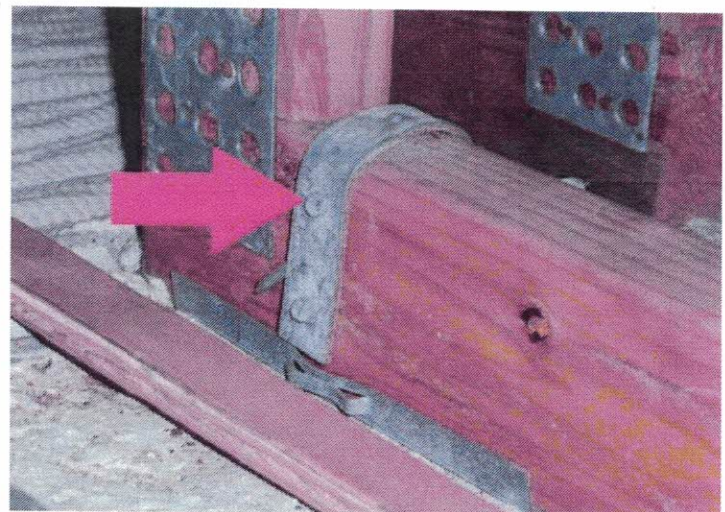
- ☒ C. Single Wraps
  - Metal connectors consisting of a single strap that wraps over the top of the truss/rafter and is secured with a minimum of 2 nails on the front side and a minimum of 1 nail on the opposing side.

**#4 ROOF TO WALL ATTACHMENT**  
OPPOSITE SIDE

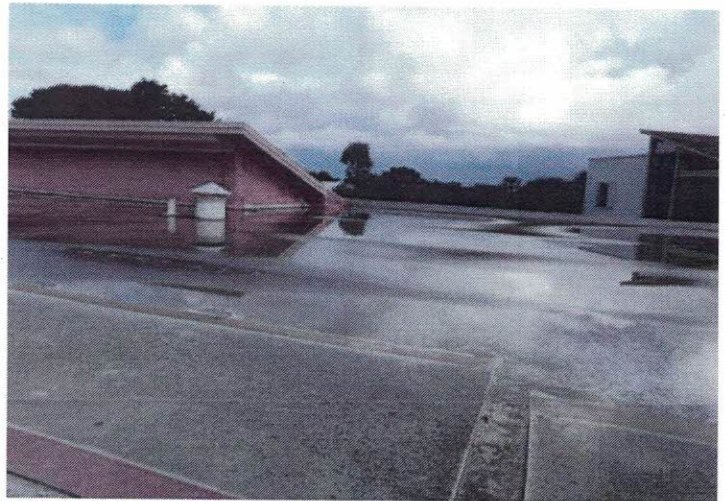
**ROOF COVERING**

| 2.1 Roof Covering Type: | Permit Application Date | FBC or MDC Product Approval # | Year of Original Installation or Replacement | No Information Provided for Compliance | Permit # |
|---|---|---|---|---|---|
| <input checked="" type="checkbox"/> 5. Membrane | ____/____/____ | _____ | <b>2006</b> | <input type="checkbox"/> | |

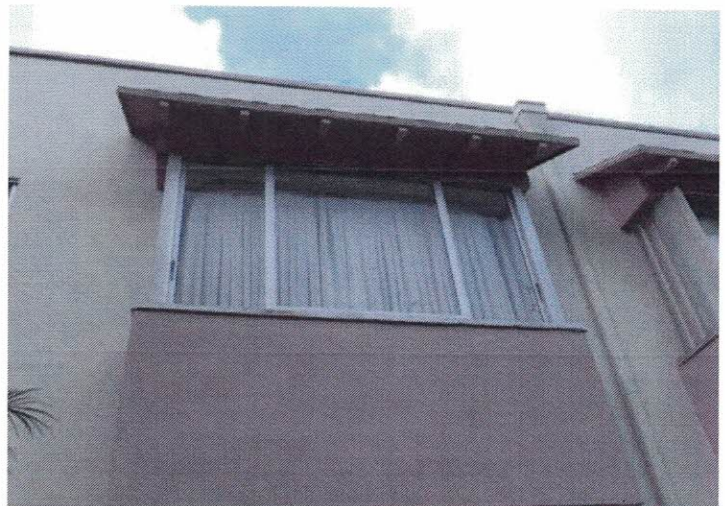
| Opening Protection Level Chart<br>Place an "X" in each row to identify all forms of protection in use for each opening type. Check only one answer below (A thru X), based on the weakest form of protection (lowest row) for any of the Glazed openings and indicate the weakest form of protection (lowest row) for Non-Glazed openings. | | Glazed Openings | | | | Non-Glazed Openings | |
|---|---|---|---|---|---|---|---|
| X | No Windborne Debris Protection | X | | | | X | |

**WINDOWS ARE NOT PROTECTED**
