Revised
FULL RESERVE STUDY
Baycrest
Homeowners Association, Inc.

Bonita Springs, Florida
Inspected - December 4, 2017
Revised - June 20, 2018

Client: Baycrest Homeowners Association, Inc. (Baycrest)
Location: Bonita Springs, Florida
Reference: 142198

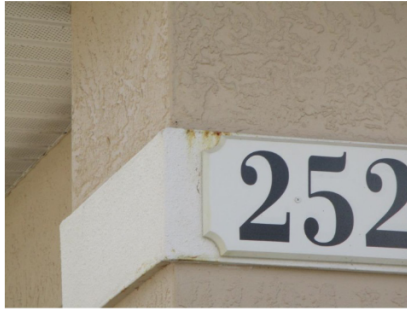
Condition: Good overall with minor rust stains evident

Minor rust stains

Useful Life: We recommend inspections, repairs and paint finish applications every five- to seven-years.

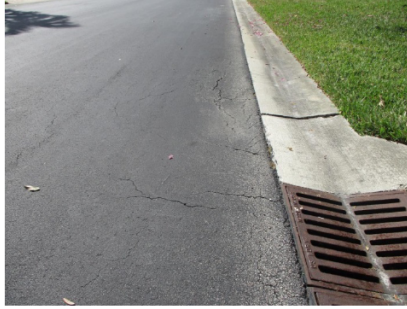
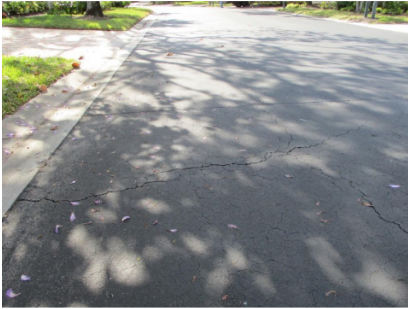
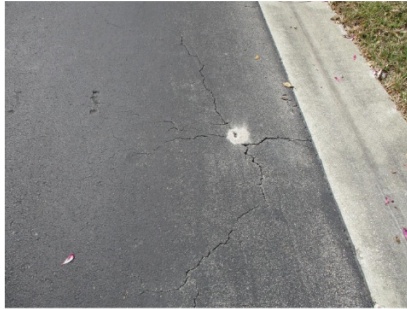
Condition: Good overall with isolated cracks

Pavement cracks

The manner of repaving is either a mill and overlay or total replacement. A mill and overlay is a method of repaving where cracked, worn and failed pavement is mechanically removed or milled until sound pavement is found. A new layer of asphalt is overlaid atop the remaining base course of pavement. Total replacement includes the removal of all existing asphalt down to the base course of aggregate and native soil followed by the application of two or more new lifts of asphalt. We recommend mill and overlayment on asphalt pavement that exhibits normal deterioration and wear. We recommend total replacement of asphalt pavement that exhibits severe deterioration, inadequate drainage, pavement that has been overlaid multiple times in the past or where the configuration makes overlayment not possible. Based on the apparent visual condition and configuration of the asphalt pavement, we recommend the mill and overlay method of repaving at Baycrest.

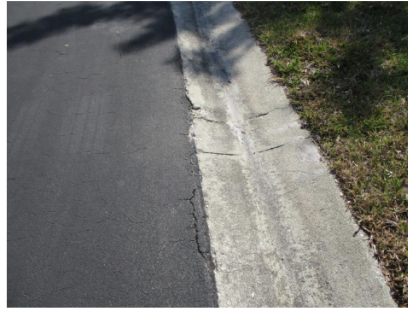
Condition: Good overall with isolated cracks

Minor gutter deterioration and cracks

Expenditure Detail Notes: Expenditure timing and costs are depicted in the **Reserve Expenditures** table in Section 3. We estimate that up to 1,200 linear feet of curbs and gutters, or twenty percent (20%) of the total, will require replacement during the next 30 years.

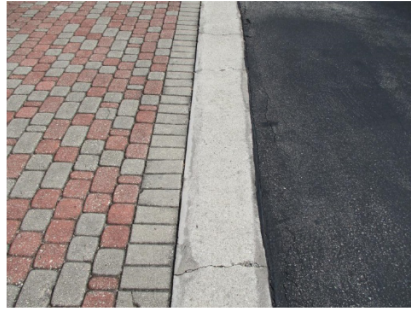
Condition: Good overall with isolated cracks

Cracks at pavement edge

Expenditure Detail Notes: Expenditure timing and costs are depicted in the **Reserve Expenditures** table in Section 3. We suggest the Association conduct interim resetting

and replacement of minor areas of pavers as normal maintenance, funded from the operating budget.

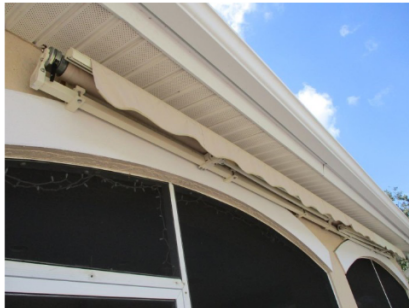
Condition: Good to fair overall condition

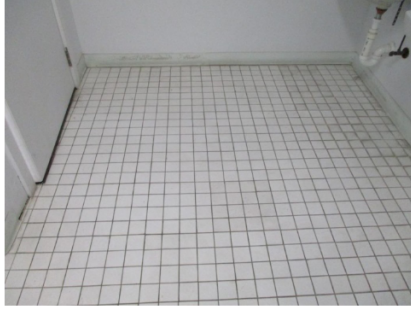
Condition: Fair overall

Rest room tile floor covering

Expenditure Detail Notes: Expenditure timing and costs are depicted in the **Reserve Expenditures** table in Section 3. The complete renovation should include replacement of all the interior components listed above.

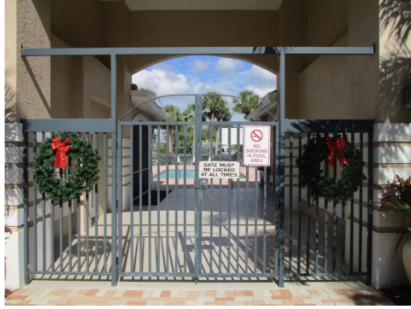
Condition: Good to fair overall with paint finish deterioration

Clubhouse gate

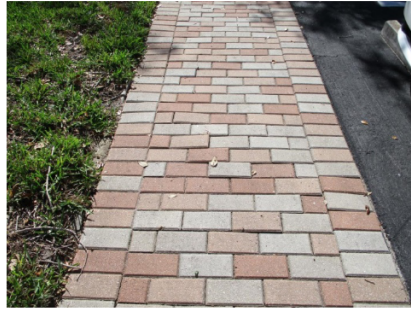
Condition: Good to fair condition overall with isolated displaced pavers

Displaced pavers at entry sidewalk

Expenditure Detail Notes: Expenditure timing and costs are depicted in the **Reserve Expenditures** table in Section 3. We recommend the Association fund interim inspections, partial replacements and repairs through the operating budget.

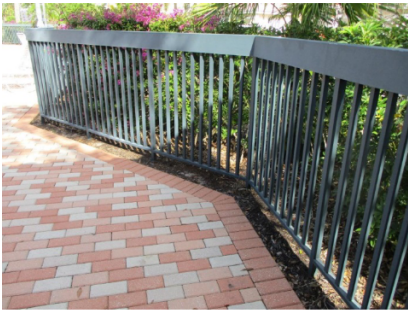
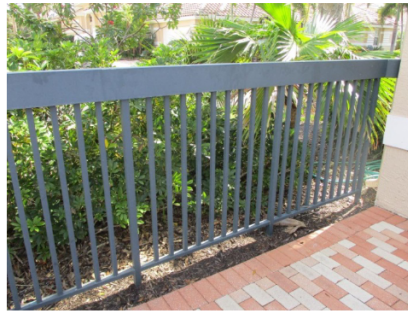
Condition: Good to fair overall condition with paint finish deterioration

Pool fence overview

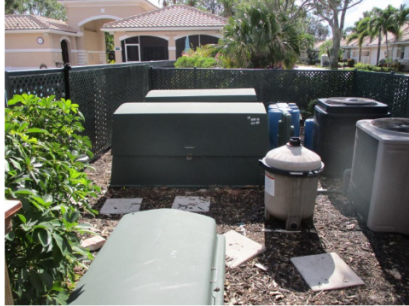
Condition: Reported satisfactory

Pool mechanical equipment

Expenditure Detail Notes: Expenditure timing and costs are depicted in the **Reserve Expenditures** table in Section 3. Failure of the pool mechanical equipment as a single event is unlikely. Therefore, we include replacement of up to fifty percent (50%) of the equipment per event. We consider interim replacement of motors and minor repairs as normal maintenance.

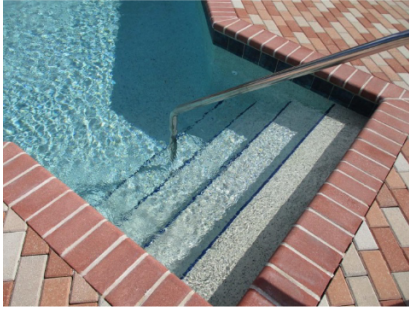
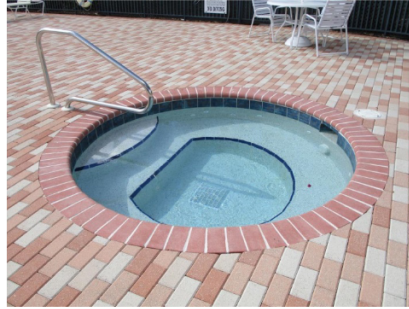
Condition: Good overall

Pool finish at entrance stairs

Spa plaster finish

Component Detail Notes: Removal and replacement provides the opportunity to inspect the pool structures and to allow for partial repairs of the underlying concrete surfaces as needed. To maintain the integrity of the pool structures, we recommend the Association budget for the following:

- Removal and replacement of the plaster finishes
- Partial replacements of the scuppers and coping as needed
- Replacement of tiles as needed
- Replacement of joint sealants as needed
- Concrete structure repairs as needed
